PROPERTY INSPECTION REPORT

18303 Saxon Creek Dr Humble TX 77338

Concerning: 18303 Saxon Creek Dr, Humble TX 77338				
(Address or Other Identification of Inspected Property)				
Michael Garcia - TREC #20817, TBPE FIRM #20170, MOLD				
By: FIRM #ACO1162, TPCL FIRM #0761253	07/29/2021 9:30 am			
(Name and License Number of Inspector)	(Date)

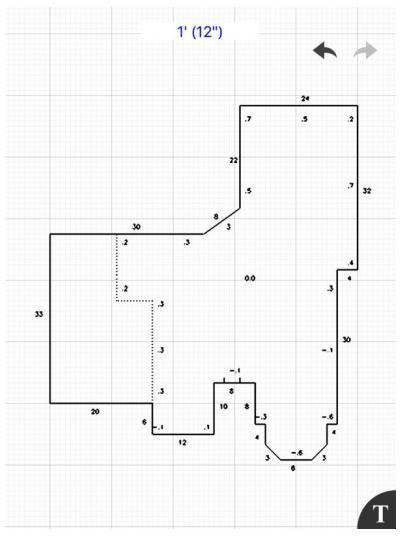
Performing - At this time, the foundation appears to be supporting the structure and immediate significant repair needs are not evident. Seasonal expansion and contraction observed which is considered normal for age, location and soil conditions. No major movement noted at the time of inspection.

Disclaimer: The attached elevations are used for information purposes only and should not be used for serious negotiations. GreenWorks inspectors are not qualified professional engineers and are not attempting to imitate one. If you have any concerns about the foundation life expectancy, insurability, or the potential for future problems, a professional engineer should be consulted.

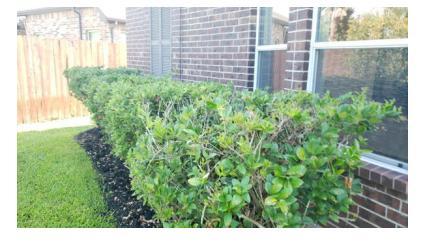
There were bushes and shrubs blocking visibility of the foundation wall in areas.

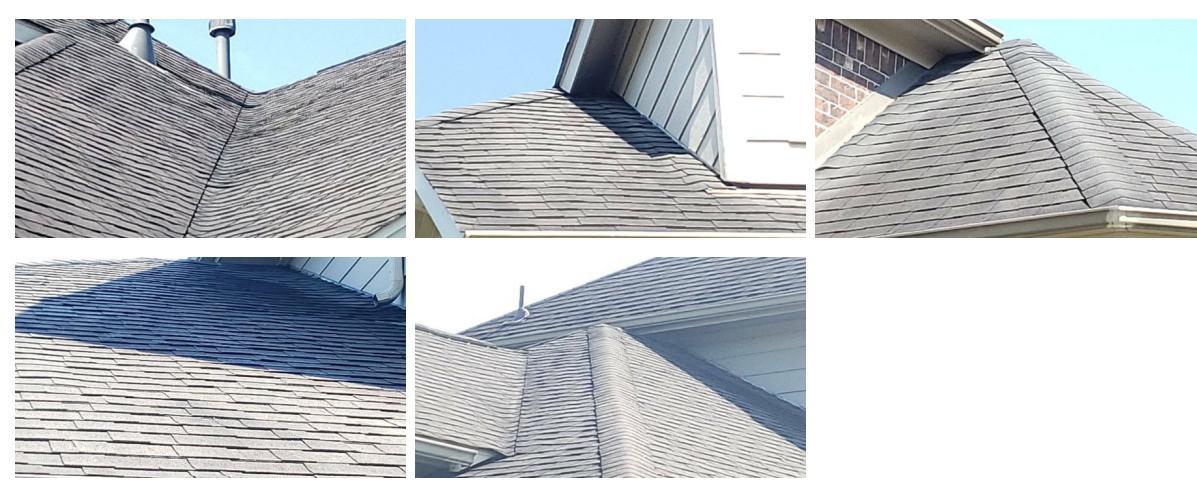
Aggregate loss was observed at the roofing material.

Recommendation: Contact a qualified roofing professional.

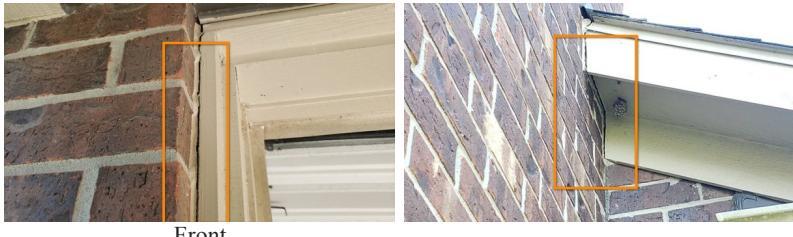
Front

There were gaps at the exterior wood surfaces. These areas can allow water penetration into the structure. It is recommended these areas be sealed.

Recommendation: Contact a qualified professional.

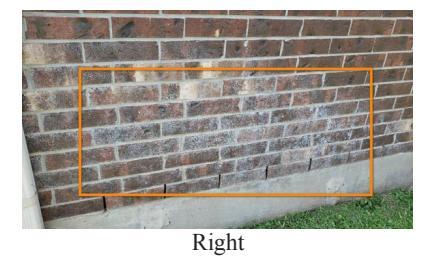
2: Exterior Discoloration Constant

Discoloration was noted at the exterior walls of the home.

Recommendation: Contact a qualified professional.

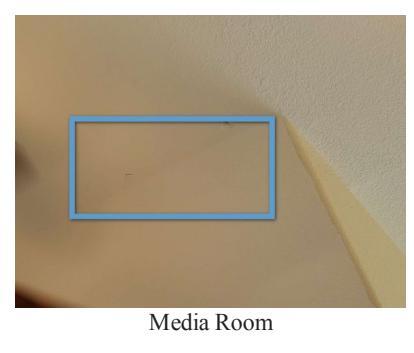
Nail pops noted in the interior walls at time of inspection.

Recommendation: Contact a qualified drywall contractor.

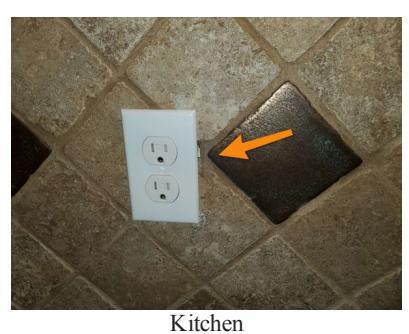
Grout was missing at the backsplash.

Recommendation: Contact a qualified professional.

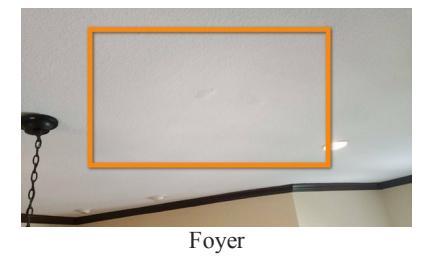
There were areas of water penetration at some of the ceilings. The areas did not register elevated moisture readings at the time of inspection. Further evaluation to determine cause is recommended.

Recommendation: Contact a qualified painting contractor.

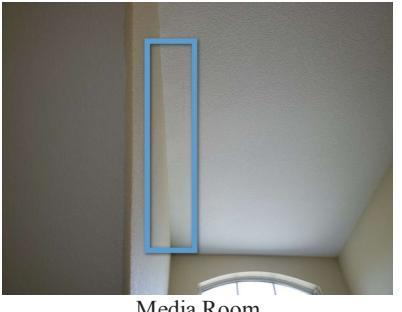
Media Room

There is joint separation in various areas.

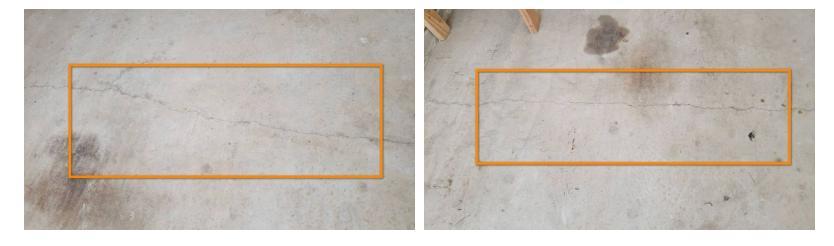
There were cracks in the garage floor.

Recommendation: Contact a qualified professional.

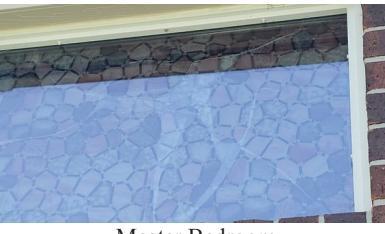
Master Bedroom

There was a broken window observed. Recommend repair or replacement.

Recommendation: Contact a qualified window repair/installation contractor.

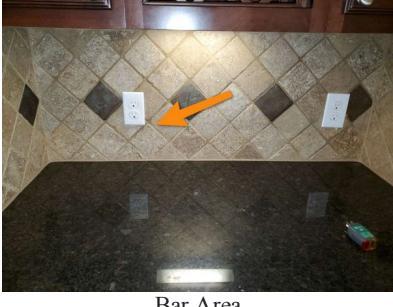
Bar Area

Various loose outlets observed in the home. Tightening of these outlets is recommended to prevent any loose wiring or electrical shock from occurring.

Recommendation: Contact a qualified electrical contractor.

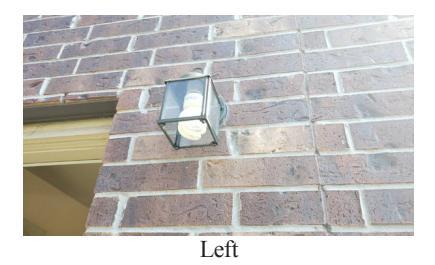
2: Lights Not Responding Recommendation

Some lights did not respond to testing.

Recommendation: Contact a qualified electrical contractor.

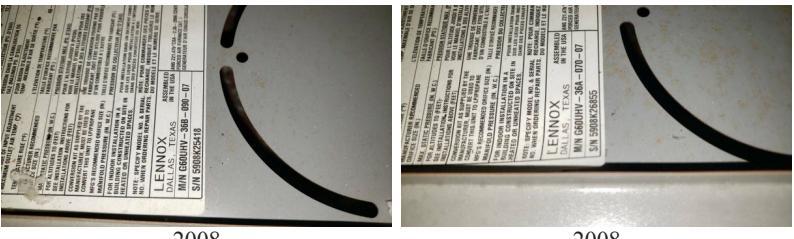
2008

Take this into consideration when noting the manufacture date for the unit at this property. It is recommended that units of the above ages be further evaluated and cleaned to verify that the heat exchanger and/or heating elements are working properly.

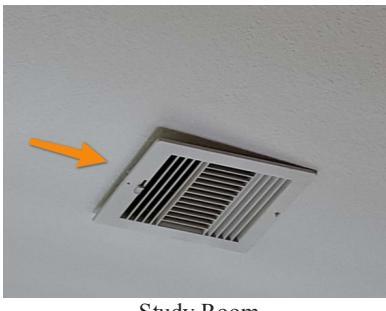
Study Room

One or more register were loose or gapped.

Recommendation: Contact a qualified professional.

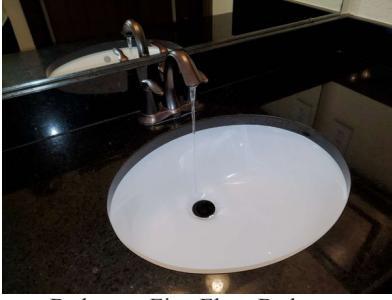
Bathroom First Floor Bedroom

Low water pressure is noted when cold water is in use.

Recommendation: Contact a qualified plumbing contractor.

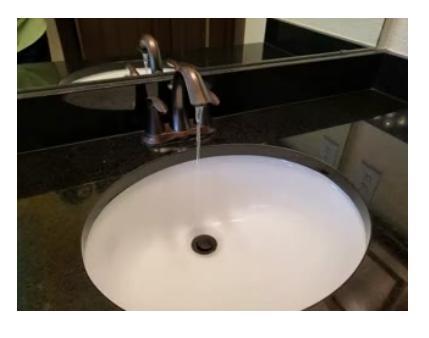
3: Water Pressure - Low when Hot Water is Used Recommendation

Low water pressure is noted when hot water is in use.

Recommendation: Contact a qualified plumbing contractor.

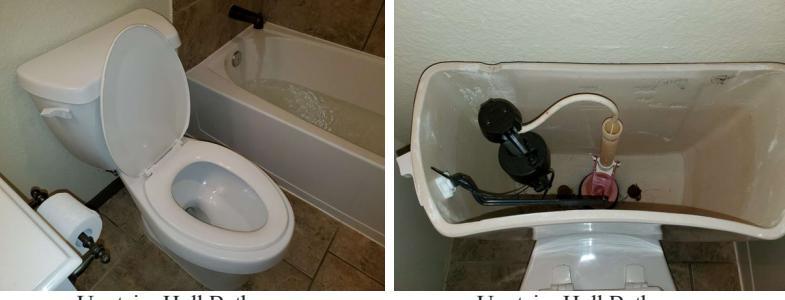
Upstairs Hall Bathroom

The toilet did not properly flush when tested.

Recommendation: Contact a qualified professional.

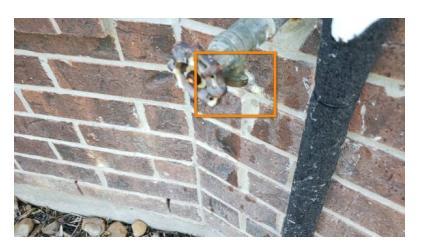
Part of the anti-siphon device on the exterior faucet is missing.

Recommendation: Contact a qualified professional.

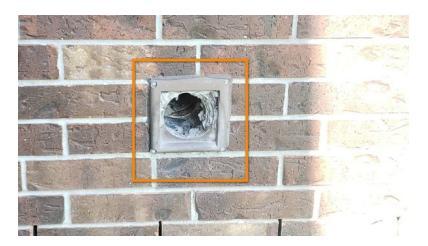
1: Vent Cover - Missing Recommendation

The exterior dryer vent cover was missing. Installation of a damper type cover is recommended.

Recommendation: Contact a qualified professional.

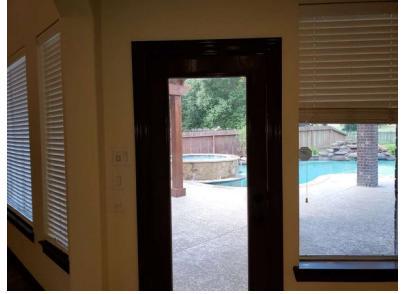
1: Door Chimes - Missing

There were not door chimes on the patio doors that directly lead to the pool.

Recommendation: Contact a qualified Swimming Pool Contractor

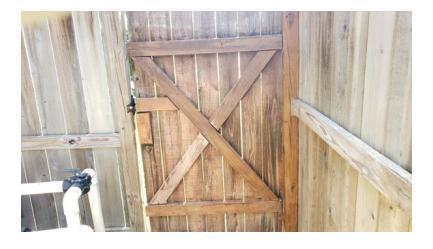
2: Self Closing Gate - Not Latching Recommendation

The self-closing gate did not latch when shut.

Recommendation: Contact a qualified Swimming Pool Contractor

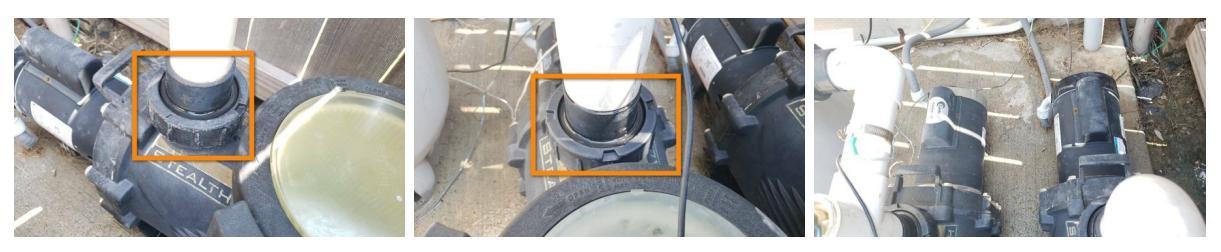
3: Water Leak - Piping Connection

There was a leak present at the pool piping connection point.

Recommendation: Contact a qualified Swimming Pool Contractor

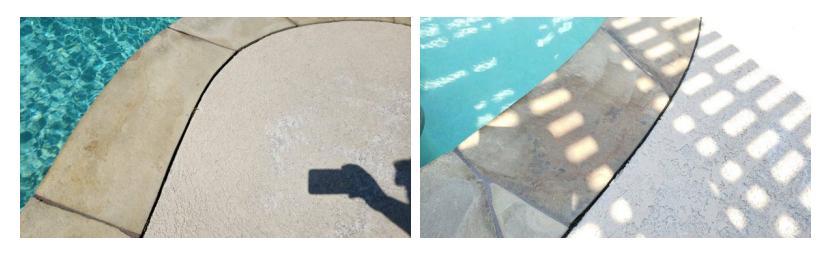
5: Deck-O-Seal Damage — Recommendation

There was Deck-O-Seal damage and separation around the pool.

Recommendation: Contact a stucco repair contractor
