## PROPERTY INSPECTION REPORT

10207 Eagle Hollow Dr  
Humble TX 77338

Prepared For: Lance Goble  
(Name of Clients)

Concerning: 10207 Eagle Hollow Dr, Humble TX 77338  
John Rugg - TREC #24498, TPCL FIRM #2017015000  
FIRM #ACO1162, LEAD FIRM #2110697, ASBESTOS  
By: AGENCY #100576, TPCL FIRM #0761253 10/26/2021 9:30 am  
(Name and License Number of Inspector) (Date)

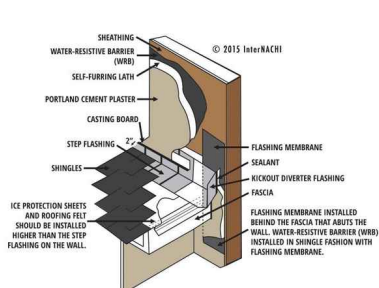
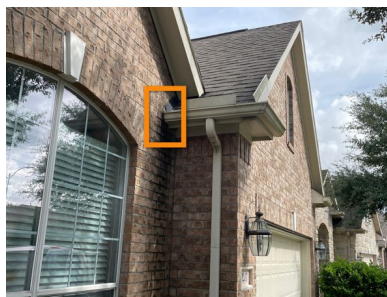
Kick out flashing was not observed at the wall/roof connection point. Kick out flashing should be installed where the roof terminates along a vertical wall so as to reduce the possibility of water entering the home.

Recommendation: Contact a qualified roofing professional.

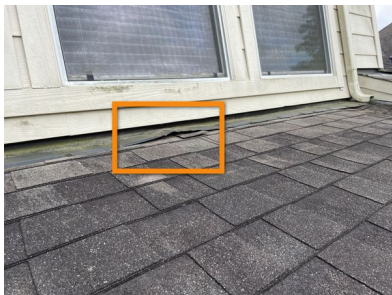
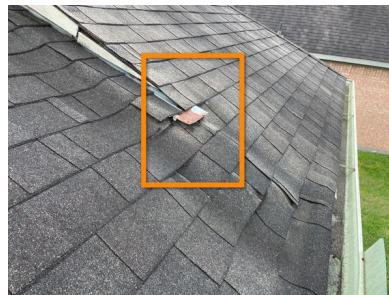
Flashing was uplifted and not properly sealed. This can allow water penetration into the structure. Repairs are recommended.

Recommendation: Contact a qualified professional.

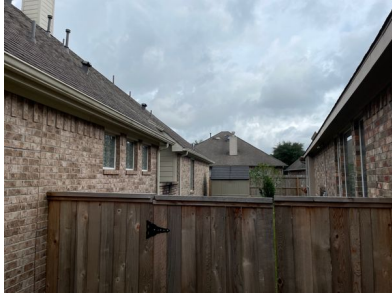
*Shared Wall - Exterior:*

The exterior wall was not visible due to being on the neighbor's property behind the fence.

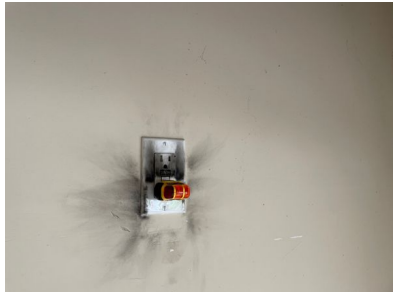
Outlet did not respond to testing. Repair or replacement is recommended.

Recommendation: Contact a qualified electrical contractor.

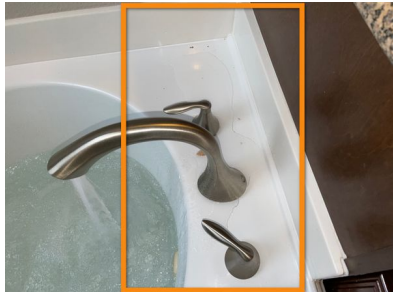
### 1: Leaking Faucet Handle

There is a leak at the faucet handle.

Recommendation: Contact a qualified plumbing contractor.

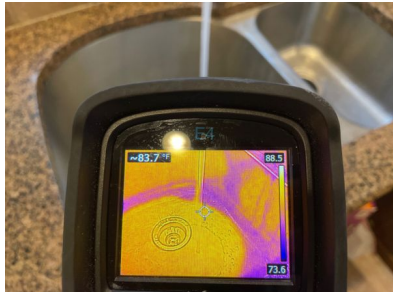
Unit did not respond to testing at time of inspection. Further evaluation and repair or replacement is recommended.

Recommendation: Contact a qualified plumbing contractor.

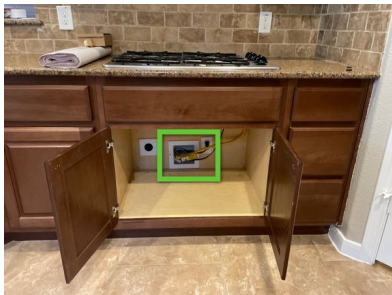
The range cooktop was not operated at time of inspection due to gas not being turned on to home at the time of inspection.

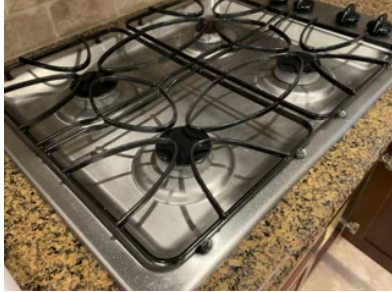
The pilot spark noise occurs every 30 seconds when the range is off. Recommend this be repaired prior to use.

Recommendation: Contact a qualified professional.

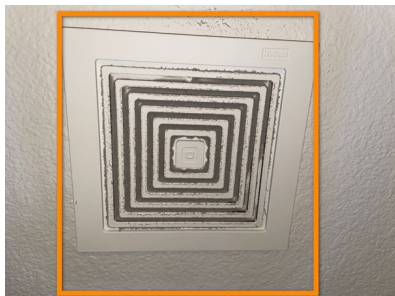
Downstairs Guest Bathroom

Exhaust fan covers are clogged with dust and should be cleaned.

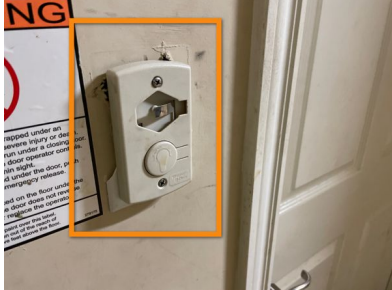
**1: Damaged Switch**

The wall switch was damaged.

Recommendation: Contact a qualified professional.

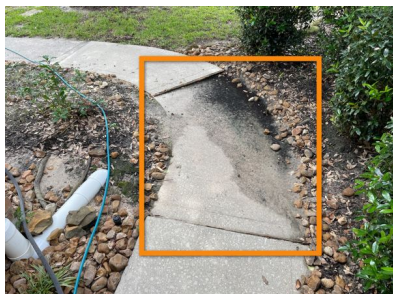
Cracking, damage, uplift or Settling was noted at the sidewalk. Recommend a qualified professional evaluate and repair.

Recommendation: Contact a qualified professional.
