HEDDERMAN ENGINEERING, INC.

REF: CONDITION OF PROPERTY SURVEY

At your request, a visual survey of the townhouse/condo located at 3010 Holly Hall Street Unit 3010, Houston, Texas, was made by Mr. Ruben Martinez and Mr. Tim Hedderman.

3010 Holly Hall Street Unit 3010

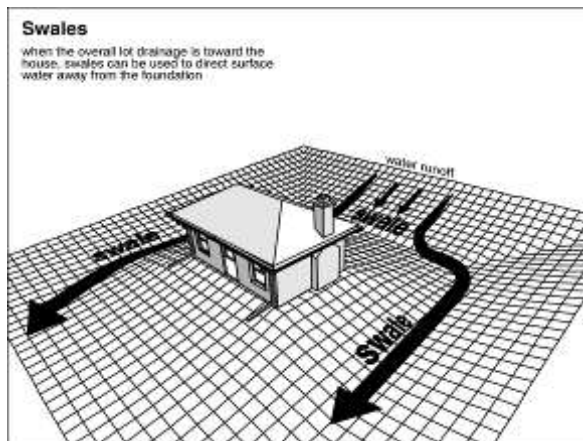
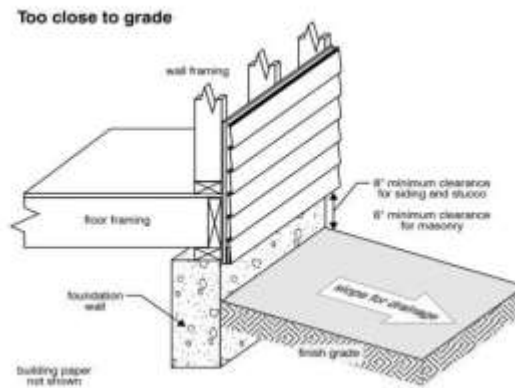
The perimeter drainage at the front and the rear of the property appeared to generally be adequate. It was not raining at the time of the inspection and, therefore, it could not be determined with certainty if water would pool at any localized low areas around the property. Further investigation with the homeowner is recommended to determine if there are any drainage problems or standing water after a rain.

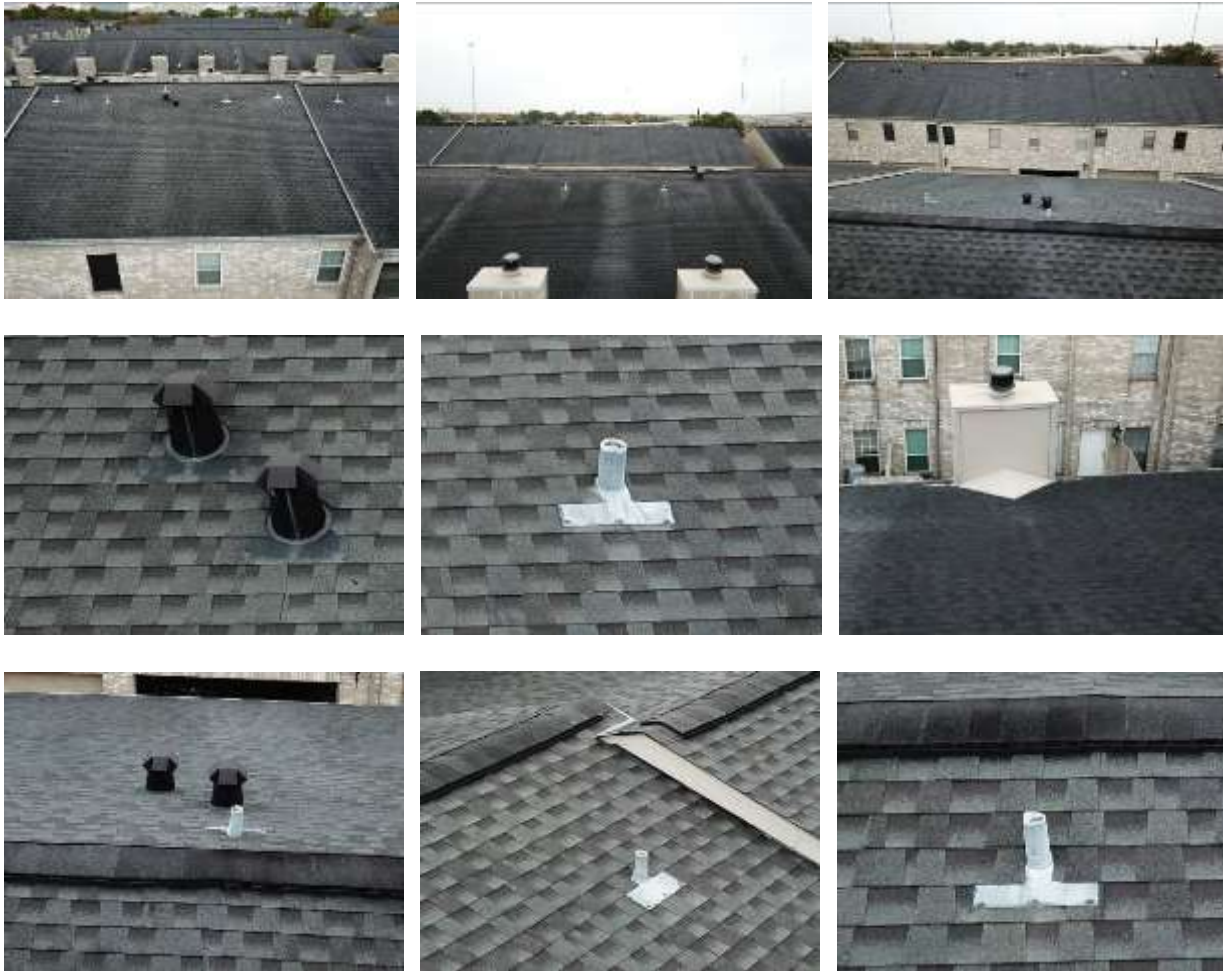
Due to the height of the roof, the roof was not viewed from its surface due to safety concerns but was viewed with a drone.

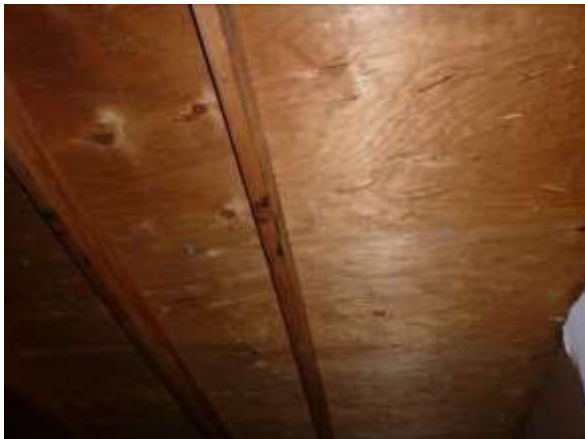
It was observed that spacer clips were installed at the joints between the roof decking to allow for expansion of the roof deck.

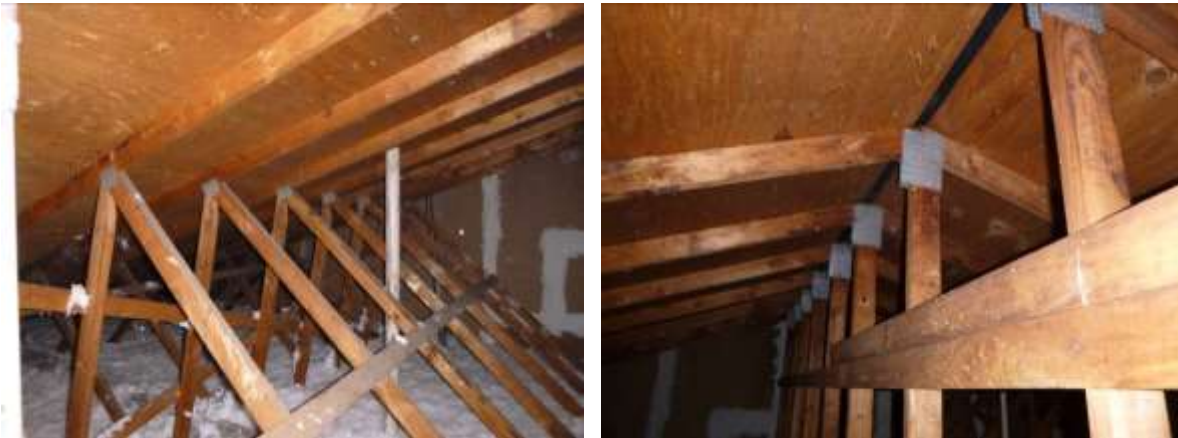
The roof framing members in the attic were constructed of prefabricated trusses connected with metal gusset plates pressed into the wood at the joints.

We did not observe metal hurricane clips/straps installed at the attic framing members. These clips/straps provide a stronger structure that will be more resistant to wind uplift from hurricane and tornadoes. These clips/straps were not commonly used on this age home at construction.

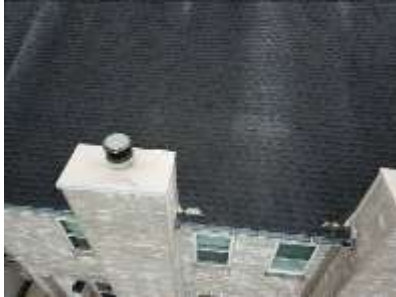
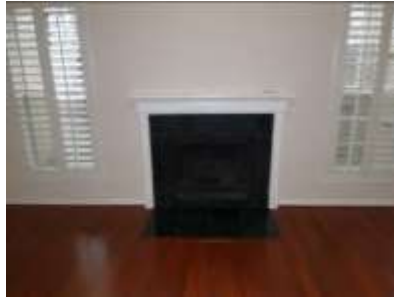
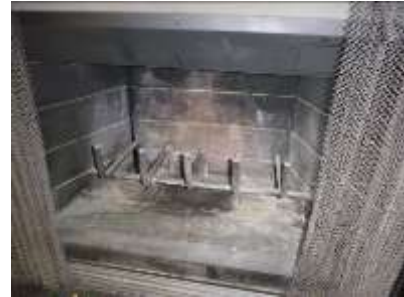
The fireplace was a prefabricated metal fireplace with a metal flue pipe that extends up through the roof. The firebox was not equipped with a gas supply line.

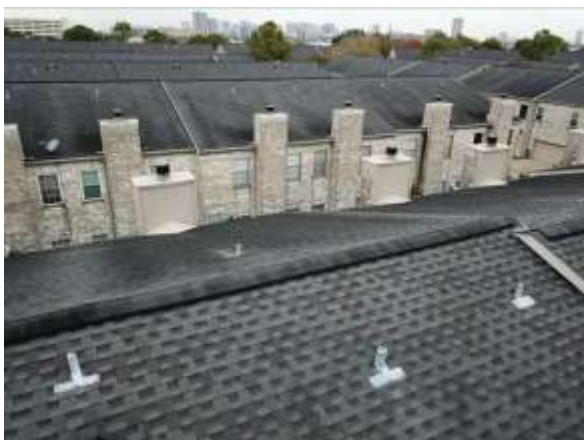
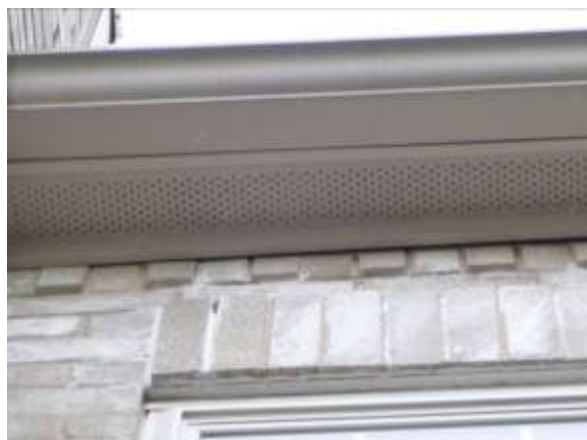
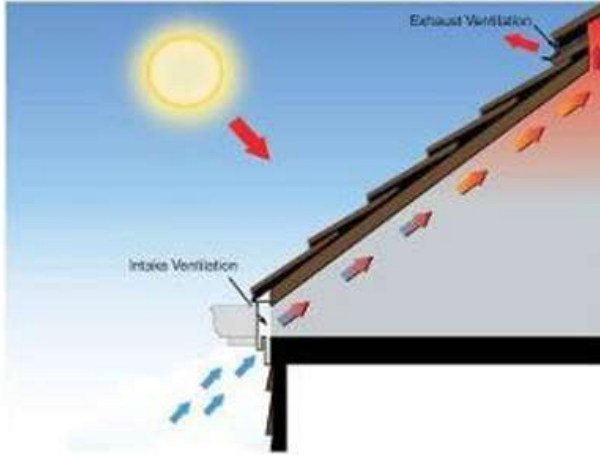
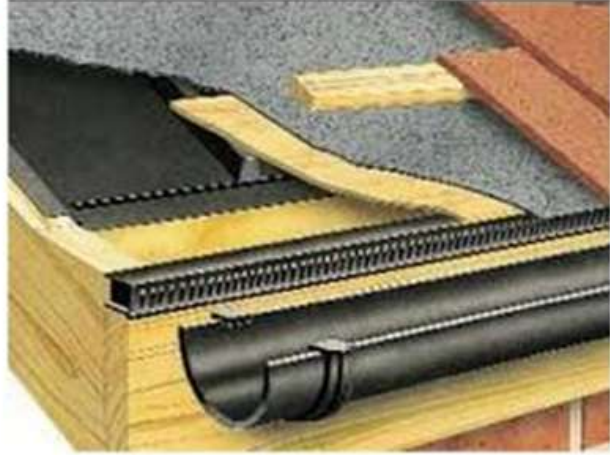
The ventilation for the attic included continuous ridge vents and continuous soffit vents.

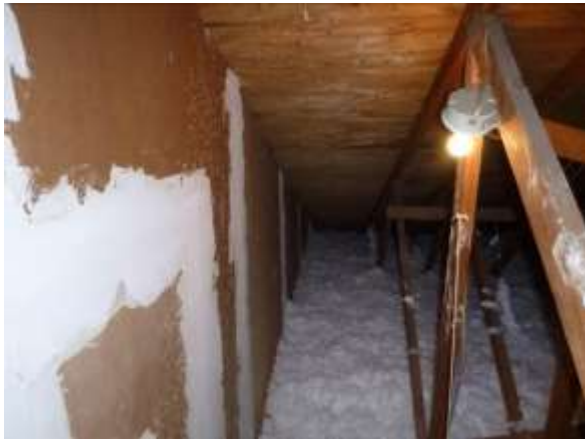
The insulation in the attic was approximately average by today's standards. The normal amount of insulation for attics in this area is R30 energy rating. This attic appeared to have approximately 12 inches of insulation in the ceiling, which is typically an R30.

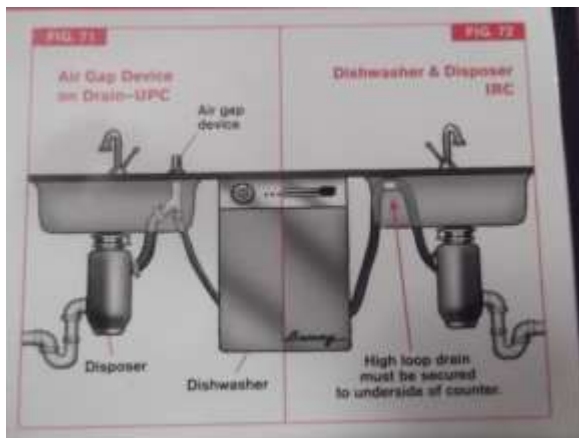
The drain line under the sink was looped up so that the top of the loop was higher than the point where the drain line connected to the disposal. This will help to prevent garbage from running down the drain line into the dishwasher.

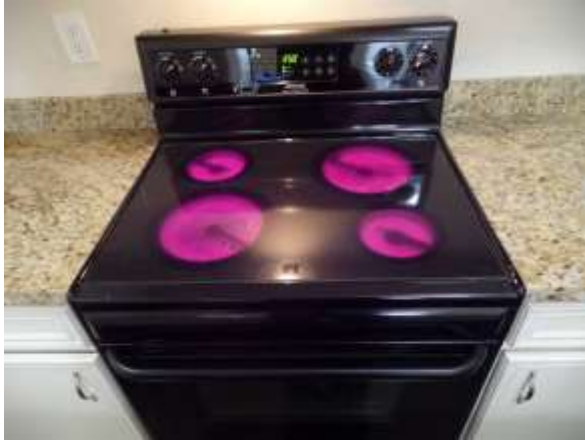
No items requiring repair were visible for the operation of the electric cooktop. All of the elements and controls were operating properly at the time of the inspection.

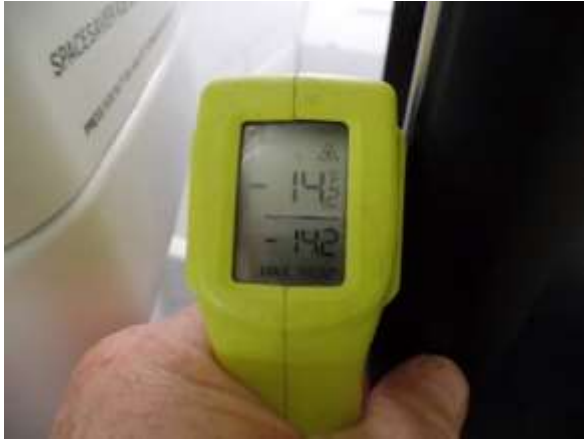
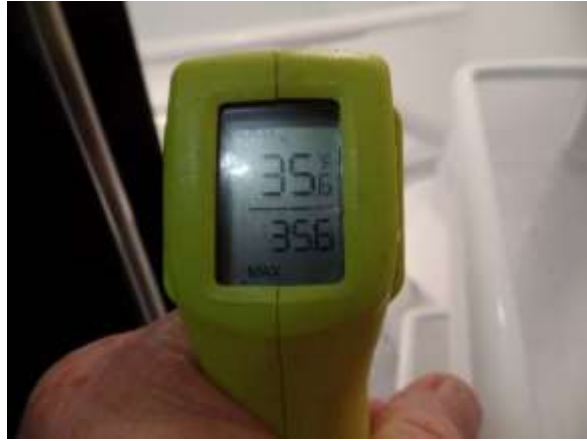
It is pointed out that our inspection of the refrigerator is only cursory to see if the refrigerator compartment is cooling, and the freezer compartment is freezing. The freezer was cooling to -14 degrees and the refrigerator to 35 degrees at the time of the inspection, according to our infrared thermometer.

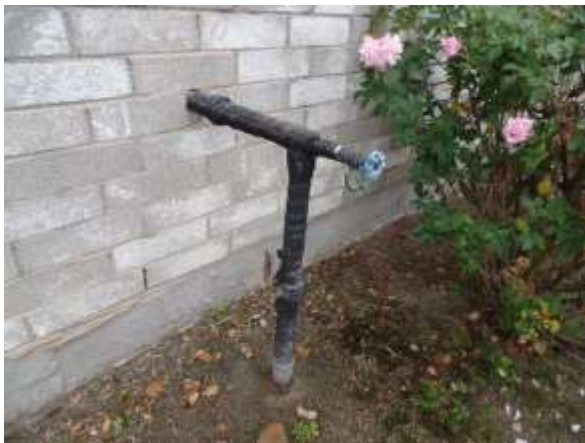
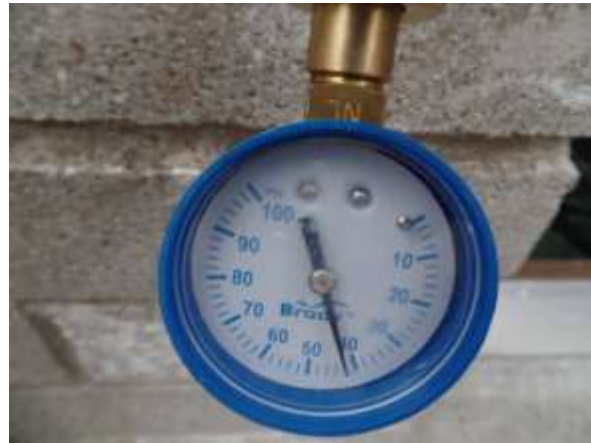
The shut-off valve for the main inlet water line was located at the exterior of the unit at the end of the building.

The water pressure to the house at the time of the inspection was checked with a pressure gauge at a hose bibb, and the pressure was observed to be 42 psi.

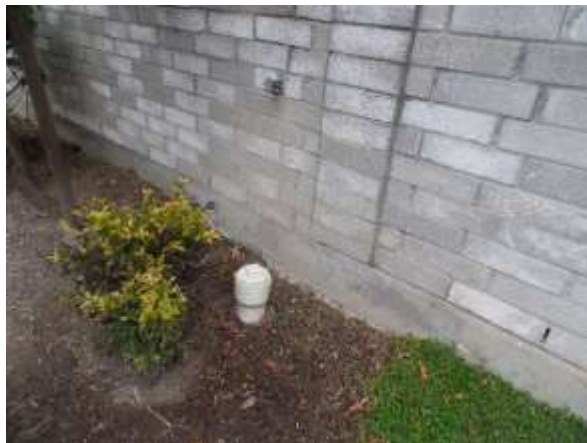
CLEAN OUT

The main sewer clean out was located at the end of the building. The clean out is needed in the event of a stoppage in the main sewer drain line, and the clean out is where a sewer snake would be installed to remove the clog in the drain line.

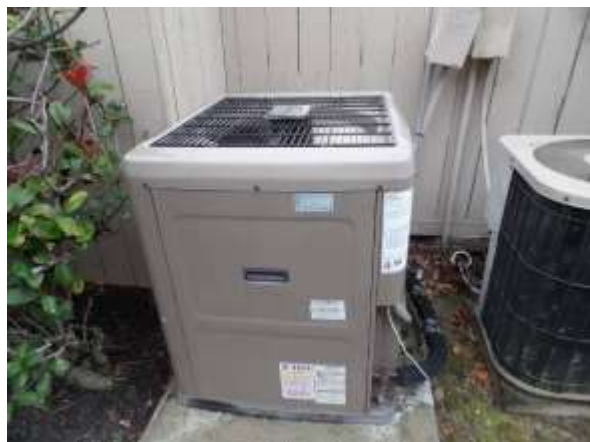
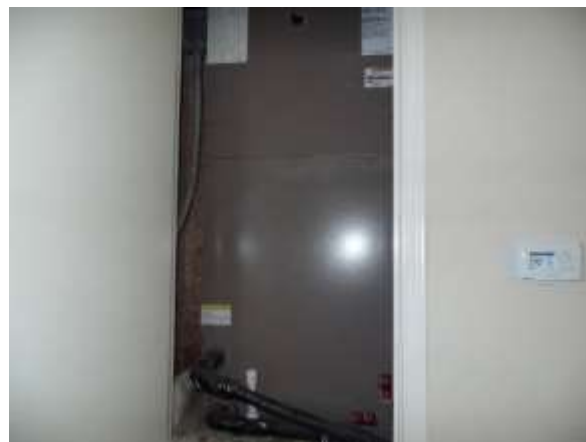
The air conditioning for the house was provided by one forced air split system. The equipment included the following:

Zone	Condensing Unit	Date	Evap. Coil	Date	ΔT (degrees)
House	3-ton York/Unitary	2012	3-1/2 ton	2011	16-17

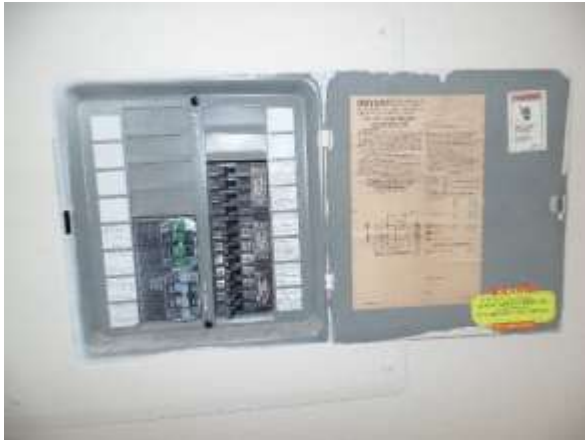
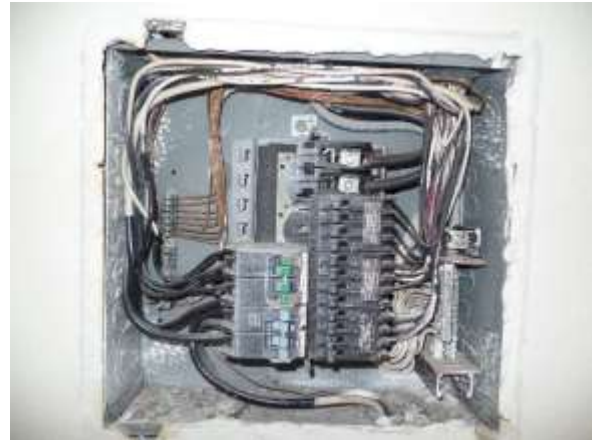
Foreign matter was observed in the panel box, which can be a safety hazard, and it is recommended that the panel be cleaned

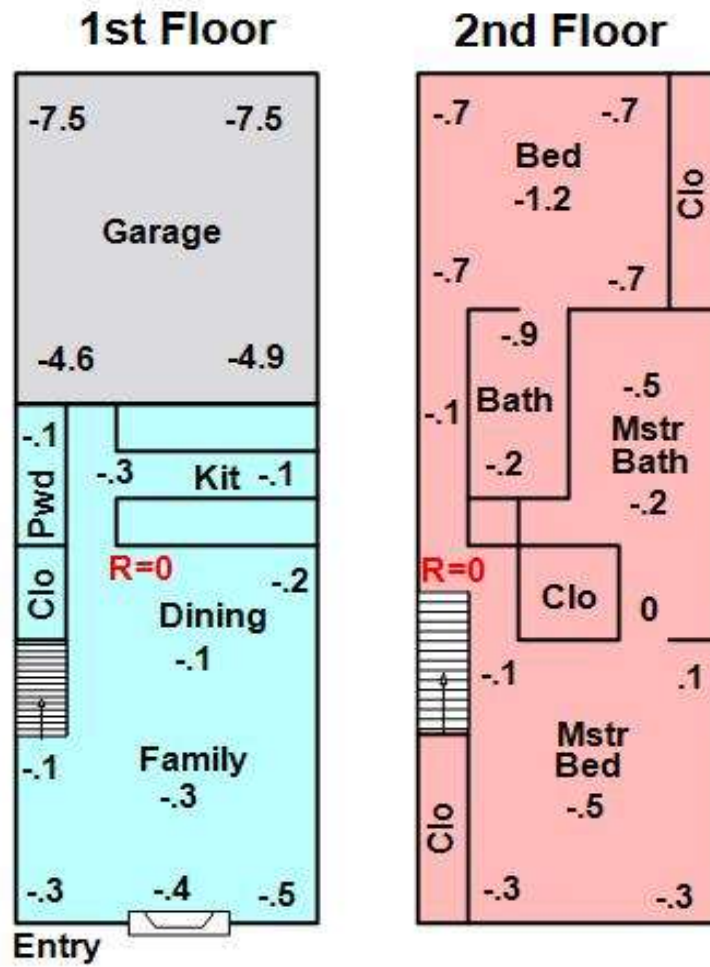
3010 Holly Hall Street Unit 3010
Elevation Readings

The floors were checked with an electronic level and were observed to be acceptably level throughout the house. The difference in elevation between the high point and low point was 0.5 inch at the 1st floor and 1.3 inches at the 2nd floor. The high point at the 1st floor was located at the reference point, and the low point was located at the family room. The unlevelness takes place over a horizontal distance of approximately 20 feet.
