### RESIDENTIAL HOME INSPECTION

### 2110 Winged Foot Dr League City TX 77573

Charles Akers JANUARY 28, 2021

## **PROPERTY INSPECTION REPORT**

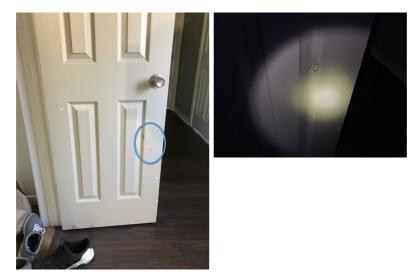
6: Minor damage ✓ Maintenance/Note Coat closet, Minor damage was observed at the door.

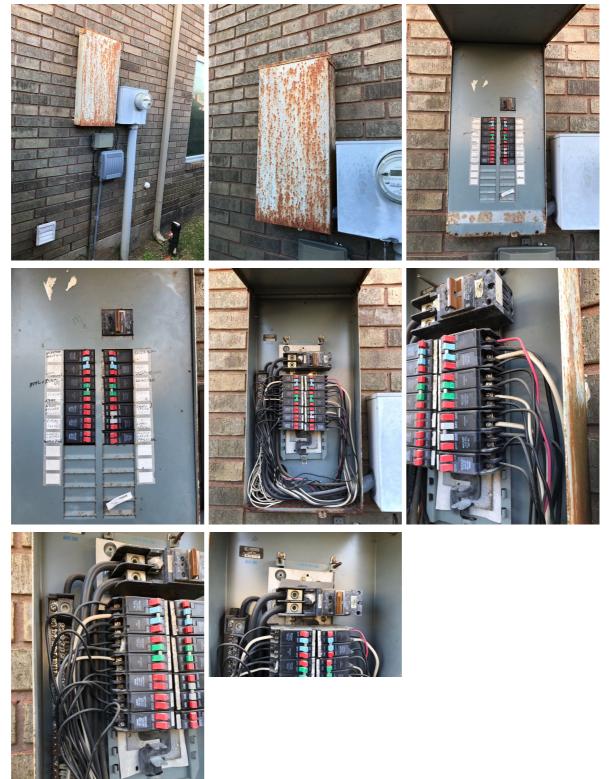
1: White Wires Used As Hot Wires Recommendation

Any white wires used as hot wires (connected to breakers) should have black tape or markings on them to indicate to service personnel that they are used as hot wires and not as neutrals.

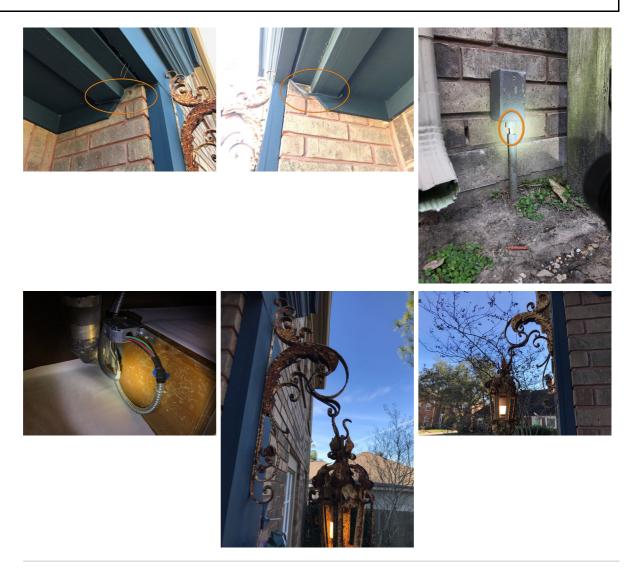
#### 8: Wiring - Exposed Splices Commendation

Garage, Kitchen, Attic,

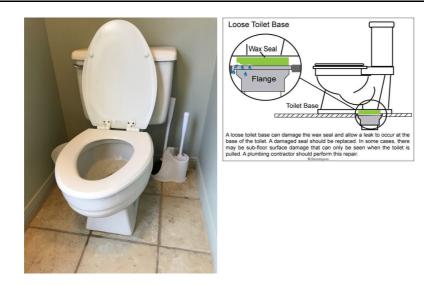
6: Toilet - Loose
Recommendation
Half bath,

The toilet was not secure to the floor which can result in damage to the wax seal and possible leakage.
