PROPERTY INSPECTION REPORT

Concerning: 23846 Beaverwood Dr. Spring, TX 77373
(Address or Other Identification of Inspected Property):

By: Giovanni Angel, 22909 12/13/2021
(Name and License Number of Inspector) (Date)

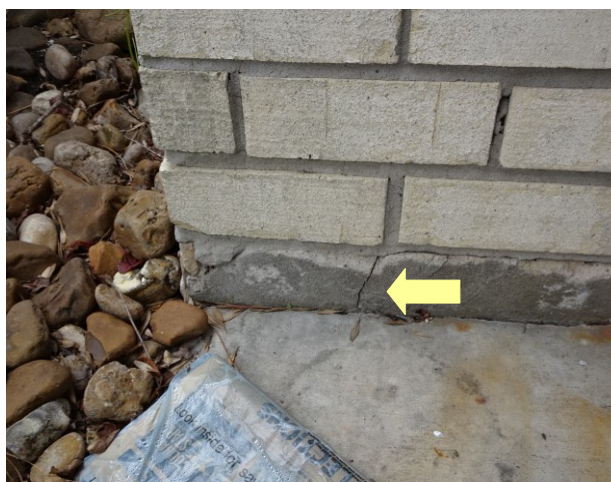
- Corner pops (spalling) on at least one corner. Note: This usually is caused by thermal expansion of the brick wall and a typical tight connection connecting the brick and concrete surface. The brick will expand in the hot weather and will put forth a force adequate to shear the corner from the foundation. This is quite common and is not to be considered a structural defect. Recommend to properly seal gaps to avoid any further damage and deter the possible entrance of termite or other bugs

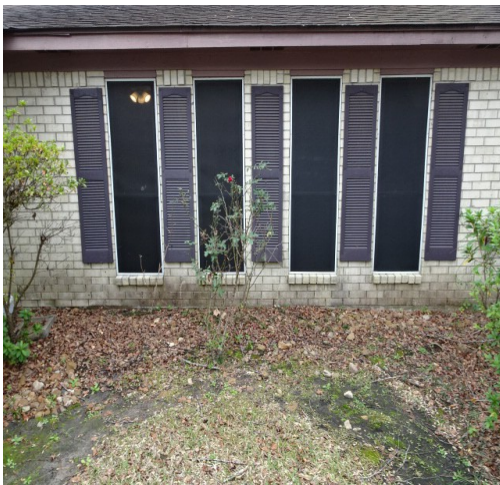
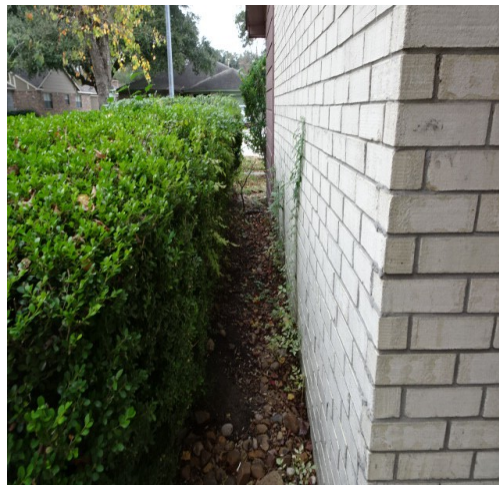
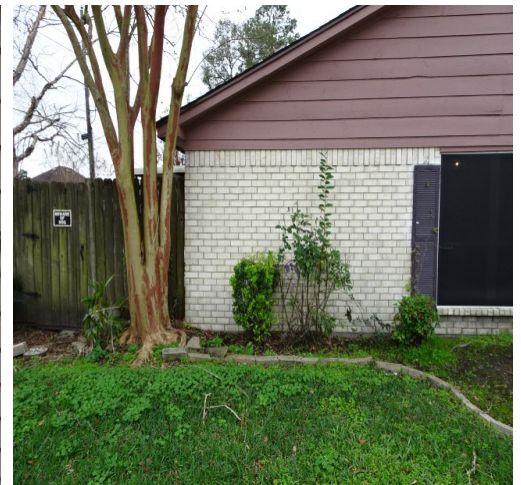
- The soil level was high on multiple sides of the house. When soil levels and vegetation are high against the face of the foundation it promotes water penetration, siding rot and insect infestation. Brick veneer wall cladding should have about 4" of clearance between the soil and the first of bricks, and other materials should have 6" of clearance between other materials and the soil. We recommend lowering the grade.

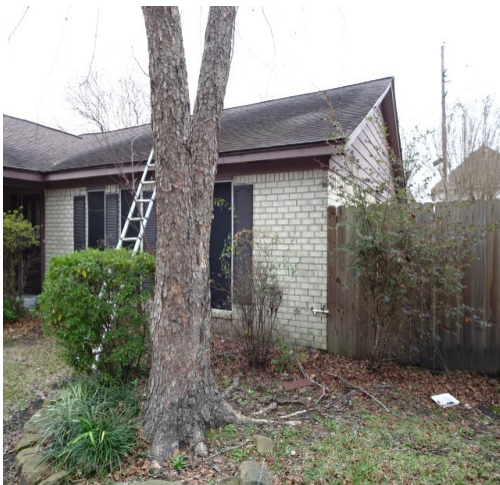
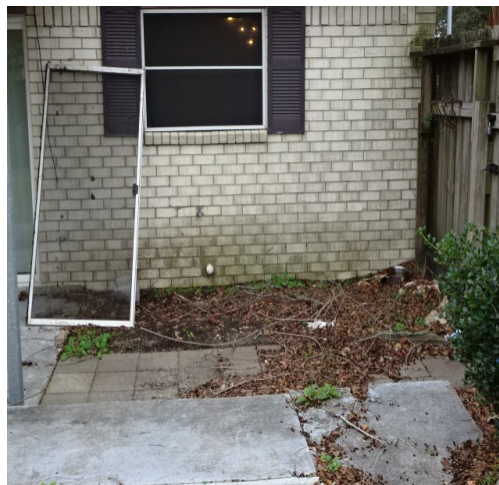
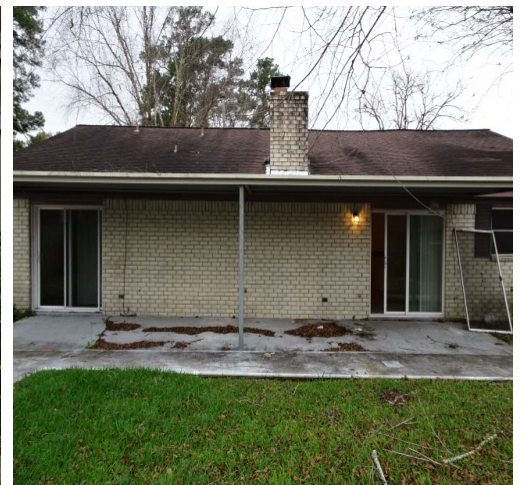
- Soil is of reverse grade on multiple sides of the house (low spots, negative slope, etc), creating vulnerability to the accumulation of standing water at the foundation wall, a condition known to be a factor in foundation failure. Re-grading is required for a more positive drainage. Samples below.

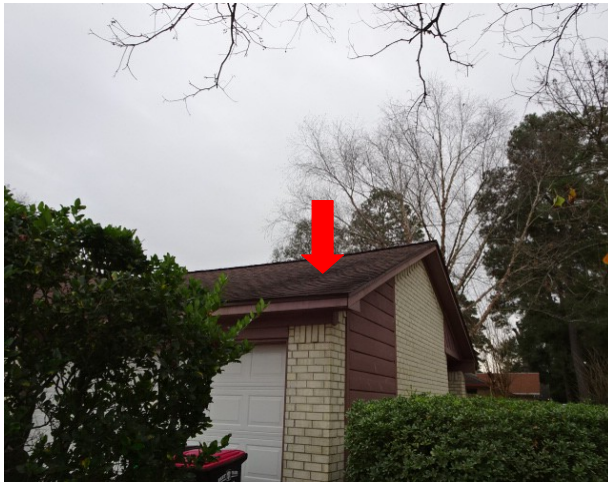
- Sags/depressions on multiple sides of the roof. This may be associated with structural movement. Recommend further evaluation and proper repair as needed by qualified contractor(s).

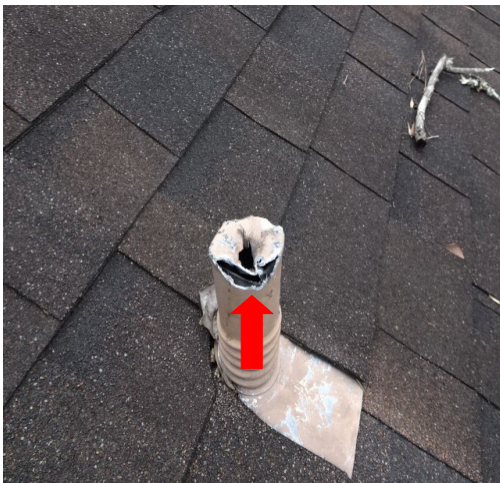
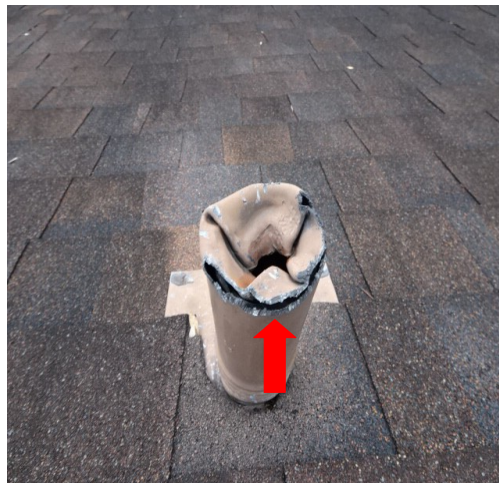
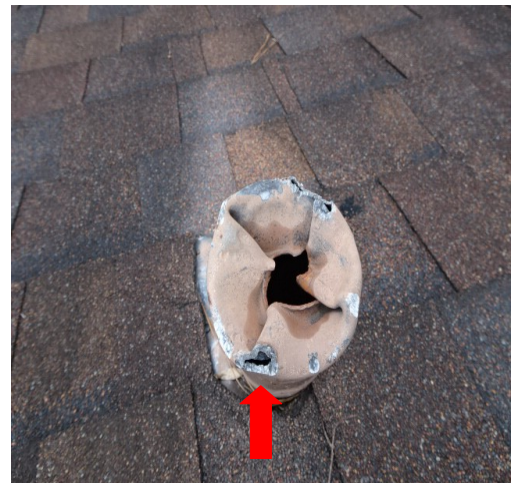
- Damaged lead pipe boots on multiple plumbing vents. In need of repair by a qualified roofing contractor to prevent possible water intrusion and damage to property.

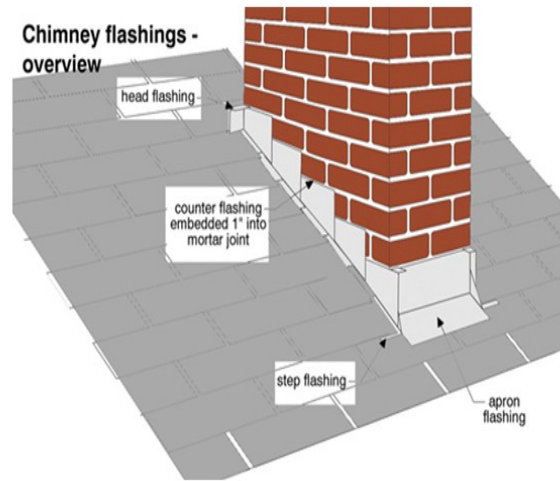
- Improperly installed chimney flashing. Repair by a qualified roofing contractor to prevent premature deterioration and possible water intrusion.

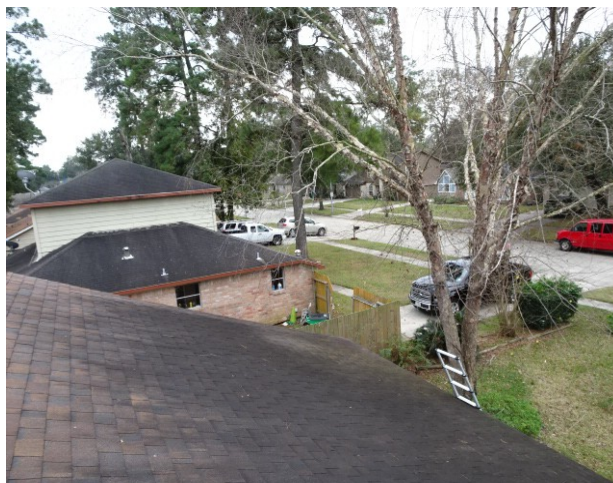
- Trees in close proximity of roof shingles. Maintain tree limbs trimmed to prevent from contacting and damaging roof shingles

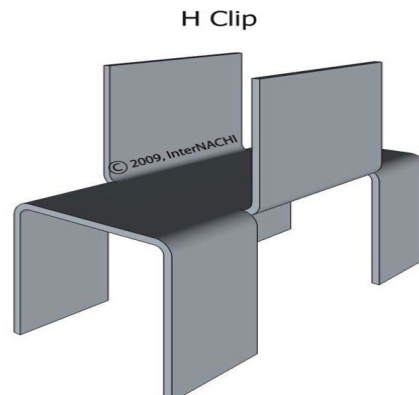
- Observed absence of “H” clips between sheathing **Note:** H-clips increase panel stiffness by allowing distribution of weight between adjacent panels.

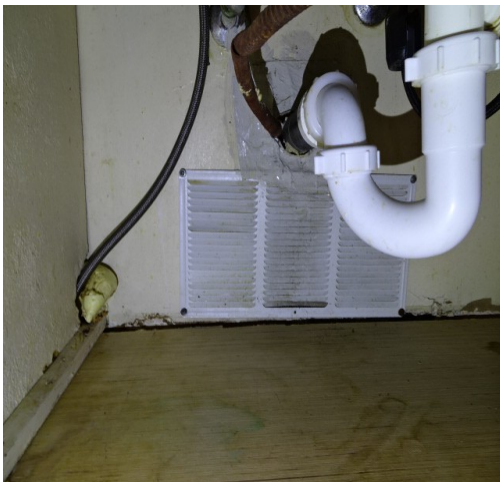
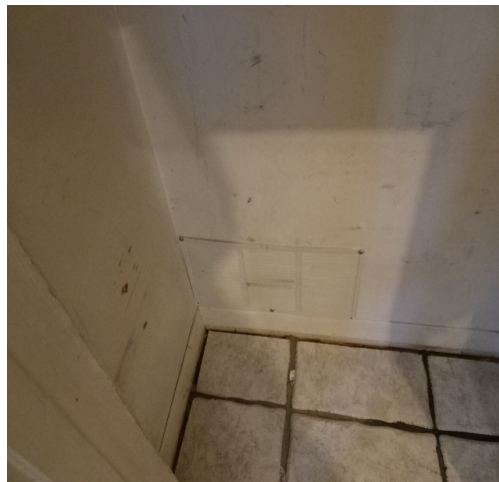
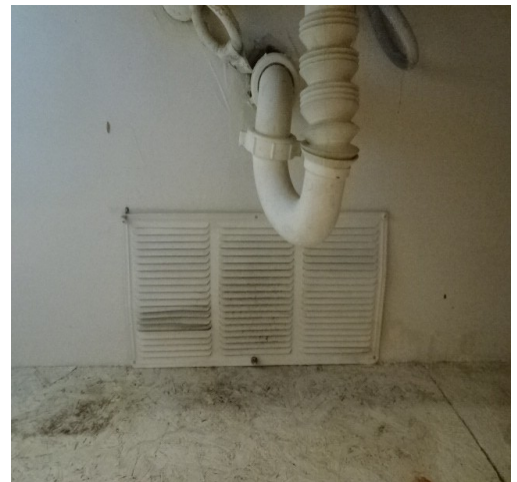
- Air vents on multiple walls. Further investigate function of same and proper repair as needed. Locations but not limited: kitchen, pantry, and master bathroom.

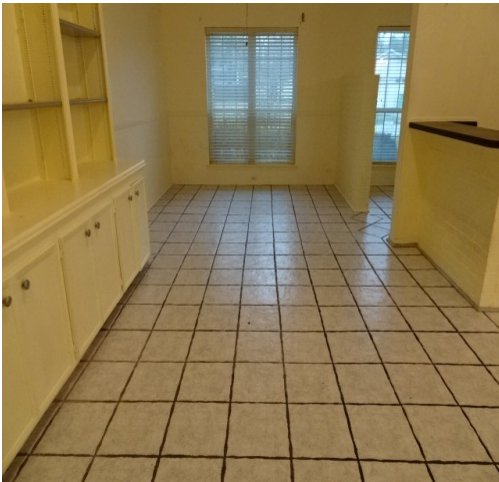
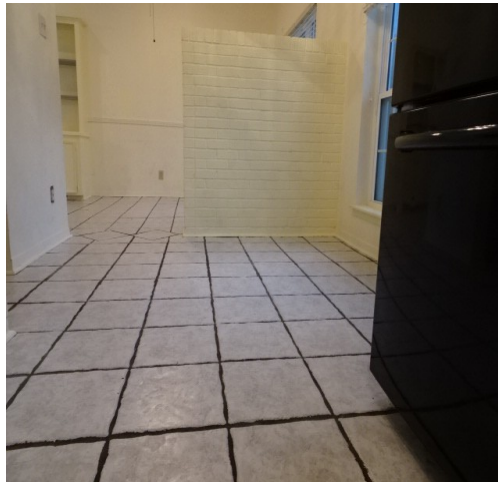
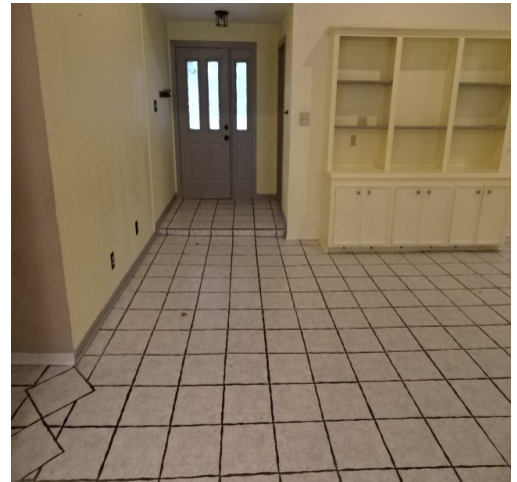
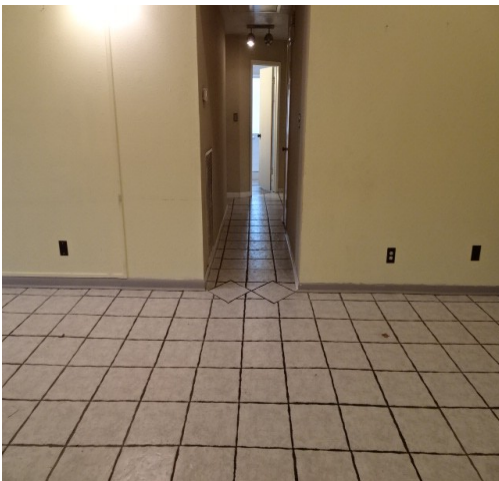
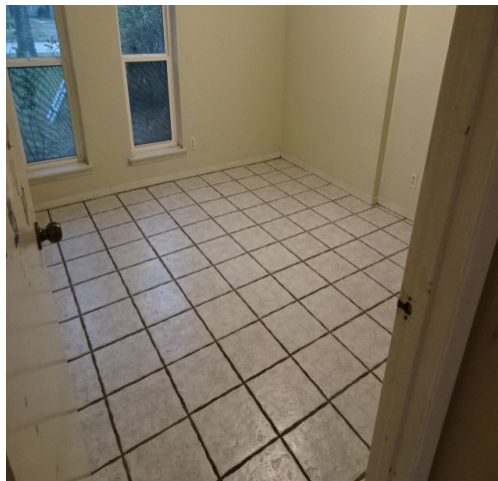
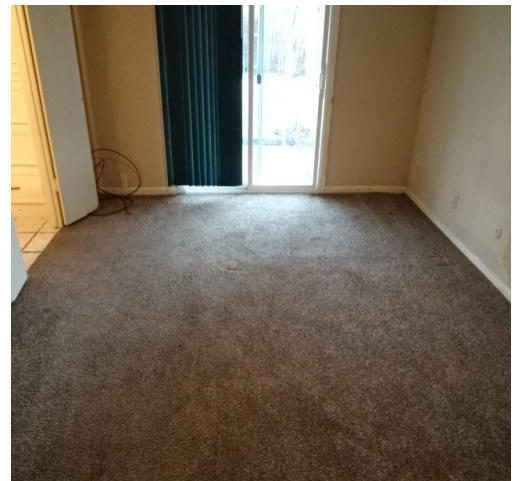
- Sloping/uneven floors in multiple areas. Recommend further evaluation by a qualified foundation repair company and/or structural engineer to further assess the integrity of the foundation slab to determine corrective action details, if any. Locations but not limited to: Dining and breakfast area, living room, hallway, front left bedroom, and master bedroom.

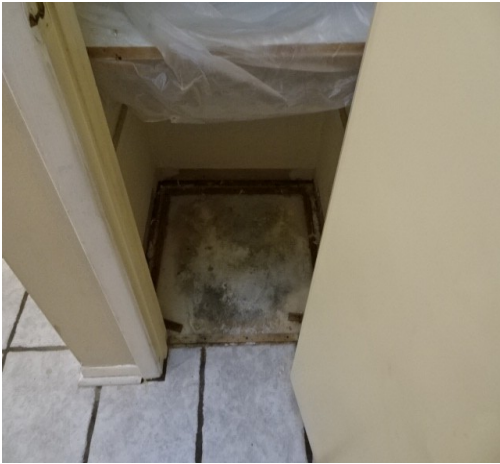
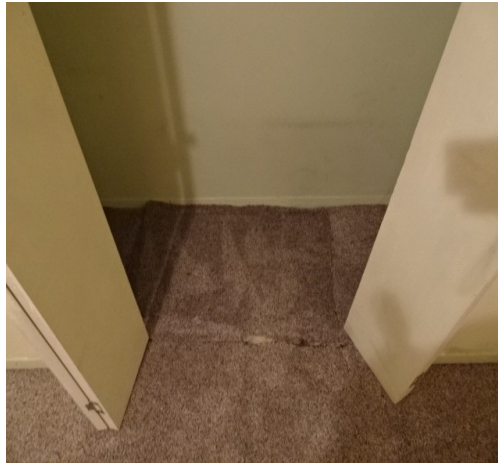
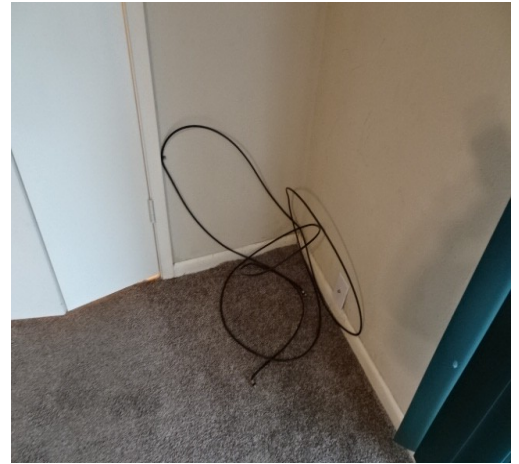
- Missing flooring in the hallway closet and loose and/or lifting carpet in the front right bedroom closet, and master bedroom. Repair as needed. Samples below.

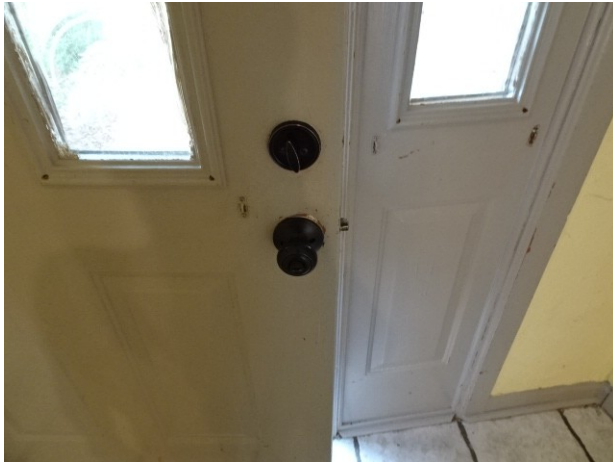
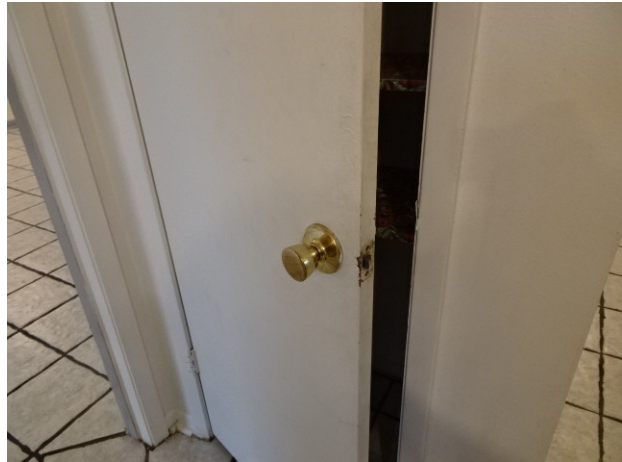
- Entrance door handle is loose. Secure same.
- Kitchen pantry door knob did not function properly. Repair/replace as needed.

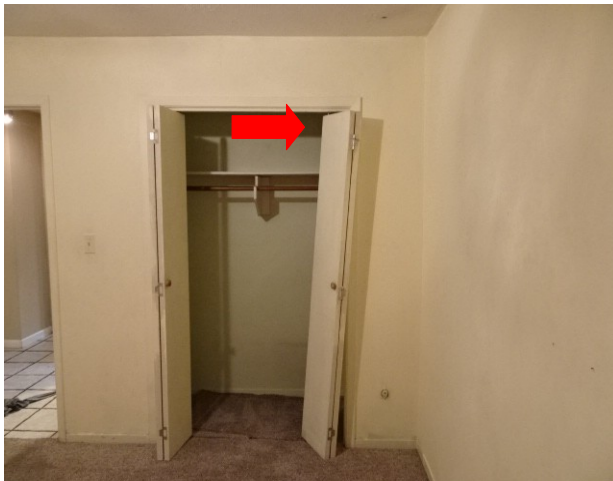
- Front right bedroom closet door is out of the track. Repair same.
- Master bathroom door did not latch shut and missing handles.

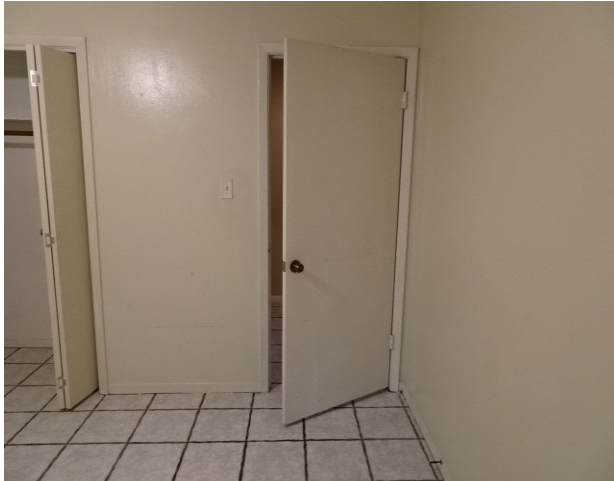
- Front left bedroom door swings open and master bathroom closet door sticks.. Further investigate root cause and properly repair as needed by a qualified contractor. This condition may also be indicative of structural movement. Further investigate root cause and repair as needed by a qualified contractor(s).
- Mirrors on master bathroom closet doors do not appear to be safety/tempered glass (not visibly labeled). **Note:** Proper use of safety glass is critical in areas that are subject to human impact.
- Install missing door stoppers where needed to avoid damage to wall.

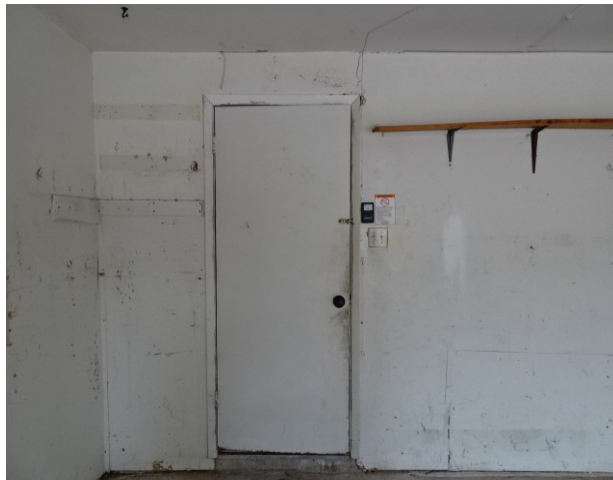
- Door between garage and habitable area does not appear to be a fire-rated door (Not visibly labeled). Openings between the habitable space(s) and the garage should be equipped with solid wood doors not less than 1 3/8” in thickness, solid or honeycomb core steel doors, or 20 minute fire-rated doors.
- The garage door separating the garage from the residence is not self-closing. Some authorities having jurisdiction over local building standards require that openings between the garage and residence shall be self closing. Without regard to your governing body, we *recommend* installing a self-closing device as a safety upgrade to preserve the fire break between the habitable area and garage

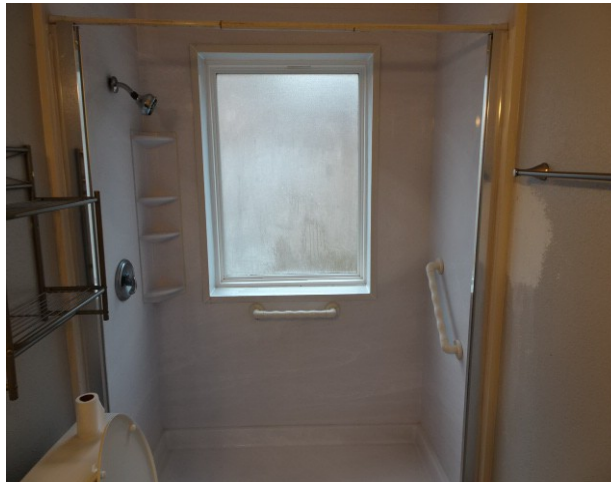
- Hallway bathroom shower enclosure doors are missing. Replace same.

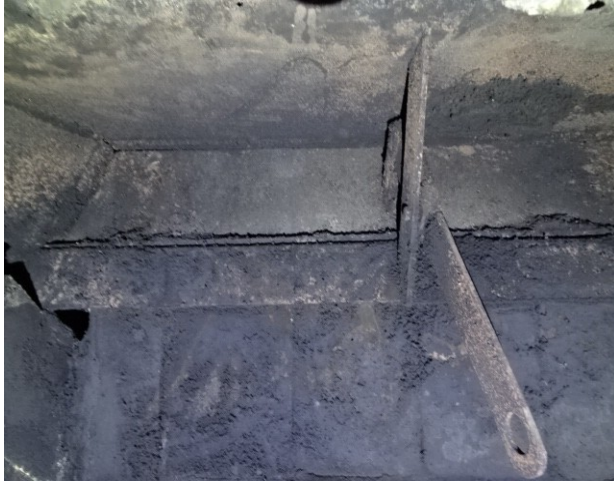
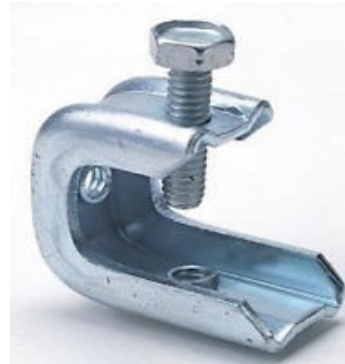
- Fireplace damper did not have a “c” clamp. This clamp is designed to attach to the damper to ensure that even while the damper is in the “closed” position, the exhaust flue will be slightly open. This clamp is a safety device used with gas units that can be purchased at most home improvement stores and is easy to attach.
- Creosote on fireplace walls. Recommend cleaning of fireplace and/or chimney as needed for safe operation of same.

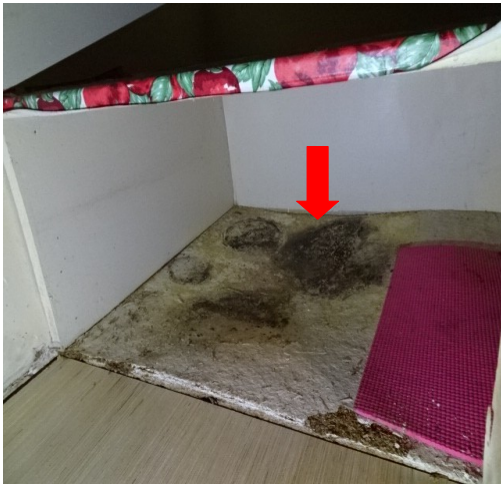
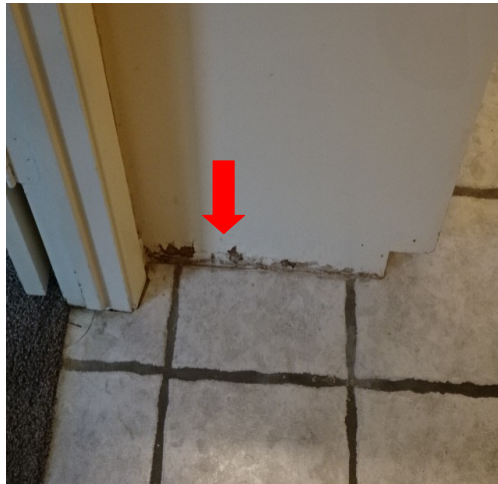
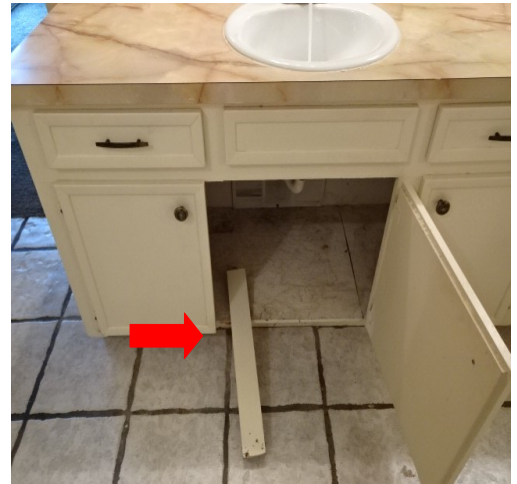
- Damaged kitchen and bathroom cabinets. Recommend repair where needed. Samples below.

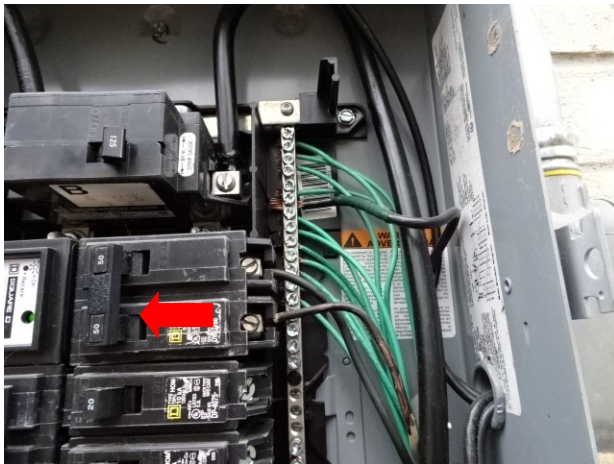
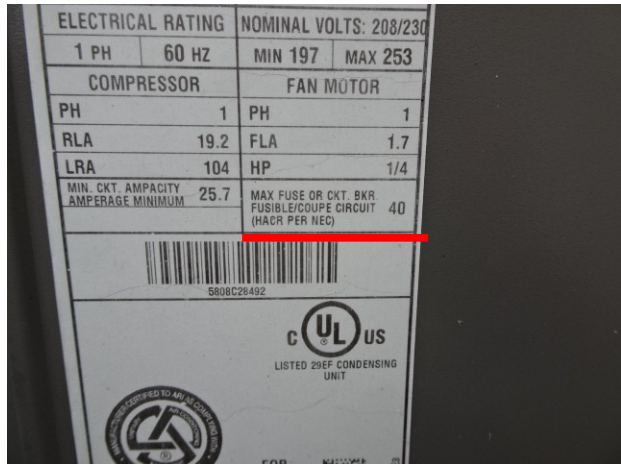
- The 50 amp circuit breaker labeled “A/C” is oversized for the equipment installed. Max breaker size should be 40 amp per the manufacturer. Repair by a qualified electrical contractor.

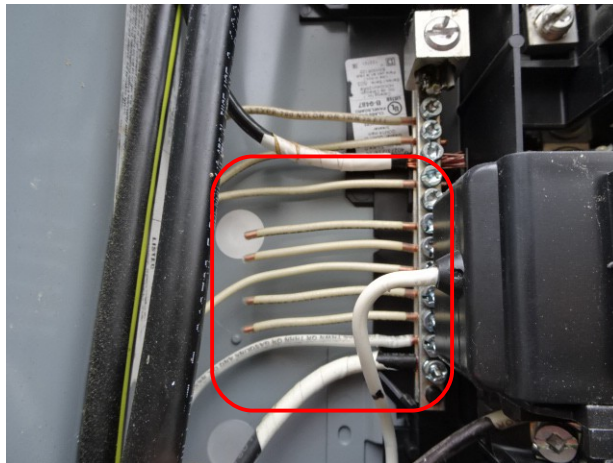
- There were multiple cut neutral wires in the electrical panel. Further investigate root cause and properly repair as/if needed by a qualified electrical contractor.

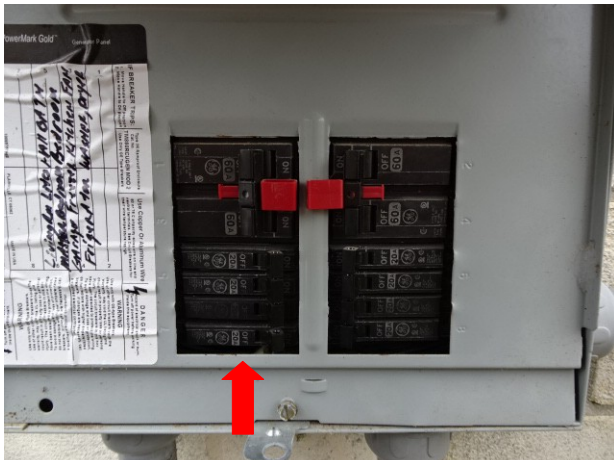
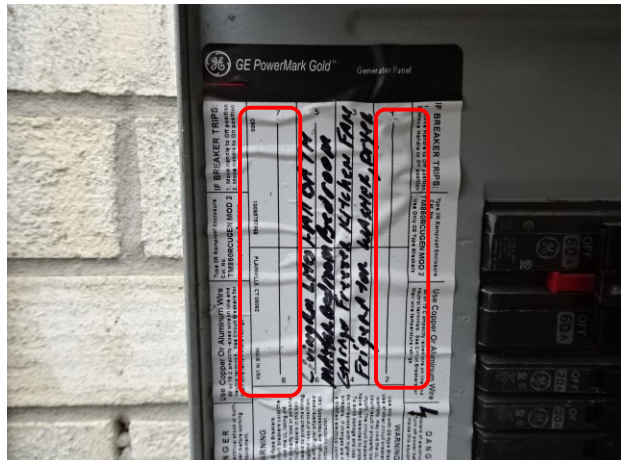
- There were lock out devices installed on multiple circuit breakers in the sub panel. Further investigate root cause and repair as/if needed by a qualified electrical contractor. **Note:** Inspector was not able to remove the dead front cover for proper inspection without removing the lock out tags.
- Loose breaker in the sub panel. In need of repair by a qualified electrical contractor for safety.
- Missing circuit breaker ID labels. Accurately identify each breaker according to their function

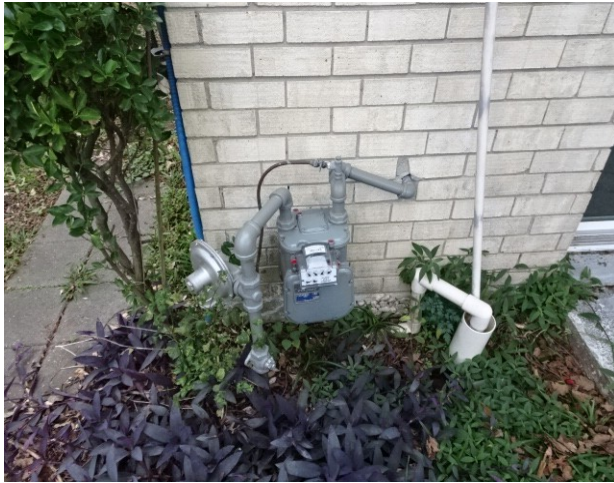
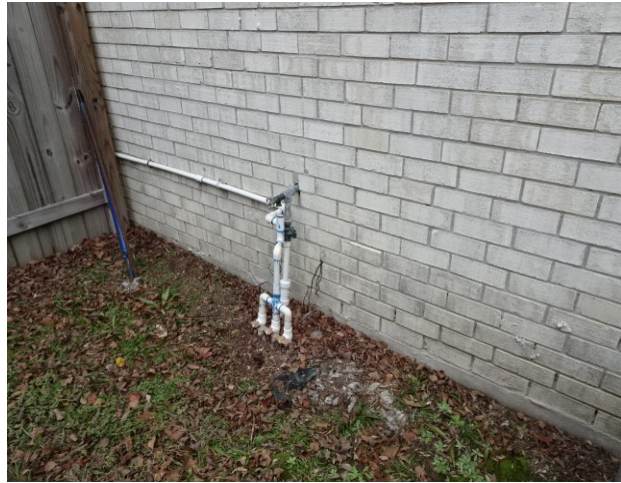
- Inspector did not observe bonding of the gas and water supply piping. This connection may be made somewhere in the house that is not observable. **Note:** The metal gas and water supply piping should be grounded or bonded to the electrical system for safety.

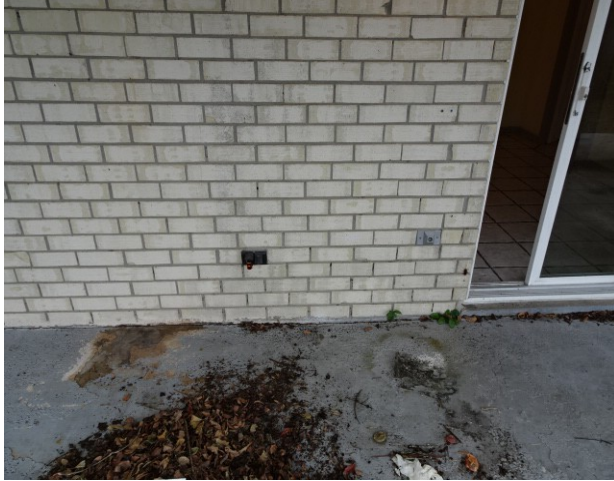
- Improperly wired outlets in multiple locations (Hot and neutral wires reversed, open ground, etc). In need of repair by a qualified electrical contractor for safety. Locations but not limited to: Exterior, living room, and hallway bathroom.

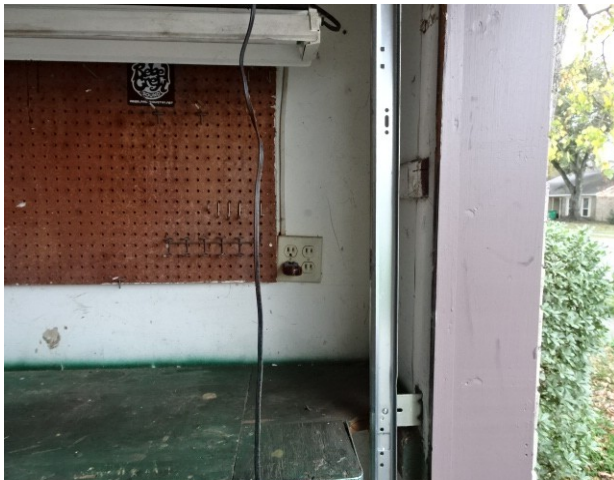
- No power supply to outlet in the garage. In need of repair by a qualified electrical contractor.
- Switch in the master bedroom did not function. Repair as needed by a qualified electrical contractor.

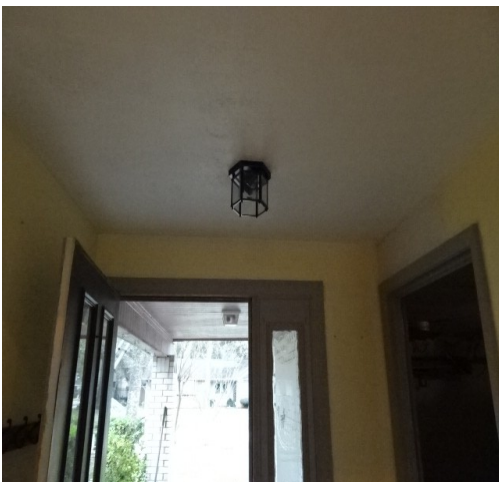
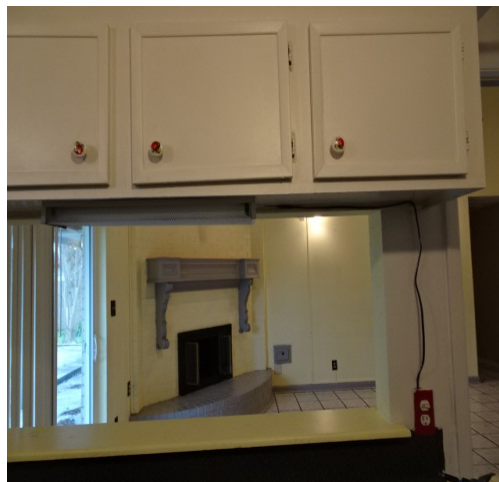
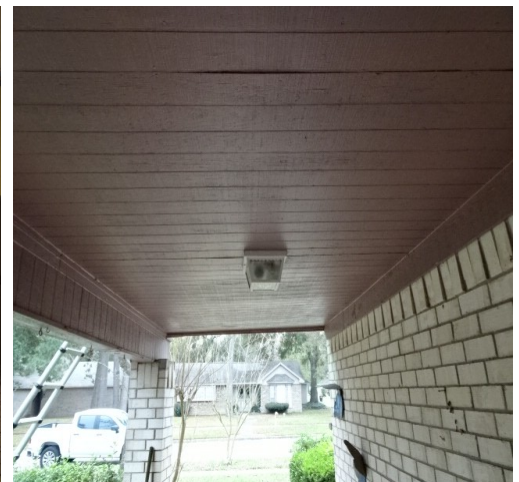
- Repair defective light fixtures/bulbs where needed

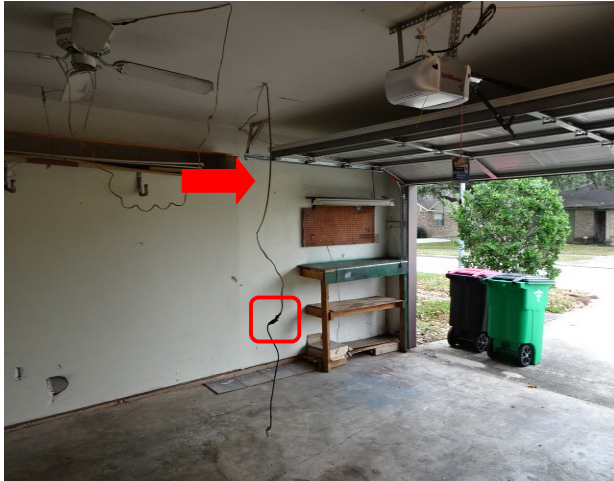
- There appears to be a field made extension cord in the garage. Note: Extension cords are only for temporary use. In need of proper repair ex: install a dedicated outlet
- Observed spliced wires in the garage (field made extension). Note: All spliced wires should be placed inside a junction box. Properly repair
- Electrical cable is exposed and loose in the garage and kitchen. Note: Cables should be concealed in walls or protected from physical damage using proper conduit.

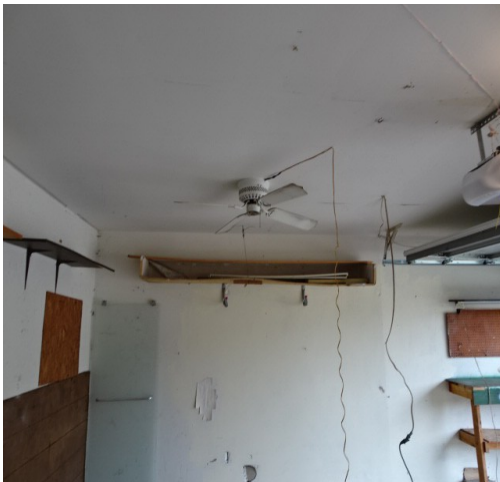
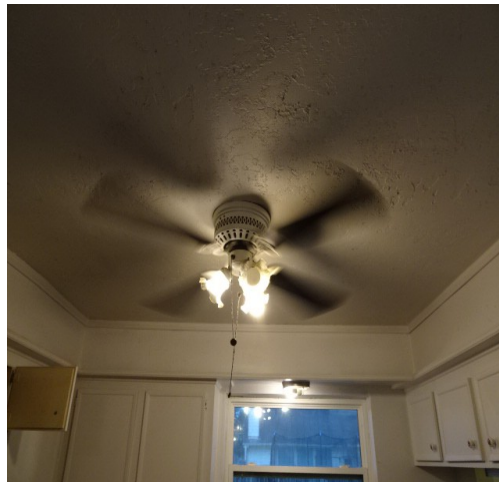
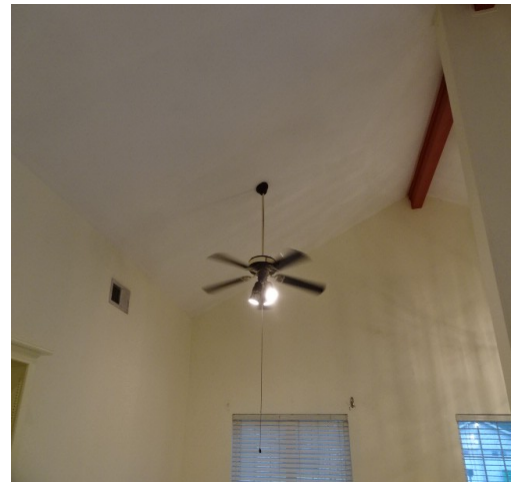
- The garage ceiling fan was disconnected and could not be tested at the time of inspection.
- Kitchen light fixture is loose. Secure same.
- Wobbling ceiling fan in the dining area. Repair as needed.

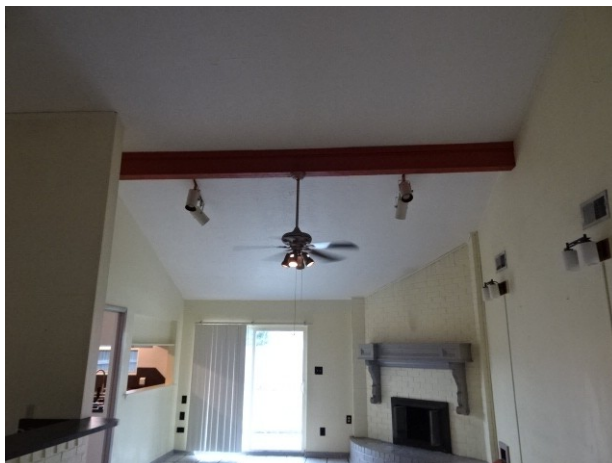
- There was no functional wall switch for the light/fan in the living room. Repair and/or install as needed.
- The living room light flickered when inspector was turning off the living room lights at the end of inspection. Recommend further evaluation and proper repair as needed by a qualified electrical contractor.

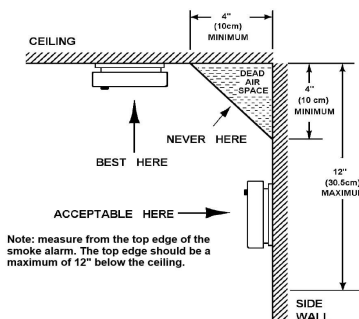
- Recommend to consult a licensed electrician to perform repairs on all deficiencies appropriately
-
- Install missing smoke alarms and/or carbon monoxide alarms at each required location:
Smoke alarms should be installed at each sleeping area , outside each sleeping area and on each level of the dwelling. Install smoke alarms for the safety of the occupant

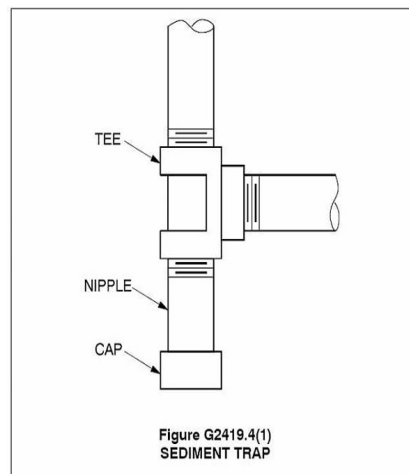
- Missing sediment trap on the furnace gas line. Note: The sediment trap shall be either a tee fitting having a capped nipple of any length installed vertically in the bottom most opening of the tee or other device approved as an effective sediment trap

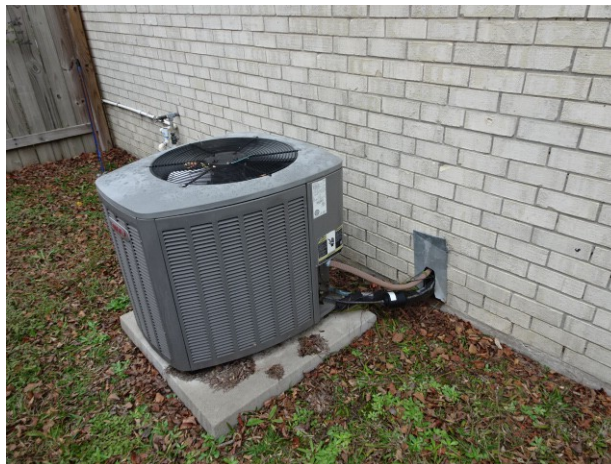
- Properly secure condensing unit to the mounting pad to prevent movement and damage of equipment.

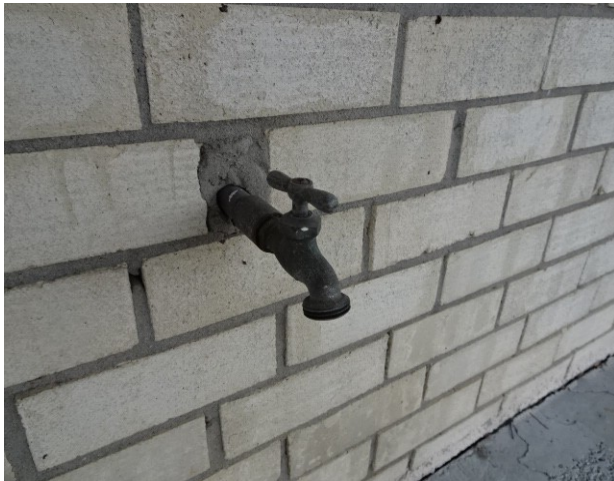
- Noted missing “Back Flow Prevention” device on hose bibs. This prevents contaminants such as sewage etc from being siphoned into the water supply. Recommend installation of device for safety

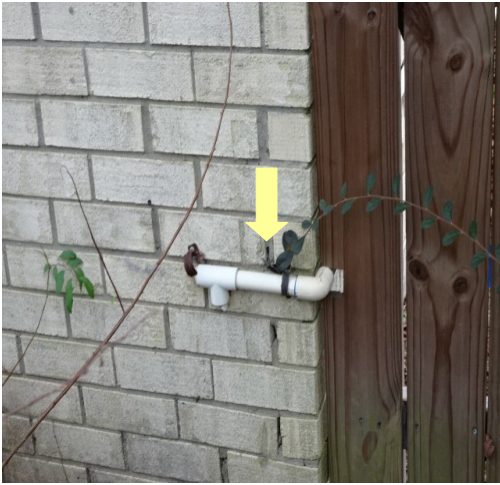
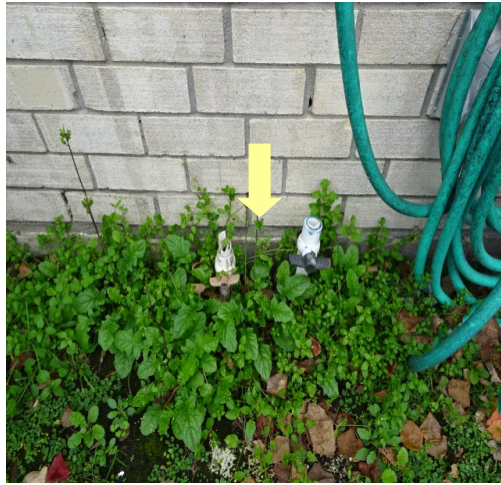
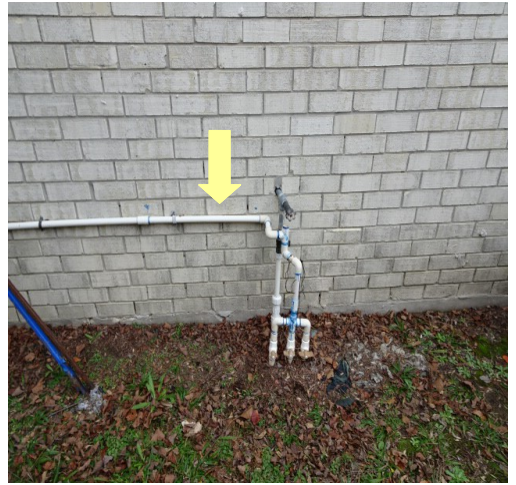
- Terminated/abandoned PVC piping on the front, left, and right side of the structure. Further investigate root cause and repair as/if needed.

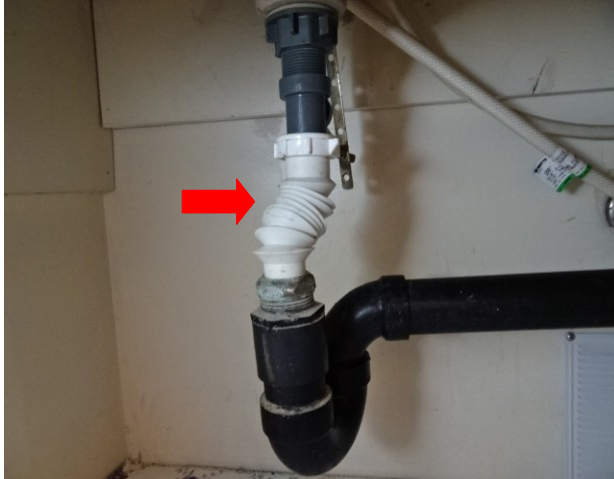
- Non-approved drain connector in both bathroom sinks plumbing. **Note:** Drainage fittings shall have a smooth interior waterway of the same diameter as the piping served. Drainage fittings shall have no ledges, shoulders or reductions which can retard or obstruct drainage flow in the piping. Any configuration other than smooth interior will cause solids to catch and begin to clog the pipe

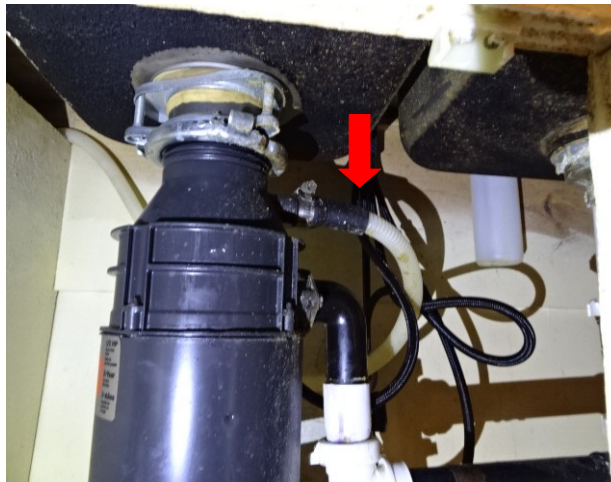
- Drain line should loop to the highest point of under the sink, then down to the drain line at the disposal to prevent back siphoning of dirty dishwasher back into the dishwasher.

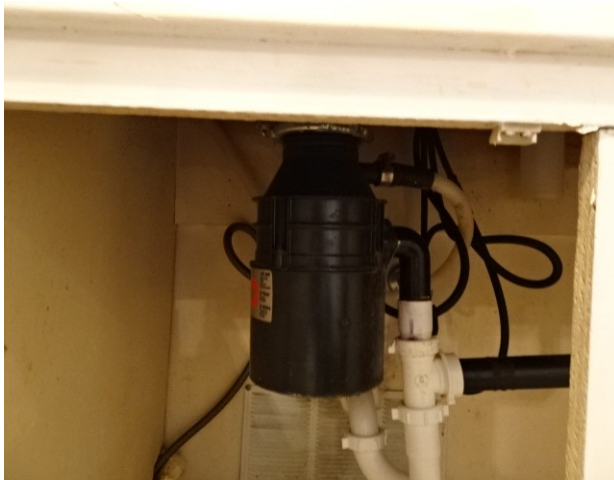
- Food waste disposer did not function. Repair same.
- Install missing clamp on power cord to protect cable from damage due to excess of movement

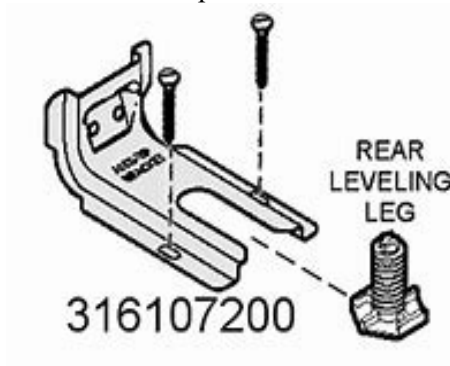
- Range oven standard: 350°F +/- 25°F, **Actual: 340°F** (approx)
- Noted missing anti-tip device on range. Recommend installation for child safety
