**SUMMARY**  
 3406 Watersedge Dr, Sugar Land TX  
 77478  
 Chet Pack  
 January 13, 2022

Phil Bullock  
 Professional Home Inspector (TREC ID:  
 24461)  
 Noble Home Inspections  
 (832) 319-8846  
[philbullock1223@gmail.com](mailto:philbullock1223@gmail.com)

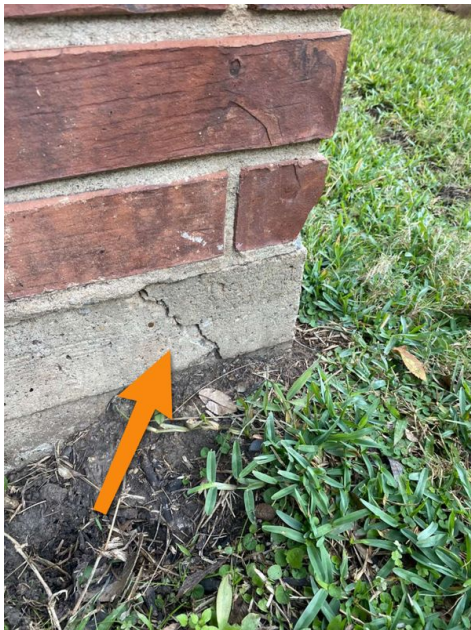
Back Left

**FOUNDATION CRACKS - CORNERS**

Corner cracks are visible in the foundation slab but are of minimal structural concern. Shrinkage is a natural part of the curing process of concrete and cracks located in corners of structures are common. Recommend monitoring to confirm the cracking does not worsen.

Recommendation  
 Recommend monitoring.

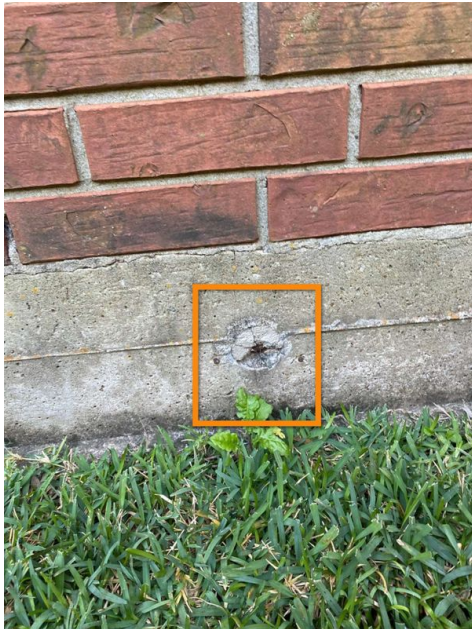
Left

**EXPOSED POST-TENSION ANCHORS**

Exposure of these ends can result in corrosion of the cable, anchor, or locking wedges and eventually cause the cable to lose its tension and leave the foundation concrete with insufficient compression to resist cracking. Inspector recommends masonry be placed to cover the exposed tension anchors

Contact a qualified masonry professional.

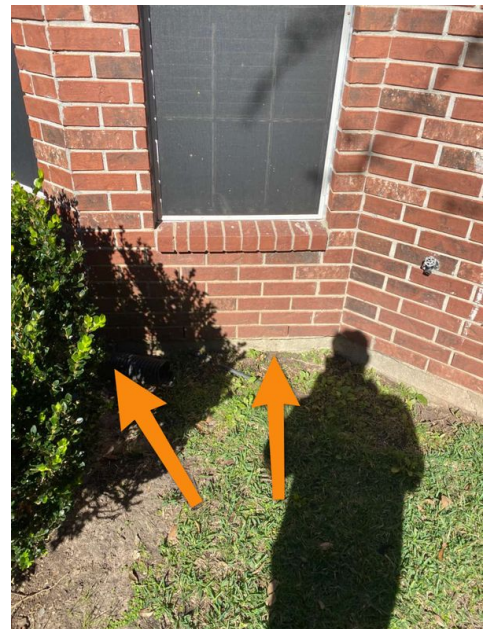
Back

#### **BRICK EXTENDS BEYOND FOUNDATION AREA**

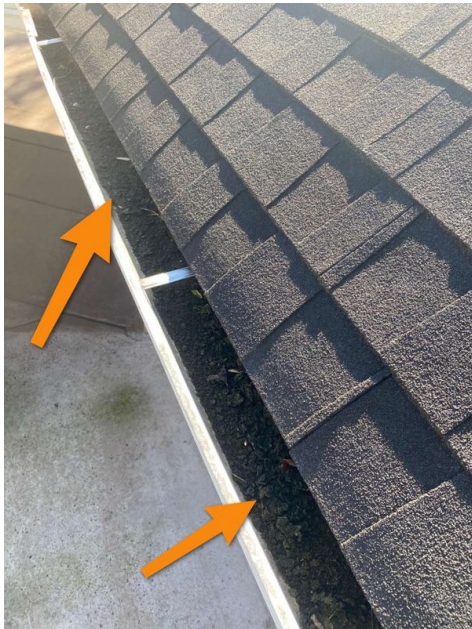
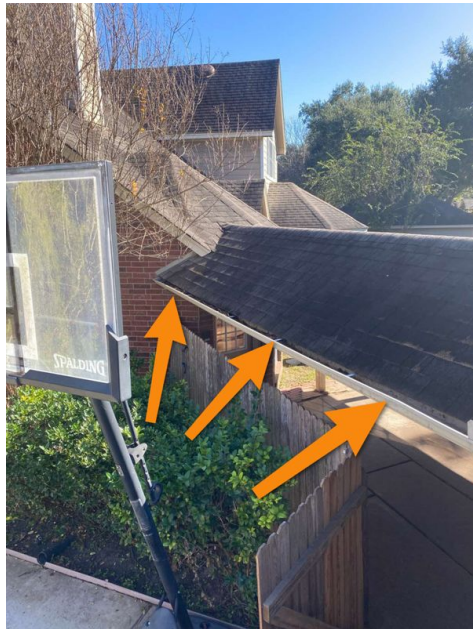
The gutters are full of leaves and debris. Recommend removal.

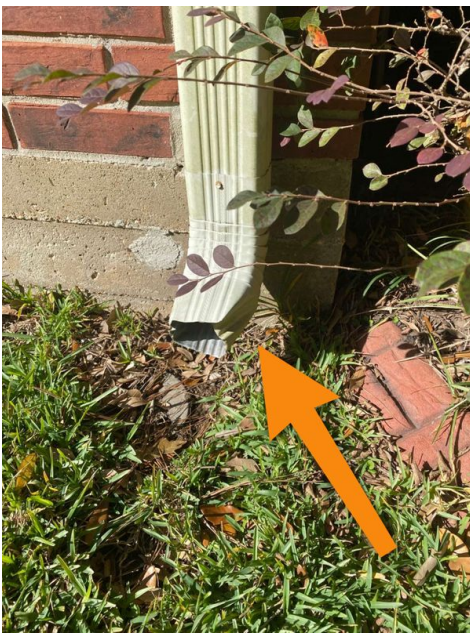
A downspout gutter is crushed. This can cause flow restrictions and debris buildup in the gutter system that could lead to an overflow. Recommend replacing the crushed portion of the gutter, as necessary.

Contact a qualified gutter contractor

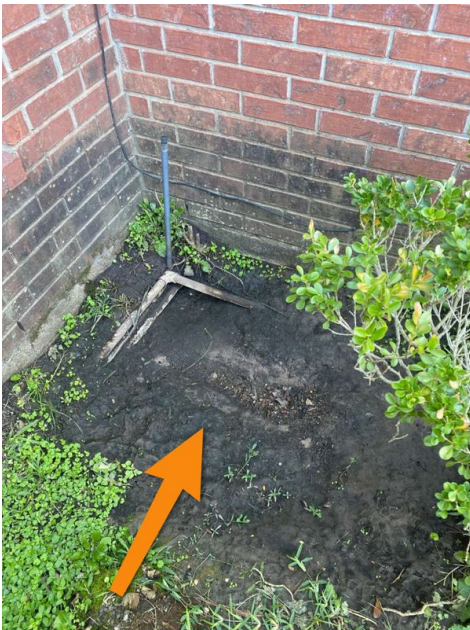
Back

#### AREA WHERE WATER WILL STAND

Area where water can occur, which could indicate poor drainage and/or grading. Recommend monitor and/or have landscaper correct.

Contact a qualified landscaping contractor

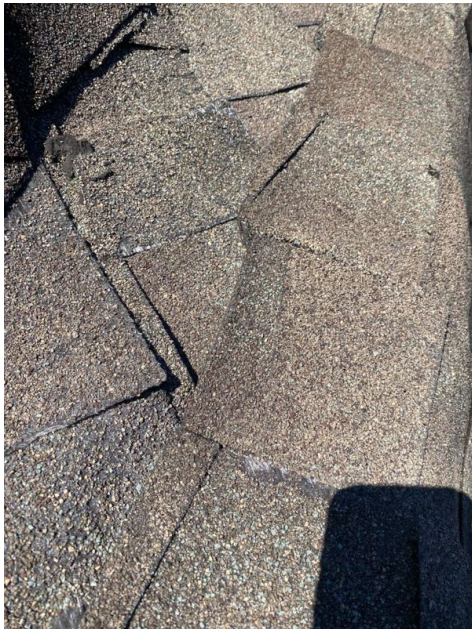
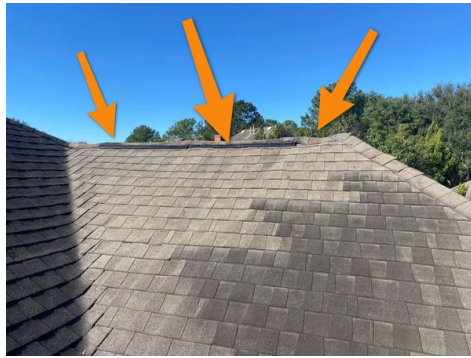
### 2.3.3 C. Roof Covering Materials **DAMAGED COVERINGS**

Roof coverings exhibited general damage that could affect performance. Recommend a qualified roofer evaluate and repair.

Recommendation  
Contact a qualified roofing professional.

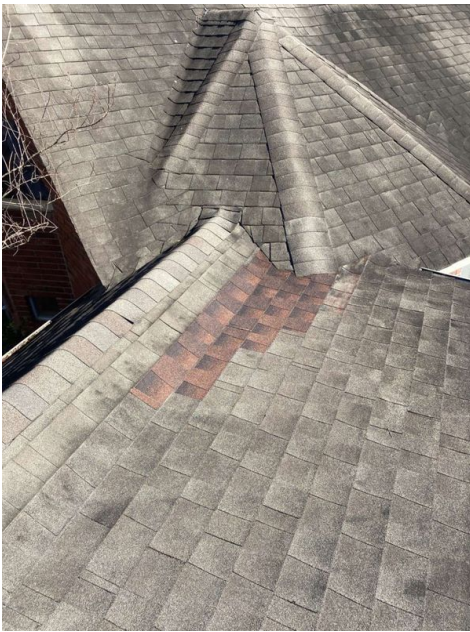
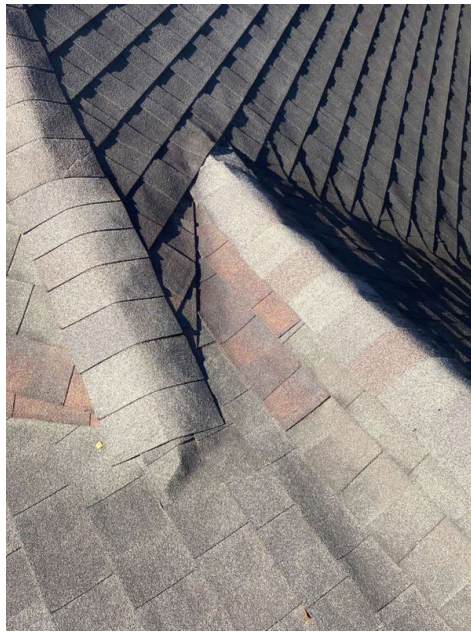
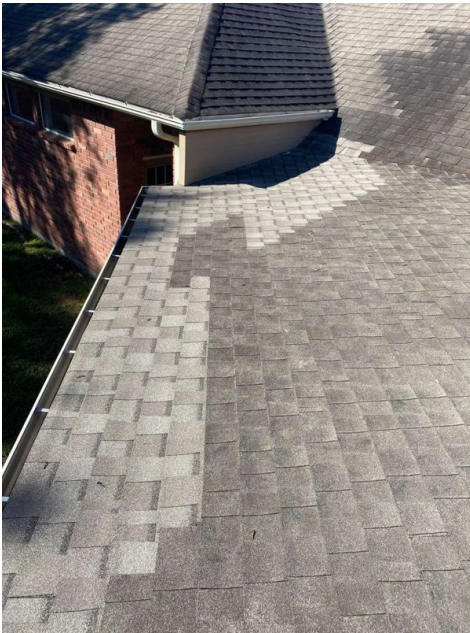
A roof patch was discovered and should be monitored for future leaks.

Recommendation  
Recommend monitoring.

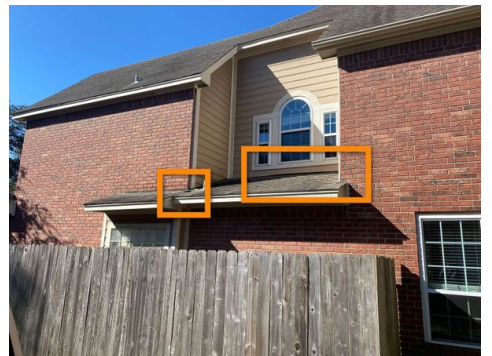
Left

2.3.6 C. Roof Covering Materials  
**LIFTED FLASHING**

Areas of the roof show lifted flashing areas. Lifted flashing areas will not seal with the lower shingle areas or siding and can allow for water intrusion. Recommend a roofing contractor to replace.

Recommendation  
Contact a qualified roofing professional.

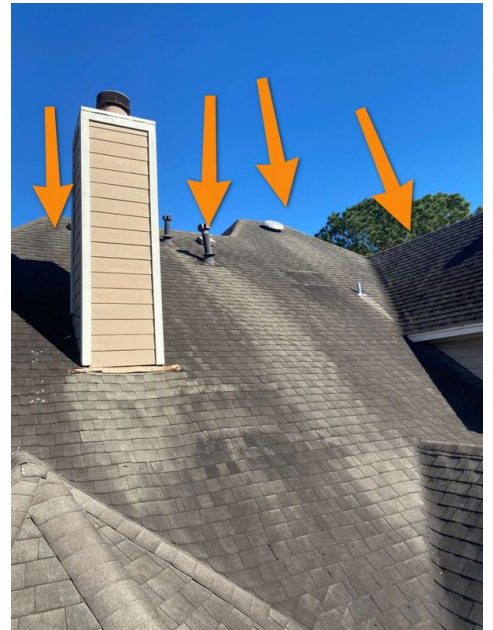
The attic structure has limited observed venting. Recommend a ridge vent be installed by a roofing professional when the client decides to make the purchase of a new roof.

Recommendation  
Contact a qualified roofing professional.

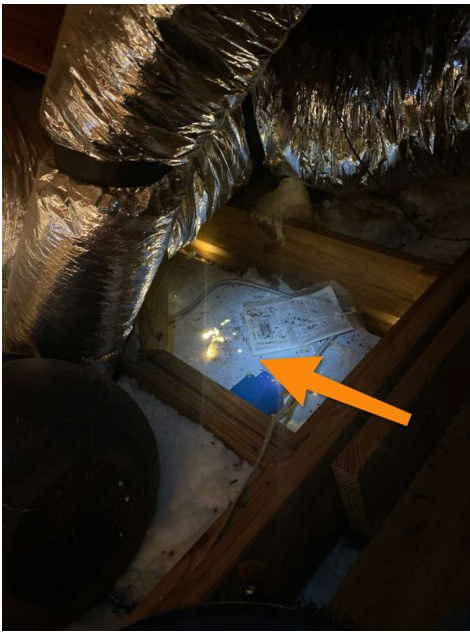
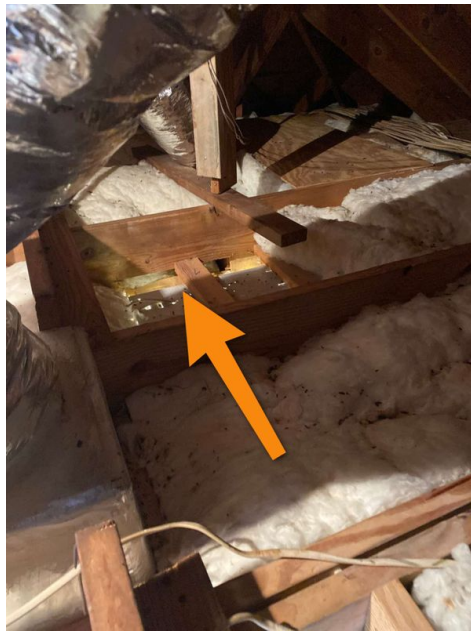
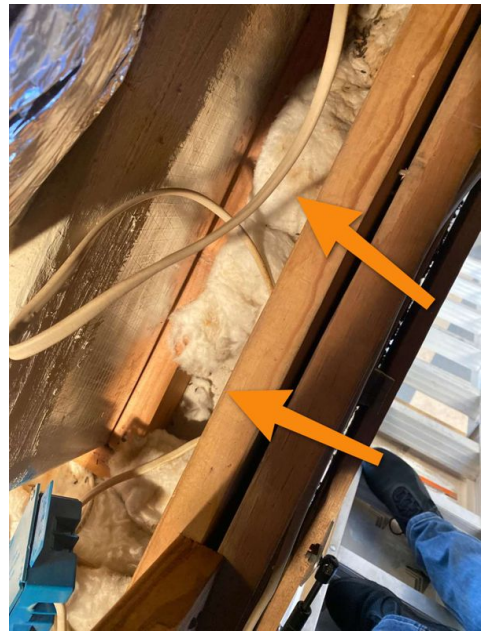
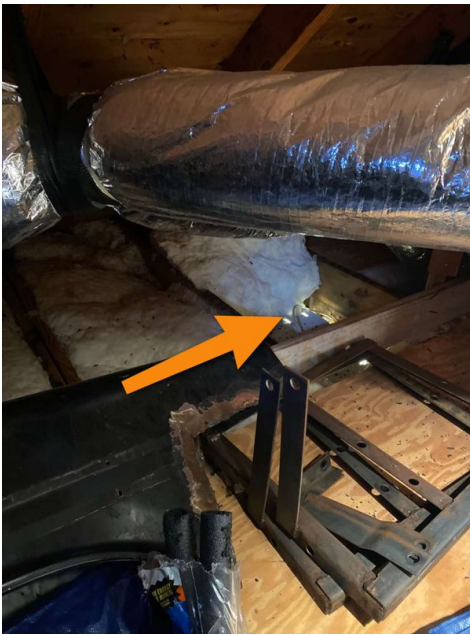
Insulation depth was inadequate. Recommend a qualified attic insulation contractor install additional insulation.

Recommendation  
Contact a qualified insulation contractor.

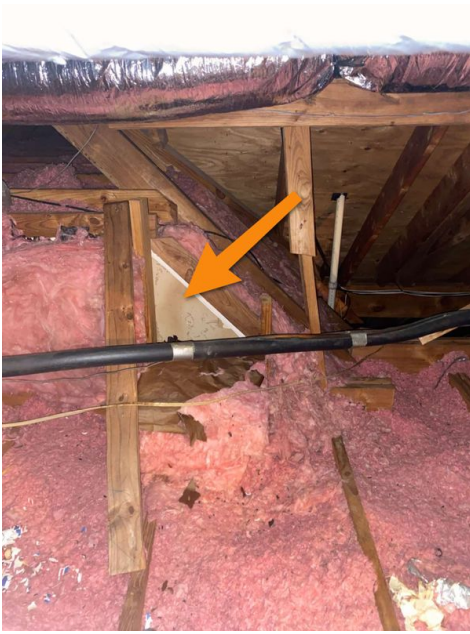
### DAMAGED INSULATION

Insulation appears to have been pulled out and/or damaged by contractors and/or pests. Recommend a qualified insulation contractor evaluate and repair.

Contact a qualified insulation contractor.

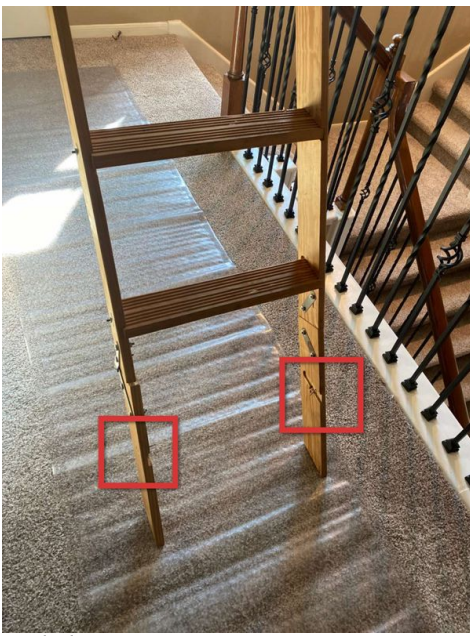
2nd Floor

### ATTIC LADDER DAMAGED

The attic ladder is damaged or was installed at an incorrect height. Unsafe. Recommend replacement of the ladder.

Contact a qualified general contractor.

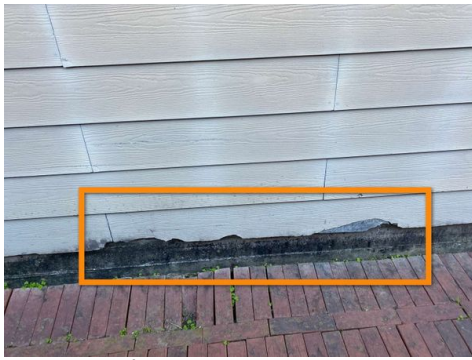
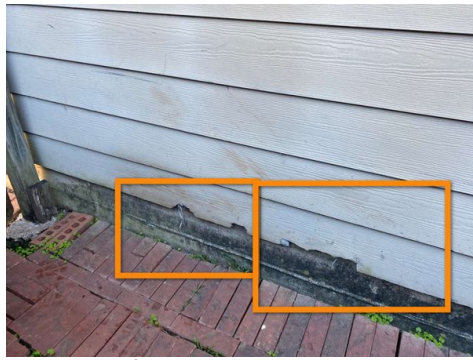
Garage Right

**SIDING IS DAMAGED OR MISSING**

The siding is damaged in these areas. Recommend a general contractor to resolve, as necessary.

Contact a qualified general contractor.

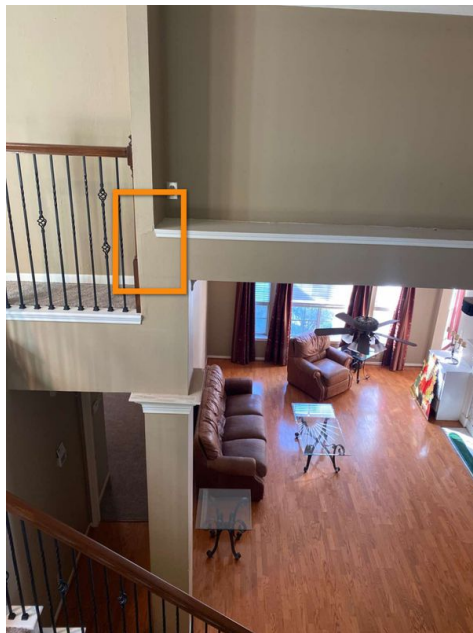
2nd Floor

**CRACKS MINOR**

Minor cracking was observed in wall structure. This is common in homes this age and is often determined to be cosmetic. Cracks can grow over time; recommend monitoring.

Recommendation  
Recommended DIY Project

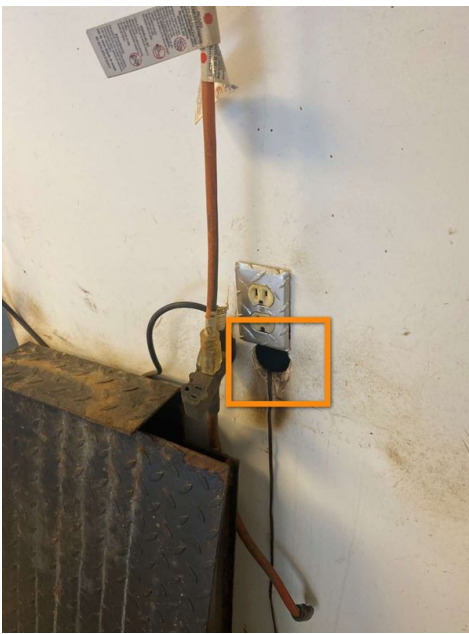
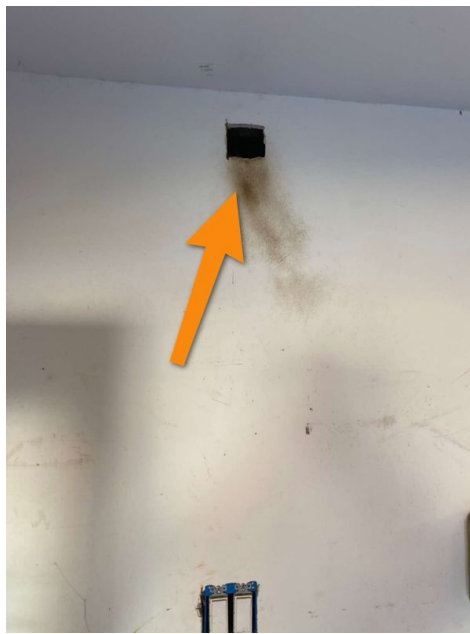
Garage

There is a hole in the wall that should be patched. Wall holes could allow for insects to enter, water infiltration (if exterior), but also allow for airflow escape causing a HVAC inefficiency. Recommend repairing the hole or sealing off the hole as necessary.

Recommendation  
Contact a qualified professional.

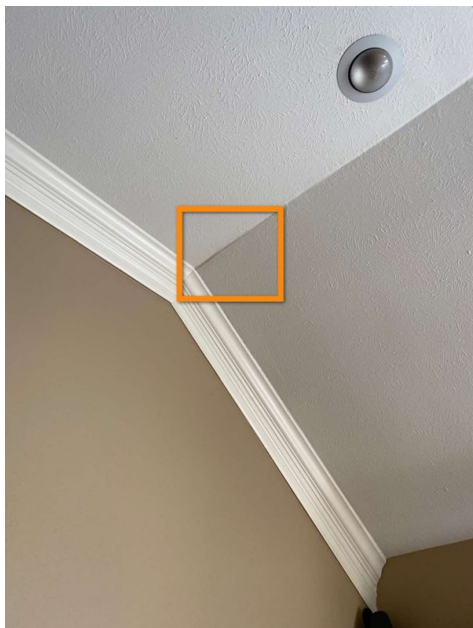
Living

**CEILING - WATER STAIN OBSERVED**

A stain on the ceiling is present. This stain did not visually appear damp and could be from a previously resolved water leak. Inspector is not always able to perform a spot moisture test on ceiling water stains because of the location and height. Recommend monitoring and addressing as necessary.

Contact a qualified general contractor.

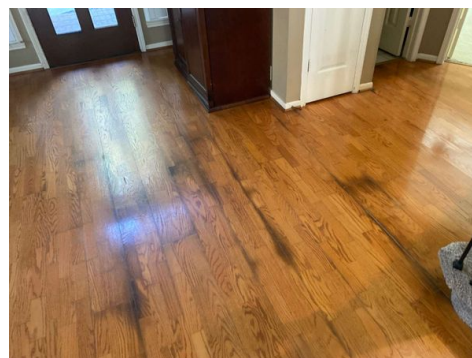
Entry

**FLOORING - DAMAGED**

The home flooring had general moderate damage visible at the time of the inspection. Damaged flooring may be primarily cosmetic and should be resolved as necessary. Recommend evaluation by a qualified flooring contractor.

Contact a qualified professional.

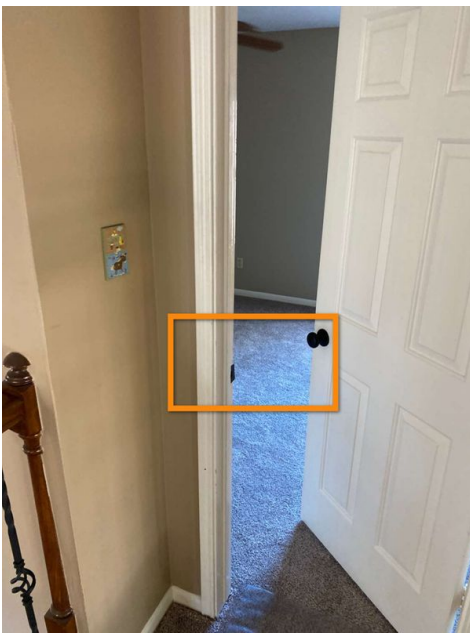
2nd Floor Bedroom

Door doesn't latch or close properly. Recommend handyman repair door, latch, and/or strike plate.

Contact a qualified handyman.

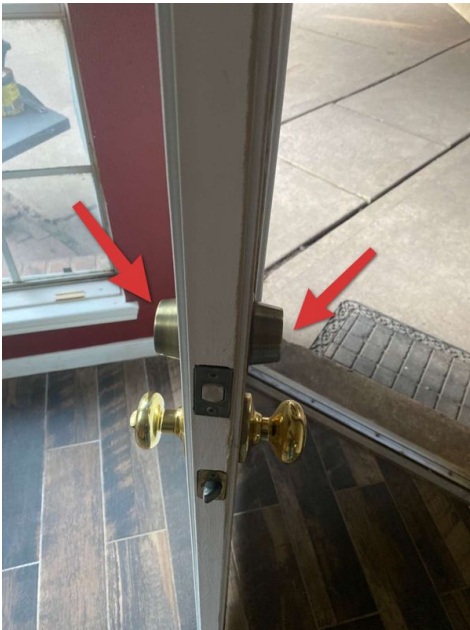
Back Kitchen

Doors should not lock from the inside, particularly when they are used as a method of escape to the exterior of the home in the event of an emergency. Doors that lock from the opposite side are reported as a safety hazard and should be replaced with a single-side lock.

Contact a qualified door repair/installation contractor.

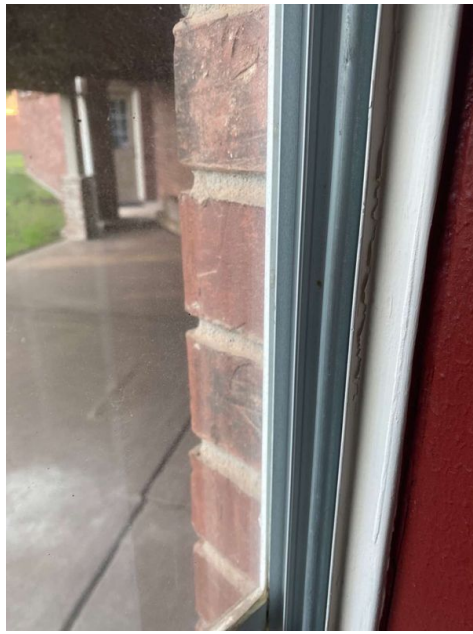
Living

Some windows in the home appear to be single pane. Single pane windows are less efficient and will lead to higher utility bills. Not all window photos are documented in the section, and photos here should be used as an example. Recommend budgeting for replacement of windows, as necessary, in the future for the entire property to undergo a window replacement.

Contact a qualified window repair/installation contractor.

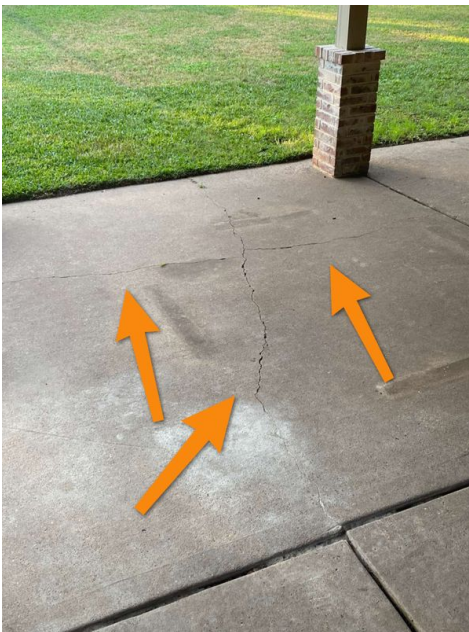
Back

### OLD CONCRETE - CRACKS, SEPARATION, AND HEAVING

The driveway and/or sidewalks show signs of aged cracking, separation, heaving, and/or deterioration. This is common in areas of Texas that have clay-based soils. Compromised concrete will continue to exhibit decay, failure, collapse, and uplift if not remediated. Cracking can also be a safety hazard for pedestrians if it becomes (or is currently) a trip hazard.

Recommendation  
Recommend monitoring.

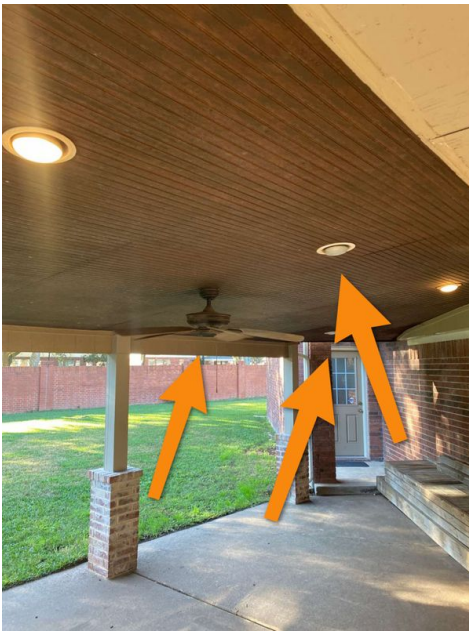
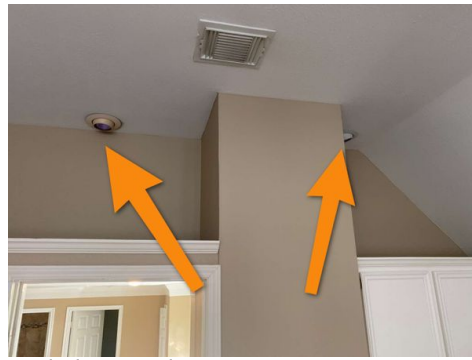
2nd Floor Bedroom

One or more light fixtures were inoperable (didn't turn on when nearby switches were operated). Recommend further evaluation by replacing bulbs and/or consulting with the property owner. If replacing bulbs doesn't work and/or no other switch(es) can be found, then recommend that a qualified electrician evaluate and repair or replace light fixtures as necessary.

Recommendation  
Contact a qualified electrical contractor.

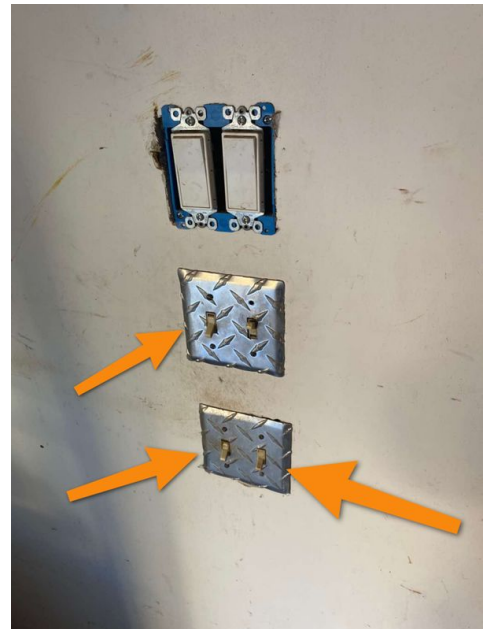
Garage

Switch did not appear to operate a light or devise in the home. This can sometimes occur if switches operate outlets or if bulbs are burnt. Recommend further investigation by the client or evaluation by an electrical contractor if the switch's use remains undetermined.

Recommendation  
Contact a qualified electrical contractor.

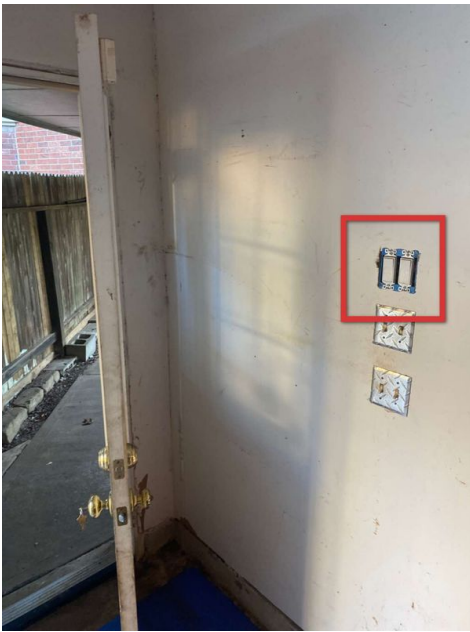
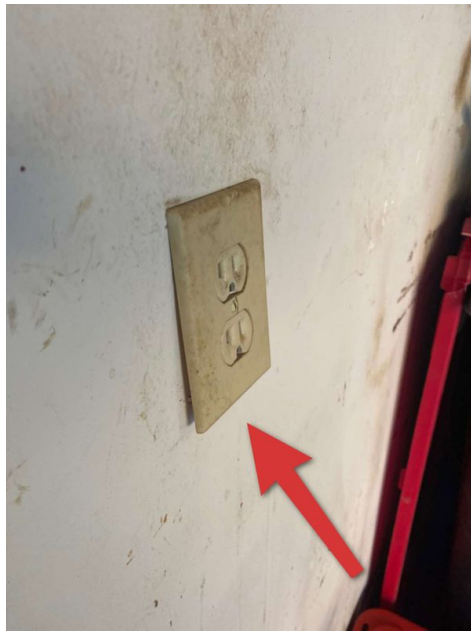
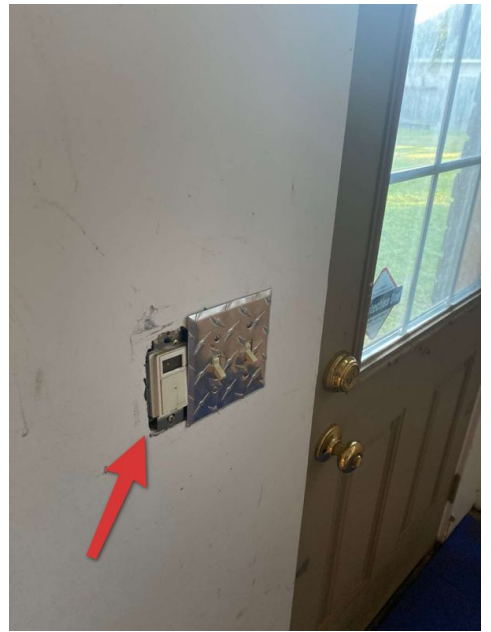
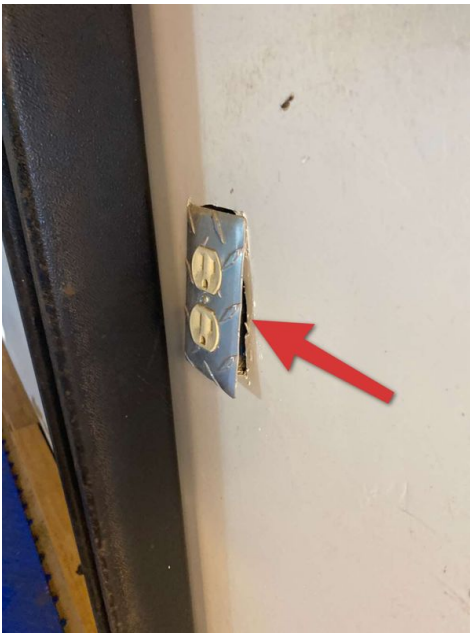
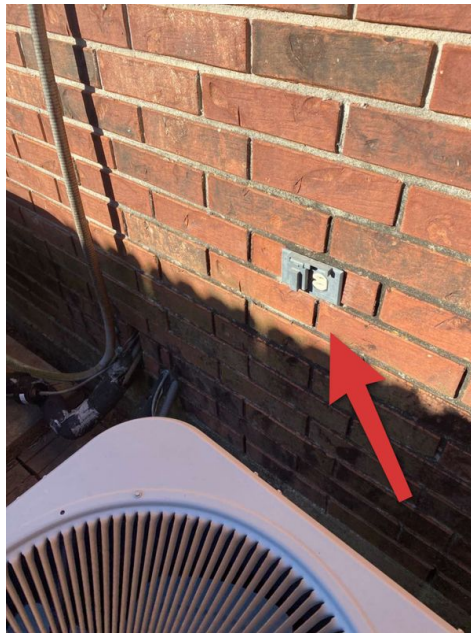
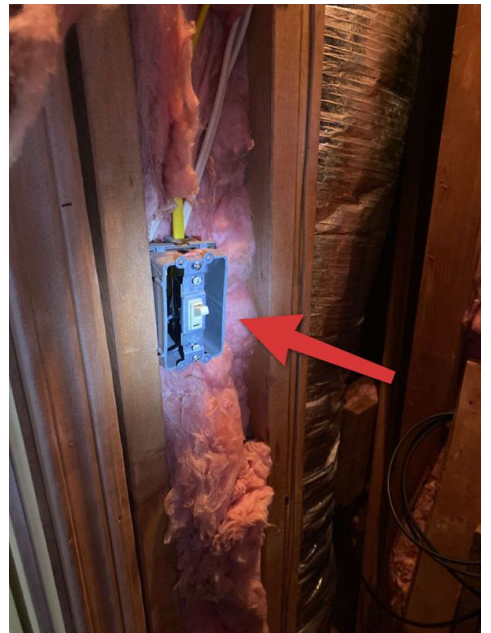
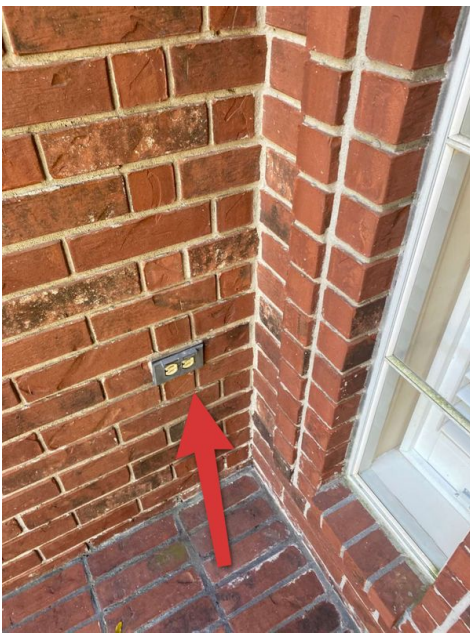
**COVER PLATES MISSING, DAMAGED, OR ARE THE WRONG TYPE**

One or more receptacles are missing a cover plate, the cover plate is damaged, or the wrong type of cover plate is being used. This causes short and shock risk. External cover plates must always be present and sealed to protect against water intrusion.

Recommend installation of correct cover plate.

Recommendation  
Contact a qualified electrical contractor.

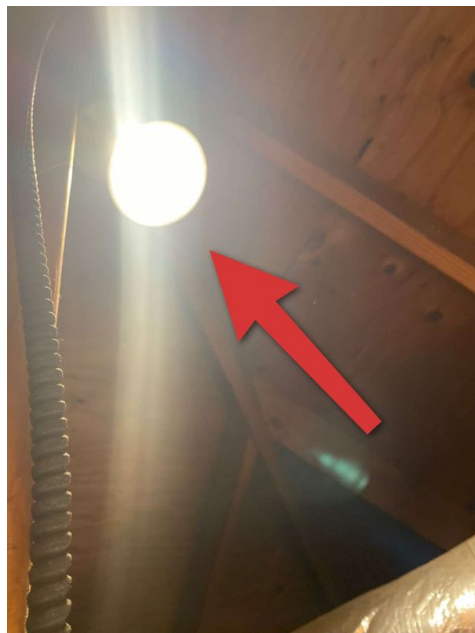
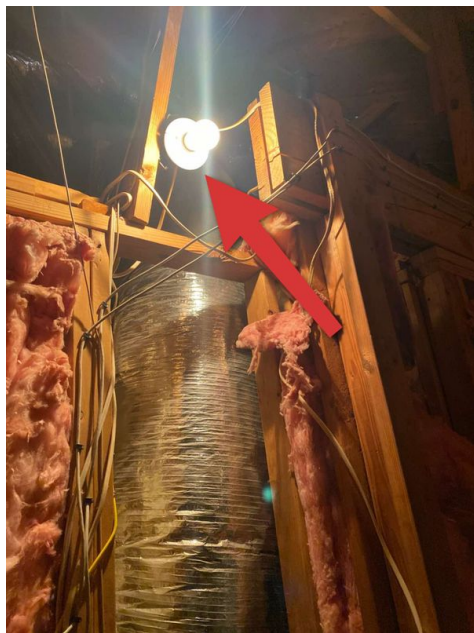
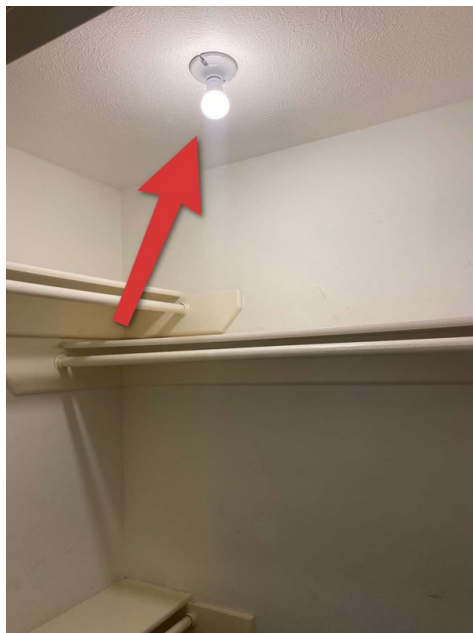
### CLOSET OR ATTIC HAS OPEN BULB

Recommended DIY Project

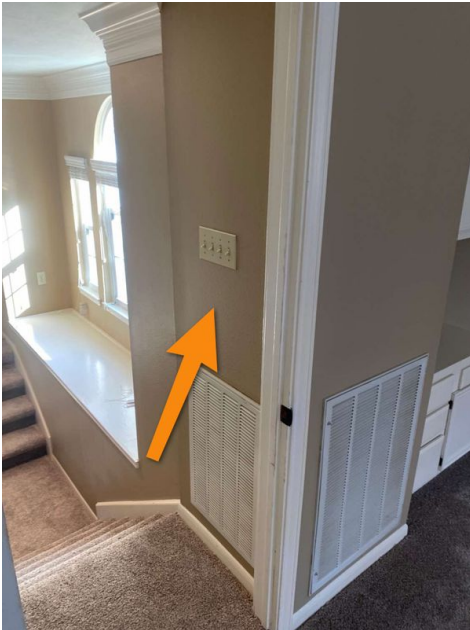
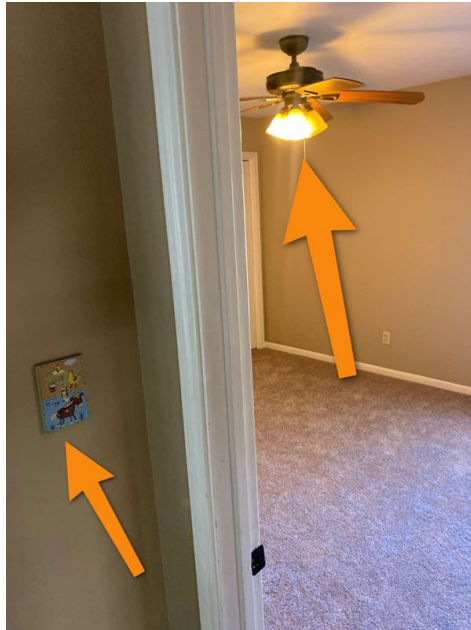
2nd Floor Bedroom

3.2.9 B. Branch Circuits, Connected Devices, and Fixtures  
**SWITCHES ARE OUTSIDE OF THE BEDROOM**

The switches for the bedroom are outside. This is not necessarily a deficiency but just an FYI.

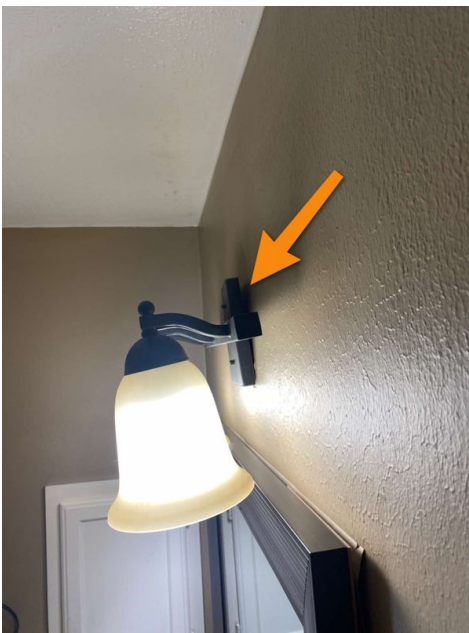
2nd Floor Bathroom

3.2.10 B. Branch Circuits, Connected Devices, and Fixtures  
**FIXTURE IS FALLING**

Recommendation  
Contact a qualified professional.

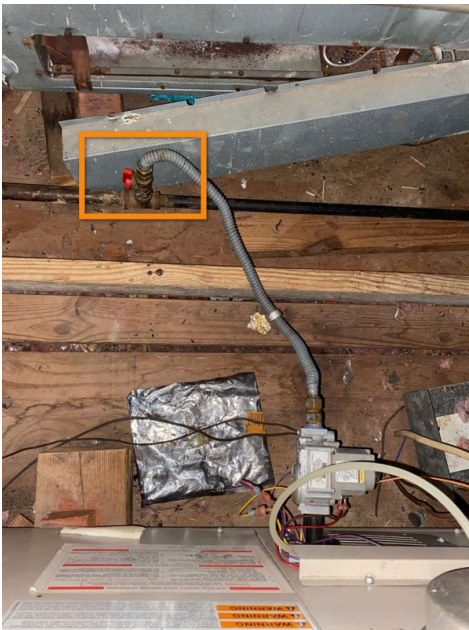
### FURNACE - SEDIMENT/DRIP TRAP MISSING OR INCORRECTLY ORIENTED

The sediment/debris and drip trap/leg on the gas line is incorrectly oriented or is missing. The trap should allow for condensation or sediment in the gas line to fall into the trap. Additionally the shut-off valve should be located before the trap to allow for cleanout. Recommend installing a correctly oriented sediment/debris trap on the gas line prior to entering the unit.

Contact a qualified plumbing contractor.

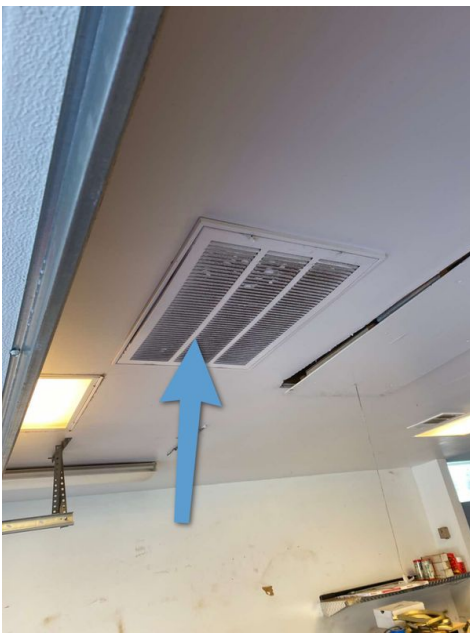
Garage

**FILTER REQUIRES REPLACEMENT**

Contact a qualified HVAC professional.

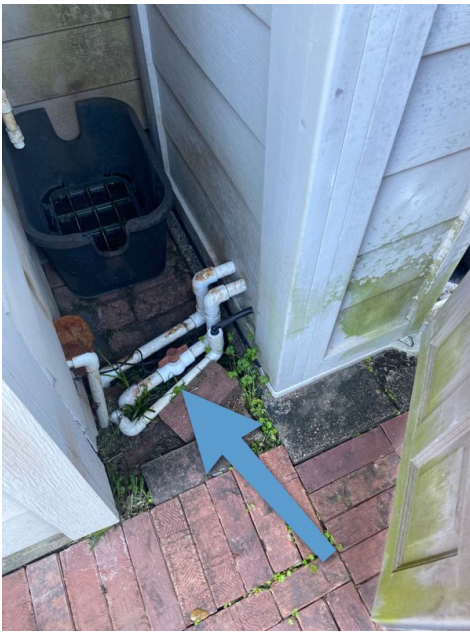
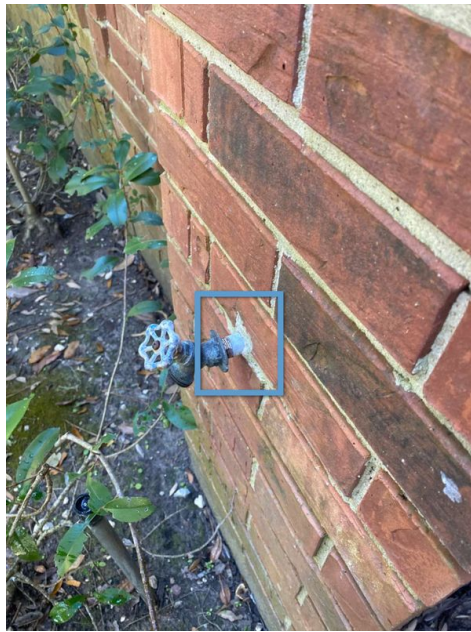
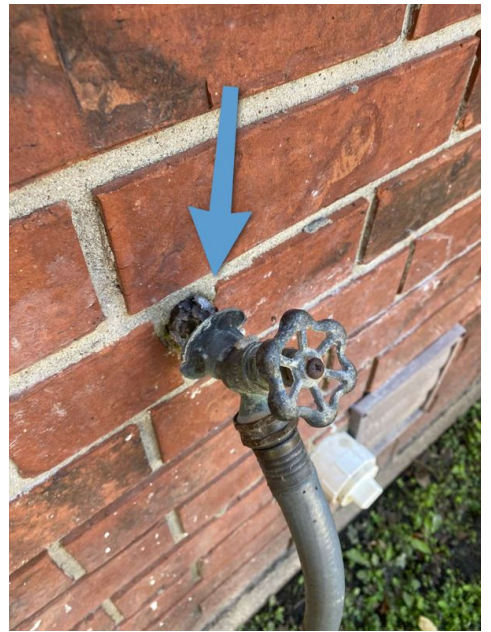
Garage Right

Water line insulation is important to keep distribution lines from freezing and bursting in cold weather. This includes areas in the attic, garage, or exterior areas where freezing temperatures can occur. Water lines should be insulated regardless of their type. Missing or damaged water line insulation was discovered and should be replaced.

Recommendation  
Recommended DIY Project

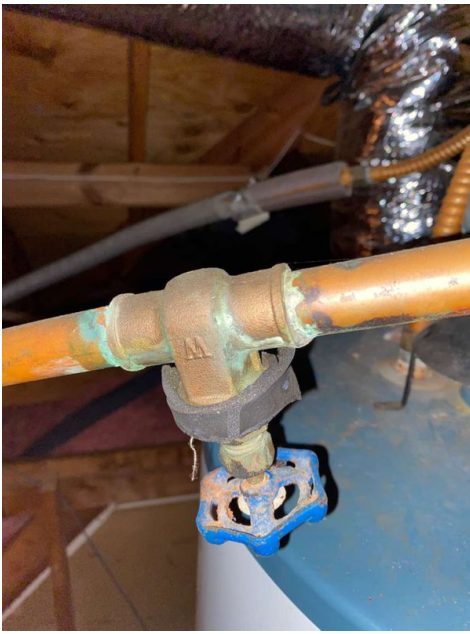
#### **CORROSION AT VALVE OR PIPE CONNECTORS**

Contact a qualified plumbing contractor.

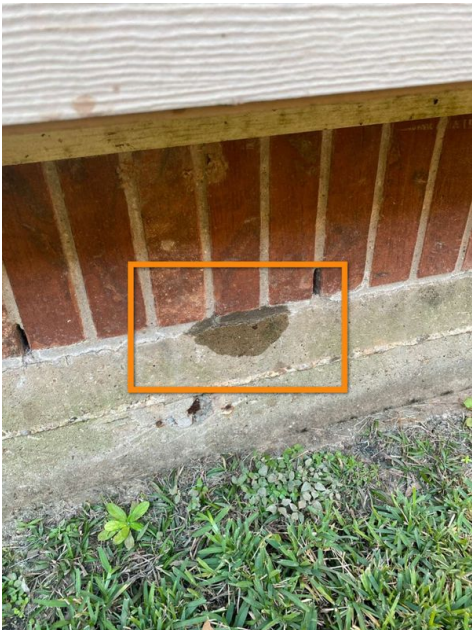
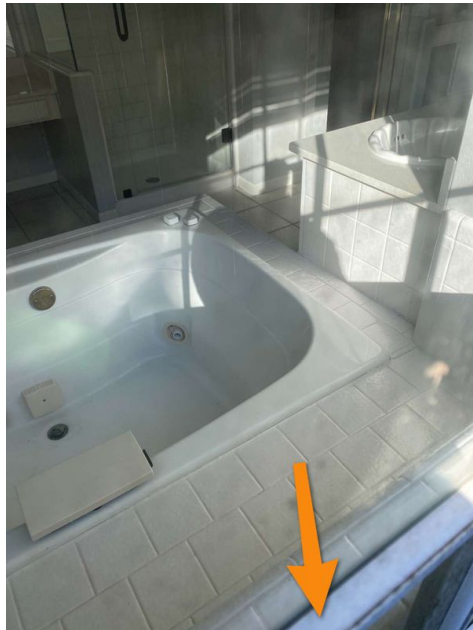
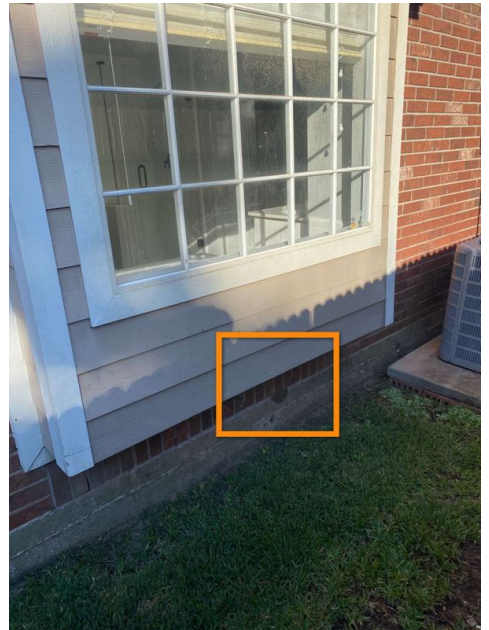
5.4.2 D. Hydro-Massage Therapy Equipment  
**HYDRO TUB IS LEAKING**

Recommendation  
Contact a qualified professional.

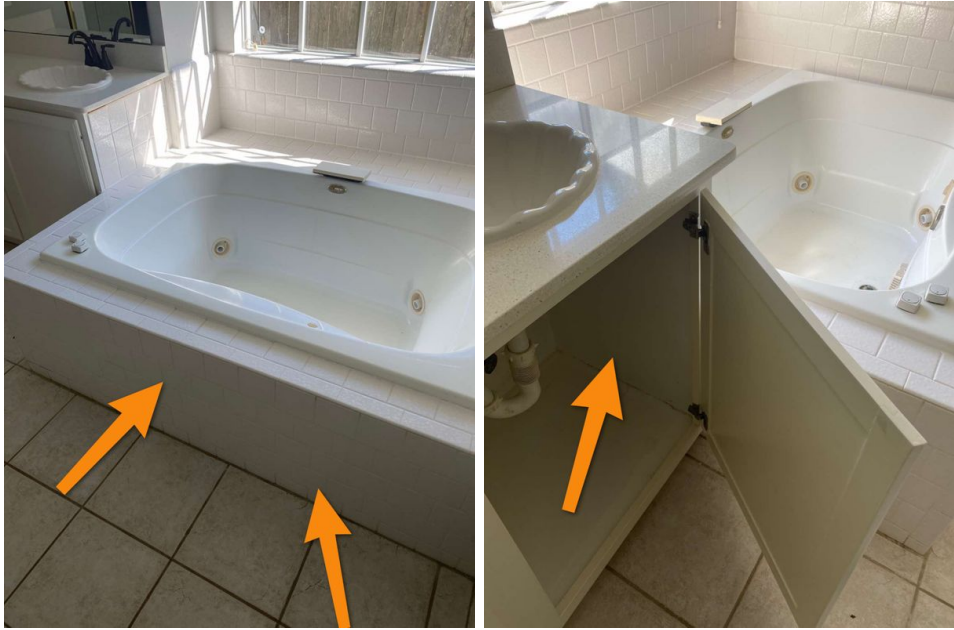
Primary Bathroom

### 5.4.3 D. Hydro-Massage Therapy Equipment **NO ENRTY TO HYDRO TUB COMPONENTS**

Recommendation  
Contact a qualified professional.

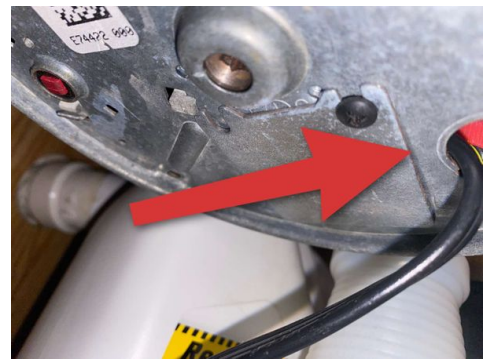
#### **MISSING OR DAMAGED STRAIN RELIEF CONNECTOR**

The food disposer wiring has a missing or damaged strain relief connector (sometimes referred to as a Romex connector or anti-strain device). Recommend re-installation.

Recommendation  
Contact a qualified electrical contractor.

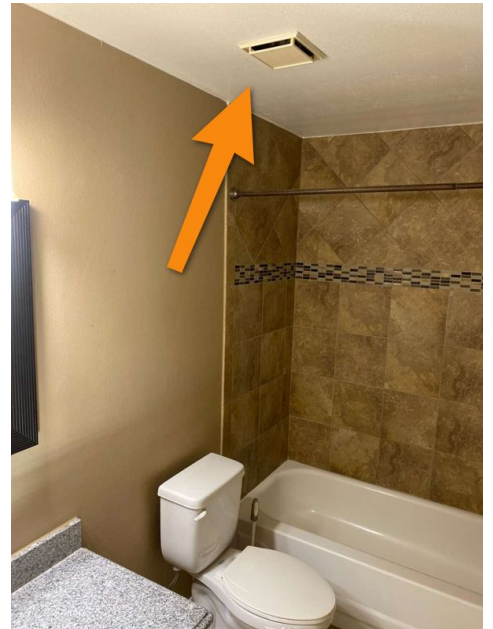
2nd Floor Bathroom

**VENT FAN IS NOISY**

The vent fan is unusually noisy when powered on. Recommend further investigation to determine the cause of the problem.

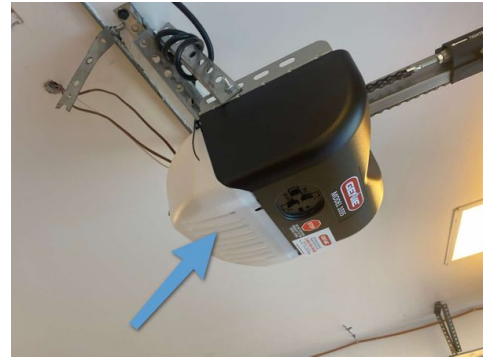
The garage door opener light was inoperable. This is likely caused by a burnt out lightbulb. Recommend replacement of bulb and/or further investigation for possible deficiency.
