# Inspection Report

**Property Address:**  
6606 Belmont Bend  
Katy TX 77450

# PROPERTY INSPECTION REPORT

**By:** Steven Walters TREC#22910 / Home Plate Inspections, LLC 11/23/2021

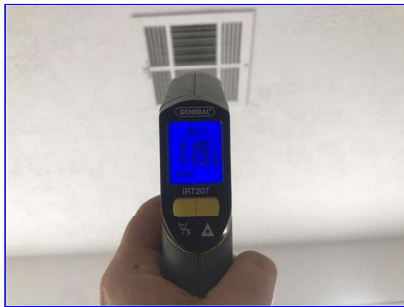
A. Item 1(Picture)

The heating equipment and furnace all appeared to be working as intended at the time of inspection. The heat was metered at 119 average at the supply registers.
