RESIDENTIAL HOME INSPECTION

3518 Durness Way
Houston TX 77025

PROPERTY INSPECTION REPORT

10/15/2021 8:30 am

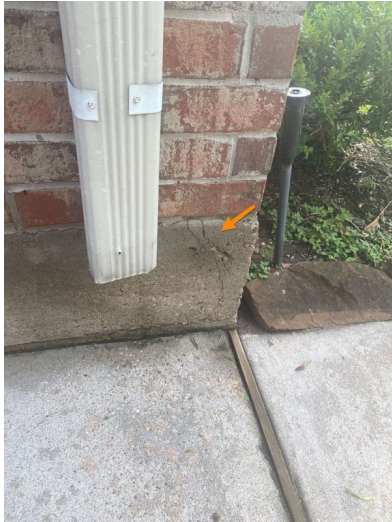
Back Right

1: Foundation cracks - corners

Corner cracks are visible in the foundation slab but are of minimal structural concern. Shrinkage is a natural part of the curing process of concrete and cracks located in corners of structures are common. Recommend monitoring to confirm the cracking does not worsen.

Recommendation: Recommend monitoring.

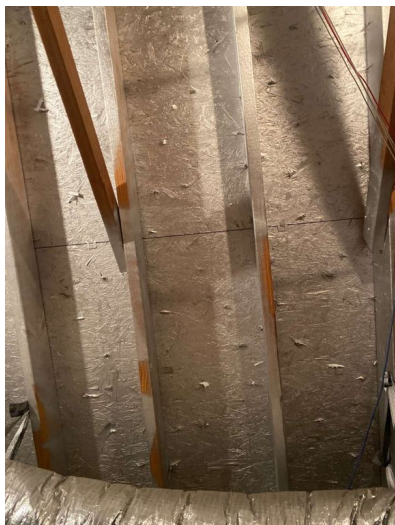
Attic

1: Insufficient insulation

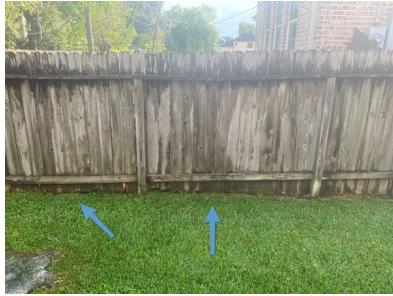
Right

Fence appears to have minor rot damage and/or structural issues. Recommend contract a fencing contractor for repair and/or replacement of the elements that are exhibiting rot or structural issues.

Recommendation: Contact a qualified fencing contractor

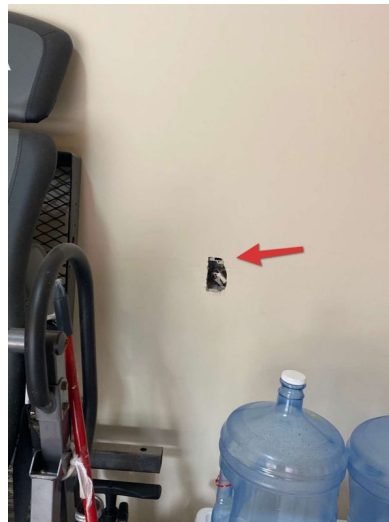
Garage

2: Cover plates missing or damaged

One or more receptacles are missing a cover plate or the cover plate is damaged. This causes short and shock risk. Recommend installation of plates.

Recommendation: Contact a qualified electrical contractor.

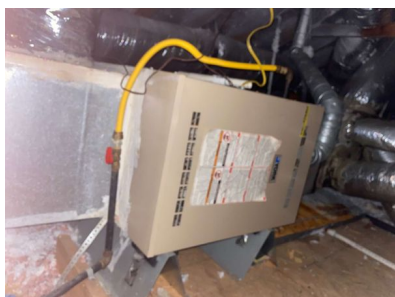
Back

1: Furnace - sediment/drip trap missing or incorrectly oriented

The sediment/debris and drip trap/leg on the gas line is incorrectly oriented or is missing. The trap should allow for condensation or sediment in the gas line to fall into the trap. Additionally the shut-off valve should be located before the trap to allow for cleanout. Recommend installing a correctly oriented sediment/debris trap on the gas line prior to entering the unit.

Recommendation: Contact a qualified plumbing contractor.

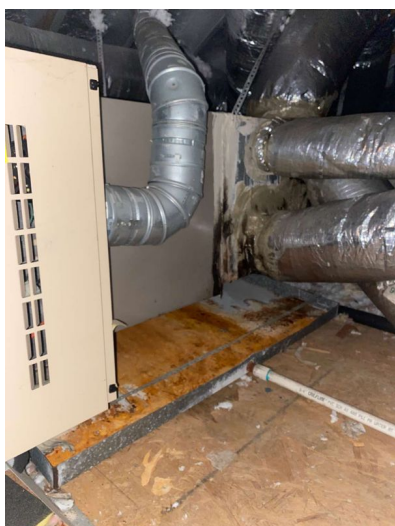
Back

1: Condenser - freon insulation missing or damaged

Missing or damaged insulation on the refrigerant line can cause energy loss and condensation. Recommend contacting an HVAC professional to replace the missing or damaged insulation.

Recommendation: Contact a qualified HVAC professional.

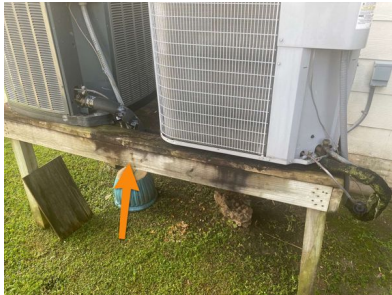
The condensers are sitting on wood platforms that are starting to rot. Recommend replacing supports with concrete pads.

Recommendation: Contact a qualified professional.

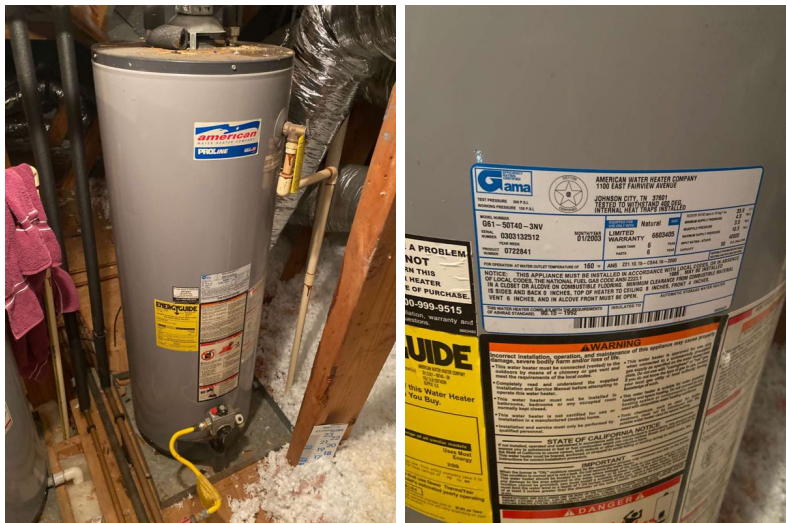
1: Gas - sediment/drip trap missing or incorrectly oriented

The sediment/debris and drip trap/leg on the gas line is incorrectly oriented or is missing. The trap should allow for condensation or sediment in the gas line to fall into the trap. Additionally the shut-off valve should be located before the trap to allow for cleanout. Recommend installing a correctly oriented sediment/debris trap on the gas line prior to entering the unit.

Recommendation: Contact a qualified plumbing contractor.

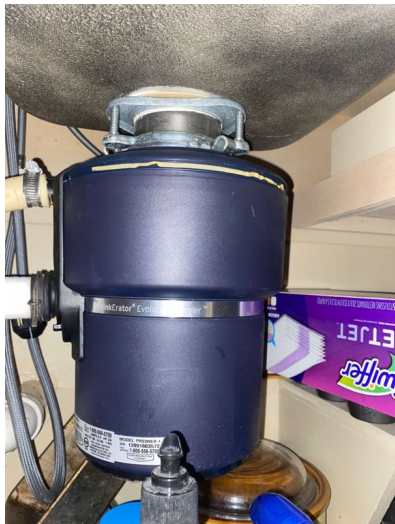
1: Excessive motor noise

Garbage disposal motor was excessively noisy. Recommend a qualified plumber evaluate and repair or replace.

Recommendation: Contact a qualified plumbing contractor.

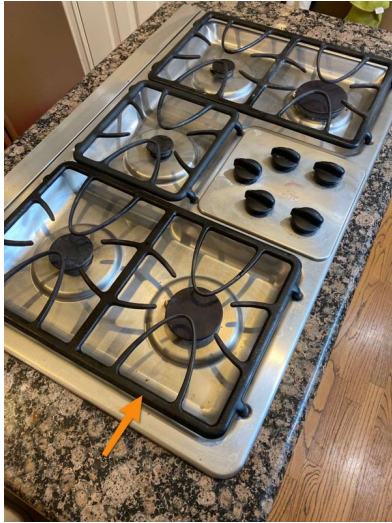
1: Burner not lighting / turning on

One or more burners did not light (gas) or heat up (electric) when turned on. Recommend an appliance repair technician or a qualified professional evaluate & repair.

Recommendation: Contact a qualified appliance repair professional.

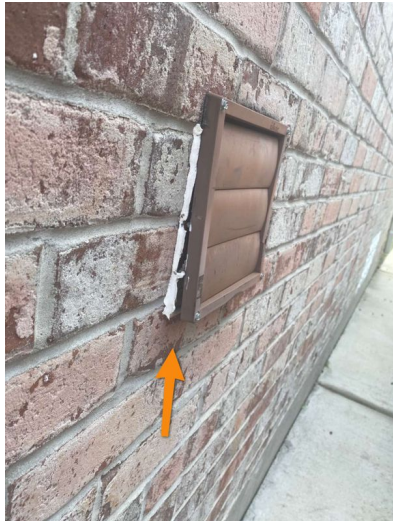
Left

1: Vent cover is damaged or missing

The mechanical duct vent cover is missing or damaged. Recommend repair or replacement.

Recommendation: Contact a qualified plumbing contractor.
