PROPERTY INSPECTION REPORT

Prepared For: Bryon Bauer
Concerning: 15200 Moonlight Trail Conroe, Texas 77384
Inspection Date: 06/25/2019

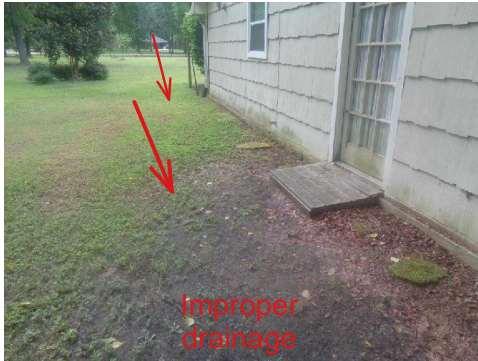
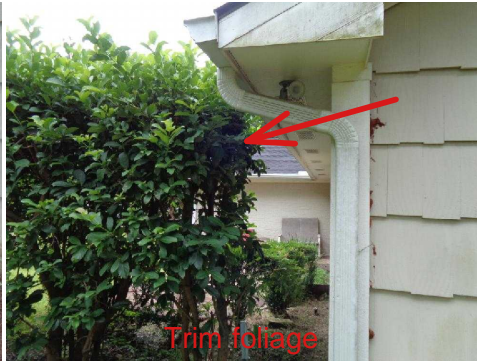
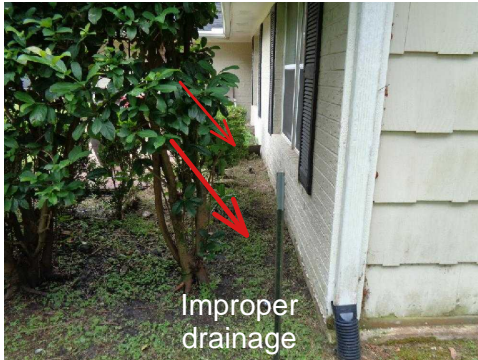
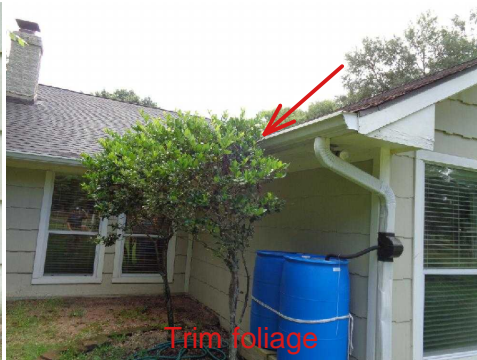
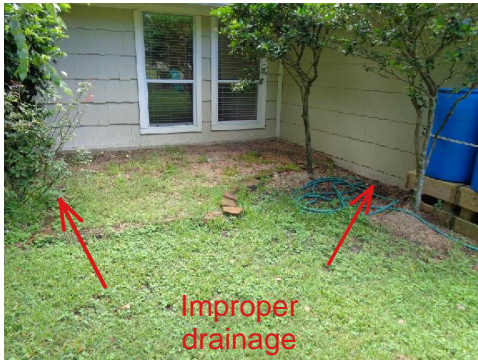
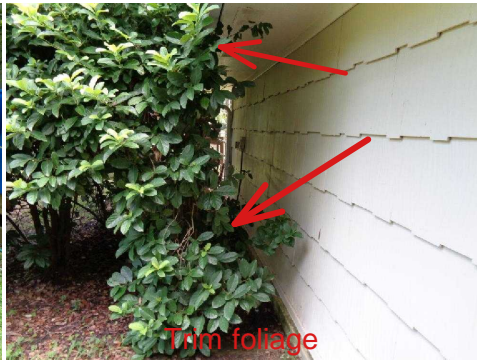
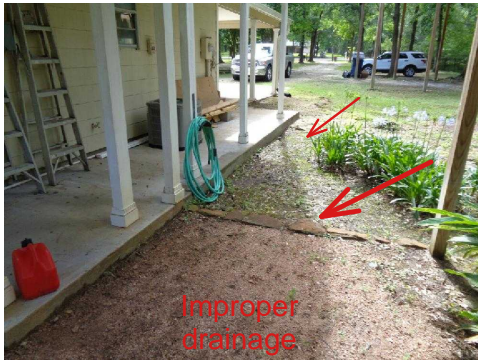
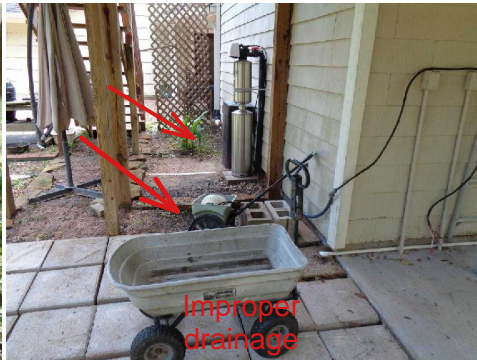
- There appears to be improper grading and drainage of the property at the front, right and rear side of the main house, and also at the left and rear side of the garage. The property should be graded so that surface water will drain away from foundation walls at a minimum slope of 6" within 10'. Lot drainage should divert to the street as to not create a hazard on the property. A few subsurface drains were noticed around the yard, effectiveness can not be determined.

- The section of gutters above the balcony, was observed to be damaged and starting to separate from the structure, causing

B. Grading and Drainage (continued)
the a negative slope. Repair/Replace as needed.

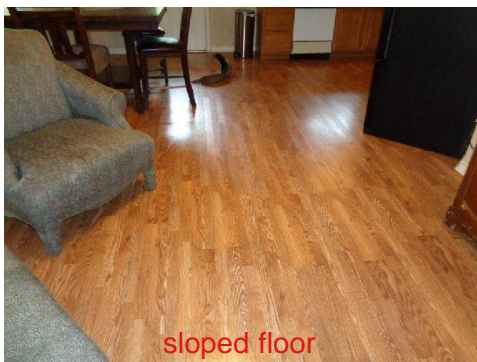
- The flooring at the apartment was observed to be slightly uneven/sloped at the kitchen and living- room. This could be from the float beneath the finished flooring or a possible issue with the subfloor decking.

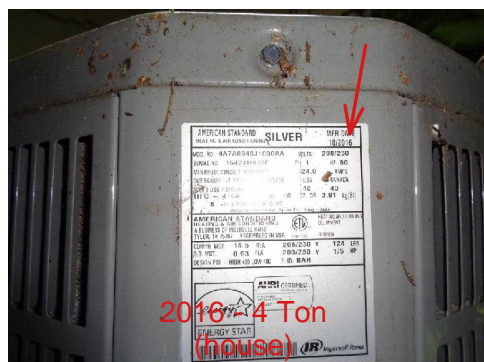
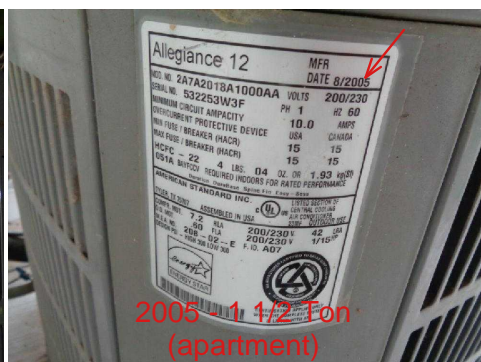
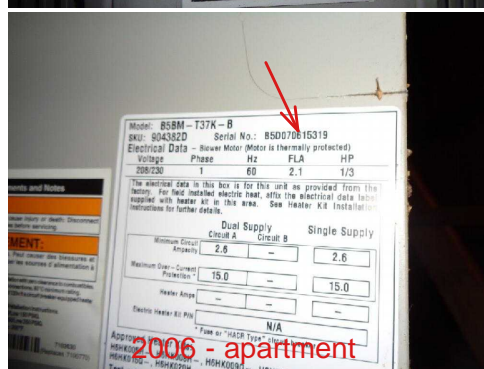
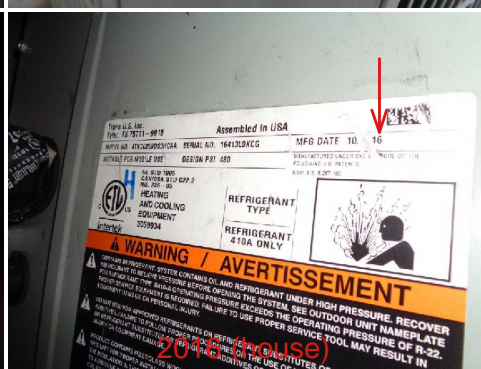
- The Cooling equipment was performing as intended at the time of the inspection.
- The HVAC system is past its manufacturers normal life expectancy, and should be fully evaluated by a licensed and insured HVAC technician.
- The thermal revealed no leaks from the condenser or exposed liquid/suction lines at the time of the inspection.

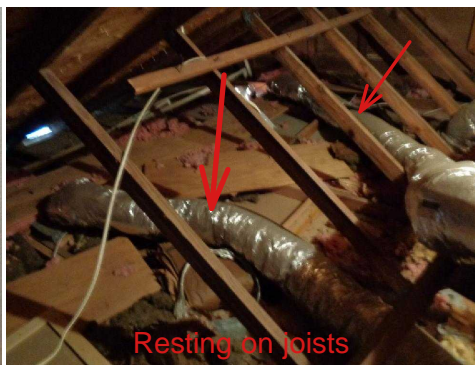
- The filters were observed to be dirty and in need of replacement. Recommend replacing filters every 3-6 months for maximum efficiency of the system.
- The ductwork should be suspended from the rafters and not resting on the ceiling joists. This helps to prevent kinks and warped ducts for better air flow of the system. Correct as needed.
- Duct work touching / overlapping at several locations. These areas should be separated with batt insulation to prevent the buildup of condensation between the ductwork.
- There were no supply vents noticed at the master bathroom or laundry room. Recommend installing ducts to these rooms for better air balance and comfort in the home.

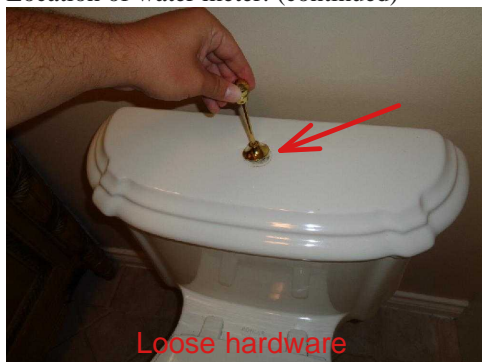
- The hose bibs located at the exterior were noticed to be missing the proper insulation material around the exposed pipe. Recommend installing to prevent freezing during lower temperatures.
- The exterior hose bibs did not have anti-siphon devices installed. These are required on all exterior supply fixtures to prevent dirty water from backing up into the clean water supply. Install as needed.

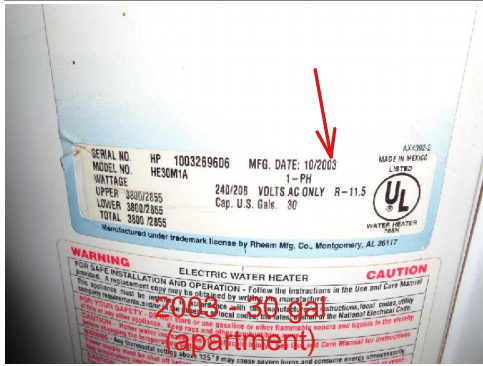
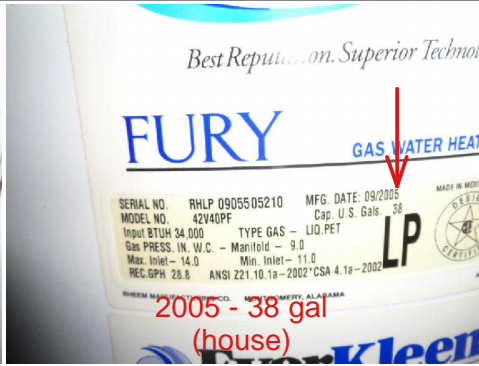
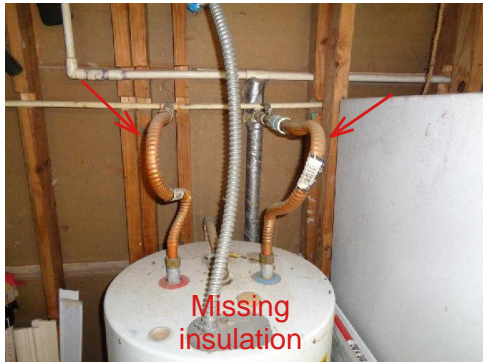
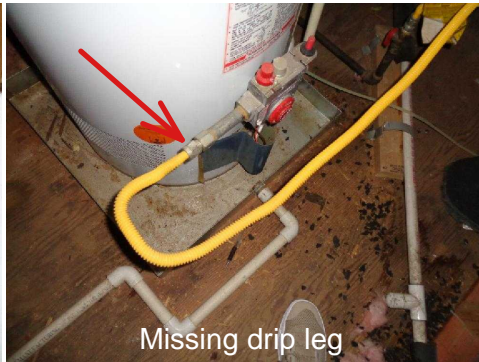
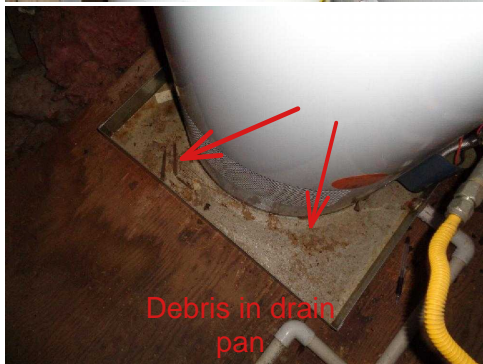
- The gas line for the water heater was noticed to be missing its drip leg/sediment trap. The drip leg helps prevent blockage and should be installed to prevent build-up of sediment inside the gas line. Install for proper functionality.
- Debris/insulation was observed in the drainage pan. Recommend removing debris to prevent blockage in the drain line.
- The water heater is beyond its normal life expectancy and should be fully evaluated by a licensed plumber for an accurate estimate on remaining life expectancy.
- The water heater was operating as intended at the time of the inspection.

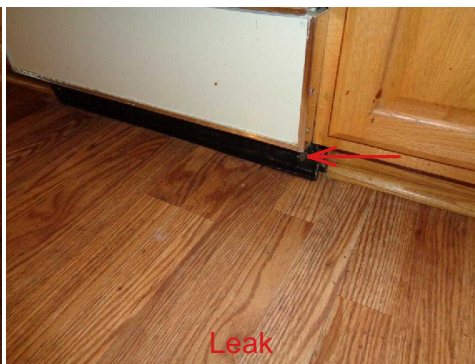
- The dishwasher at the house completed a full cycle and was performing as intended at the time of the inspection.
- The dishwasher for the apartment was noticed to have damaged door and was also leaking at the time of the inspection. Repair/Replace as needed.

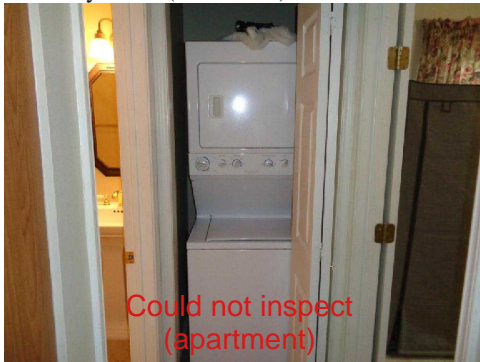
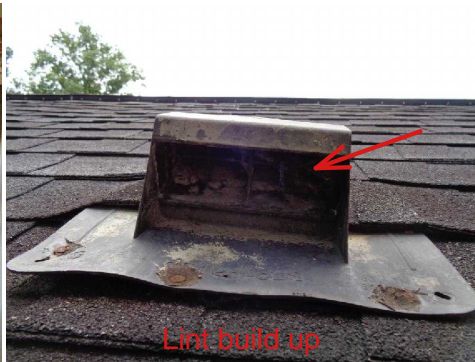
- The dryer exhaust was observed to have lint build up. This can create a fire hazard if the exhaust gets completely compromised. Correct as needed.

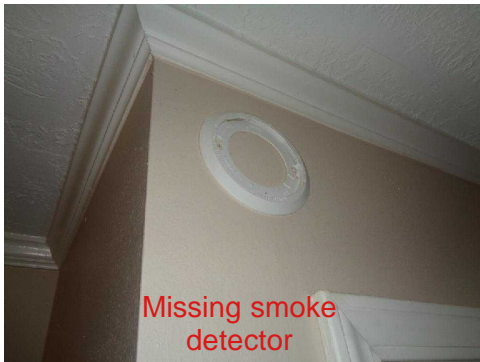
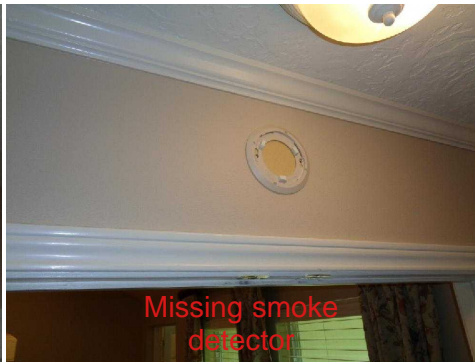
- Several smoke detectors were missing throughout the house and apartment. Smoke detectors are required in all bedrooms outside all bedrooms and at least one on each floor of the structure. This is a safety issue and should be corrected as soon as possible.

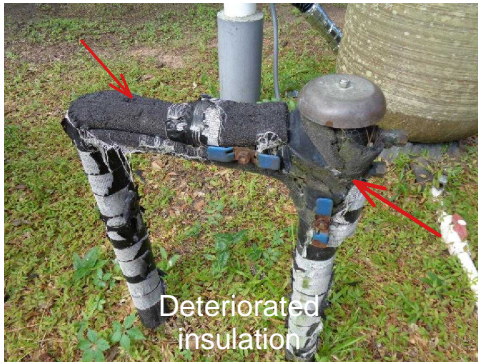
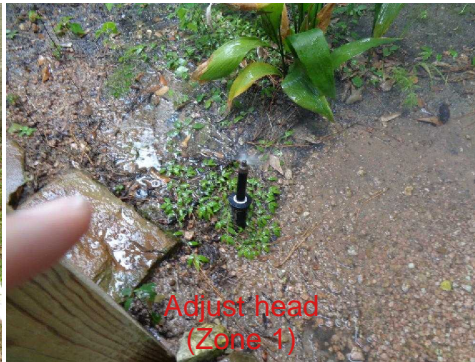
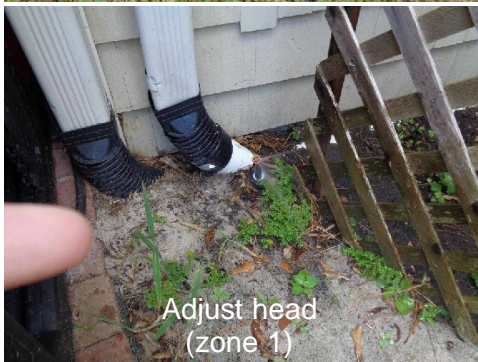
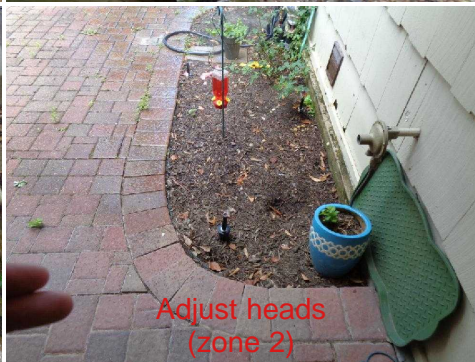
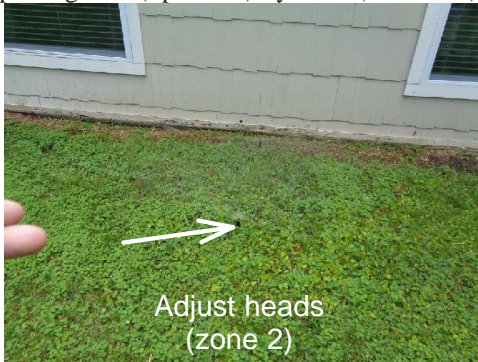
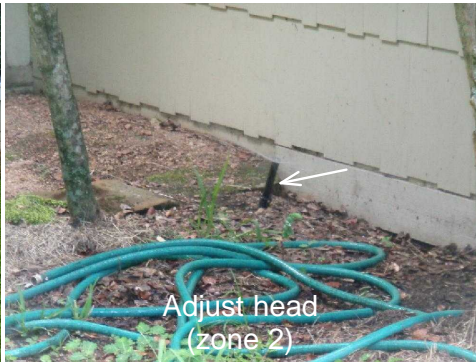
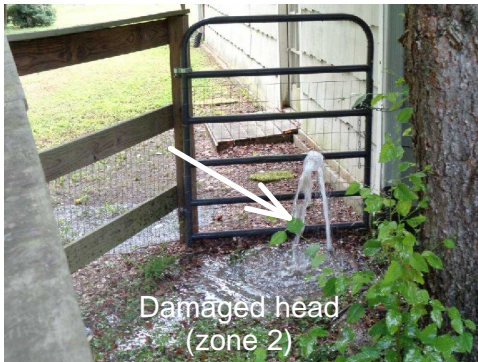
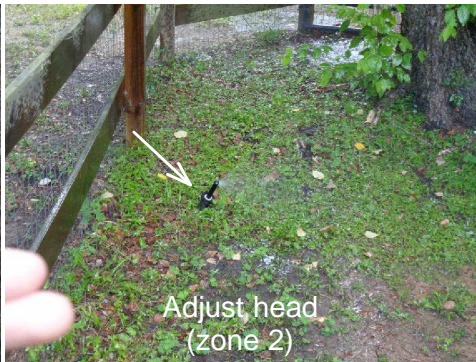
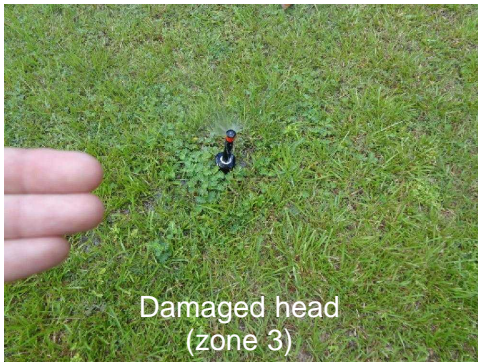
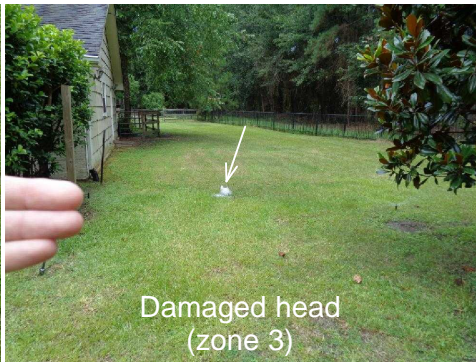
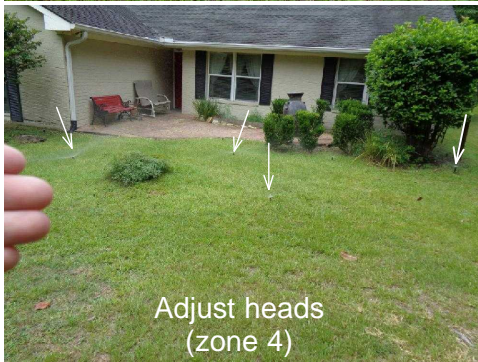
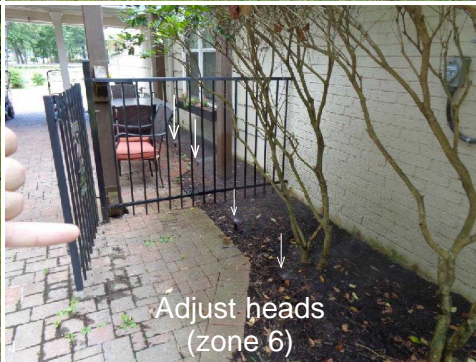
- The insulation for the backflow diverter, was observed to be deteriorated. Correct as needed.

- Several zones have sprinkler heads that are in need of adjustment. heads should not lean, be installed above grade, spray structures, flat concrete surfaces, or fences. This helps with preventing damage, wasting water, and deteriorating surrounding features. adjust as needed.

- The following zones have sprinkler heads that are damaged. Repair/Replace as needed.

- Zone 2
- Zone 3

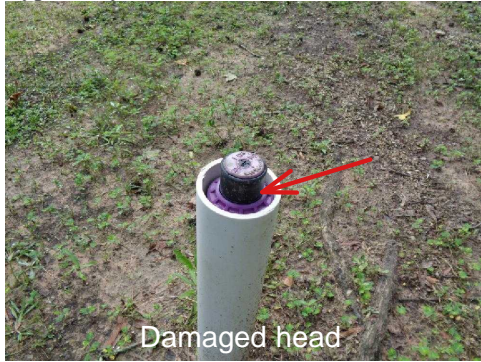
- The handle for the lid of the aerobics pump, was observed to be damaged. Repair/replace as needed.
- Trees were observed to be within the perimeter of the drain field. Trees should not be located in or near the drain field to prevent damage to subsurface drain piping.
- The rear right spray head for the septic system would not retract back into the housing compartment. Repair/Replace as needed.
- The septic system appears to be performing as intended at the time of the inspection.
