RESIDENTIAL INSPECTION REPORT

727 Davis Rd
League City TX 77573

PROPERTY INSPECTION REPORT

Concerning: 727 Davis Rd, League City TX 77573
(Address or Other Identification of Inspected Property)

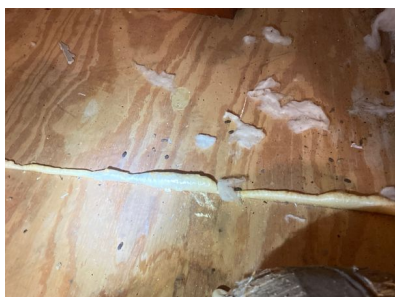
There was evidence of prior and/or current rodent activity in one or more areas of the home. Pest control services are available through our sister company, Green Team Pest, and can be scheduled through our office. If you have any concerns regarding rodent infestation we strongly recommend you schedule this service.

Recommendation: Contact a qualified pest control specialist.

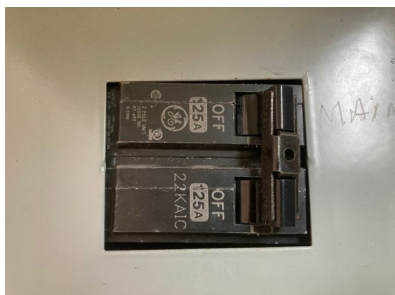
1: Circuits Not Labeled

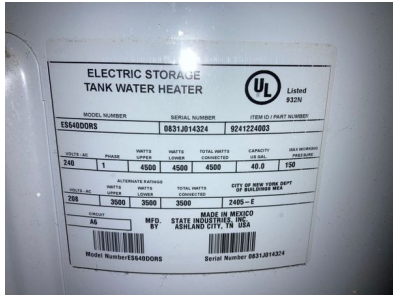
Location: Utility Room

Inspector Does Not Test TPR Valve or Open/Remove Burner Covers:

The inspector does not test TPR valves or remove the burner compartment covers due to safety reasons and risk of damage to the property.

1: Annual Maintenance Flush Recommended

Water heaters should typically be flushed annually to prevent sediment buildup and maintain efficiency. It is recommended that you refer to the manufacturer's manual for maintenance schedules specific to this device and make any service appointments as needed.

2: TPR Valve Note: Replacement may be needed

The manufacturer recommends replacement of the pressure relief valve every three years to ensure proper emergency function. The inspector does not test TPR valves due to safety hazard or possible damage to unit.

Recommendation: Contact a qualified plumbing contractor.

Recommendation: Contact a qualified professional.

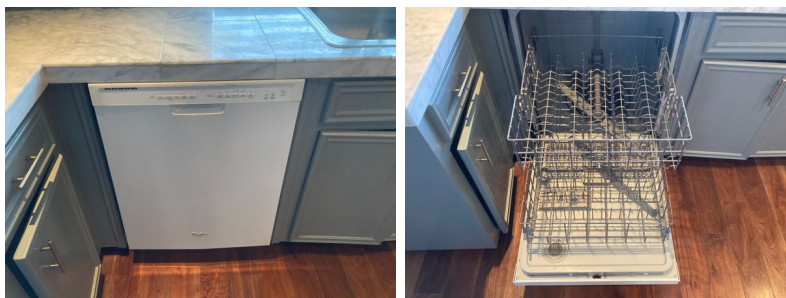
General Photos of Dishwasher:

No wire clamp had been installed at the base of the unit. Evaluation and remediation is recommended.

Recommendation: Contact a qualified professional.

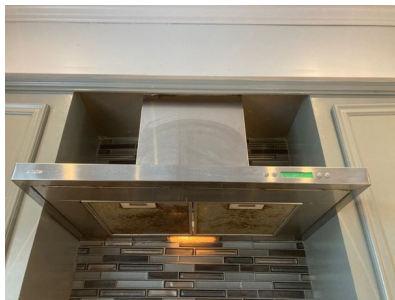
General Photos of Range Hood/Exhaust Systems:

Kitchen exhaust filter had excessive grease build-up. Clean and/or replace as needed.

Recommendation: Contact a qualified professional.
