## MECHANICAL INSPECTION

13515 St Marys Ln  
Houston TX 77079

# PROPERTY INSPECTION REPORT

07/12/2021 9:00 am

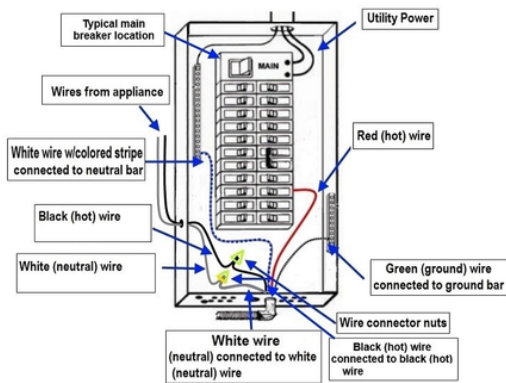
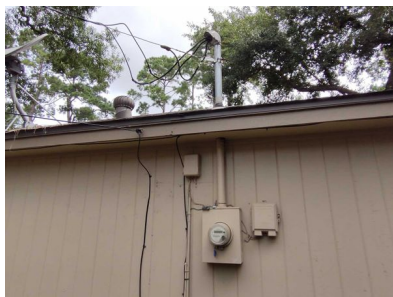
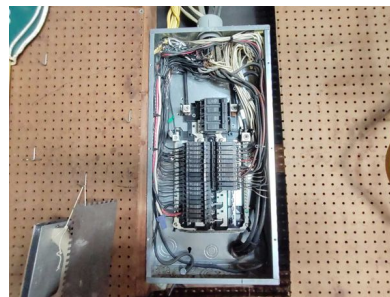
Circuit Breaker Wiring Diagram

<u>Location</u>	<u>Manufacturer</u>	<u>Rating - Amps</u>
Garage	G. E.	200-amps

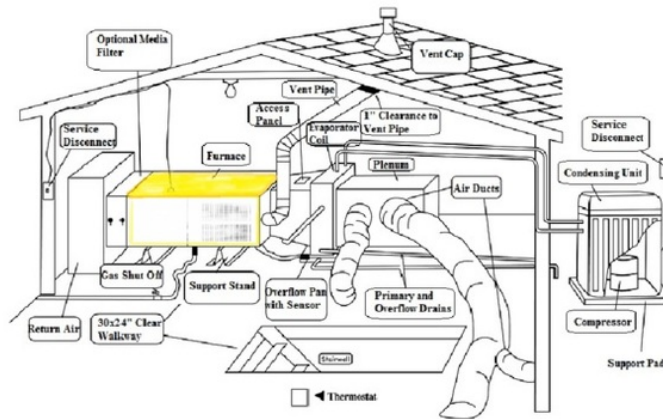
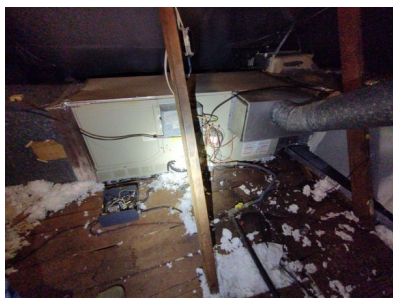
<u>ZONE</u>	<u>BRAND</u>	<u>BTU</u>	<u>DATE</u>	<u>LOCATION</u>
House	Carrier	125k	1989	attic

The heating equipment was observed to be operating and functional at the time of the inspection. The heating equipment responded to the thermostat and the equipment appeared to be heating the air adequately.

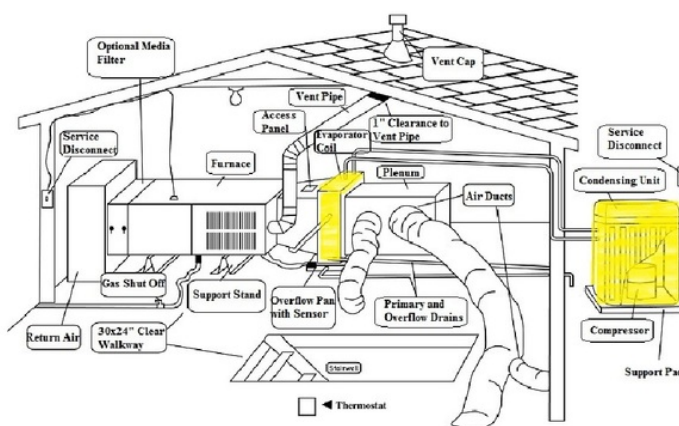
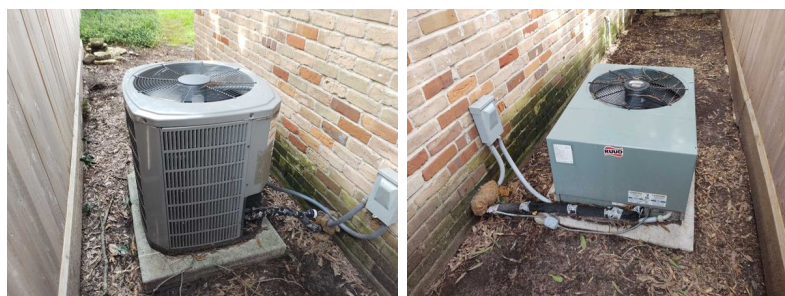
Zone	Brand	Size/Age Condenser	Size/Age Coil	Temp Drop Degrees
Downstairs	Amer.Stan.	3T/2016	3T/2016	20
Upstairs	Ruud	2T/2007	2T/2008	16

The condensing unit equipment was functional at the time of the inspection. The equipment responded to the corresponding thermostat, and the compressor components and fan motor components were operating.

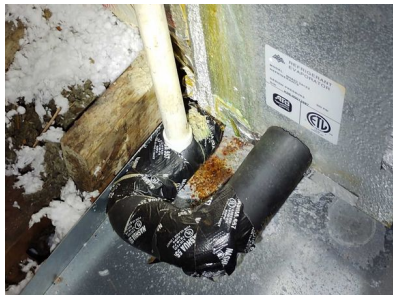
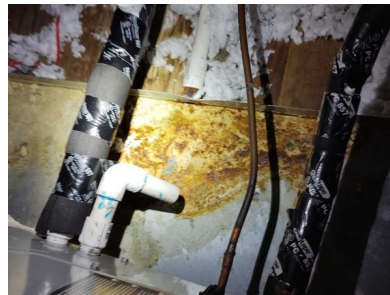
**4: Overflow Pan - Debris in pan**

Insulation and/or debris was observed in the overflow pan. The pan needs to be cleaned out to prevent clogging of the drain line.

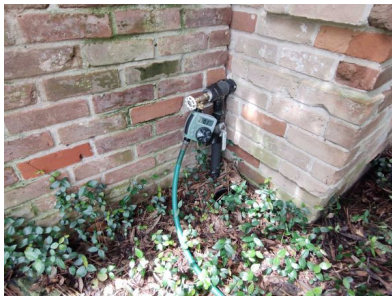
Front

The shut-off valve for the main inlet water line was located at the exterior of the house.

**Original location from 1967**

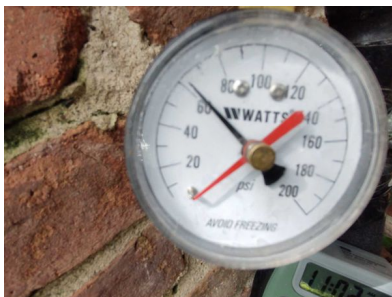
The static water pressure to the house at the time of the inspection was measured with a pressure gauge at the hose bibb nearest the shut off valve, and the static pressure was observed to be 62 PSI.

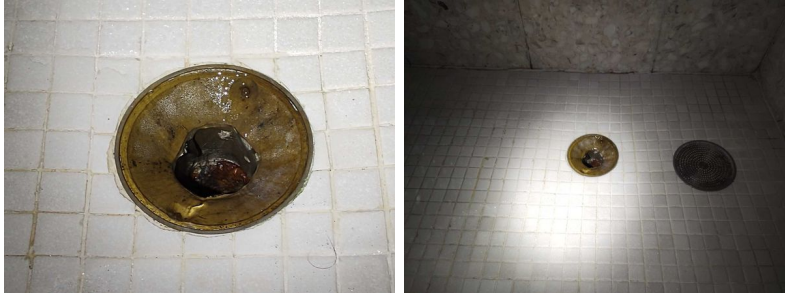
**13: Shower Pan - Evidence of leak**

Master bathroom,

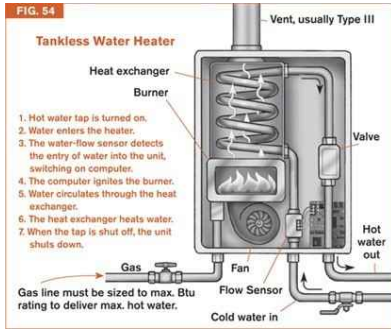
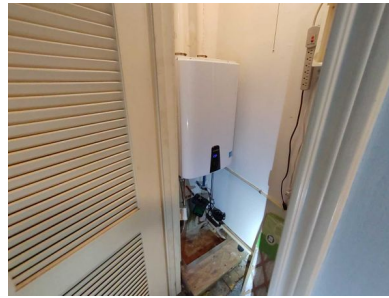
<u>Location</u>	<u>Brand</u>	<u>Capacity</u>	<u>Age</u>	<u>Energy Type</u>
Upstairs hallway	Navien	301-gph	2014	gas

The water heater equipment was functional at the time of the inspection and providing hot water to the applicable plumbing fixtures.

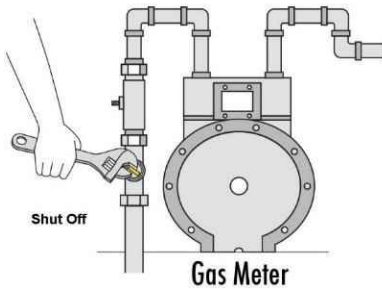
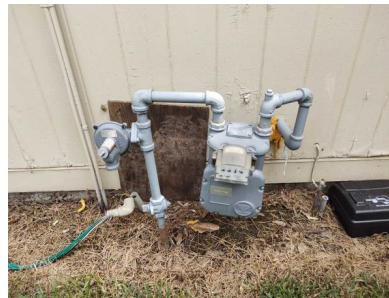
Behind garage

The main gas shut off valve was located at the inlet side of the gas service meter.

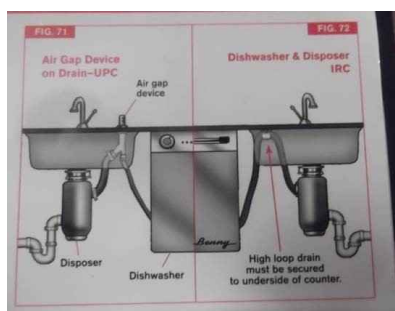
The drain line under the sink was looped up so that the top of the loop was higher than the point where the drain line connected to the disposal. This will help to prevent garbage from running down the drain line into the dishwasher.
