## STRUCTURAL INSPECTION

13515 St Marys Ln  
Houston TX 77079

JULY 12, 2021

REF: CONDITION OF PROPERTY SURVEY

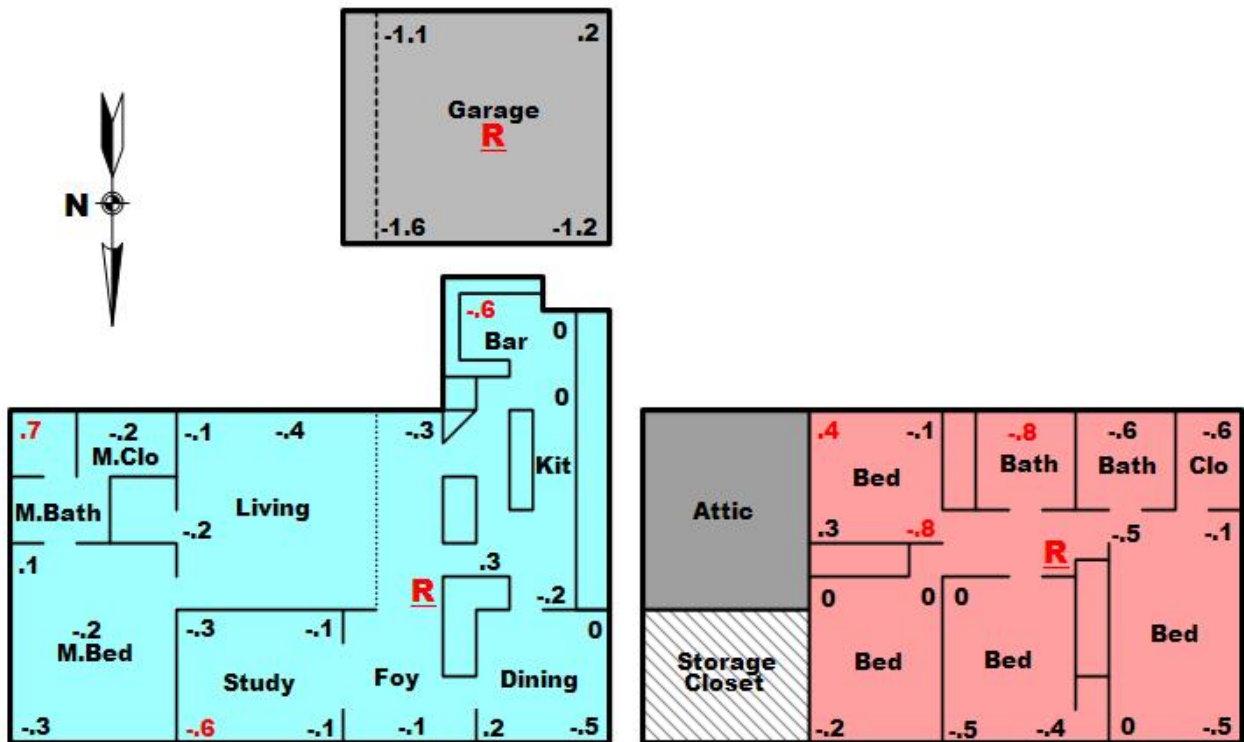
**Elevation Readings  
13515 St. Marys Ln.**

**Foundation has been in tolerance since the current homeowner has occupied the house (1996)**

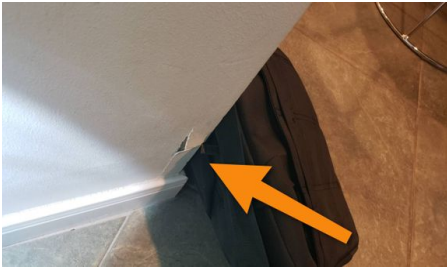
Living Room

The sheetrock tape was observed to be wrinkled at some locations during the inspection including at the above locations.

Repaired

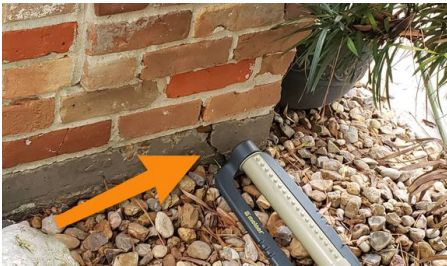
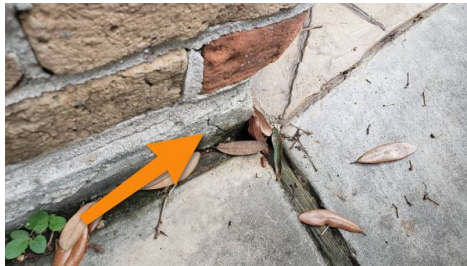
Northwest Southwest

**Differential Movement: Corner Chipped**

The corner of the foundation was observed to be chipped at the above locations. This condition is typically caused by differences in thermal expansion between the brick veneer and the concrete foundation. Also, this condition can be caused by a lack of reinforcement in the corner of the foundation during original construction. In our opinion, this condition does not affect the overall structural integrity of the foundation, nor is it an indication of foundation movement.

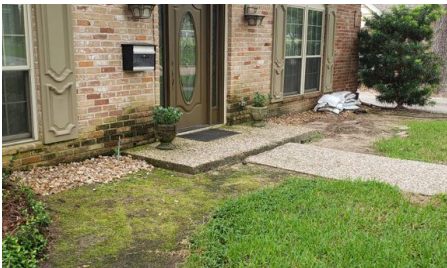
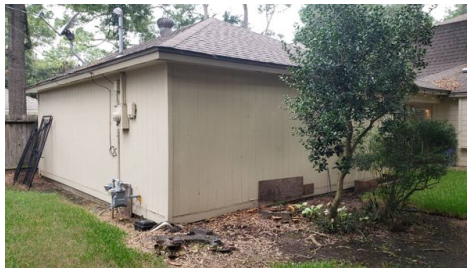
**Differential Movement: Slab Not visible - High Soil**

It is pointed out that a portion of the foundation concrete could not be viewed due to soil that was graded near or above the top of the foundation and/or heavy foliage growing against the house. The soil and/or foliage should be removed, and 3-4 inches of foundation concrete exposed.

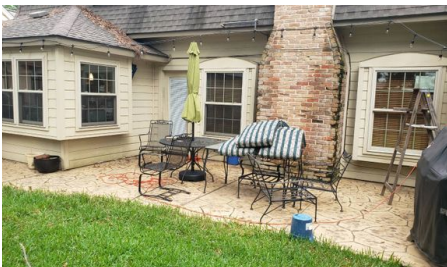
**Differential Movement: Slab not Visible - Patio**

It is pointed out that a portion of the foundation concrete could not be viewed due to the concrete patio that adjoined the foundation.

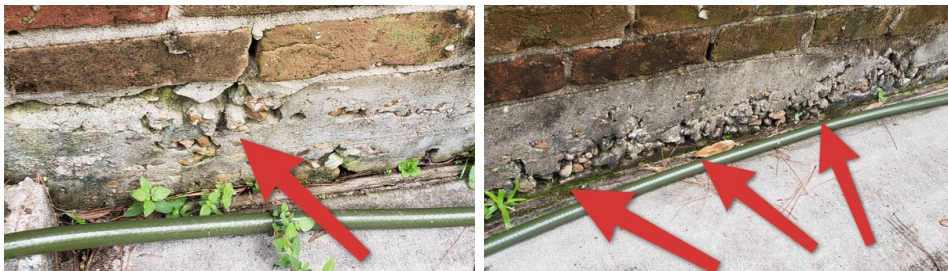
**FOUNDATION - HONEYCOMBED**

The foundation concrete was observed to be honeycombed due to poor original construction workmanship. The honeycombed area should be grouted to present a smooth surface finish.

**Repaired**

Contact a qualified professional.

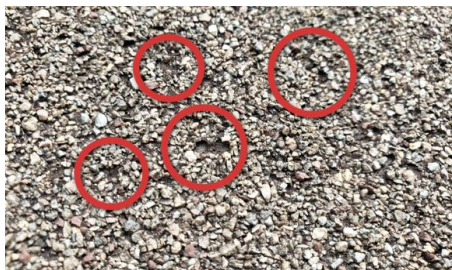
Exposed Nails

Agregate loss

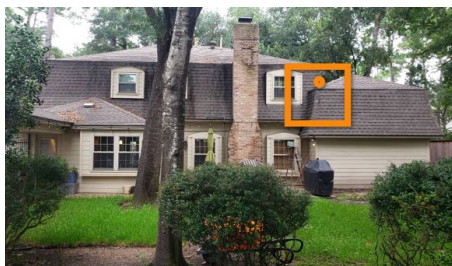
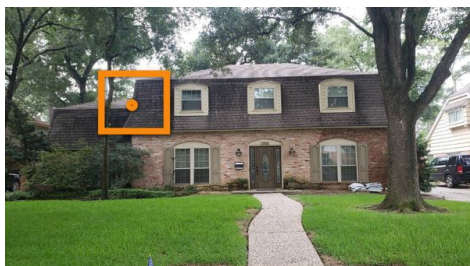
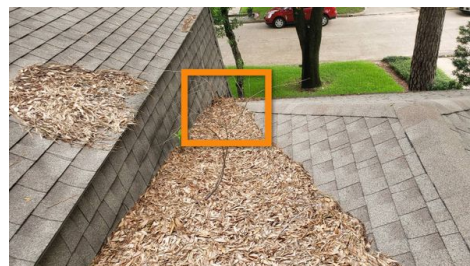
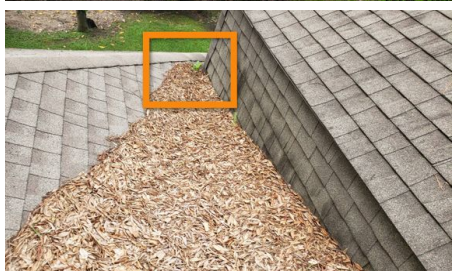
Front-East, Rear-East

There was a narrow valley in the roof, where the valley narrows down and will be susceptible to the accumulation of leaves and other debris. This can cause a damming of water running down the valley, possibly causing a roof leak. It is recommended that this valley be monitored, and cleaned on a regular basis.

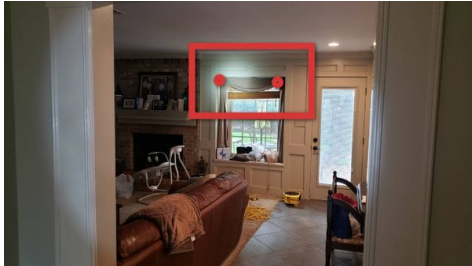
Stained area was dry

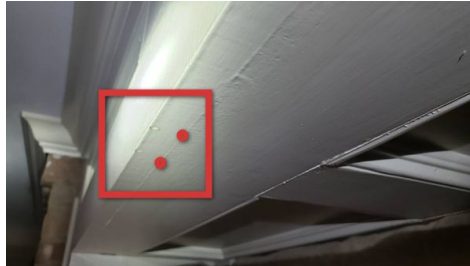
Water damage above living room window

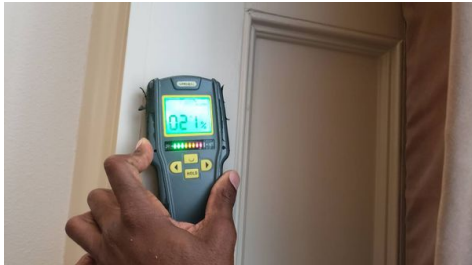
Water damaged finish details

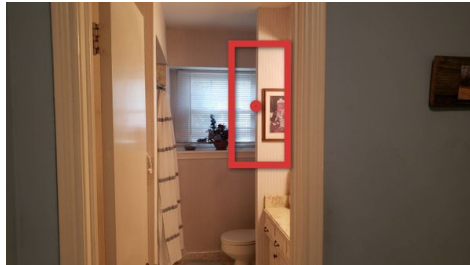
High moisture

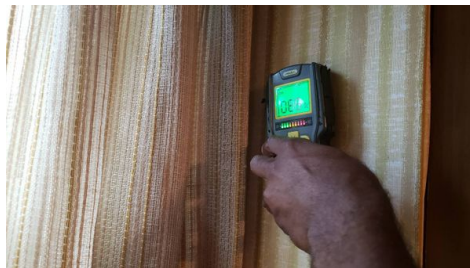
High moisture at and around southeast bedroom dormer window

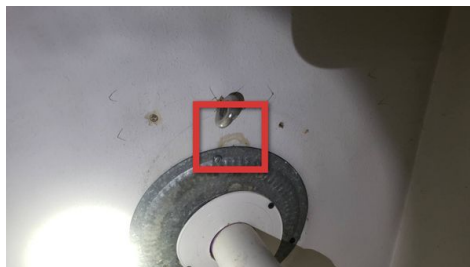
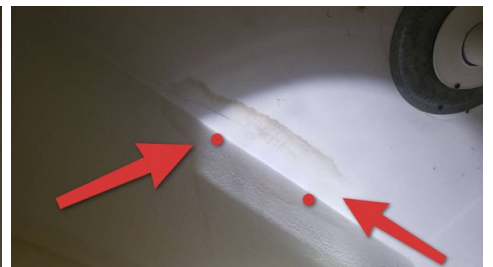
Water stains at water heater closet

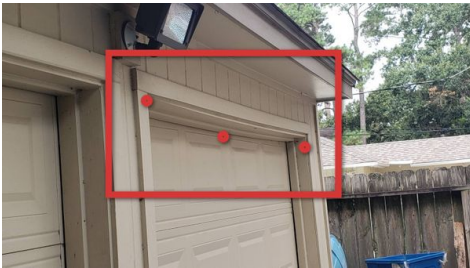
Deflected header

**Repaired**

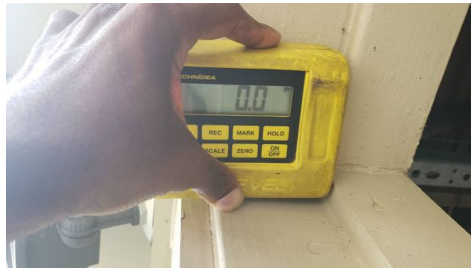
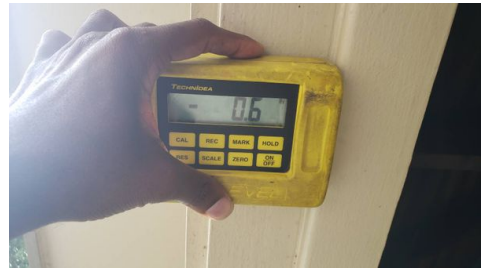
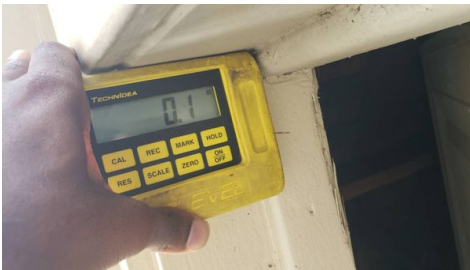
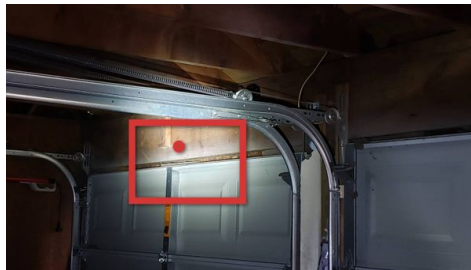
Gap between wood shim and header

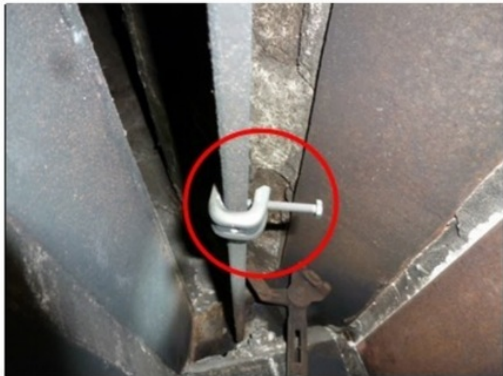
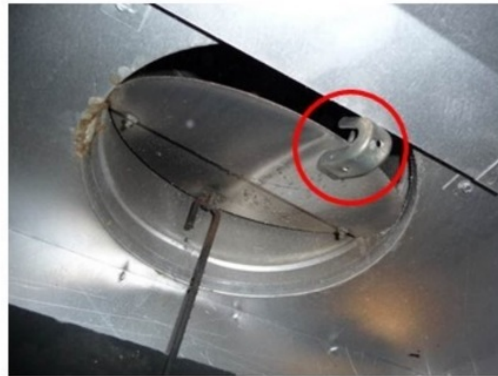
HEI file photo showing c-clamp in masonry fireplace

HEI file photo showing c-clamp in metal fireplace

**Repaired**

Recommendation  
Contact a qualified professional.

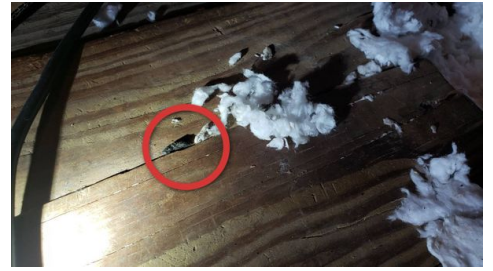
**INADEQUATE WALKWAY AND PLATFORM DECKING**

Contact a qualified professional.

**Cleaned, sanitized and repaired  
See Chem-Tech**

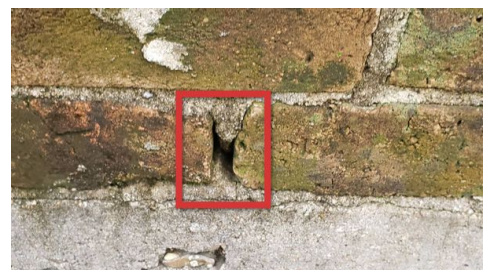
The weepholes at the bottom of the brick wall were clogged with mortar. Weepholes are intended to be gaps left in the bottom course of bricks on a brick wall, typically every second or third brick (approximately 33 inches), to allow moisture behind the bricks a path to exit the wall cavity, and also to allow for some ventilation inside the wall cavity. However, it has been our experience that during the original installation of the brick veneer, enough brick mortar falls off the back sides of the brick into the wall cavity to clog the weepholes and inhibit their proper function. It is recommended that further investigation and repairs be done by a contractor to provide functional weepholes.

Contact a qualified masonry professional.

**Not Addressed**

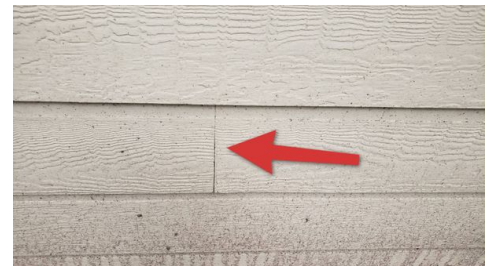
The siding was unsealed at the vertical joints which can allow water to penetrate behind the siding. It is recommended that the vertical joints be caulked to prevent water penetration.

Contact a qualified professional.

**Not Addressed**

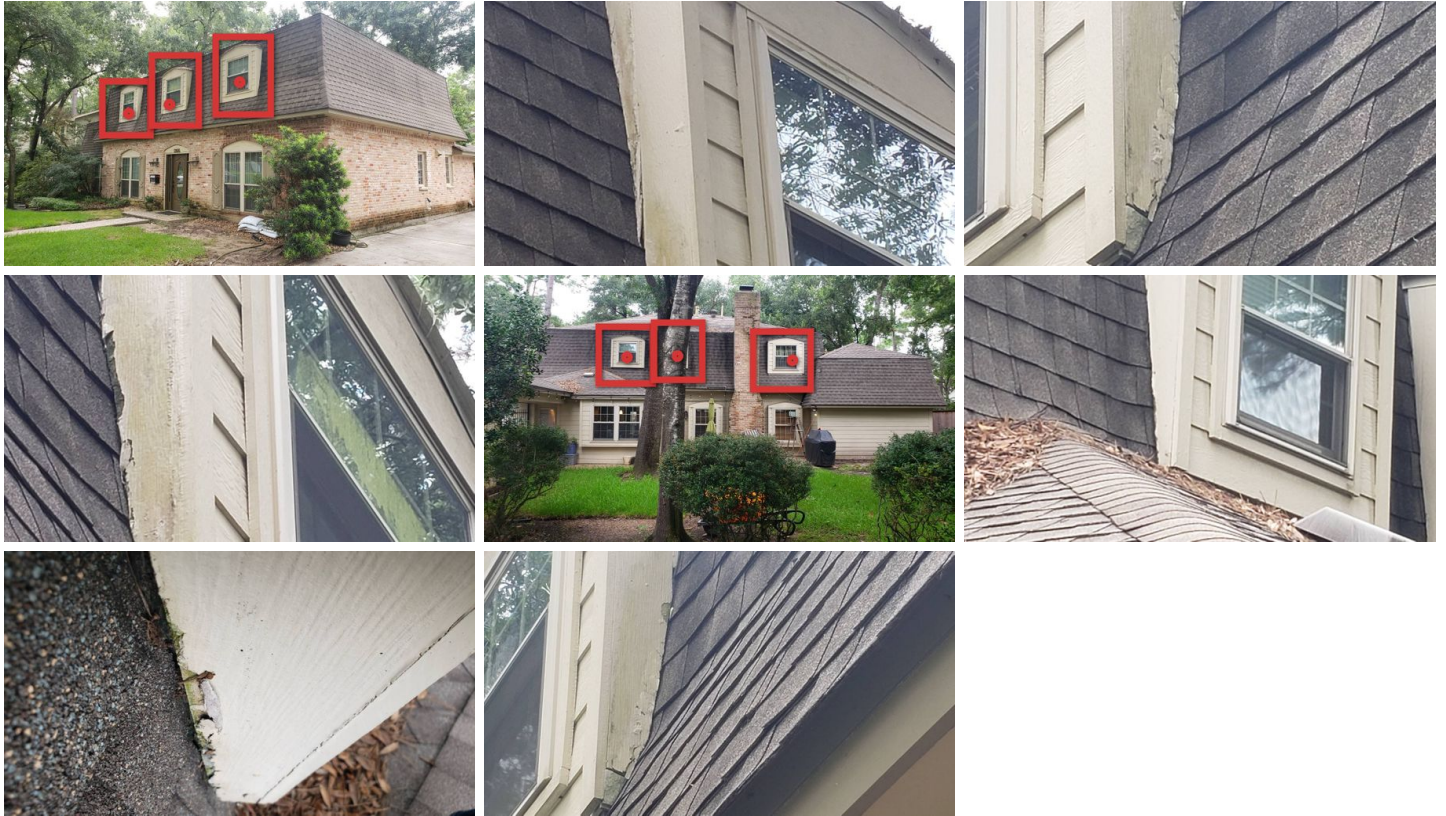
10.3.2 Fiber Cement Siding

**DAMAGED / BROKEN**

The siding was damaged/broken and needs to be repaired. Contact a service company to obtain an estimate for repairs.

Contact a qualified professional.

**Repaired**

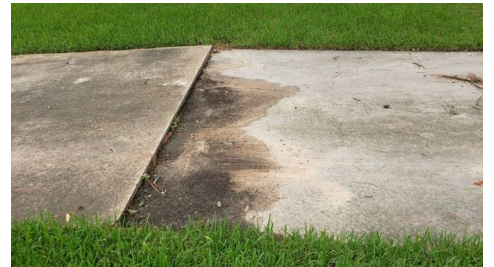
### 11.1.1 Flatwork Concrete/Patios/Walkways

The sidewalk was cracked and uneven at the front of the house, and presents a tripping hazard.

**Obtain Cost Estimate**

**Not addressed**

Contact a qualified professional.

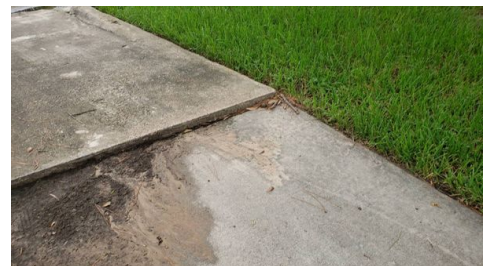
#### DRIVEWAY REPAIR

The driveway concrete was badly cracked, and the damaged portion presents a tripping hazard. It is recommended that a contractor be contacted to provide a cost estimate to make the needed repairs.

**Obtain Cost Estimate**

**Not addressed**

Contact a qualified professional.

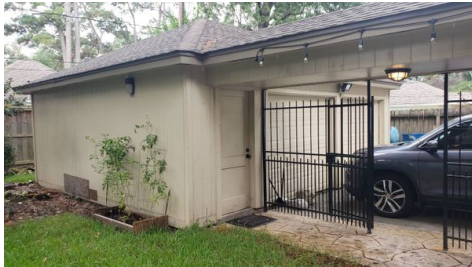
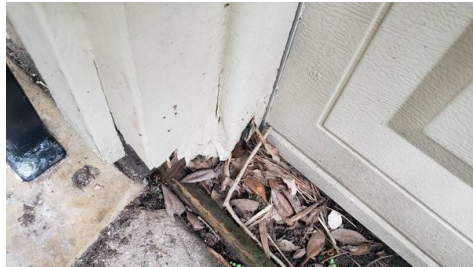
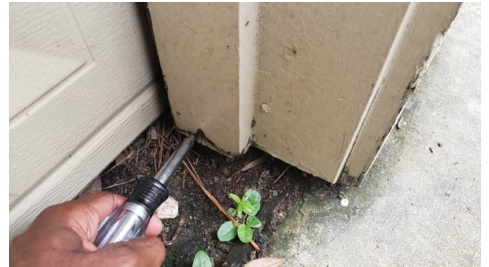
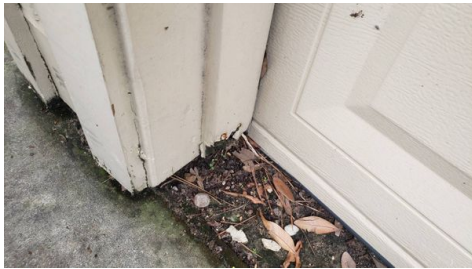
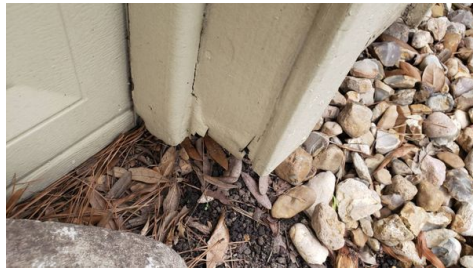
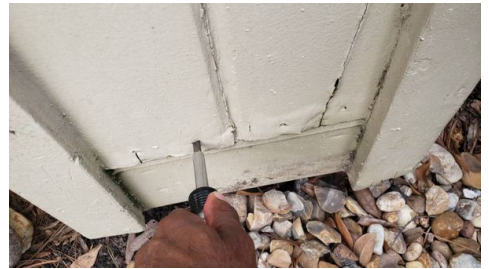
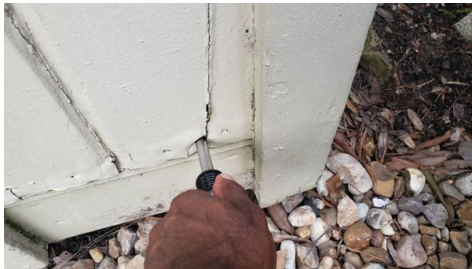
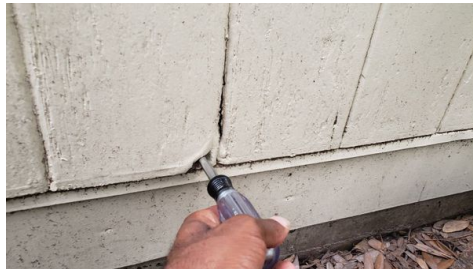
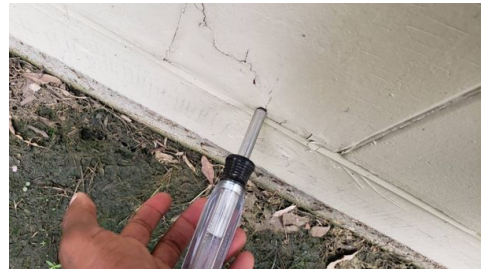
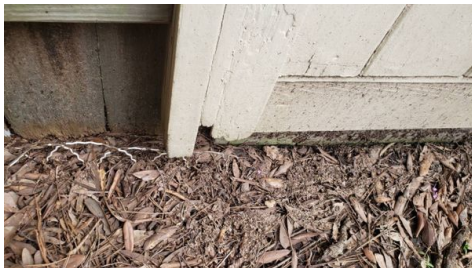
11.4.1 Wood Rot

**WOOD ROT**

Wood rot was observed and needs to be replaced. Have a contractor provide a cost estimate to determine the entire scope of the wood rot, and provide a cost estimate to replace all rotted wood in the house.

Contact a qualified professional.

**Repaired**

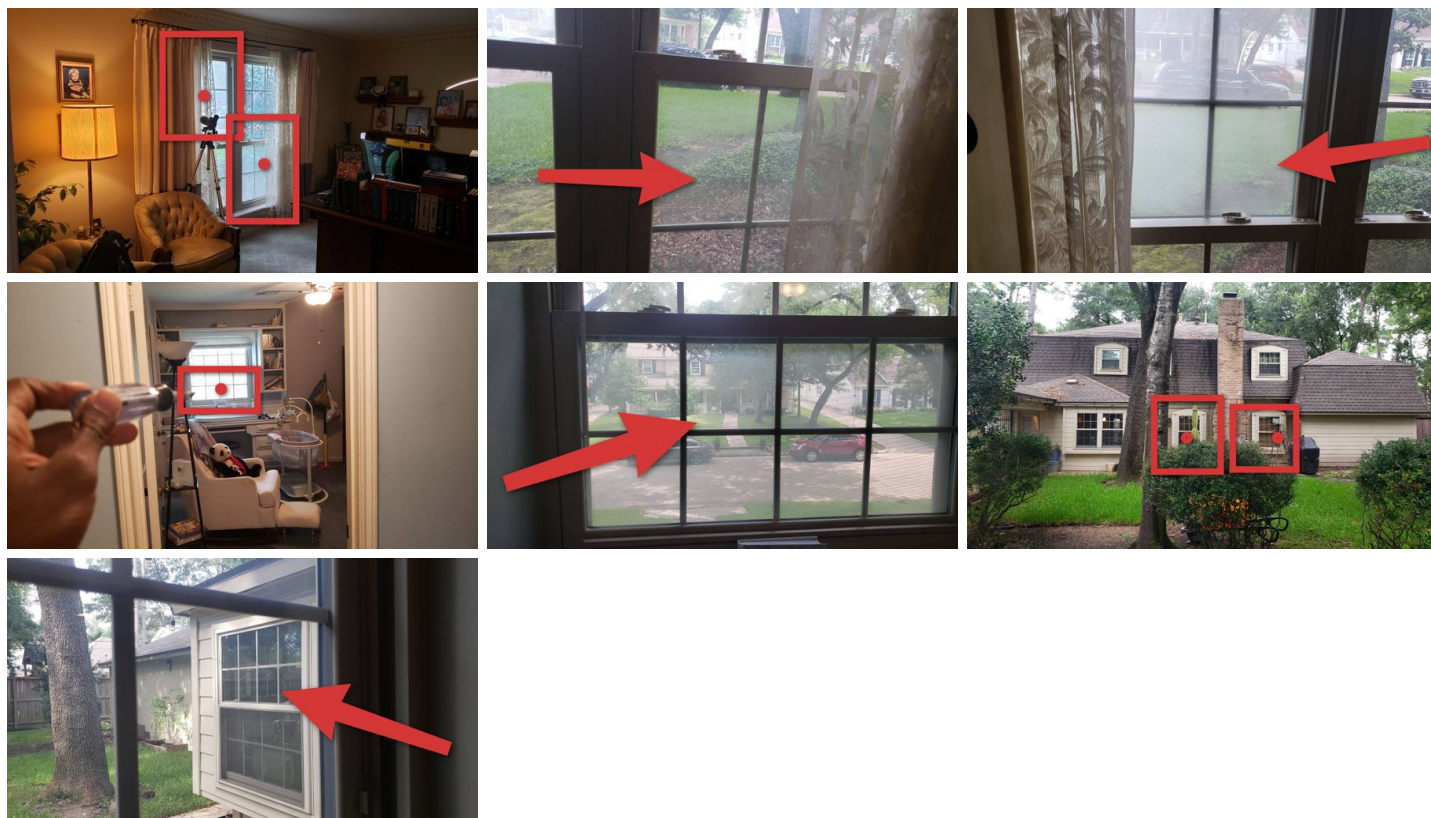
**DOUBLE PANE WINDOW SEAL DAMAGED**

One or more double pane windows were observed where the seal has been compromised and allowed moisture between the two panes. It is pointed out that we were not able to view every window under differing lighting conditions at different times of the day, and we may not be able to see discoloration that may become visible under different lighting and/or weather conditions, other than at the locations listed below. Further investigation with a window specialist is recommended concerning the windows to determine the extent of the condition throughout the house, and to make all needed repairs.

**Warranty replacement applied for**

Contact a qualified professional.

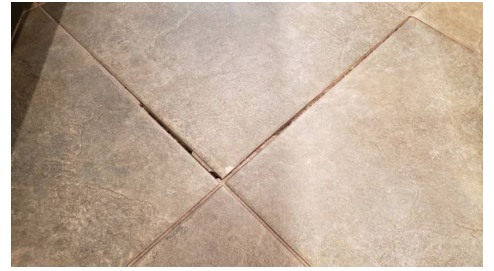
**FLOOR TILES GROUT CRACKED/MISSING**

The grout was cracked/missing and needs to be repaired.

Contact a qualified professional.

**Repaired**

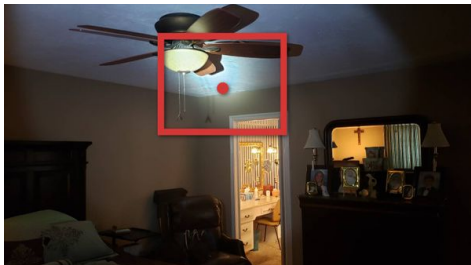
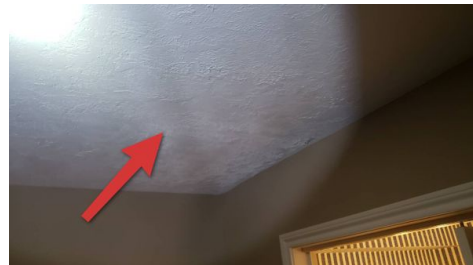
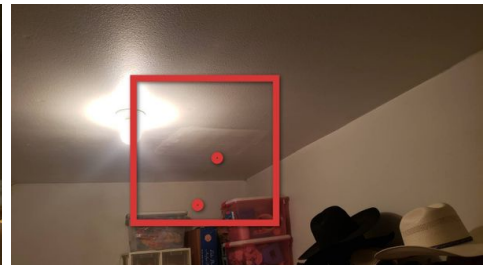
Patches in the sheetrock were seen. The cause of the patching could not be determined at the time of the inspection, and further investigation into the cause of the patch with the homeowner is recommended.

Contact a qualified professional.

**Patches are from repiping**

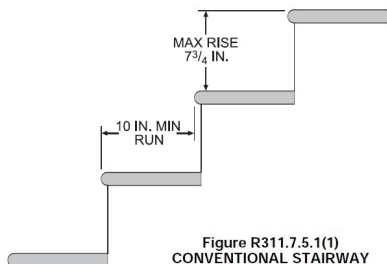
**STAIRWAY TREAD DEPTH IMPROPER**

The tread depths did not fall within the variation limits as specified by the International Residential Code. The minimum tread depth shall be 10 inches, and the greatest tread depth within any flight of stairs shall not exceed the smallest by more than 3/8 inch.

Recommendation  
Contact a qualified professional.

**Original condition from 1967. Demolition and construction not justified**

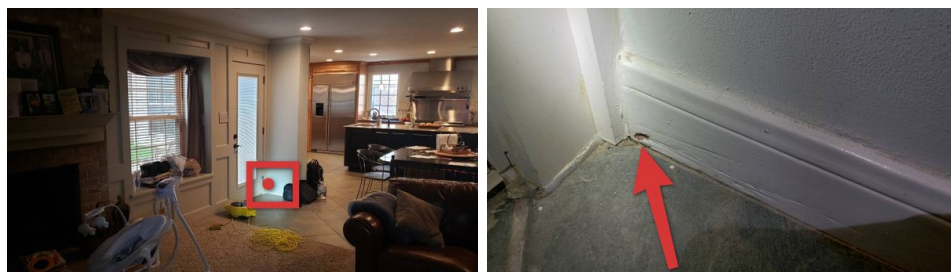
12.8.1 Wood rot interior

**INTERIOR**

**Obtain Cost Estimate**

Recommendation  
Contact a qualified professional.

**Cleaned, treated, and painted.**
