Home Inspection Report

4635 Pippin Glen Dr, Humble, TX 77396

Thursday, October 14, 2021

PROPERTY INSPECTION REPORT

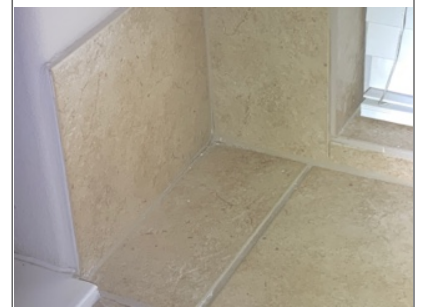
Enclosure grout improvements needed at primary bathroom bathtub.

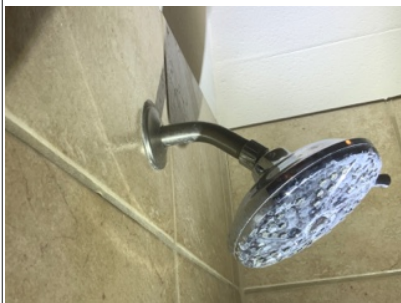
Faucet seal improvements needed at primary bathroom shower.

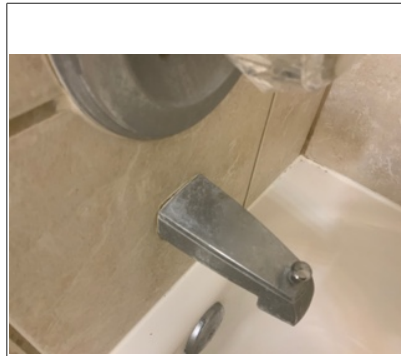
Faucet seal improvements needed at upstairs bathroom bathtub.

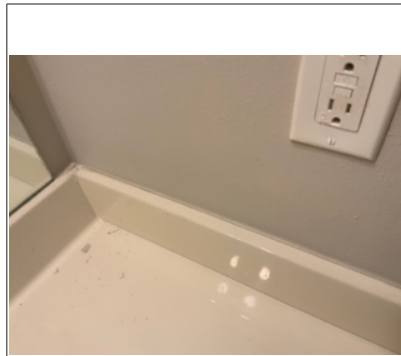
Vanity seal improvements needed at upstairs J&J bathroom.

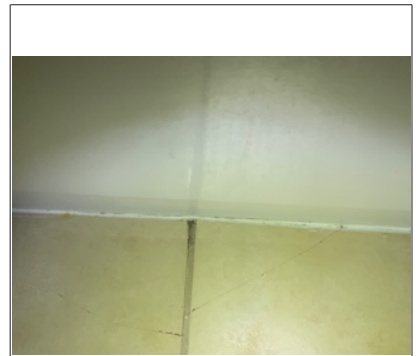
Bathtub base seal improvements needed at upstairs J&J bathroom.

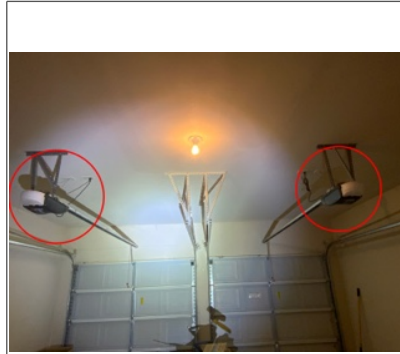
Garage door openers do not operate.

- Replace/Repair disposal
- Repair/replace microwave.
- Repair/replace garage door openers.
- Repair oven light.
- service outdoor grill.
