Lone Star Stucco, LLC

Moisture Assessment Report

2301 Hazard St Unit A

4/21/2020

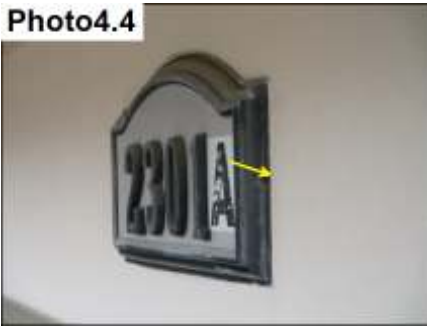
Photo4.4

- The penetration sealants are separated or missing. The inspector suggests to have a qualified stucco waterproofing contractor seal this area with NP1 or low modulus sealant an effort to prevent moisture intrusion. These types of sealants are of high quality and compatible with stucco and other termination points. Please refer to photos #4.2, #4.3, #4.4, #4.5, #4.6, #12.2, #12.3, #12.4, #12.5 and #12.6 for more detail.

Penetration Sealants/ Seal

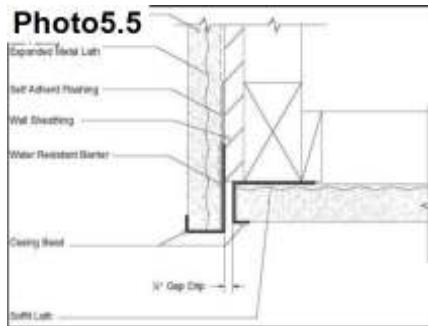
Bottom Bumpout Wall/ Create Relief

Grid Location	Item Description	Moisture Readings	Substrate Condition	Observations
Red Box	Bottom Bumpout Wall			Note that the bottom bumpout wall at this location is an improper detail with semi-firm substrate noted. The inspector suggests to have a qualified stucco waterproofing contractor further assess this area as needed and to install a relief in an effort to allow proper moisture evacuation. Please refer to photos #5.2, #5.3, #5.4 and #5.5 for more detail.
D5	Bottom Bumpout Wall	27%	Semi-Firm	A moisture probe was made at the bottom bumpout wall. An elevated moisture reading was noted with a semi-firm substrate.
E5	Bottom Bumpout Wall	28%	Semi-Firm	A moisture probe was made at the bottom bumpout wall. An elevated moisture reading was noted with a semi-firm substrate.
F5	Bottom Bumpout Wall	26%	Semi-Firm	A moisture probe was made at the bottom bumpout wall. An elevated moisture reading was noted with a semi-firm substrate.

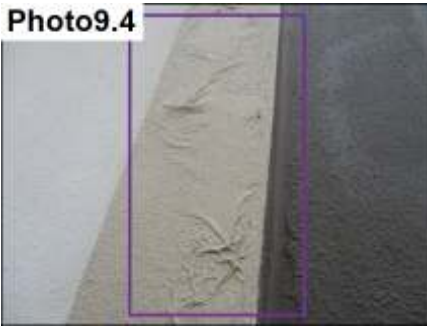
Photo9.4

- The paint on the window accents is delaminating from the stucco, as depicted in attached photo. This typically occurs when the previous stucco finish is not cleaned, primed, or otherwise not properly prepared prior to painting. The inspector suggests to consult a qualified stucco waterproofing contractor to remove all peeling paint, clean, prime, and re-paint per stucco industry standards. Please note not all delaminating areas are necessarily identified in this report. Please refer to photos #9.2, #9.3, #9.4 and #9.5 for more detail.

Delaminating Paint/ Clean, Prime And Re-Paint

Grid Location	Item Description	Moisture Readings	Substrate Condition	Observations
Purple Boxes	Delaminating Paint			The paint on the window accents is delaminating from the stucco, as depicted in attached photo. This typically occurs when the previous stucco finish is not cleaned, primed, or otherwise not properly prepared prior to painting. The inspector suggests to consult a qualified stucco waterproofing contractor to remove all peeling paint, clean, prime, and re-paint per stucco industry standards. Please note not all delaminating areas are necessarily identified in this report. Please refer to photos #9.2, #9.3, #9.4 and #9.5 for more detail.

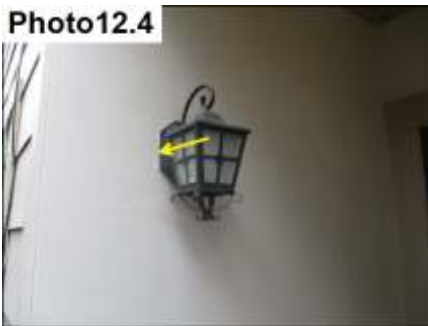
Photo12.4

Penetration Sealants/ Seal

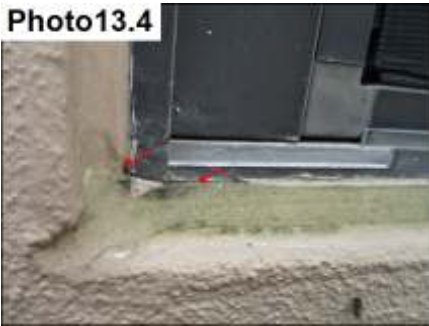
Photo13.4

- The window sealants are separated or thin. The inspector suggests to have a qualified waterproofing contractor seal this area as needed in an effort to prevent moisture intrusion. Please refer to photos #13.2, #13.3, #13.4, #13.5 and #13.6 for more detail.

Window Sealants/ Seal

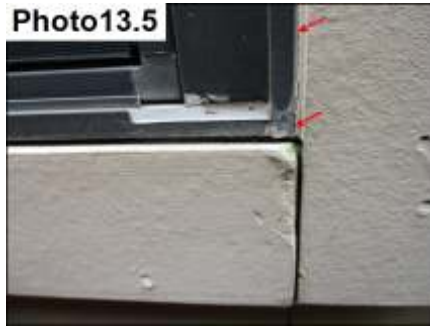
Photo13.5

Window Sealants/ Seal

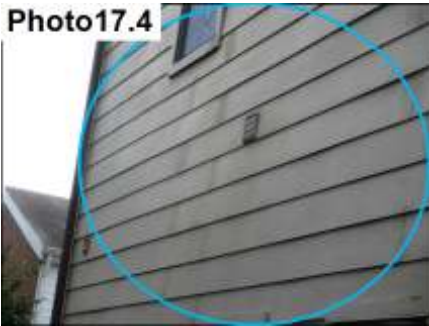
Photo17.4

Siding Sealants/ Seal

Grid Location	Item Description	Moisture Readings	Substrate Condition	Observations
Blue Circle	Siding Sealants			The siding sealants are aged. The inspector suggests to have a qualified waterproofing contractor seal and paint this area as needed in an effort to prevent moisture intrusion. Please refer to photos #17.2, #17.3, #17.4 and #17.5 for more detail.

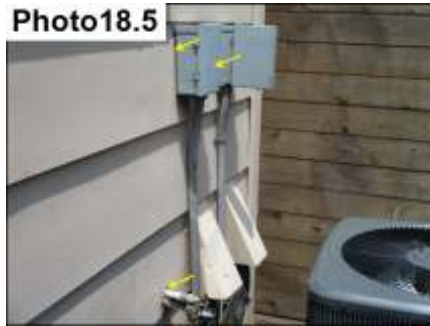
Photo18.5

Penetration Sealants/ Seal

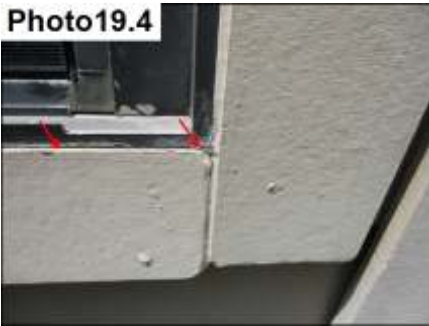
Photo19.4

Window Sealants/ Seal
