Homesmith  
*Home Inspections*

Home Inspection Report

12400 Brookglade Circle - Unit 11  
Houston, TX 77099

**Prepared For:** Busayo Okusaga  
**Concerning:** 12400 Brookglade Circle - Unit 11 Houston, TX 77099  
**Inspection Date:** 02/11/2022

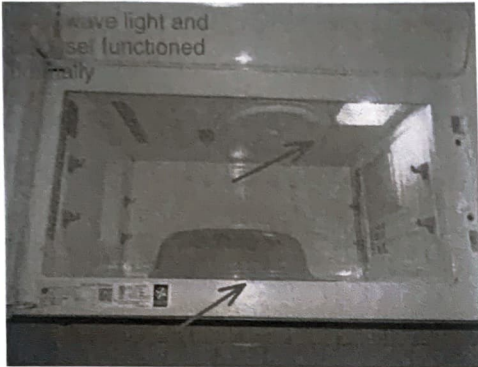
**E. Microwave Ovens** - Comments: - General Electric. - Unit was engaged and appeared to function properly at the time of the inspection.

- Carousel and light functioned properly at the time of the inspection.
