# *514 Inspections*

22 Artist Grove, Spring , TX 77382

Date of Inspection: 12/11/2021 Time: 8:30 AM Size: 0

## PROPERTY INSPECTION REPORT

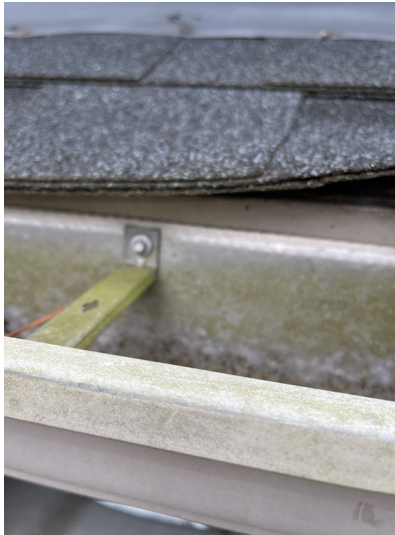
*Gutters not behind drip edge flashing*

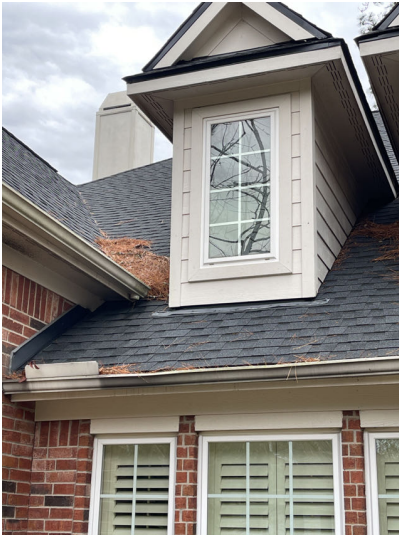
*Debris and valleys needs to be cleaned*

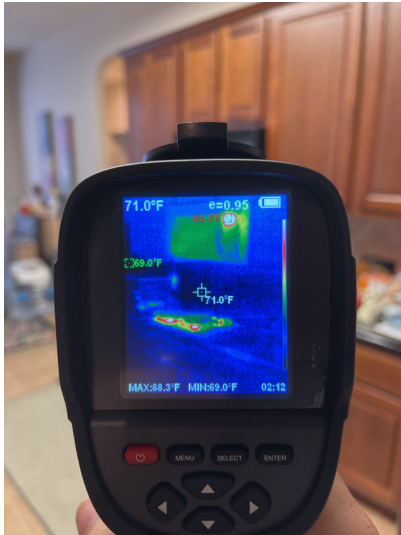
*Thermal scan performed - no anomalies*

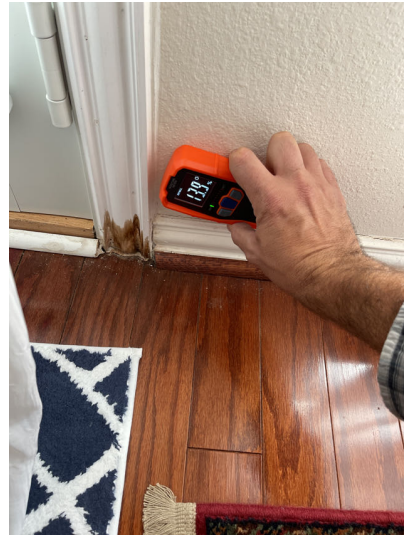
Moisture content acceptable at back door area

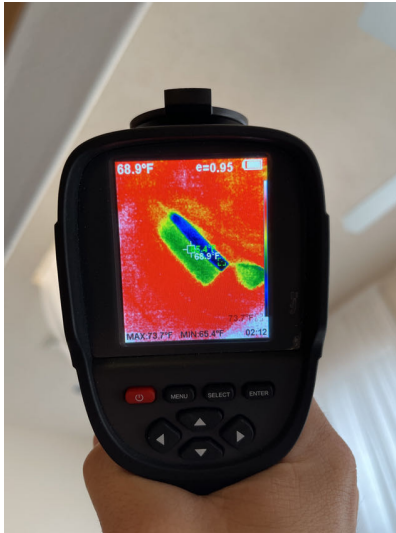
*Thermal scan performed - no anomalies*

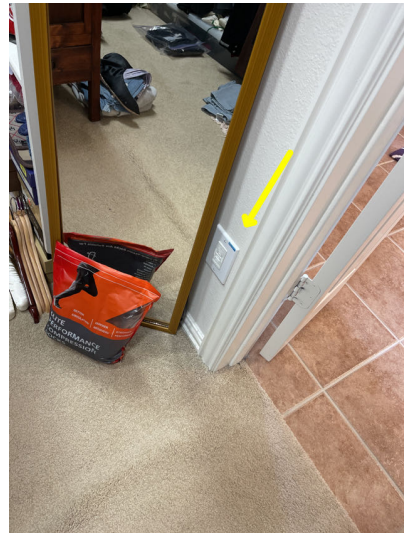
- This component appeared to be functioning as intended at the time of the inspection
- It was observed that no access panel {s} were readily available to view the motor and/or equipment lines
- There was no GFCI receptacle for the hydromassage component was located inside the master closet

GFCI reset location in master closet

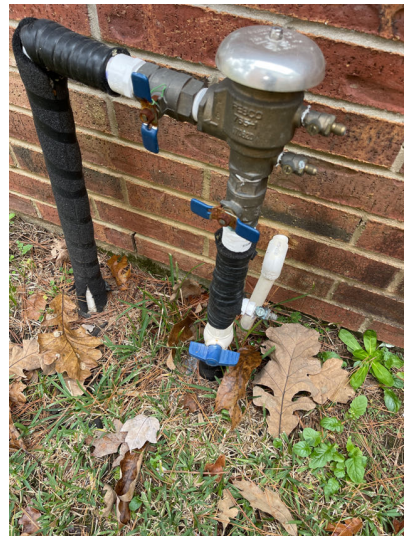
*All valves turned off*
