30410 Beyette Rd  
Magnolia, TX 77355

## PROPERTY INSPECTION REPORT

**Concerning:** 30410 Beyette Rd, Magnolia, TX 77355  
(Address or Other Identification of Inspected Property)

**By:** Joe Budzinski, Lic #23245, 08/12/2020  
(Name and License Number of Inspector) (Date)

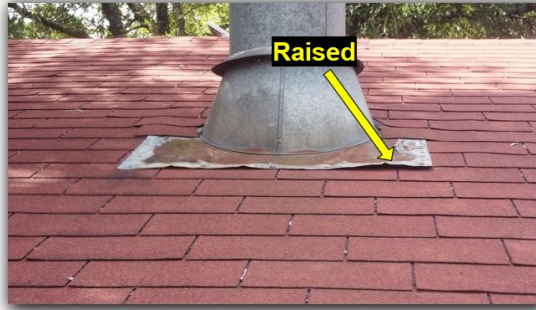
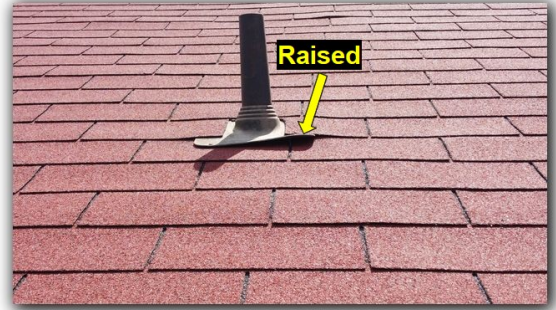
Observed bent/raised flashing in one or more areas. Recommend securing all flashing to prevent water penetration from wind driven rain.

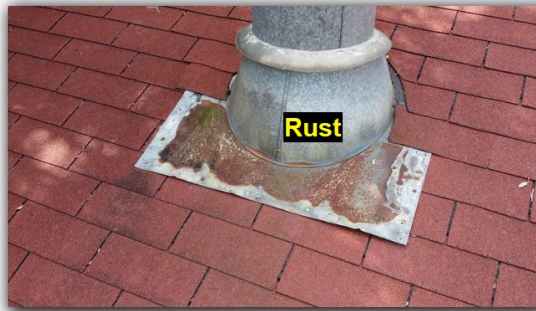
Observed multiple areas of rusted flashing. Recommend painting with rust resistant paint to slow the process or replacing roof vents.

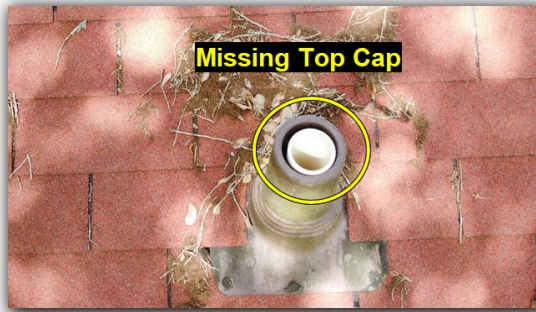
Observed one or more roof penetrations missing the top cap. Recommend further evaluation by a professional roofing contractor.

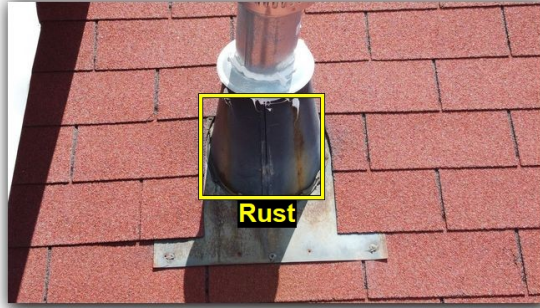
Observed multiple roof penetrations that have rusted. Recommend painting with rust resistant paint to slow the process or replacing roof vents.

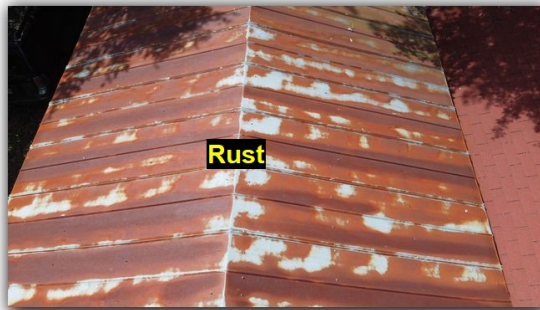
Observed multiple rusted metal roof coverings. Recommend re-coating with a rust resistant coating to slow the oxidation process.

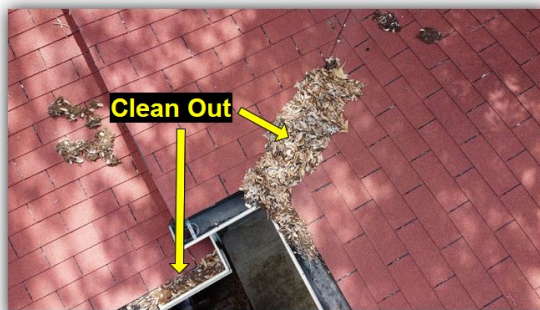
*Not all areas present at time of inspection. Recommend future installation of rain gutters to keep water away from foundation.*

*Recommend cleaning out rain gutters to allow proper drainage.*

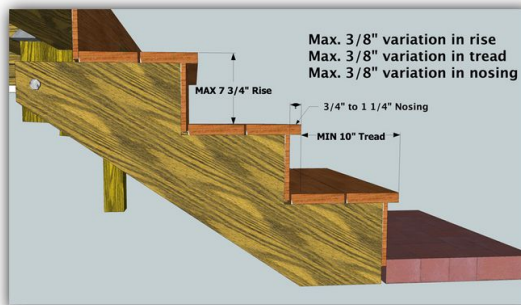
Observed the stairs in the garage and barn were not up to current standards with deficiencies that may include, but are not limited to; riser height, riser variance, improper handrail and baluster spacing. Note: Standards for stairs have changed significantly since time of construction.

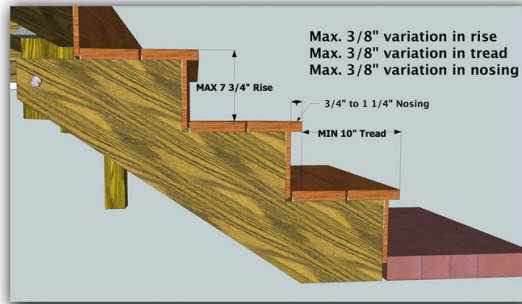
Observed the stairs were not up to current standards with deficiencies that may include, but are not limited to; riser height, riser variance, improper handrail and baluster spacing. Note: Standards for stairs have changed significantly since time of construction.

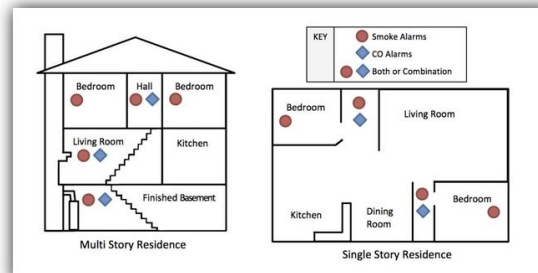
Inadequate number and/or improper location of smoke detectors in home. Smoke detectors should be located on each level of the home AND inside AND outside of all sleeping rooms. Consult the smoke detector manufacturer's instructions regarding specific placement of detectors.

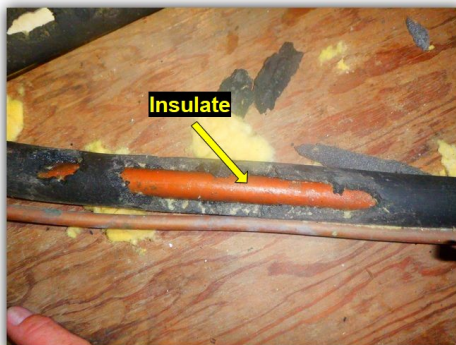
Observed the suction line is missing insulation in the attic. For optimum energy efficiency I recommend re-insulating the suction line.

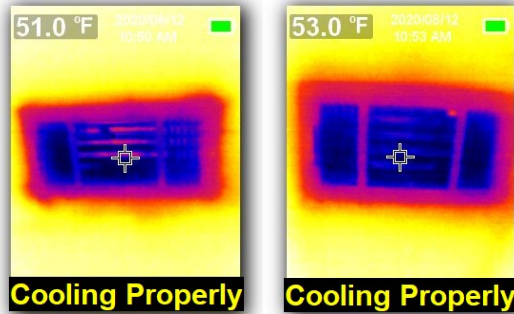
A thermal image of the air vents show the air conditioning unit(s) was / were cooling properly at time of inspection.

TEMPERATURE DIFFERENTIAL: 18 degrees (69, 51) **GOOD**  
TEMPERATURE DIFFERENTIAL: 17 degrees (70, 53) **GOOD**

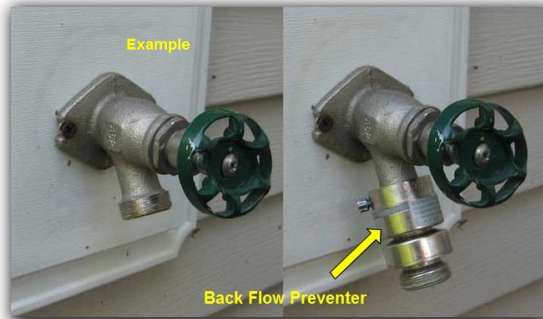
*Some exterior hose spigot(s) do not have code approved anti-back flow devices installed. Note: Back flow preventers cost approximately \$5.00 and are easy to install.*

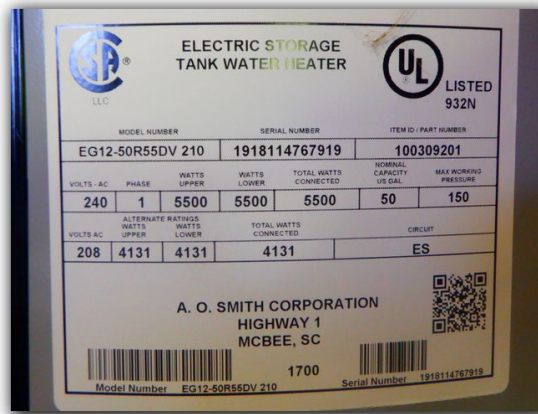
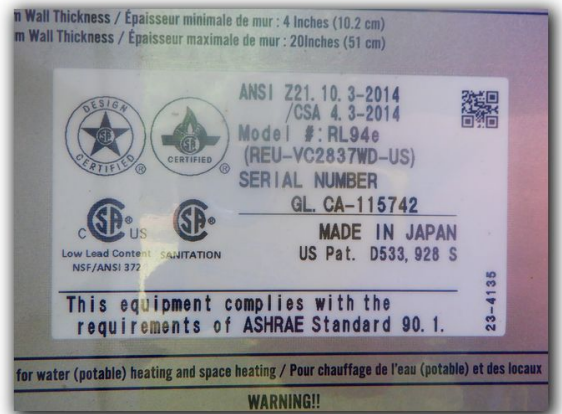
WATER HEATING UNIT(S): A & O Smith - 2019, Rannai - 2015

Observed the tankless water heater is located at the side of the well house. This is a far distance from the home. Recommend consulting a licensed plumbing contractor to determine if the placement of the tankless water heater is optimal.

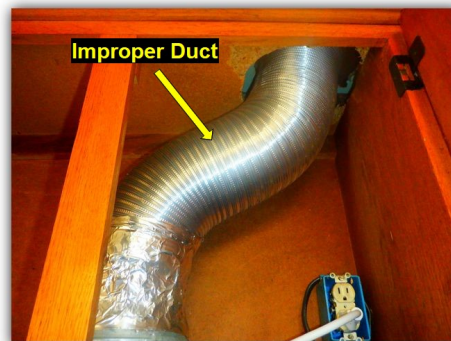
Observed the range hood vent duct is not the proper duct. Current standards call for the duct must be made from galvanized steel, stainless steel or copper. It must have a smooth interior, and be air tight.
