## Property Inspection Report

3923 Laguna Dr, Galveston, TX 77554

Date of Inspection: 5/20/2020 Time: 10:00 AM - 12:30 PM

Inspector: Ruben Vasquez

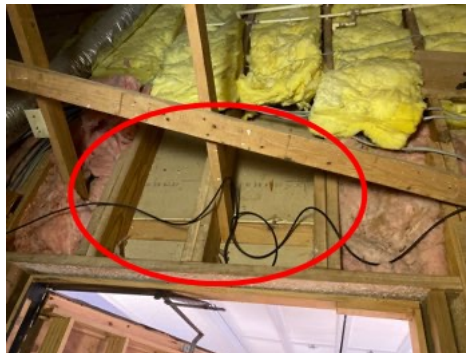
Insulation needs improvement

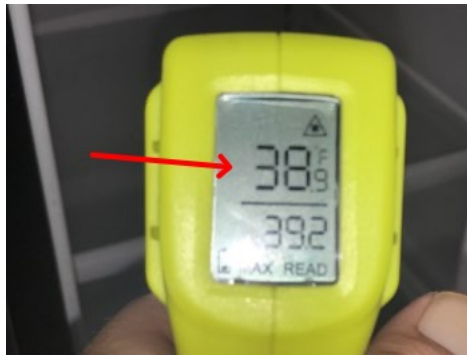
Refrigerator cool temperature
