# Acadian Home Inspection LLC

## PROPERTY INSPECTION REPORT

**Concerning:** 24430 Sundance Spring Dr, Porter, TX 77365  
(Address or Other Identification of Inspected Property)

**By:** Thomas Christopher Duhon, Lic #10577 09/11/2019  
(Name and License Number of Inspector) (Date)

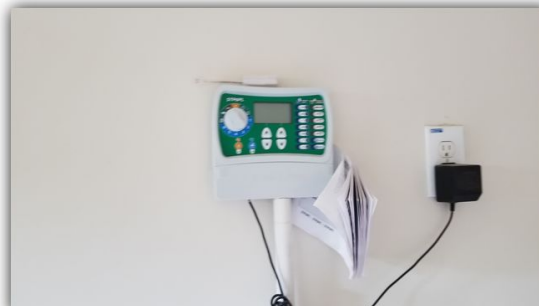
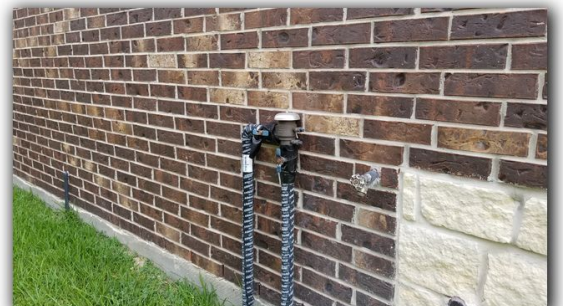
Inspected in manual mode only. Type control: Rain Bird at garage interior. Back siphon noted for system at south west exterior. Rain sensor noted at exterior fence. System appears to be performing as intended when operated in manual mode only. Total stations present/active:1-6
