Property Inspection Report #20220205-01

for property: 7603 Candlegreen Ln
Houston, TX 77071

PROPERTY INSPECTION REPORT FORM

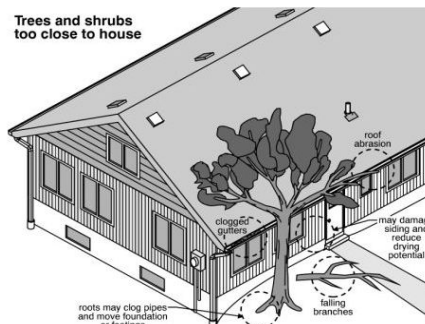
Large tree(s) near house foundation. Client should consider removal of tree(s) or the installation of root barrier to reduce possibility of damage to house foundation from tree roots and moisture removal.

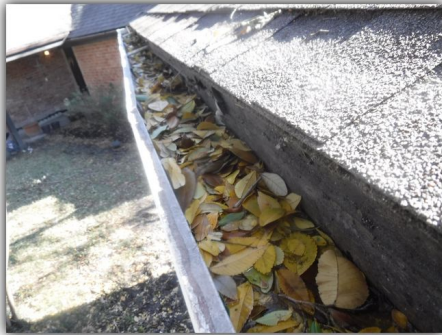
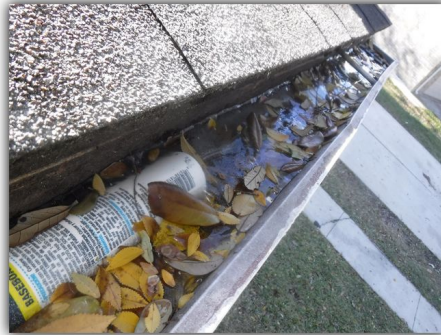
Gutters on the entire house are in need of repair. Loose gutters should be properly secured and checked for proper slope to drain. Any damaged or deteriorated sections of gutters and down spouts should be replaced on as needed bases. Defective gutters may create leakage into the roof eve causing structural damage into the home.

Full of debris and/or holds standing water. and should be removed to encourage proper drainage.

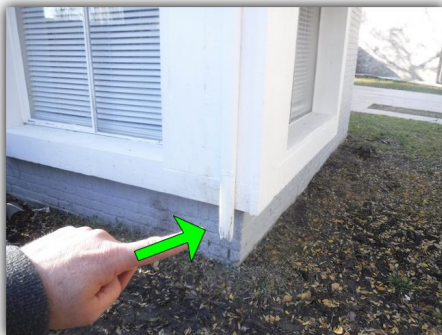
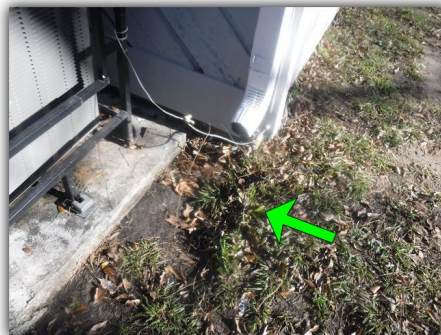
Observed one or more downspout extension damaged. recommend repair
Downspouts need splash blocks at bottoms to prevent soil erosion.

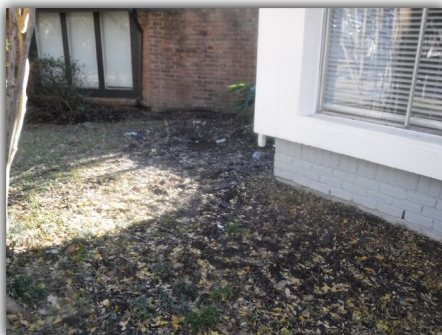
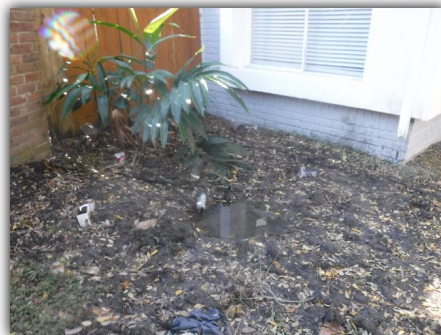
The grade around the house should not have any low-lying areas but should be sloped so that water will not collect and puddle here and there.

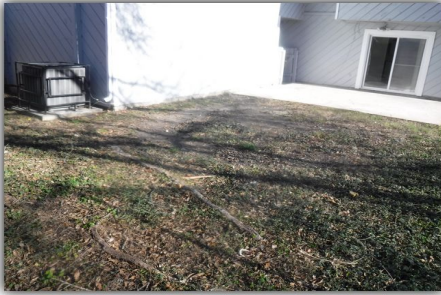
■ The drainage and grading around this home is inadequate. In order for the drainage to be effective, the landscaping must be configured so that the yard is sloped away from the foundation by at least 6 inches in the first 10 feet and/or adding additional gutters/downspouts to the house is another option to improve drainage and/or in-ground drains should be designed and added to divert rainwater and runoff away from the house as appropriate and/or drainage swale should be improved/installed.

The means should be provided to catch and channel the water away from the house and foundation. Improvements should be undertaken by professional landscaper and/or gutter company.

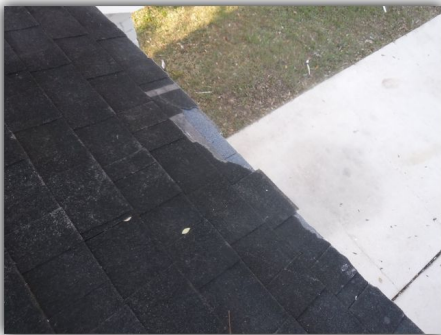
Roof coverings exhibited general damage and repairs that could affect performance. Recommend a qualified roofer evaluate and repair.

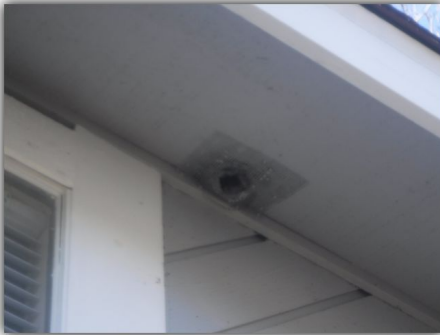
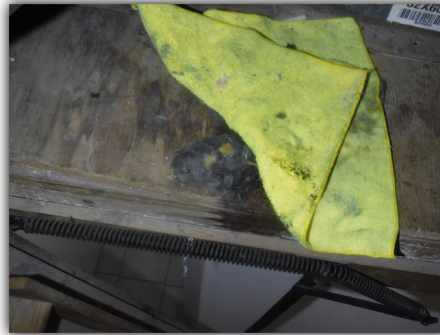
■ Gaps should be sealed from rodents, also may allow wind driven rain entry. Recommend sealing all gaps to keep the house from rodent and water intrusion.

Evidence of previous (possibly current) rodent activity in attic.

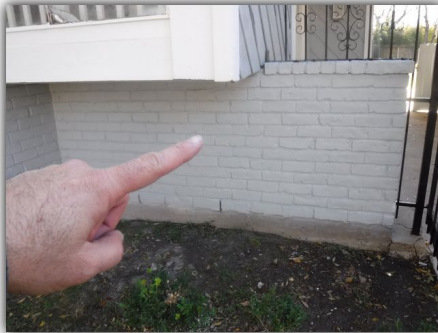
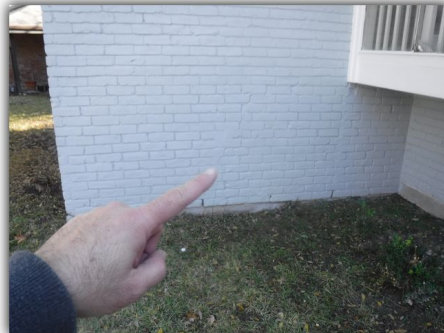
A stair-step crack is a diagonal, right-angle crack that travels through the mortar surrounding the brick since mortar is not as strong as brick. The resulting crack looks like a staircase going up and down. A stair-step crack will usually point to the area of the foundation that is sinking or settling.

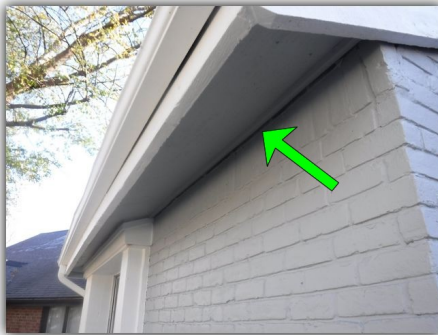
Gaps should be sealed from rodents, also may allow wind driven rain entry. Recommend sealing all gaps to keep the house from rodent and water intrusion.

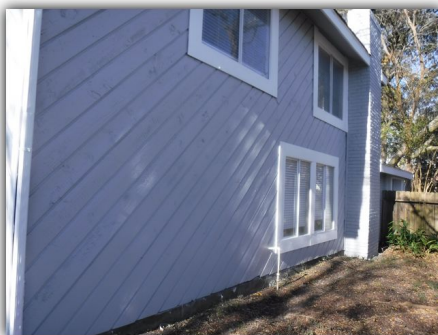
Water damaged was noted in wood siding at one or more location and it is recommended that the damaged wood be repair and/or replaced.

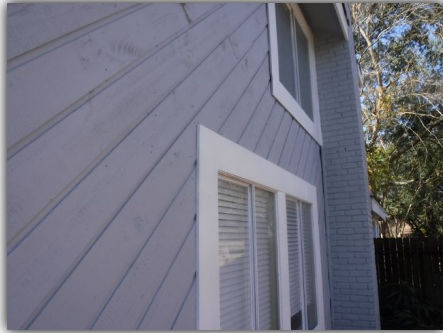
The window and/or door and/or other wall penetrations installed through the wood fiber products siding were not properly flashed.

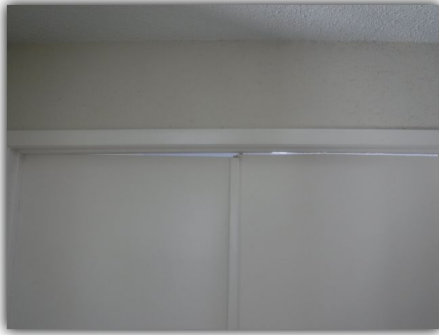
■ The door(s) were sticking and/or out of square at the time of the inspection.

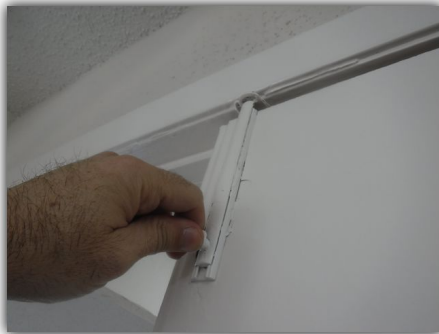
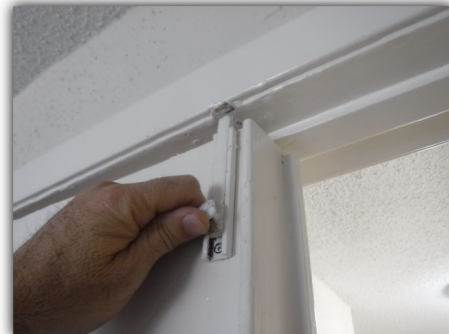
- Upstairs

The door(s) were not latching properly at the time of the inspection.

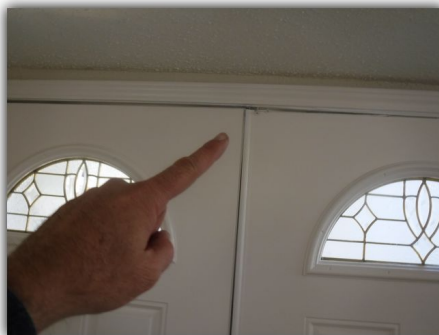
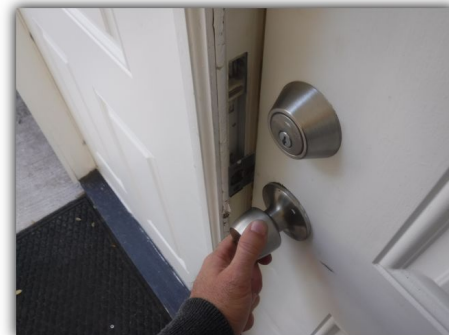
The door(s) were rubbing, sticking or hitting their frames at the time of the inspection.

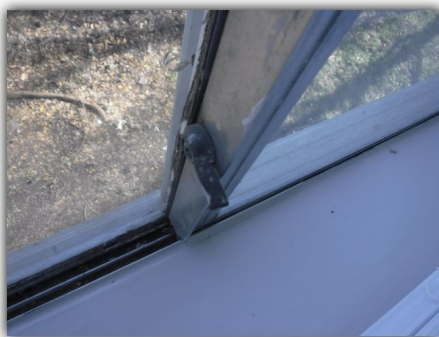
Tracks/frames of windows need cleaning / lubrication, to ensure proper/full closing of windows and ease of operation.

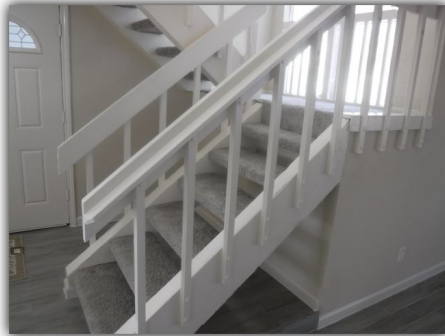
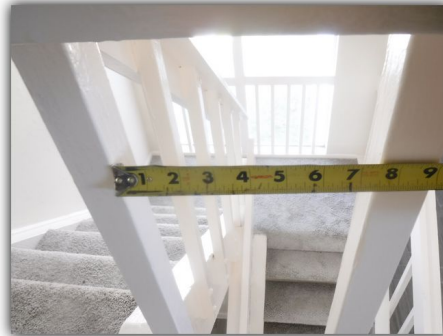
■ Space between railings does not comply with current industry standard, Requires spacing between intermediate rails do not allow passage of an object four inches in diameter.

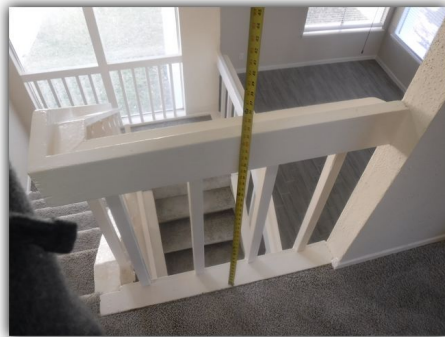
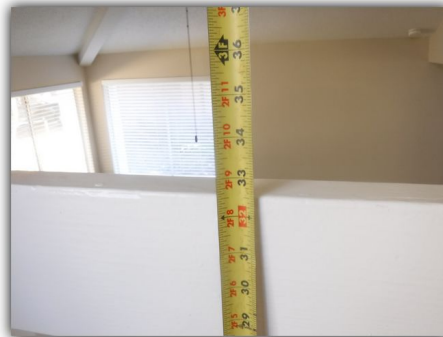
■ The hand railing is not at the proper height, which is 34-38 inches high. The hand railing was measured at 33.inches at the time of the inspection.

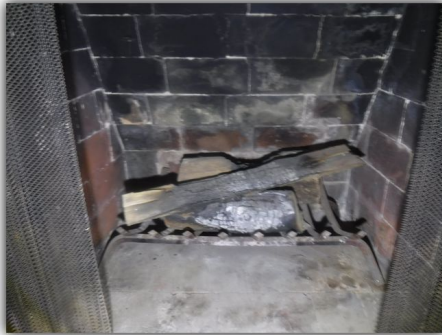
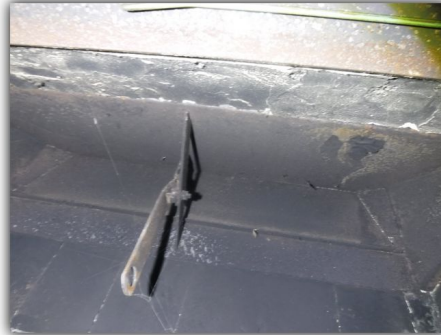
The normal use of a fireplace can result in excessive build up of creosote or a tar like substance. Chimney flue should be cleaned and/or serviced on a regular basis or as specified by the manufacture.

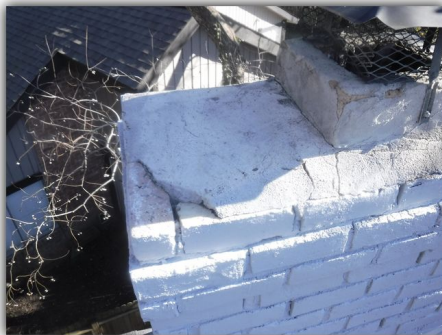
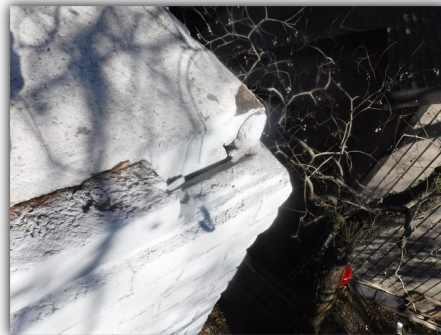
Mortar cap needs repair at top of chimney, if visible

The fireplace should be cleaned and serviced by a professional that is certified by the Chimney Safety Institute of America. For more information go to www.csia.org.

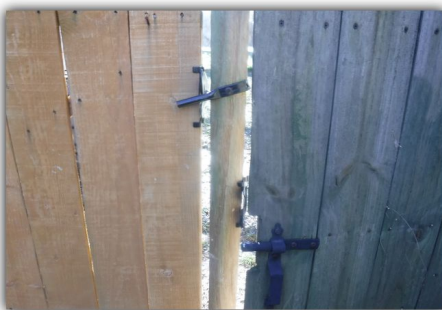
Observed damaged door latch in fence

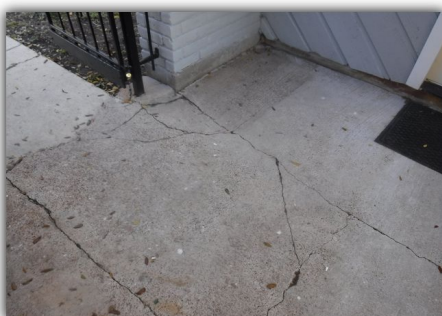
The walkway is cracked and appears to have some movement in the elevation of the concrete. The elevation differences can be a trip hazard as well as contribute to the deterioration of the driveway. I recommend having a qualified contractor evaluate and repair as needed.

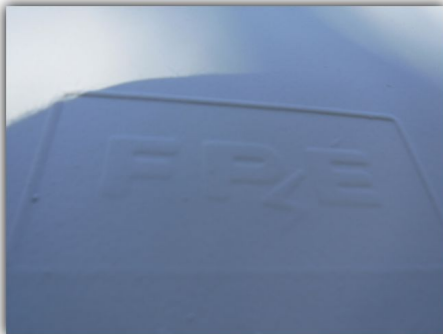
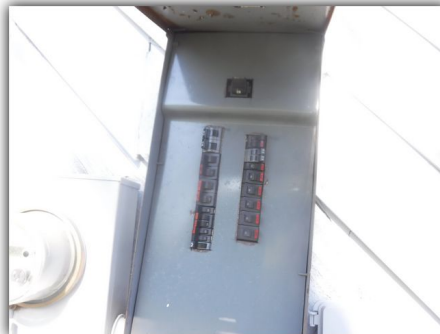
Panel loose in wall

Brand of electrical service panel is Federal Pacific. This make of panel is known for difficult to find and more costly to replace breakers. In addition this panel is associated with a higher incidence of failures / safety problems. If additional information is needed, recommend a qualified electrician be consulted. Replacement of panel recommended as an upgrade / safety improvement. For safety reason, the panel was not fully evaluated and recommend full evaluation by a licensed electrical contractor.

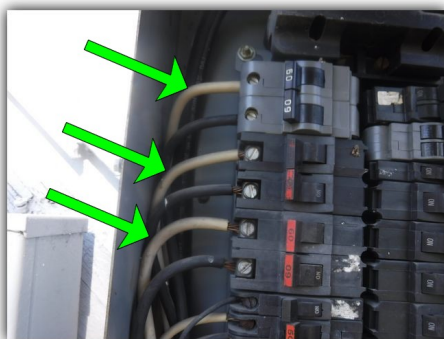
All wires should be properly color-coded. Some examples:

- Black, red, white with black or red tape will always indicate a hot wire. While white wiring is permitted- only when clearly marked with black or white tape-using any other color for a wire carrying current is strongly discouraged.
- Black wires used as neutrals and /or grounds should be appropriately marked

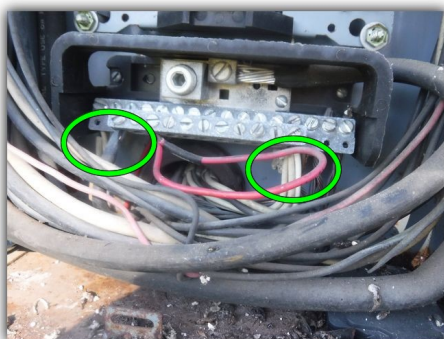
There is double lugging of the neutral wiring in the service panel. Each neutral service wire is required to be under one screw per wire.

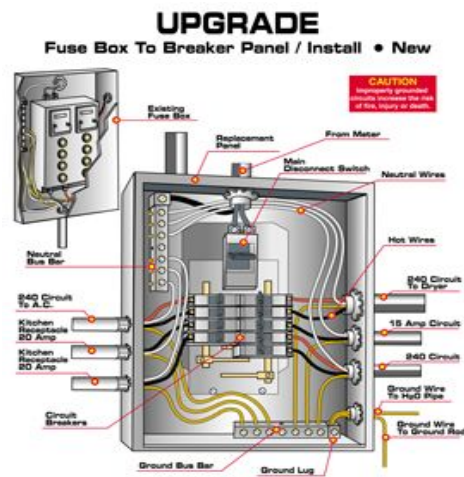
The TREC Standards of Practice require comments on bonding; however bonding cannot be fully evaluated within the scope and limitations of a visual inspection process. If you have questions or concerns regarding bonding it is recommended to contact a licensed and qualified electrician. Equipment bonding could not be verified at all key points (Examples: interior water piping and/or water heaters and/or around water meters-gas lines and/or electrical enclosure and/or electrical raceways and/or electric outlets or junction boxes and/or CSST gas piping (manufacturer's compliance)). Proper bonding conductors must be installed to equalize electrical potentials. The lack of proper bonding creates a fire or a shock hazard. The presence of proper bonding should be verified by a master electrician or proper bonding of the equipment should be installed for safety

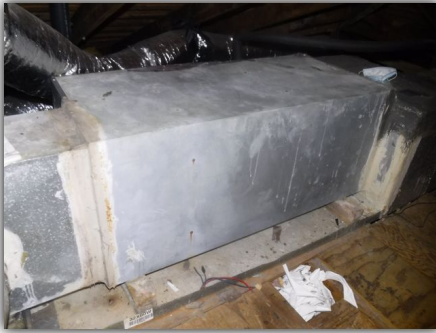
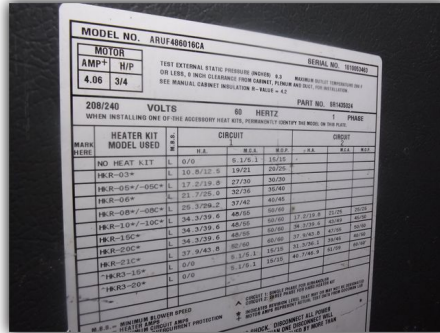
The photo shows the furnace make, model and serial numbers marked on the furnace label or data plate. MFG Date: 2010

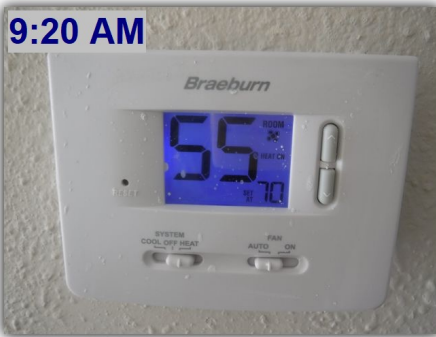
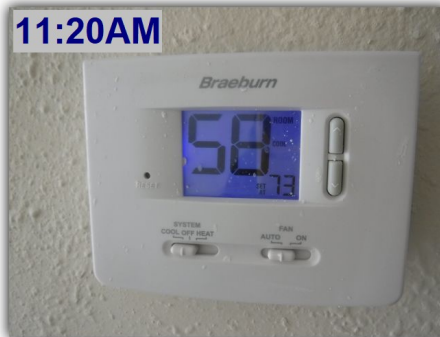
The furnace was not working properly at the time of the inspection. In need of repair.

Consultation with a HVAC technician for further evaluation of the heating system, before closing is recommended.

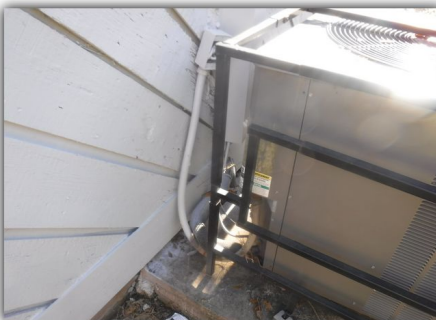
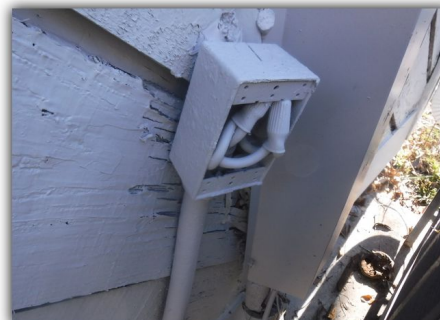
- Service disconnect for the air conditioner is missing. Recommend installing electrical disconnect within sight of unit.

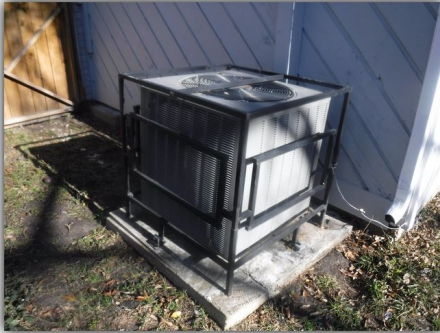
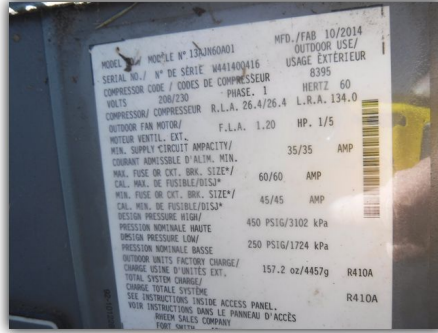
Information from the air-conditioner data plate is shown in the photo.

MFG Date: 2014

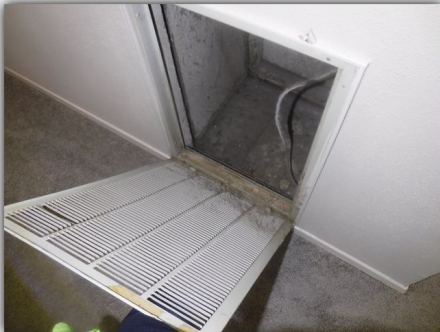
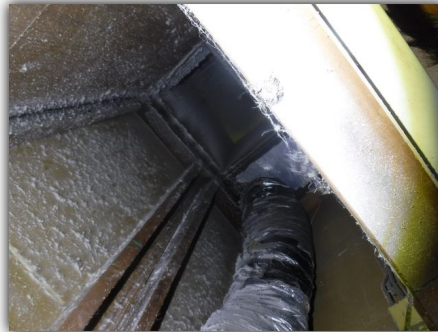
The return filters are missing or dirty. Missing or dirty clogged filters make the unit work harder and cuts down on the efficiency and life of the unit.

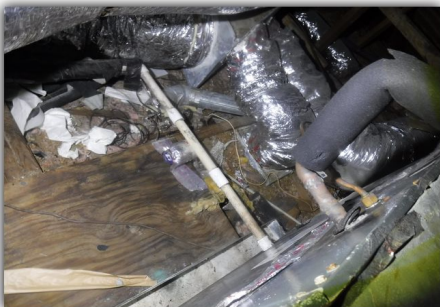
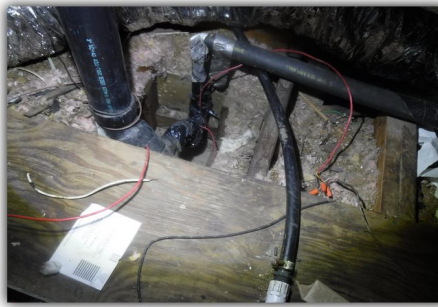
Air-conditioning refrigerant and drain lines should be checked, insulated, and cleared as necessary

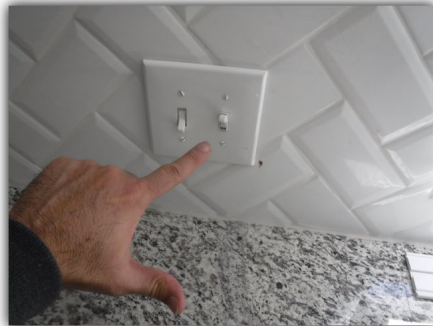
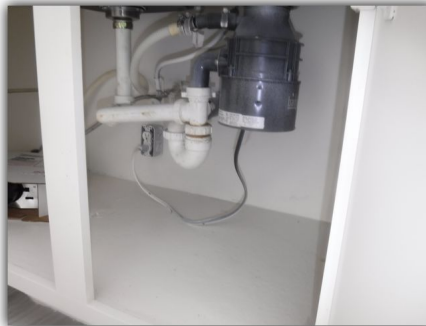
Garbage disposal did not start when operated with the wall switch.

Defects in this section should be addressed by a qualified appliance service technician or electrician.
