PROPERTY INSPECTION REPORT FORM

Lucy A. Evei Name of Client	5/26/2022 Date of Inspection
1806 Nantucket Dr, Houston, TX 77057 Address of Inspected Property	
Quinnon Yu Name of Inspector	24428 TREC License #

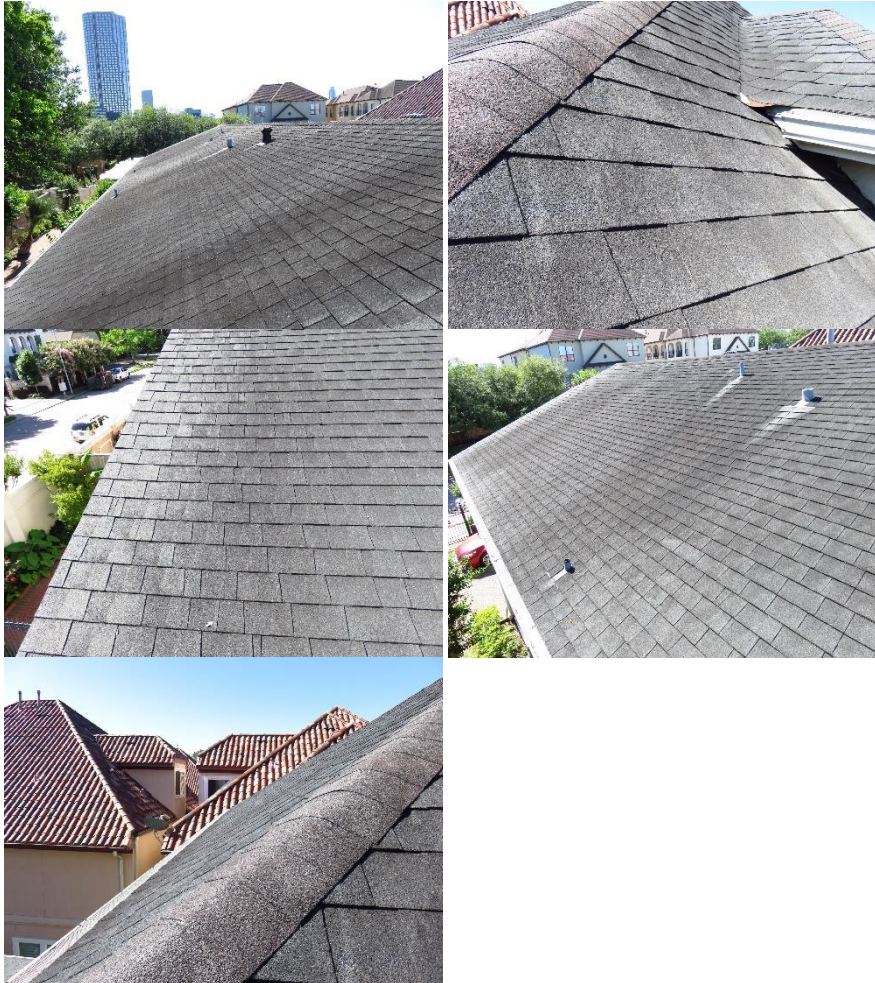
More than 2 layers of shingles were observed at the back roof. It is recommended to have no more than 2 layers of shingle roofing installed. Excessive layers of roof covering put unnatural stress on the structure and can weaken future performance.

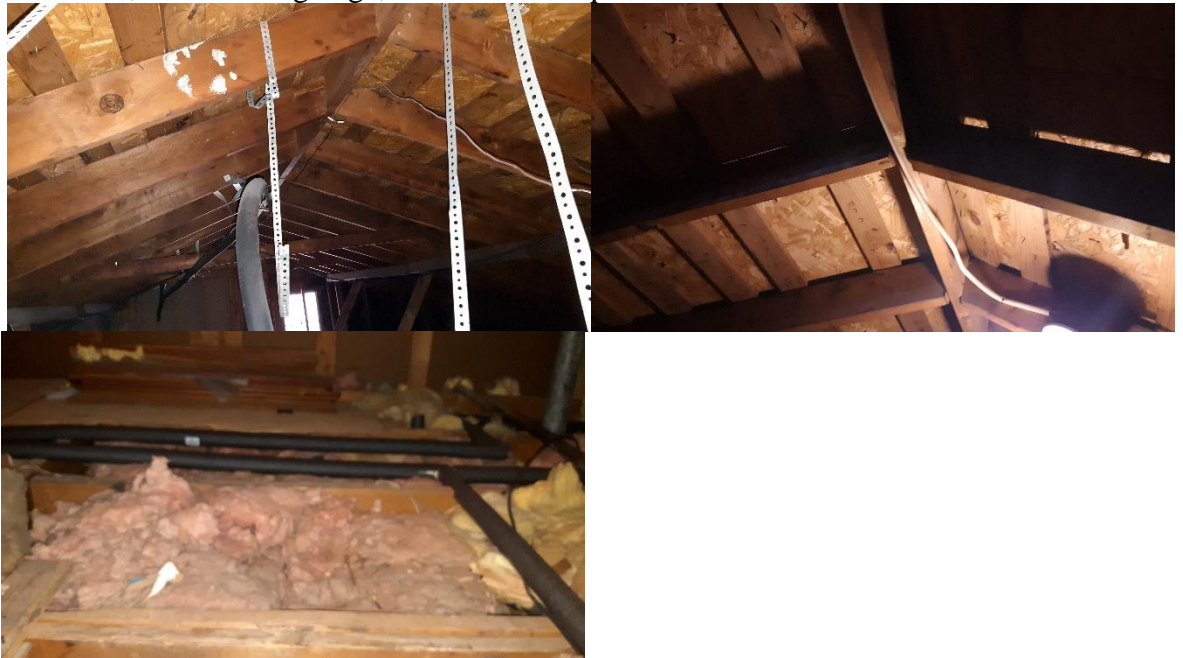
Comments: Insulation was observed in appropriate areas of the building during time of inspection. Insulation should be maintained in order to prevent heat and cooling loss. This is especially important on the ceilings above the living space. Places that are not meant for habitation, such as the garage, often do not require insulation.

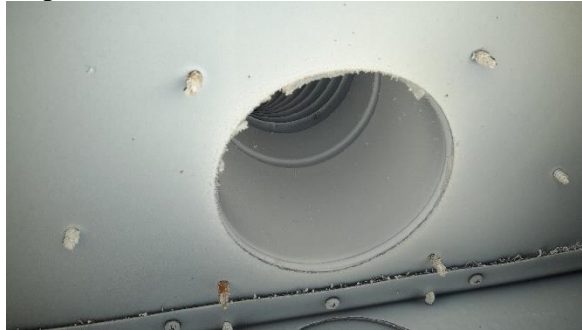
Comments: The inspector does not attempt to light fireplaces due to liability reasons. The chimney flue was inspected and was generally found to be clear during time of inspection. It is recommended to have a chimney sweep certify the system before initial use.

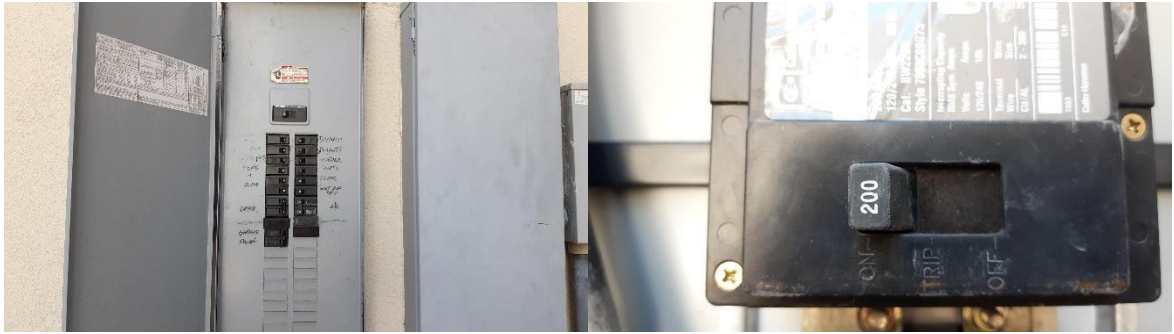
White wires were observed going into the breakers. Per electrical standards, only wires that are covered in red or black colors should be going into the breakers. This reasoning is to properly identify which wires are “hot” or live. White sheathed wires are reserved for neutral conductors.

Recommend an electrician to evaluate and remedy any potential problems as necessary.

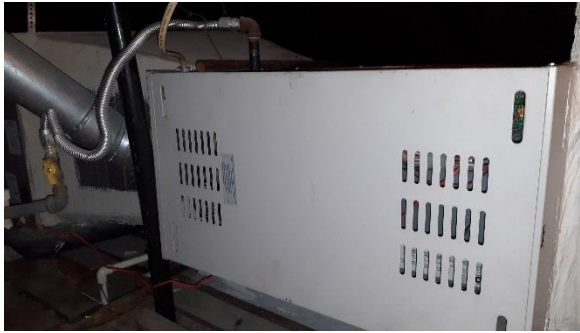
2nd and 1st floor furnace

Comments: The heating equipment typically consists of a furnace or air handler in residential construction. The heating equipment is visually inspected for signs of malfunction and is tested for performance under normal operating procedures. **Heating units were operating as intended during time of inspection.**

There was an observed lack of a sediment trap in the gas supply line. A sediment trap is a piece of piping that serves to change the direction of flow before the gas reaches the appliance. This acts as a filter for the natural gas. Natural gas can have foreign contaminants that can pollute the appliance. A sediment trap prevents those contaminants from interfering with the appliance. **An example of a sediment trap is provided below.**

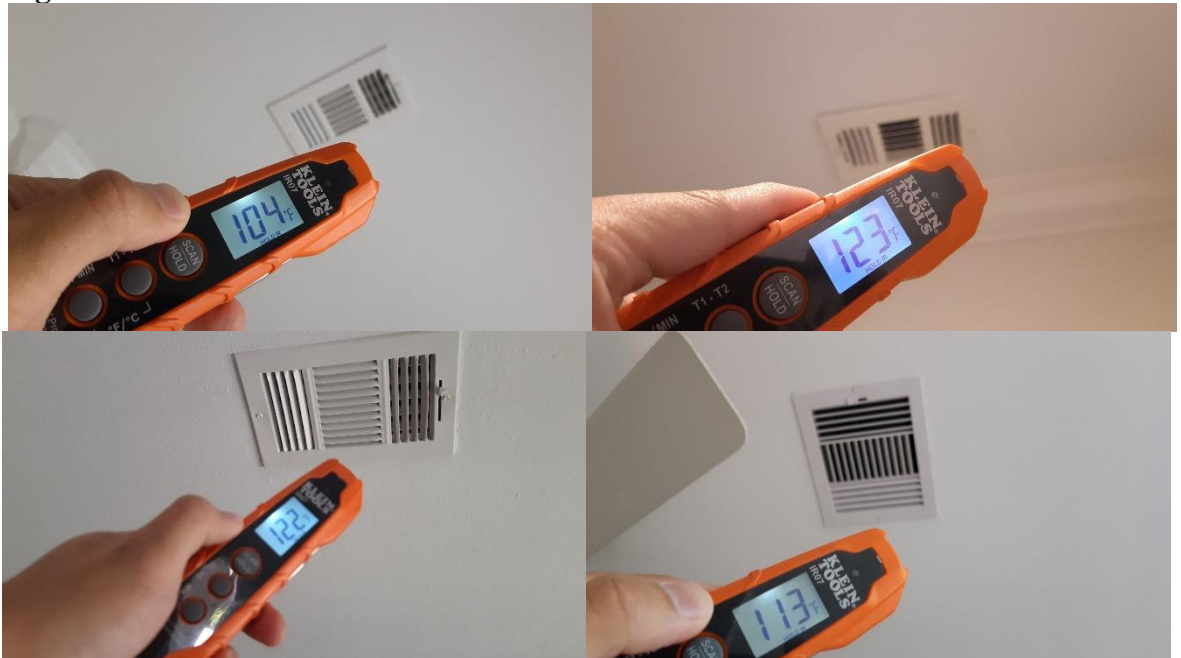
Temperatures over 90 degrees are considered adequate for heating. **Temperatures of over 100 degrees Fahrenheit were measured.**

Recommend a licensed HVAC professional to evaluate any problems and remedy as necessary.

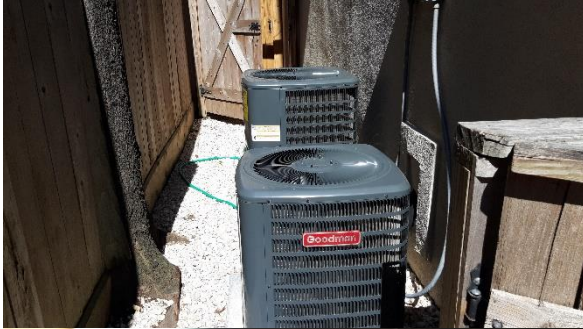
An overfusing situation has been observed. Per the manufacturer's label, the MAXIMUM fuse that can be installed in conjunction with the small and big unit is 15 and 35 amps. The breakers that correspond to the AC units are 40 amp breakers. This means that in the rare case of electrical failure, the service panel's breakers will not catch the situation before a fire risk has manifested.

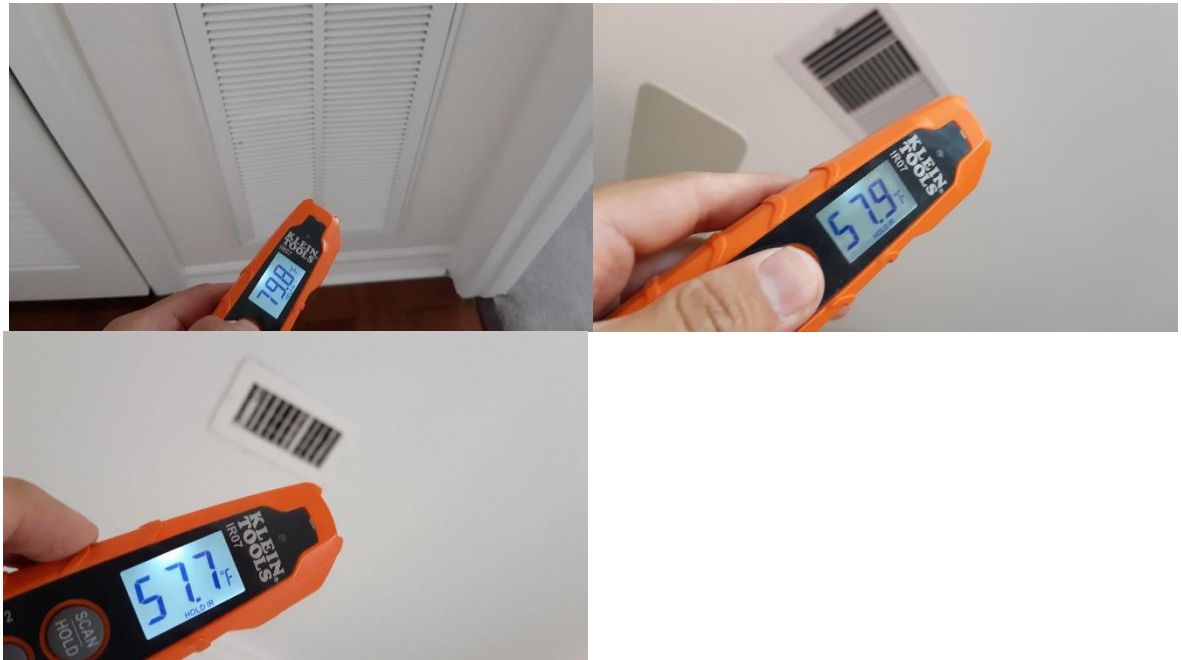
3rd floor AC

Various rooms were tested for temperature differentials. The thermostat was set to “60 degrees Farenheit” for at least 30 minutes before measuring the vents. It is recommended to have a temperature differential of between 14-22 degrees Farenheit. **About 19-22 degrees of difference was observed today.**

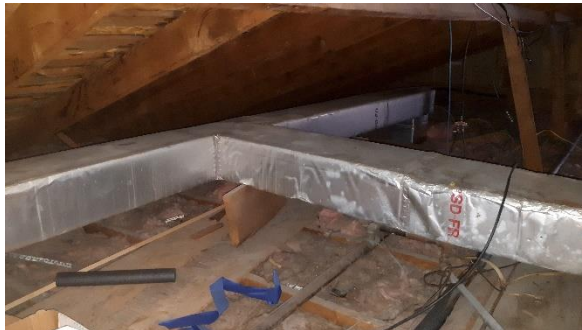
Comments: Ducting was observed to be properly elevated during time of inspection. Ductwork should ideally not be lying on the attic floor. If condensation occurs, there is an increased chance of mold and mildew formation.

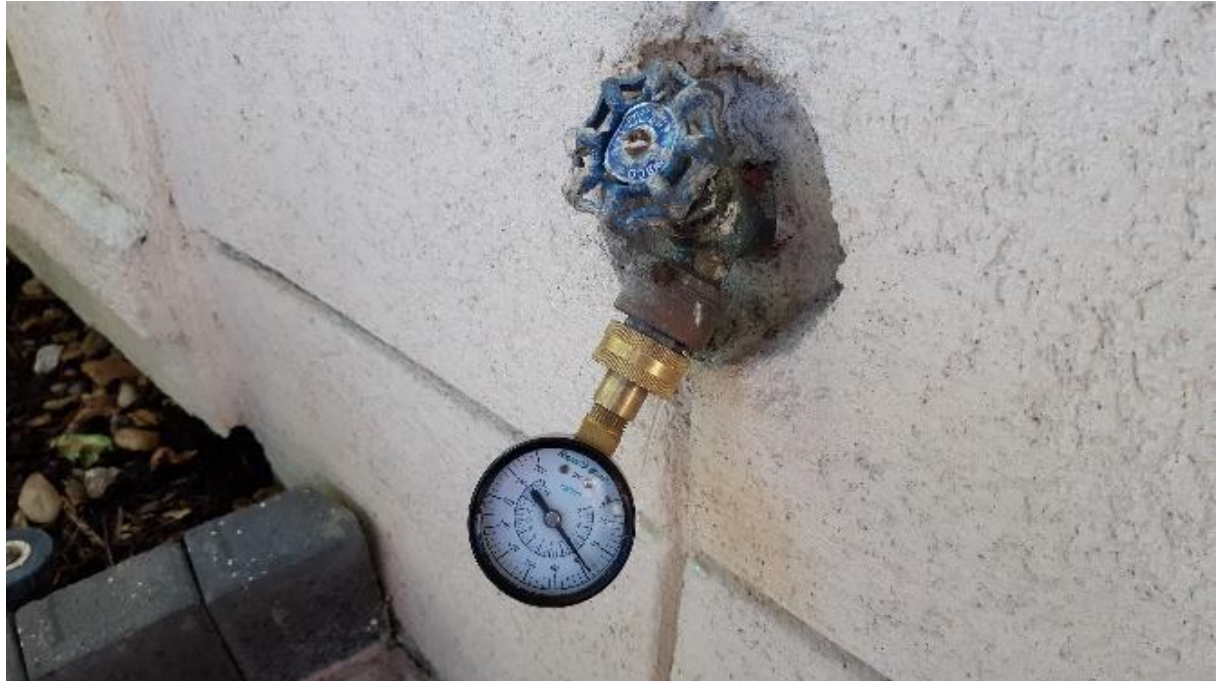
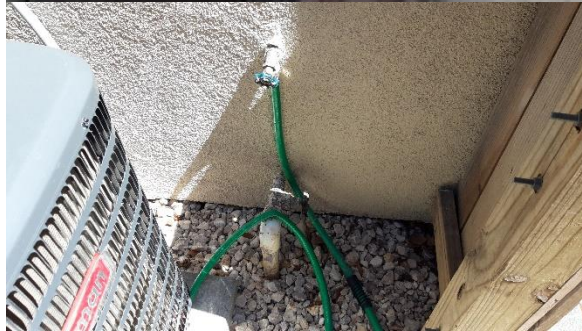
Comments: Static water pressure should ideally be between 40 and 80 pounds per square inch (PSI). Water pressure that is too low can be an inconvenience, while pressure that is too high can be damaging for the plumbing system.

Recommend a licensed plumber to evaluate and remedy as necessary.

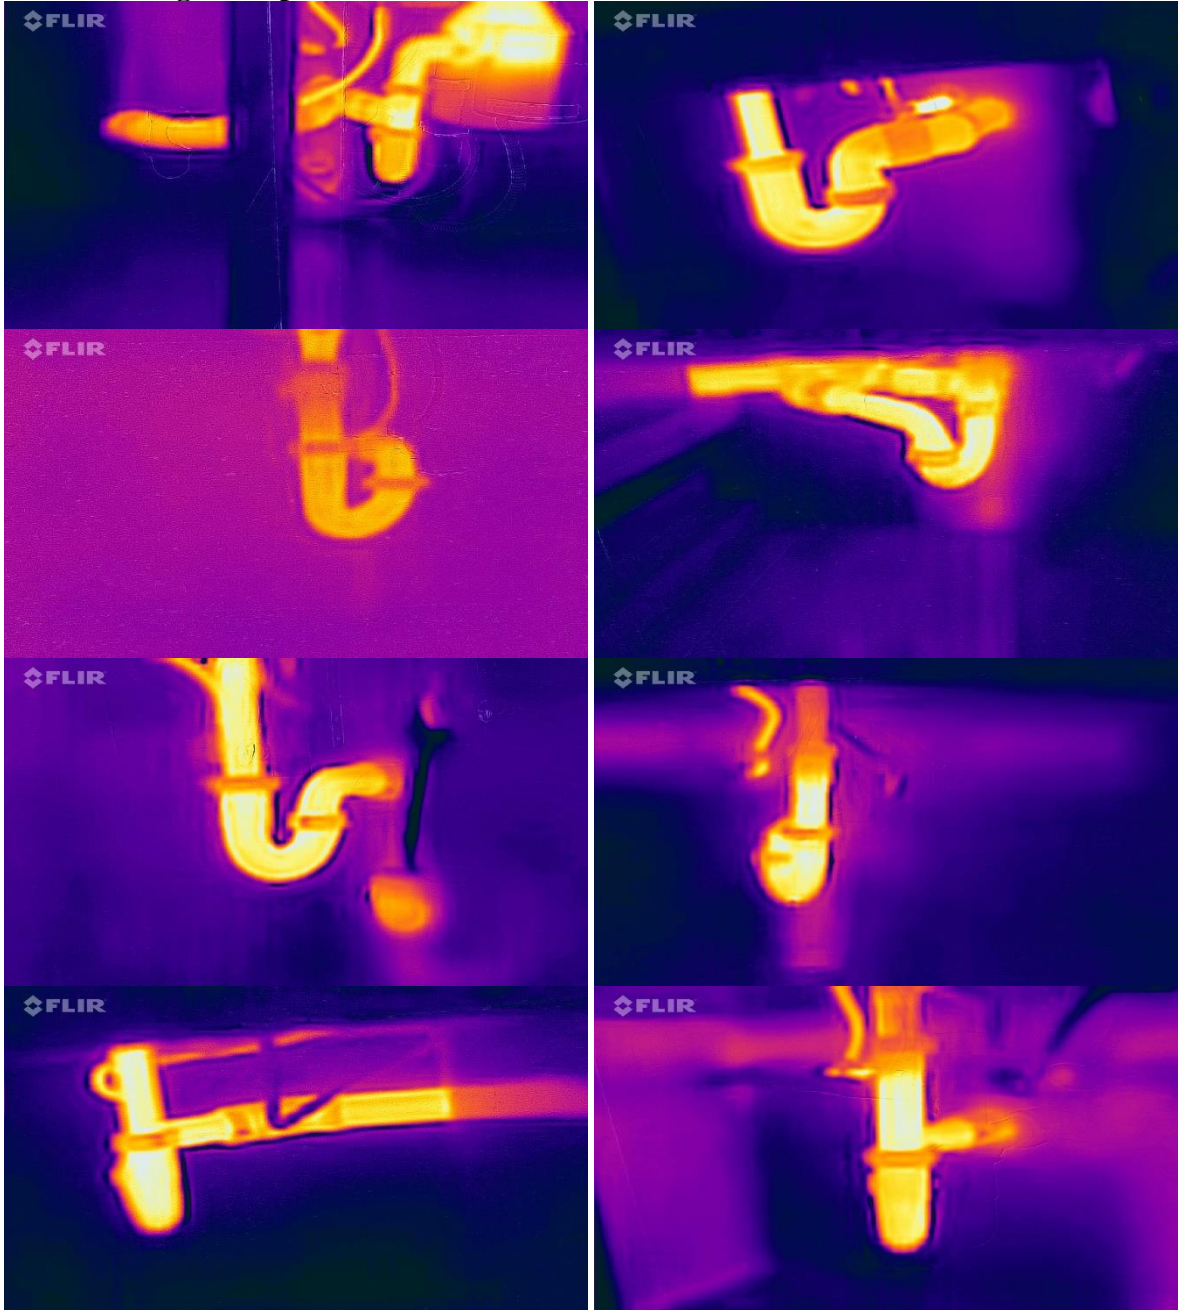
An infrared camera is used to assist in the detection of leaks in the plumbing drain system. Hot water is typically run down the drain pipes. The yellow and orange markings in the pictures represent hot temperatures. The dark spots represent cool temperatures. In a leaking drain, a dark spot will usually form directly under the plumbing fixture, identifying the leak. **The following set of pictures do NOT show leaks.**

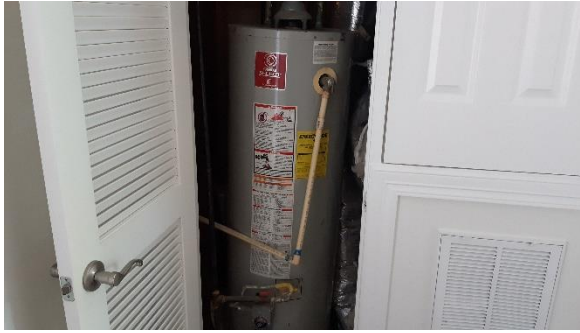
3rd floor water heater

There was an observed lack of a sediment trap in the gas supply line for both units. A sediment trap is a piece of piping that serves to change the direction of flow before the gas reaches the appliance. This acts as a filter for the natural gas. Natural gas can have foreign contaminants that can pollute the appliance. A sediment trap prevents those contaminants from interfering with the appliance. **An example of a sediment trap is provided below.**

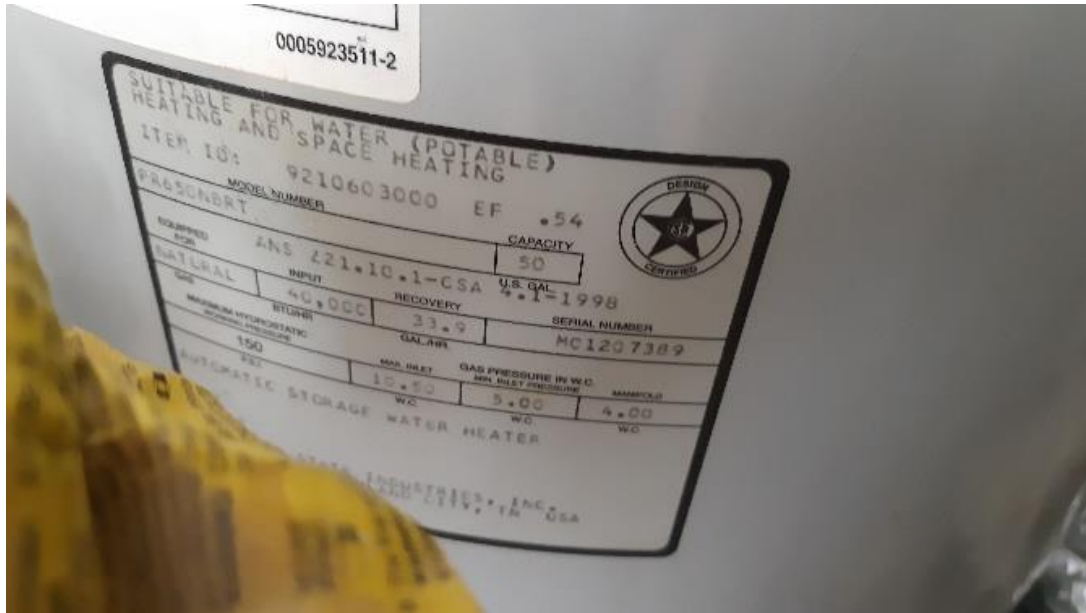
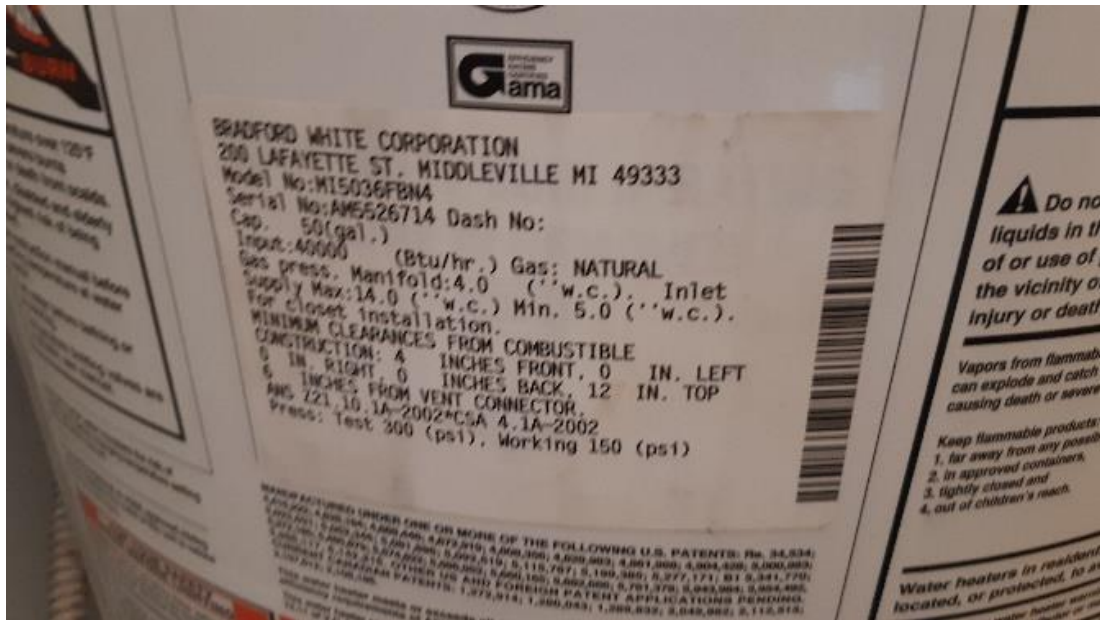
Patina was noticed on the copper piping for the 3rd floor water heater. This is most common on older heaters due to corrosion from age. While not immediately harmful, it is recommended to have a plumber evaluate for any leaks or improper piping.
