Property Inspection Report #20210805-01

for property: 3902 Fernglade Dr
Houston, TX 77068

PROPERTY INSPECTION REPORT

By: Enzo Ricci, Lic #23551 08/05/2021
(Name and License Number of Inspector) (Date)

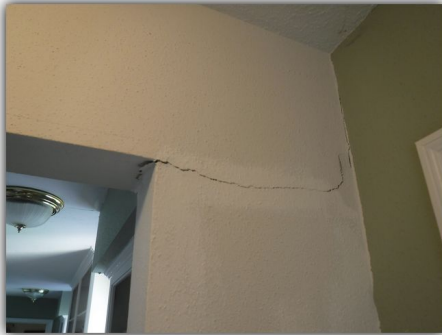
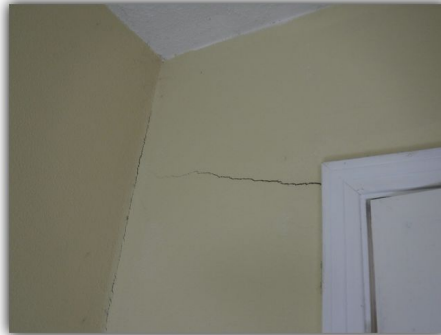
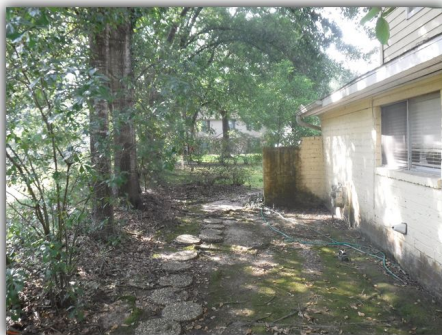
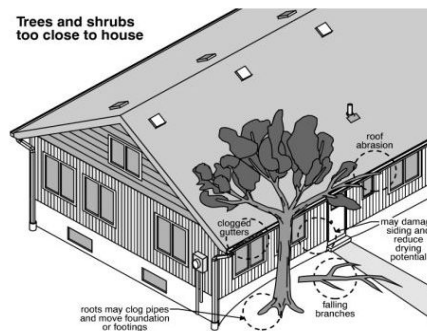
On 08/05/2021 at 9:00 am Inspector Enzo Ricci's opinion was that the foundation appeared to be in questionable condition. At this time, I did observe visible evidence that I would consider as being indications of movement and/or settlement. The areas inspected were, but may not be limited to the accessible foundation walls, ceilings, floors, doors & windows which indicated major signs of movement and/or settlement.

visual inspection. In the event that structural movement is observed, the client is advised to consult with a Structural Engineer or foundation specialist who can isolate and identify causes, and determine what corrective steps, if any, should be considered to either correct and/or reduce structural movement.

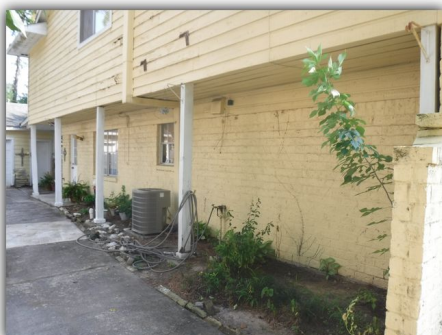
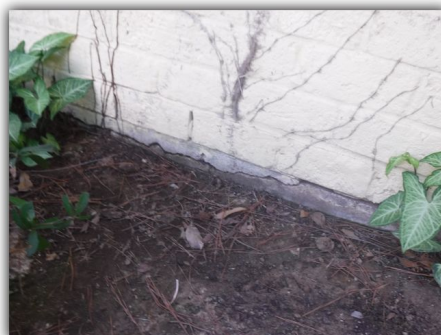
- Left side

Slab dressing observed at one or more areas of foundation.

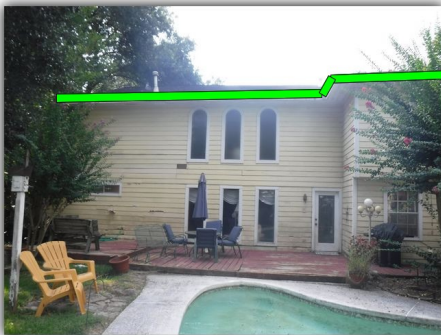
Recommend addition of a full rain gutter system to help improve drainage and/or prevent wood rot. While roof overhangs and porch roofs protect building walls from impinging rain, gutters serve to protect building walls and foundations from roof water runoff. Roof gutters, downspouts and leaders or diverters form the initial components of a drainage system for the building and site.

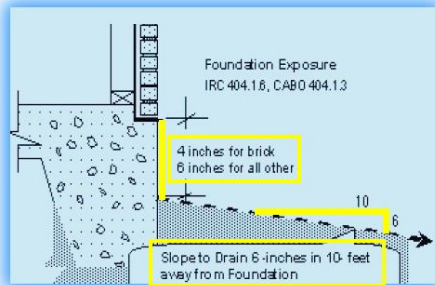
■ High soil levels were observed at the foundation walls. A minimum of **four** inches of foundation wall should be exposed under the brick veneer. High soil levels are conducive to wood destroying insect infestation, and possible water penetration into the home.

■ The drainage and grading around this home is inadequate. In order for the drainage to be effective, the landscaping must be configured so that the yard is sloped away from the foundation by at least 6 inches in the first 10 feet and/or adding additional gutters/downspouts to the house is another option to improve drainage and/or in- ground drains should be designed and added to divert rainwater and runoff away from the house as appropriate and/or drainage swale should be improved/installed.

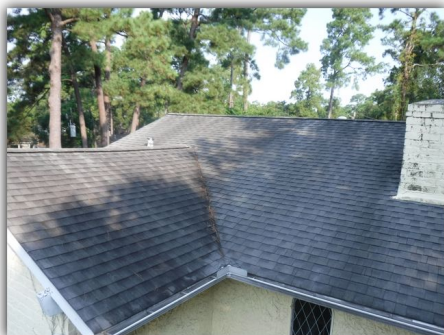
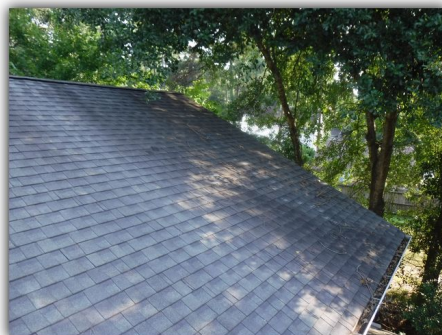
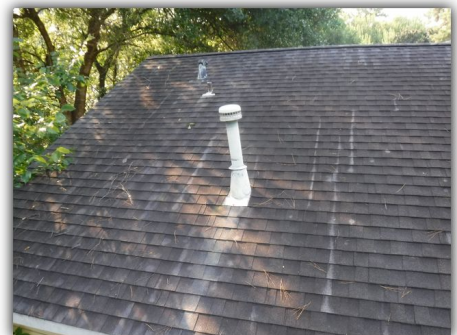
■ The roof covering appears to be in older but serviceable overall condition. Roof related repairs if needed will be noted below

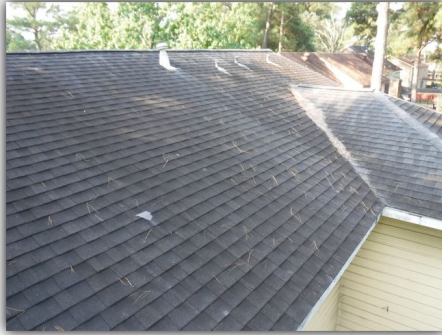
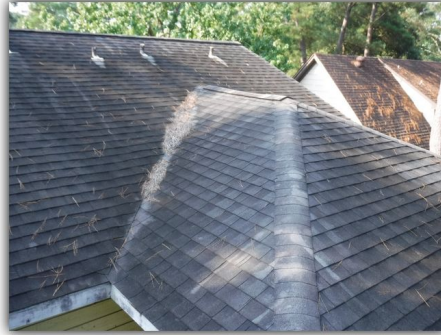
The roof does have wear and needs a maintenance performed. This would include caulking all flashing, replacing missing or damaged shingles and a full evaluation.

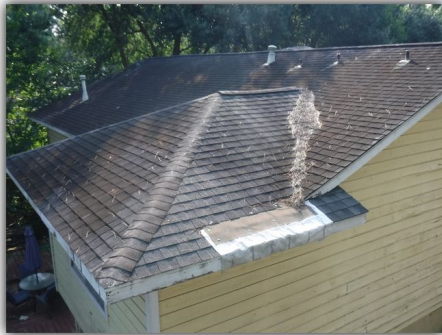
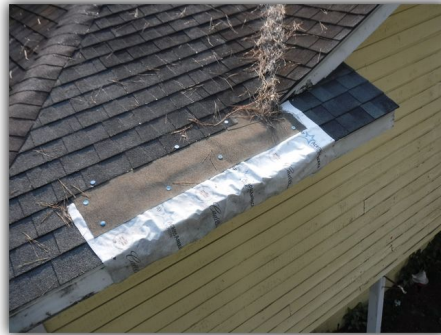
- rear left

Observed damaged section of the roof

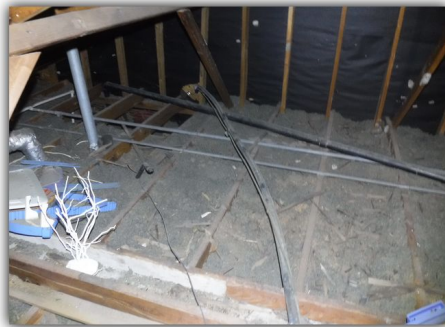
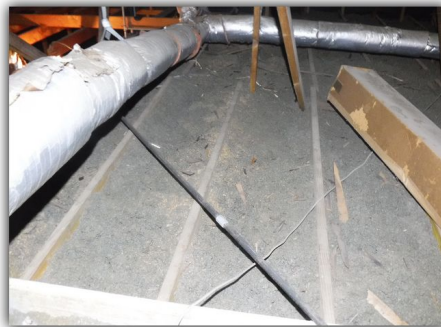
■ Some of the insulation has been disturbed. It is recommended that the insulation be redistributed, and improved as necessary to ensure consistent comfort levels throughout the home.

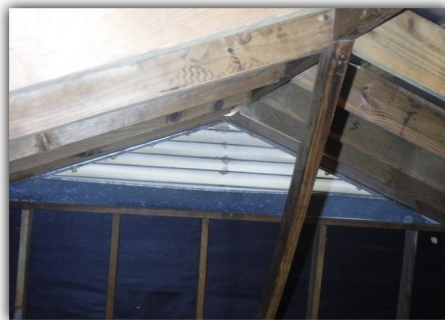
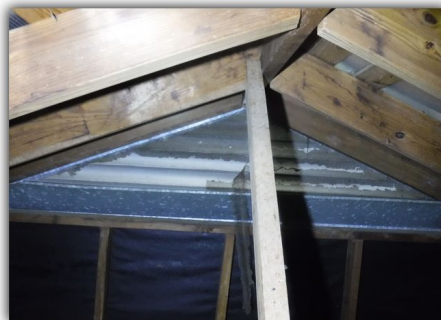
There is no gable vent screening to keep insects / vermin out of attic.

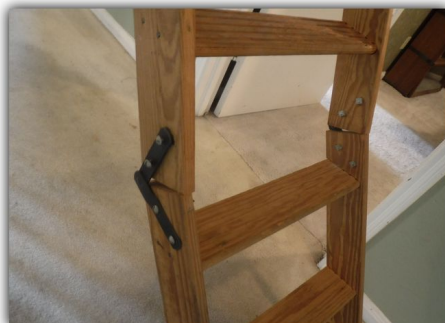
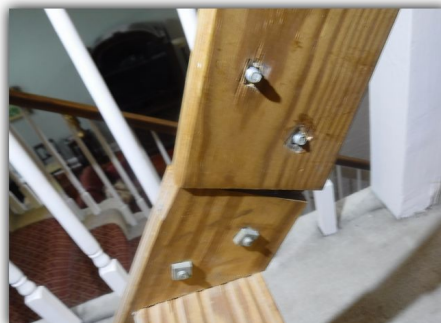
Tighten loose / replace missing nuts and bolts on stairway sections.

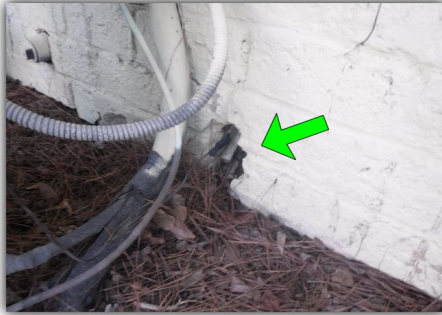
■ One or more penetrations in the exterior wall which allowed installation of an exterior faucet, gas line or electrical wiring was not sealed and may allow moisture and insect penetration. The Inspector recommends application of an appropriate sealant to prevent moisture and insect entry of the wall structure.

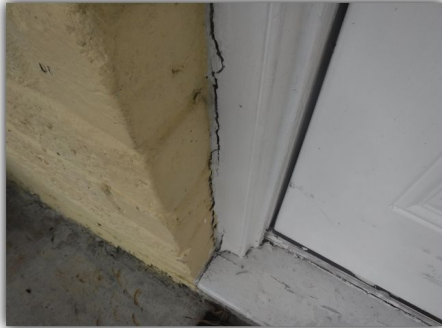
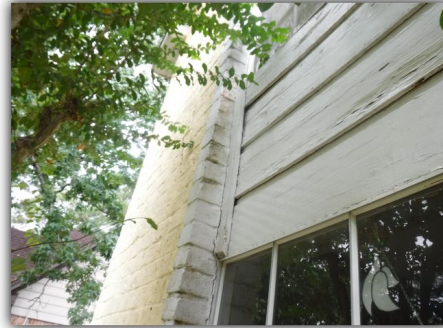
■ Caulking missing and/or deficient at vertical joints in siding; may allow wind driven rain entry.

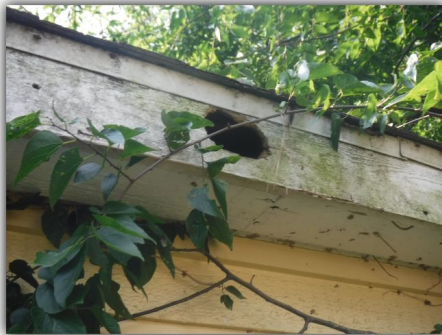
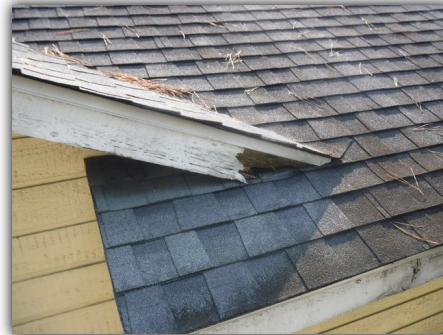
■ Damaged soffit and/or fascia boards were observed in one or more locations of the house. Repairs should be under taken to prevent water and rodent intrusions.

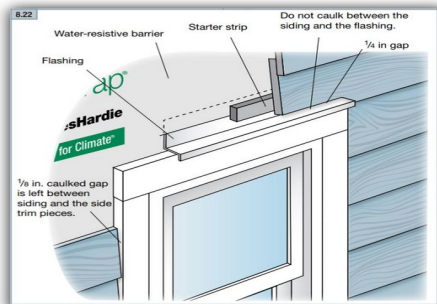
Information from the manufacturers website – Metal flashing, called “Z” flashing, should have been installed during construction of the structure. Z flashing is cut into the frame siding and covers the top piece of trim to prevent water from entering the trim or window frame. Z flashing is meant to prevent water penetration, not to act as a drain after water penetration has occurred. Proper Z flashing materials should be installed to reduce the incidences of water penetration.

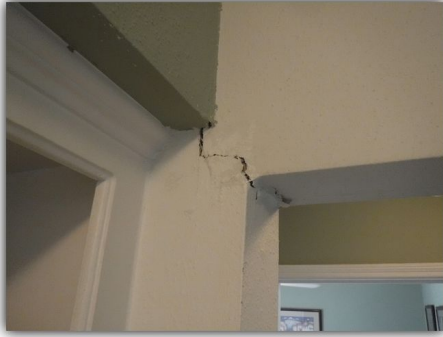
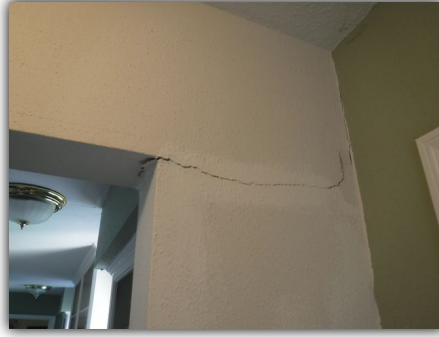
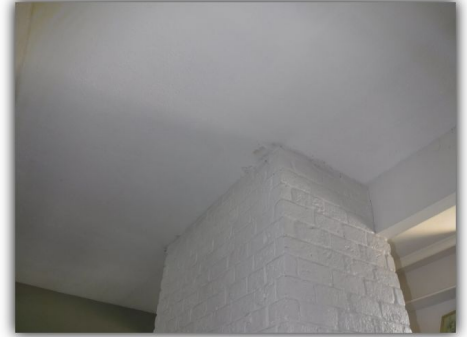
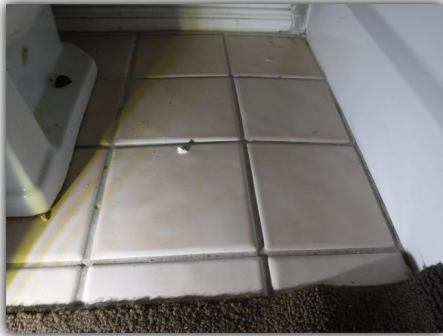
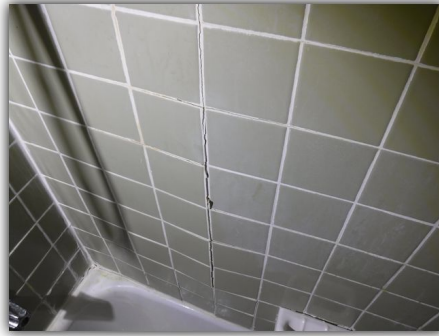
■ Cracks in the walls and/or floor were noted in the tub/shower of the jack & jill bathroom. The cracks should be repaired to match the existing structure.

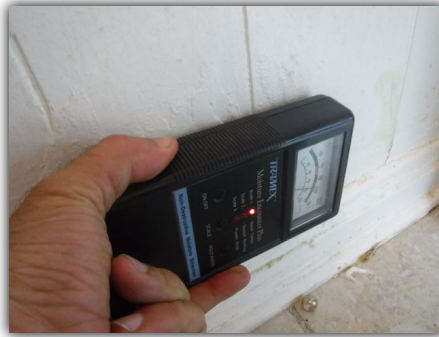
- Master bathroom adjacent to the toilet

■ Elevated moisture readings was present at the time of the inspection in / on the wall

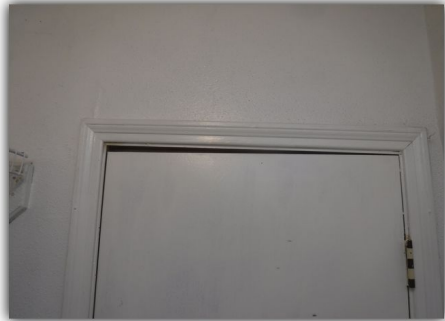
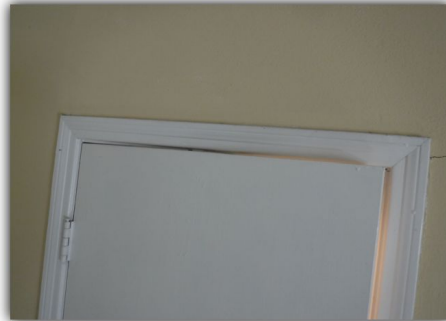
■ Numerous door(s) were sticking and/or out of square at the time of the inspection.

■ Numerous door(s) were not latching properly at the time of the inspection.

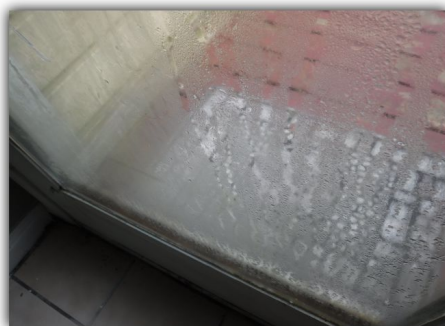
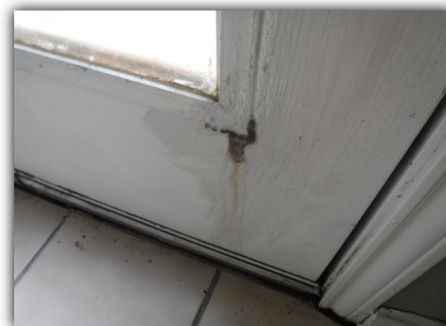
- Rear door
- Front door

Wood rot of lower door and/or jamb;

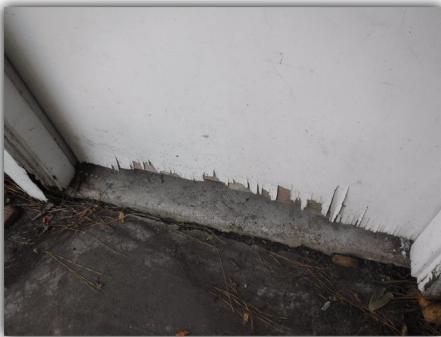
■ Wood rot, lower section of garage door vertical 2x6 trim board(s).

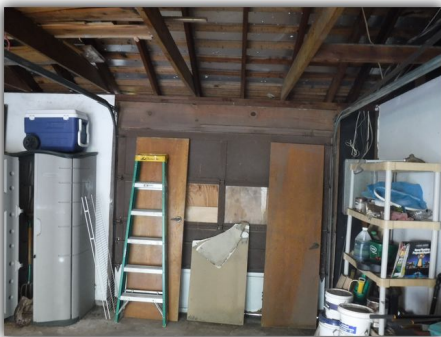
- Garage

■ Damaged door. The door(s) were not latching properly at the time of the inspection.

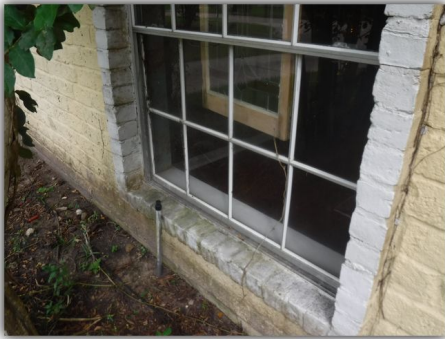
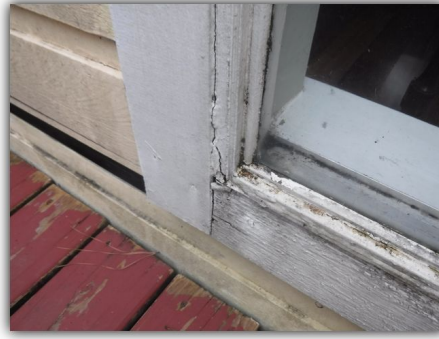
■ Most of the windows inspected were in need of caulk at the time of the inspection.

■ Screens were missing and/or damaged in the windows at the time of the inspection.

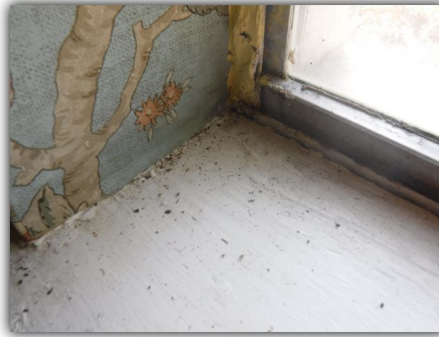
■ Signs of moisture penetration were present on one or more windowsills at the time of the inspection. The windows inspected were in need of caulking. Here are some examples but not limited to:

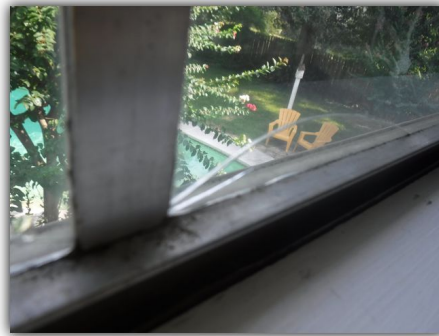
■ One or more windows had cracked / broken glass pane(s).
● Rear left bedroom

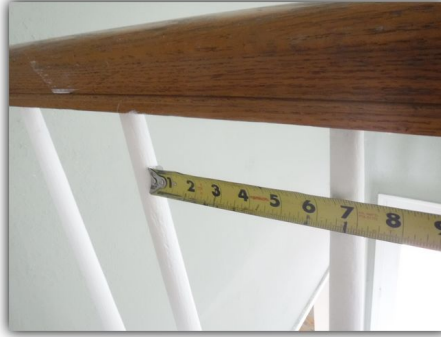
Space between railings does not comply with current industry standard, (code) UBC 421.1.1 & CABO D105.2.1. Requires spacing between intermediate rails do not allow passage of an object four inches in diameter. Recommend covering large openings in stair rails with temporary type nylon netting if small children are present in house to prevent injury.

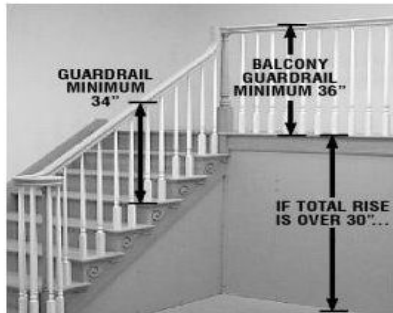
Guardrail too low for safety, current industry standards requires minimum guardrail height of 36 inches. (Code reference, IRC R316.1).

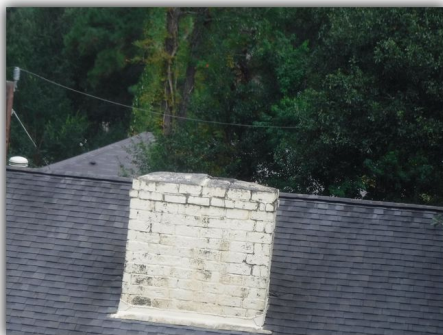
The chimney(s) had no rain cap or spark arrestor. A metal rain cap and spark arrestor should be installed on a masonry chimney. The arrestor screen should be made of a heat- and corrosion-resistant material, such as galvanized steel (19-gauge) or stainless steel (24-gauge). The screen openings should be sized to allow the passage of a sphere with a diameter between 3/8-inch and 1/2-inch.

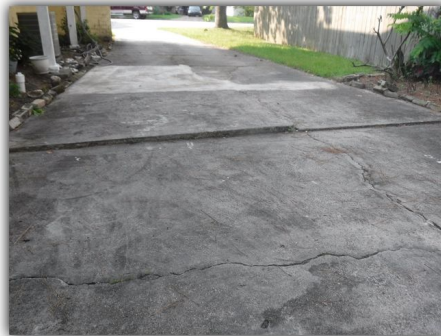
The driveway and/or walkway is cracked and appears to have some movement in the elevation of the concrete. The elevation differences can be a trip hazard as well as contribute to the deterioration of the driveway. I recommend having a qualified contractor evaluate and repair as needed.

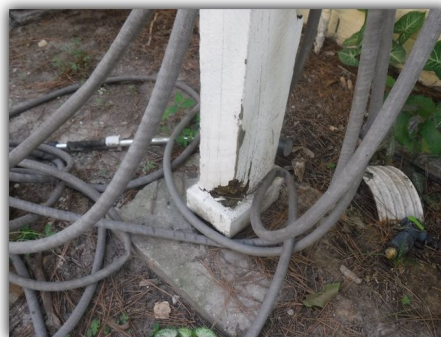
Observed wood rot at columns support. No slab pedestal or metal chairs in column were noted.

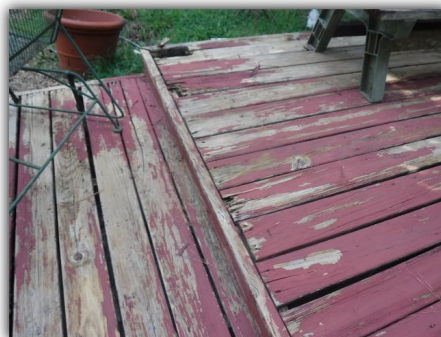
Observed wood damaged at rear wood decking. Trip hazard.

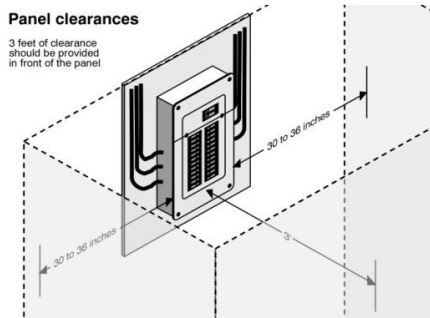
Code requires minimum clearance to electrical service panels to be 36" in front of and 30" from side to side.

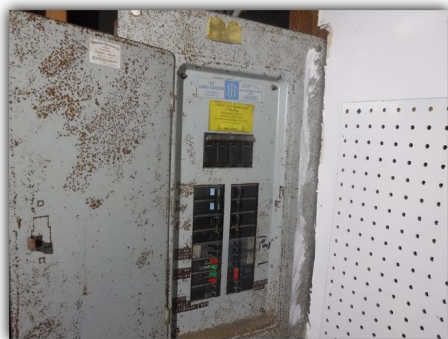
- All fuse or breaker panels are required to have an complete, legible, and accurate listing of what the circuits are connected to. This is properly called a legend.
- There is double lugging of the neutral wiring in the service panel. Each neutral service wire is required to be under one screw per wire.

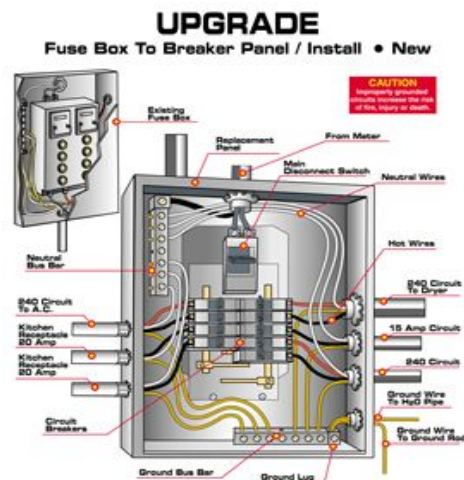
■ The TREC Standards of Practice require comments on bonding; however bonding cannot be fully evaluated within the scope and limitations of a visual inspection process. If you have questions or concerns regarding bonding it is recommended to contact a licensed and qualified electrician. Equipment bonding could not be verified at all key points (Examples: interior water piping and/or water heaters and/or around water meters-gas lines and/or electrical enclosure and/or electrical raceways and/or electric outlets or junction boxes and/or CSST gas piping (manufacturer's compliance)). Proper bonding conductors must be installed to equalize electrical potentials. The lack of proper bonding creates a fire or a shock hazard. The presence of proper bonding should be verified by a master electrician or proper bonding of the equipment should be installed for safety

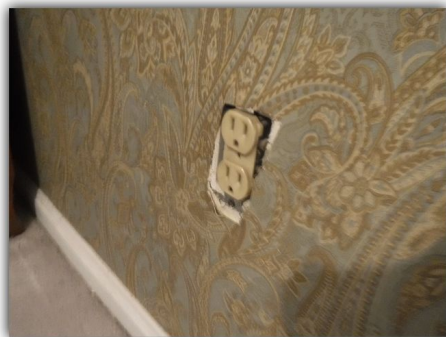
■ No outlet cover
 ● Upstairs left bedroom

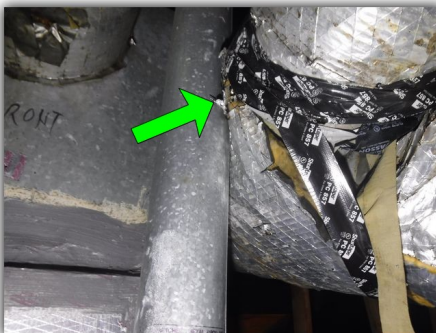
The combustion exhaust vent had inadequate clearance from combustibles. This type of exhaust vent requires 1-inch clearance from combustible materials. This condition is a potential fire hazard and should be corrected by a qualified contractor.

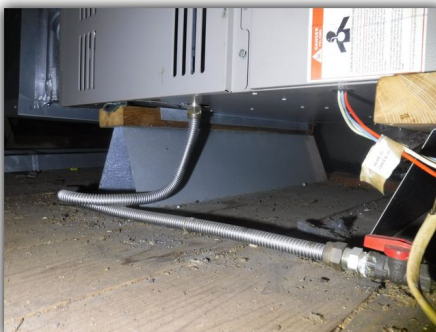
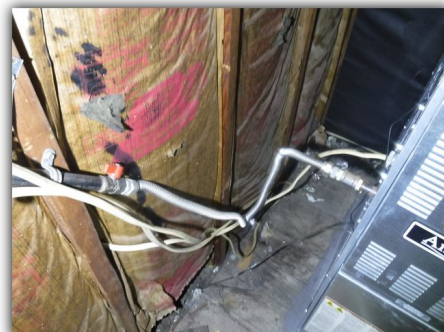
There was no sediment trap installed on the natural gas distribution pipe prior to the connections to the furnace.

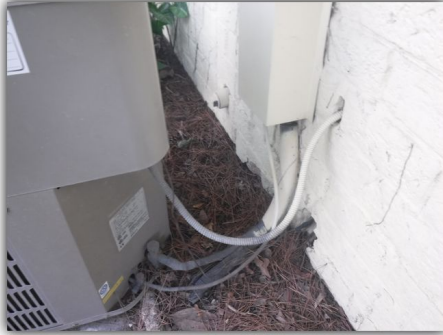
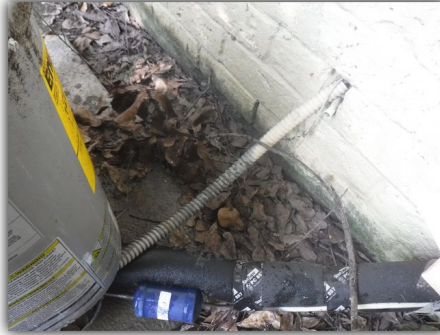
■ Service disconnect for the air conditioner is missing. Recommend installing electrical disconnect within sight of unit.

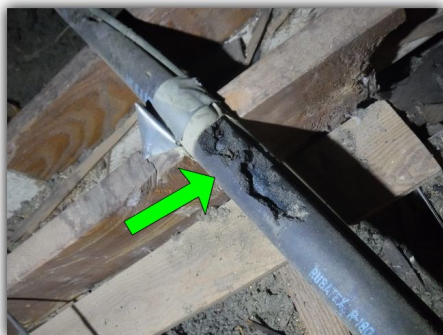
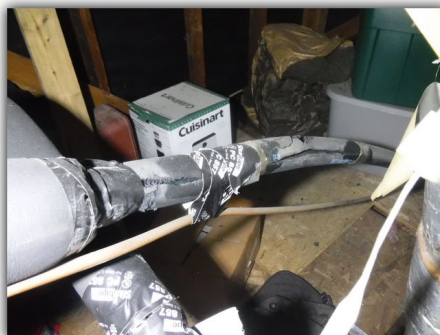
■ Air-conditioning refrigerant and drain lines should be checked, insulated, and cleared as necessary

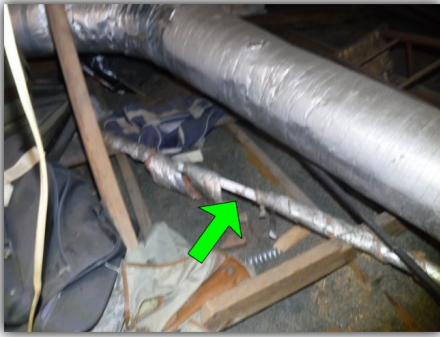
■ The primary condensation drain near the air conditioner is not fully insulated. This will most likely result in condensation of the drain line.

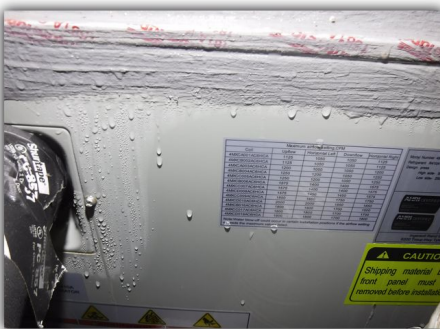
■ Observed condensation forming on unit casing. Have serviced by a qualified HVAC technician to correct cause.

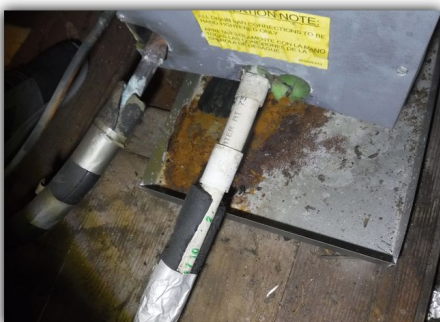
■ Corrosion and/or previous water and/or water observed in the emergency overflow pan; indication coil (or previous coil) has a history of leaking/dripping condensation into the pan.

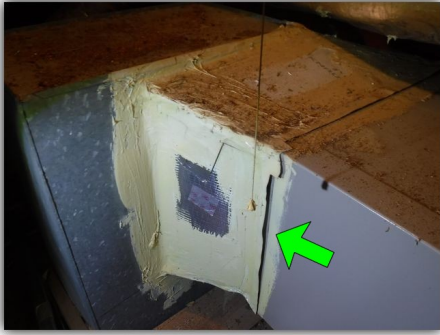
■ Conditioned air is leaking from the seams of the blower/plenum/equipment unit(s) in the attic.

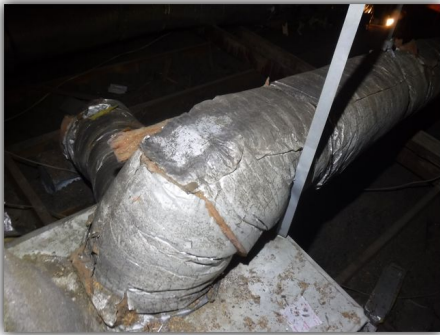
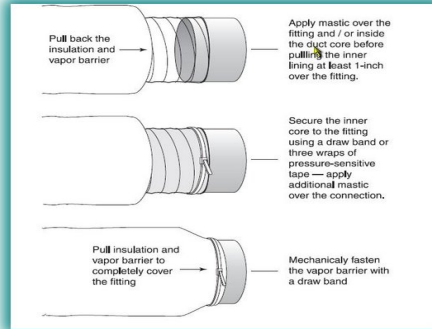
■ Conditioned air is leaking out of the duct work. Normally, the inner ductwork liner is sandwiched between two layers of mastic. Continued: It is recommended that all of the ductwork be properly attached following the Department of Energy's recommended procedures.

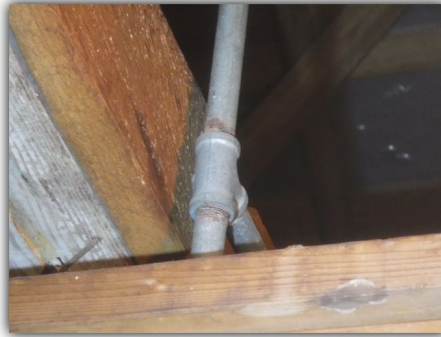
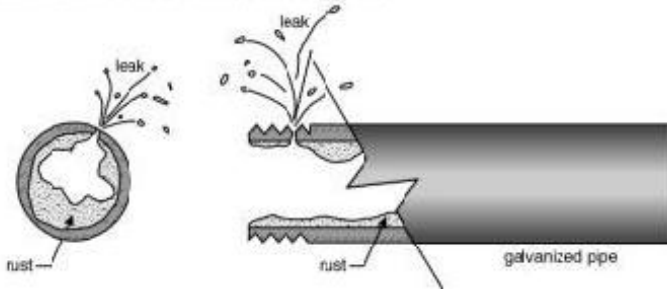
Galvanized steel pipe

rusting of galvanized pipe can greatly reduce water pressure and will eventually cause leaks as rust creates holes in the pipe walls

problems are likely to occur soonest on pipes carrying hot water, horizontal pipes and at threaded (thinner) sections

Water supply piping observed to be predominantly galvanized. This is an outdated material and as corrosion reduces the diameter of the pipe interior, water flow will be increasingly restricted. All galvanized pipe in the home may need to be replaced soon.

The Inspector recommends that before the expiration of your Inspection Objection you consult with a qualified plumbing contractor to discuss options and costs for replacement.

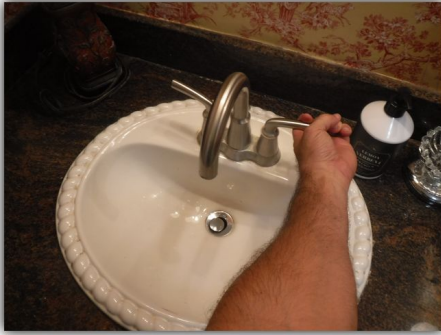
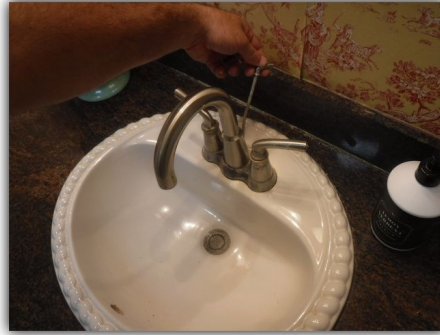
- Faucets need seals and washers.
- The drain stop was inoperable and/or missing and/or in need of repair.
- Faucets loose on sink
 - Master bathroom

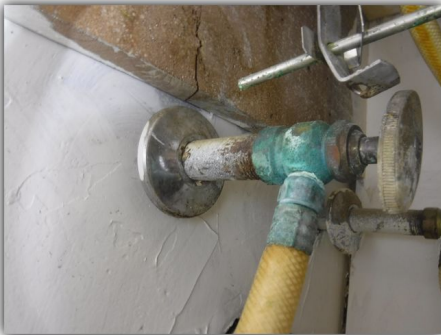
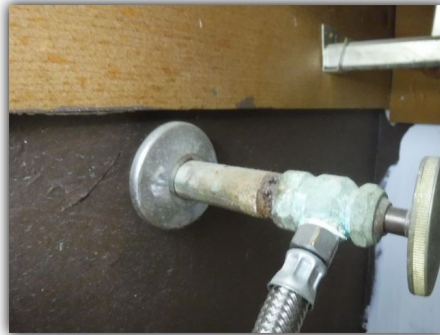
- The water supply pipe exhibited corrosion which will eventually cause leakage.
- Upstairs right bathroom
 - Jack & Jill
 - Kitchen

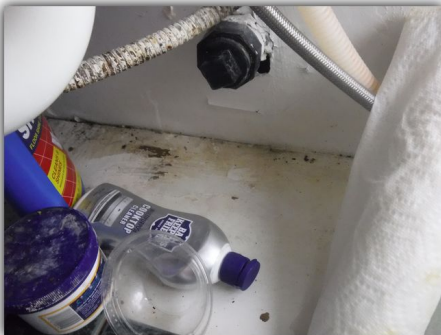
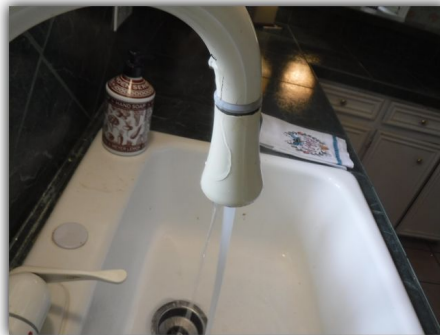
- Evidence of previous leaks under the sink.
- Vegetable spray is leaking
 - Kitchen

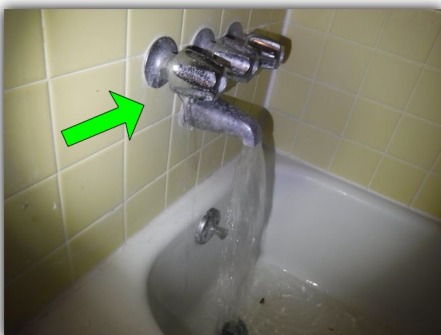
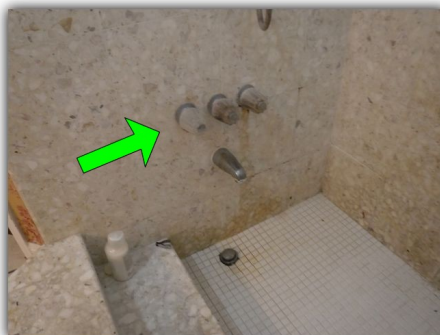
- Observed faucets leaking
- upstairs right bathroom
 - Master bathroom

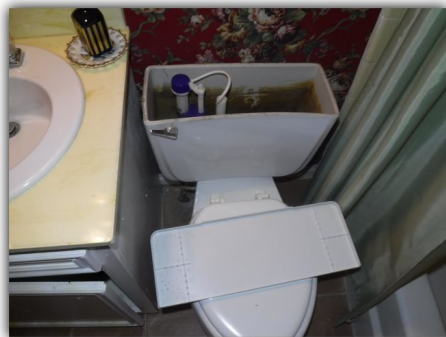
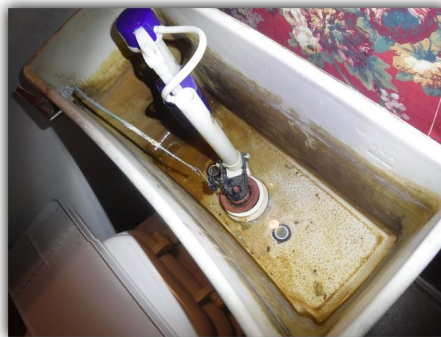
■ The floor mounting is loose. The commode(s) needs to be sealed/caulked.

■ We recommend replacing the commode's flushing mechanisms and water supply hoses as a preventative measure before occupying the house

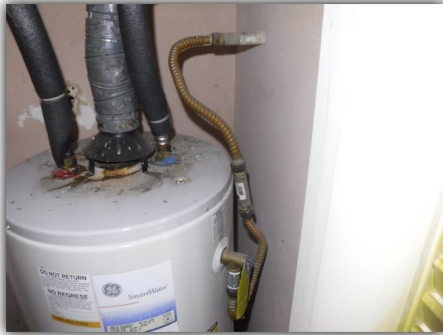
■ The drain line for the temperature/pressure relief valve was routed uphill. For safety reasons, It is recommended that the drain line be routed downhill to prevent settlement in water from clogging the relief valve.

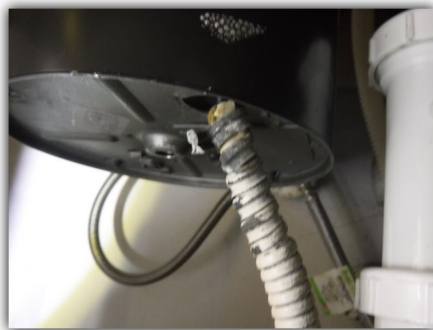
- Electrical wiring not secured, missing small fitting or grommet that secures wiring to cabinet to prevent pulling loose by service personnel or homeowner.
- The unit was hardwired at the time of the inspection. Having an electrician improve the connection as necessary is recommended.

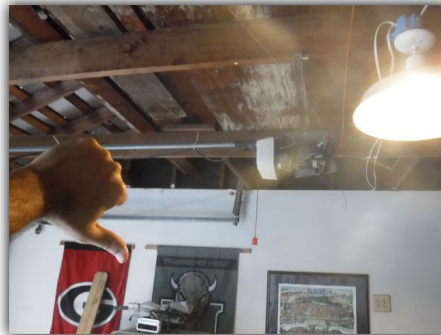
Left garage door opener is damaged.

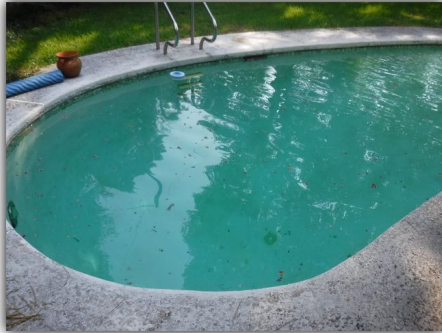
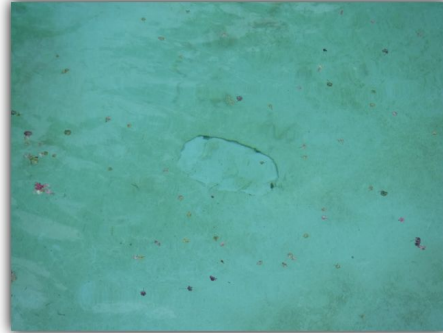
■ Observed one or more surface spot damaged at the bottom of the pool and / or on the side walls. Recommend consulting a qualified contractor.

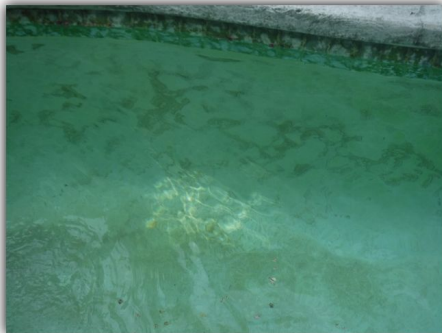
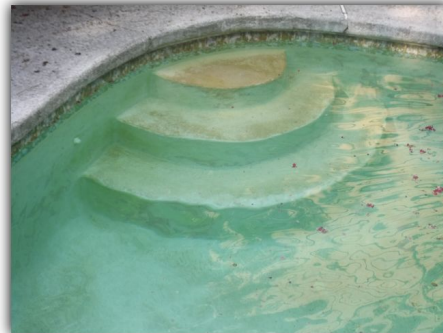
■ The pool surface shows signs of wear, stains and aging. Recommend a qualified pool contractor for further evaluation or repair.

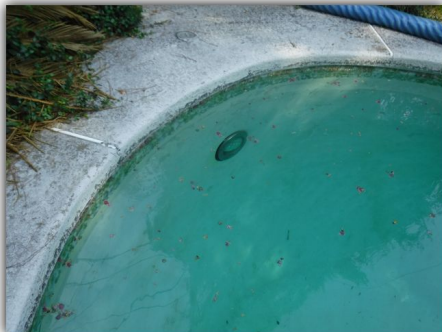
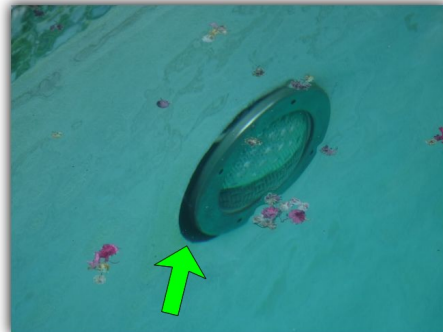
■ Observed opening between pool light and surface.

The spa light is not functioning. The pool should not be used until the light has been repaired by a qualified tradesman.

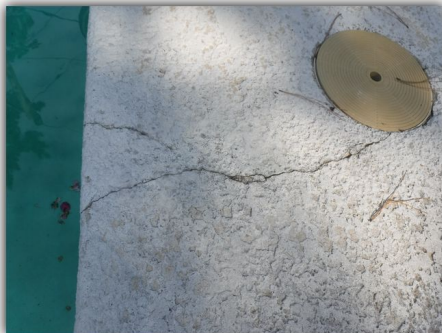
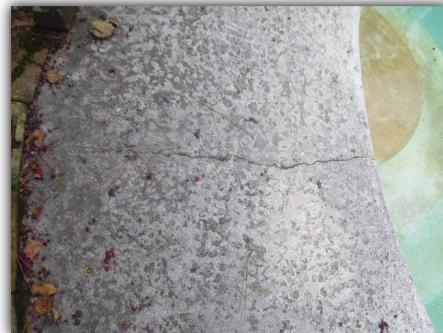
■ Cracking was noted at one section of the pool coping.

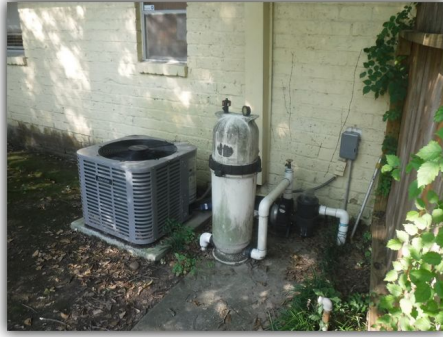
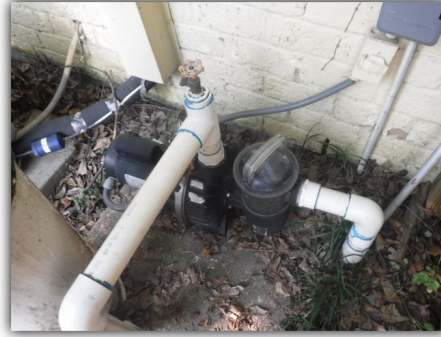
■ Ground fault circuit interruption protection has not been provided for pool equipment and pumps.
