**September 16, 2020**

## PROPERTY INSPECTION REPORT

**Concerning:** 106 Emory Birch, Montgomery, TX 77316  
(Address or Other Identification of Inspected Property)

**By:** Brendan Andrew Hirshey, Lic #22135 09/16/2020  
(Name and License Number of Inspector) (Date)

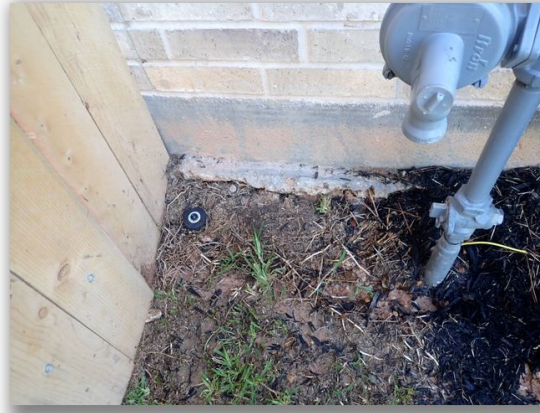
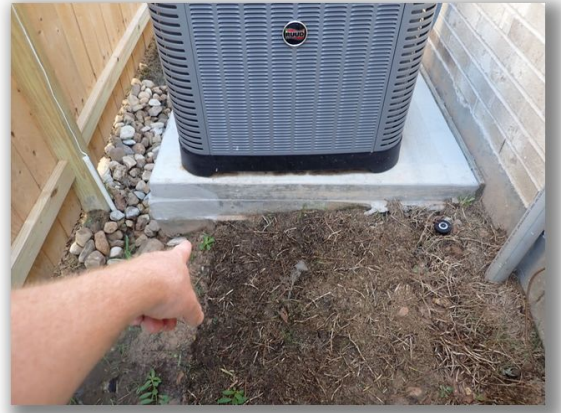
**Gutter & Downspout System**

- The gutters termination needs to be improved in the south yard.

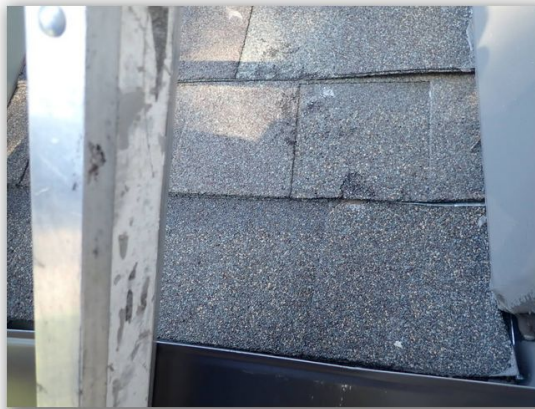
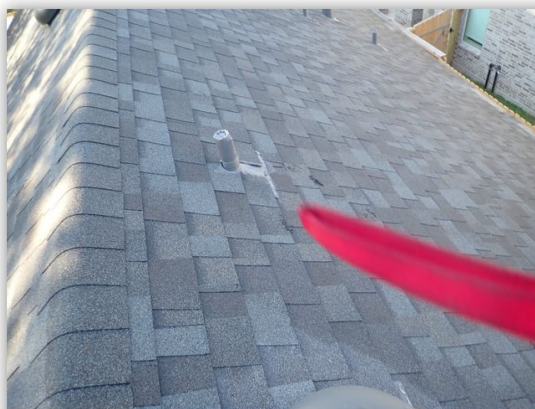
- Damaged shingles were observed on the north side, east side, west side of the roof structure.
- Some cracking and cupping of the roofing material was observed.
- There is a lot of foot traffic bruising and/or damage to the roofing material on the east side, west side, south side, north side of the roof structure.
- One or more of the shingles were observed to be lifting on the west side, north side of the roof structure.

You are strongly encouraged to have a properly certified roofing contractor to physically inspect the roof, prior to the expiration of any time limitations such as option or warranty periods, to fully evaluate the condition of the roofing material. The observation made to support the rendering of this opinion are listed but not limited to the following:

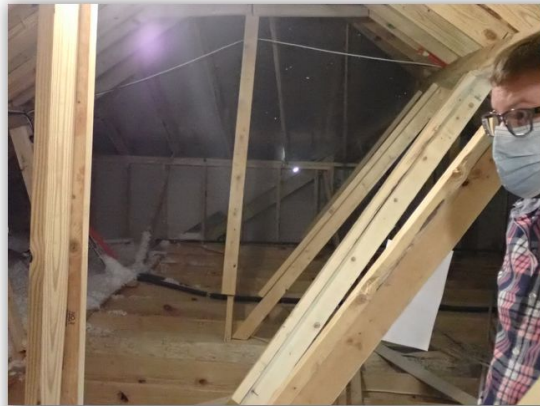
**Roof Structure**

- It is recommended to seal all openings between the soffit and roof covering to prevent pest/rodent intrusion at this point.

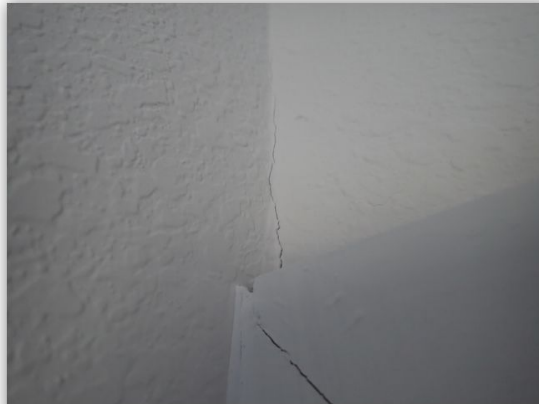
**Note:** Nail heads were observed to be pushing through the interior finish in one or more locations.

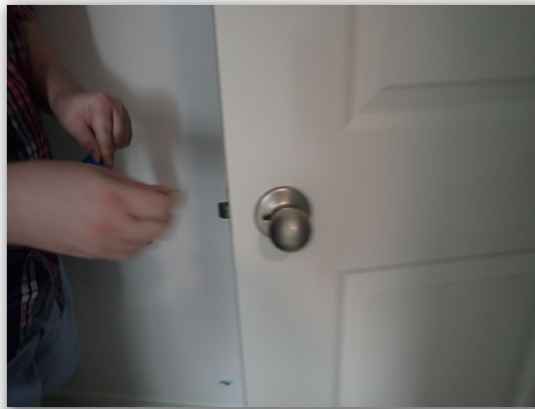
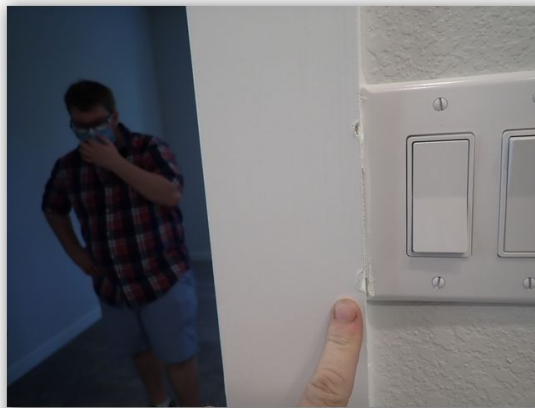
**Interior Doors**

- The door is not latching properly to the pantry, hallway closet.
- The door has some surface damage to the laundry room.
- The door hardware is missing to the laundry room.
- The door hardware is loose to the various locations throughout the house.
- The door has some surface damage to the laundry room.
- The door frame has some damage to the laundry room, front corner bedroom.

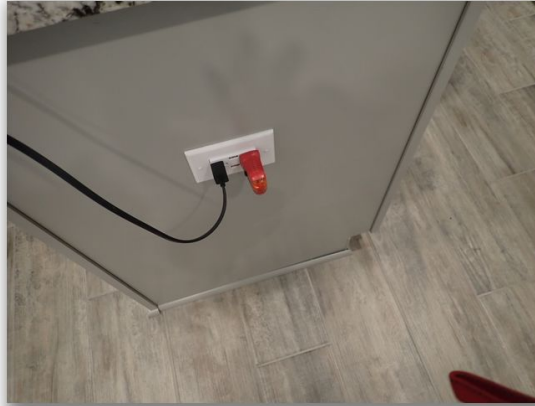
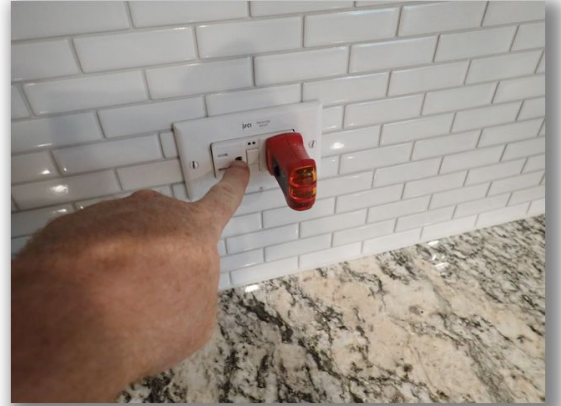
- One of the ground fault circuit interrupter (GFCI) devices does not appear to be functioning properly at the time of this inspection. The device in question is located in the kitchen area.
- One or more of the receptacles appears to be inoperative. This receptacle(s) and circuit should be investigated and corrected as necessary. Receptacle(s) were located in the kitchen.
- One or more of the receptacles were observed to be loose at the wall mount in the various locations throughout the house.

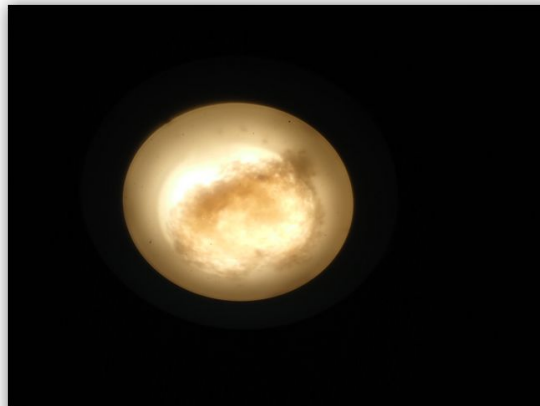
- One or more of the light fixtures were observed to be dirty in the front porch.

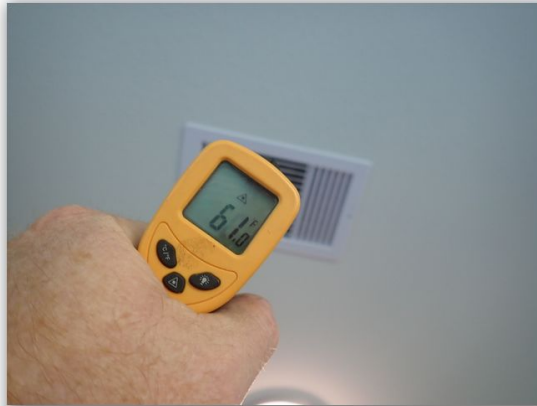
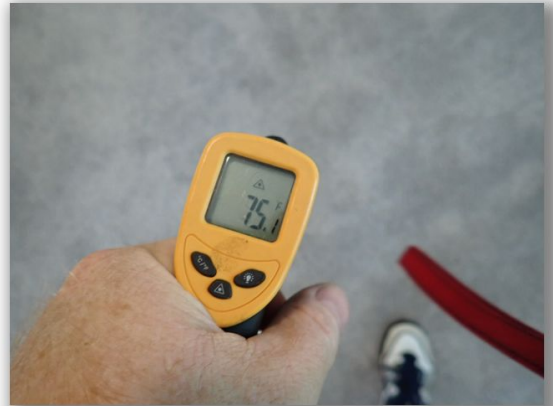
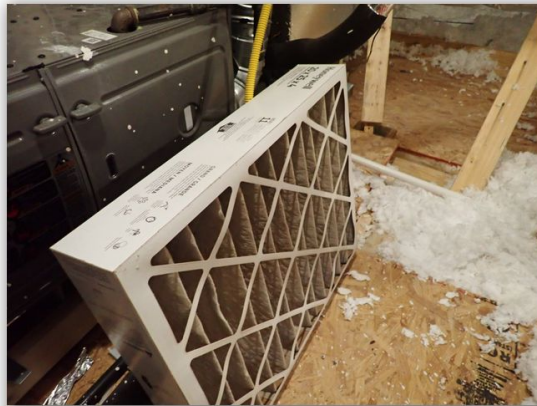
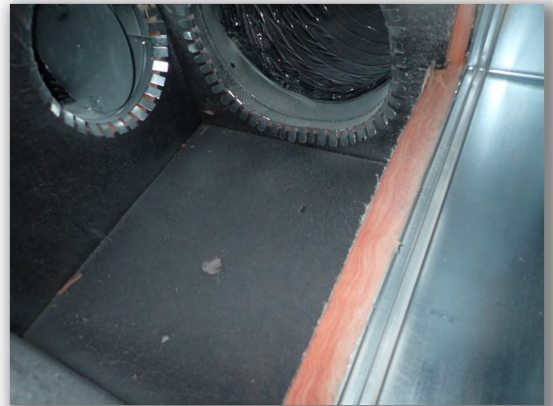
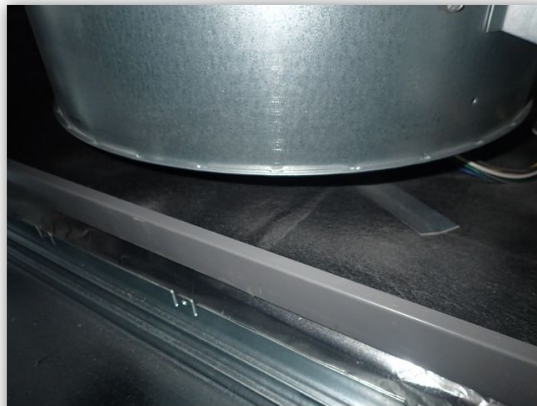
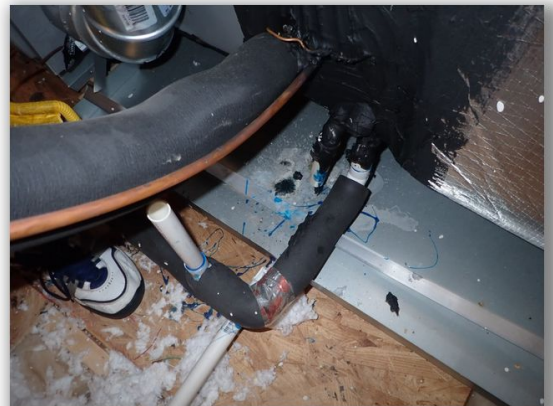
- **The temperature drop measured across the evaporative coils of the air conditioning system is lower than considered typical. The unit is not cooling properly and servicing is needed.**
- The indoor blower was observed to be dirty and should be cleaned to help improve the efficiency of the unit.
- The dirty air filter should be replaced.
- Water was observed to be leaking from the base of the coil housing. The cause and remedy should be further evaluated.

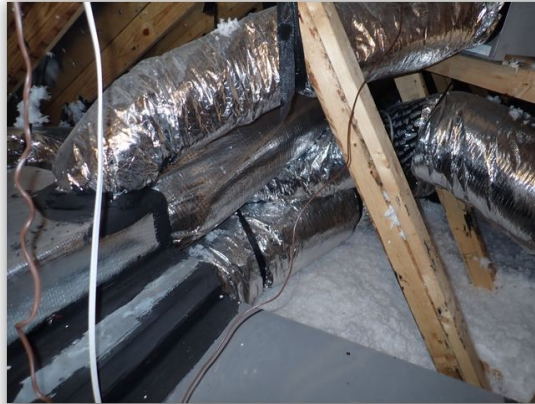
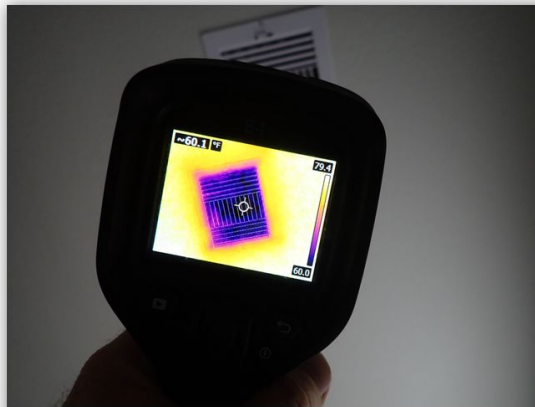
- The air register has poor air flow in the side middle bedroom, laundry room.
- The return register in the primary bedroom was observed to be damaged and/or crushed. This condition should be further evaluated and corrected as necessary.
- The duct work in the attic area does not appear to be properly suspended and separated to help prevent condensation from developing. It is recommended to separate and suspend the duct work with supports in minimum intervals of 4-feet that have a minimum width of 1.5-inches.

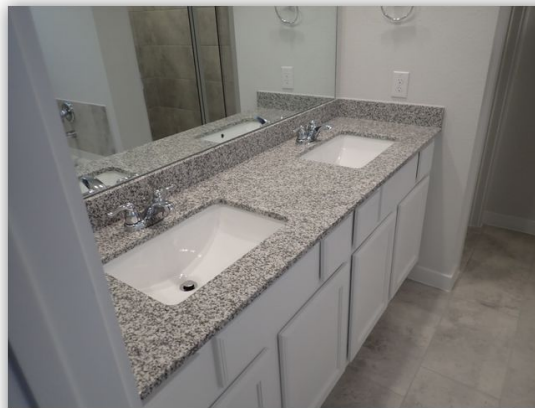
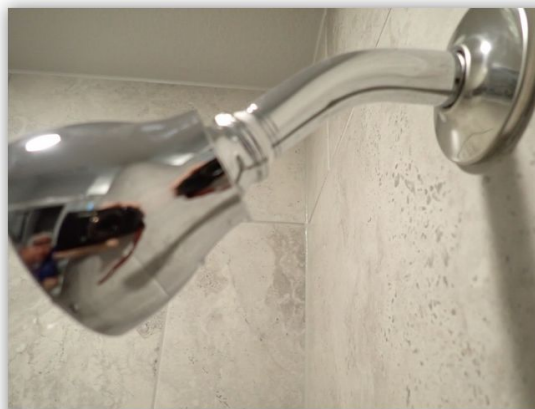
- Cracked, deteriorated and/or missing shower stall grout and/or caulking should be repaired or replaced as necessary.
- The shower spout is leaking at the neck connection.

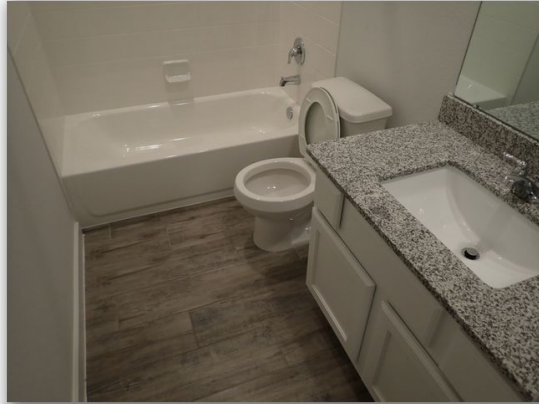
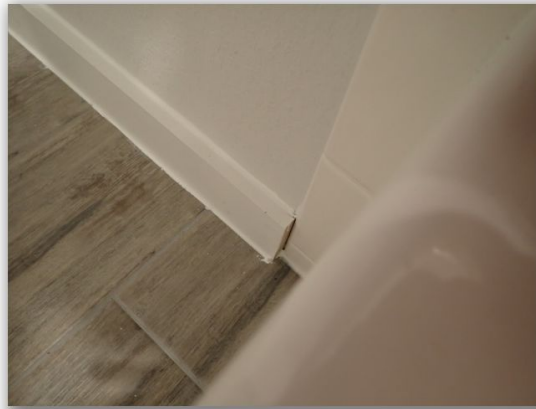
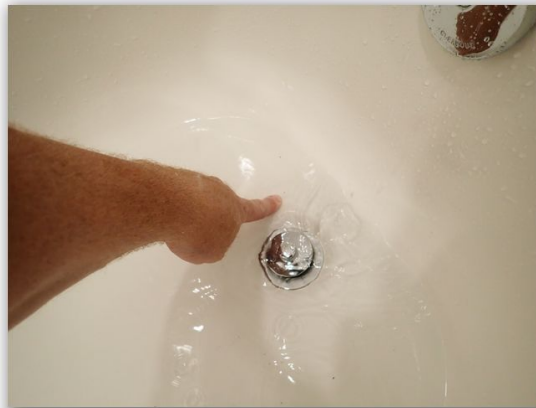
- The bathtub has some surface damage.
- Cracked, deteriorated and/or missing bathtub enclosure grout and/or caulking should be repaired or replaced as necessary.

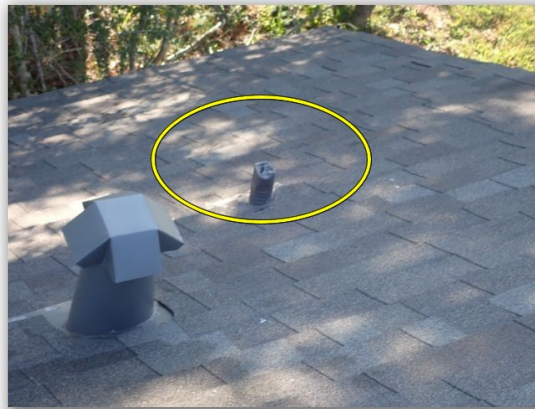
- One or more of the roof level plumbing vent stacks was observed to be capped. This condition needs to be corrected to help prevent slow draining of the plumbing fixtures.

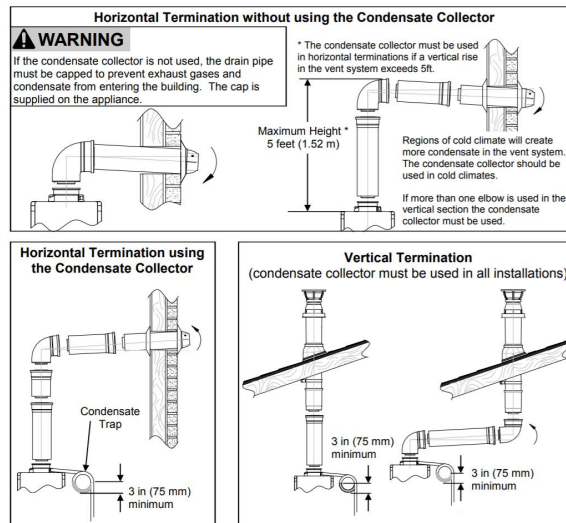
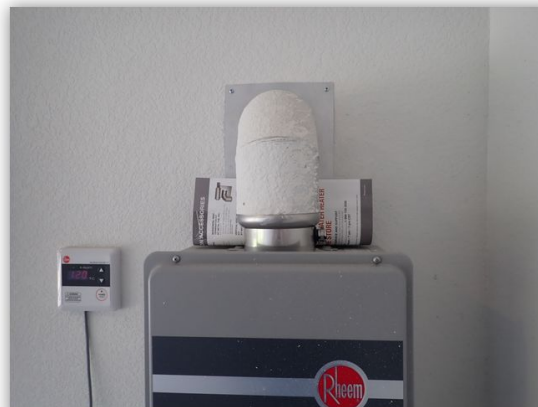
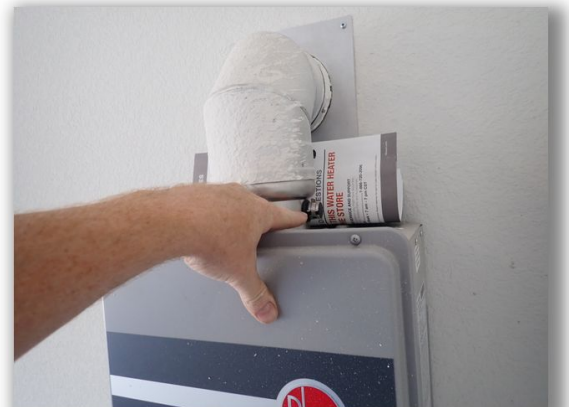
- This water heater and associated components need to be checked and serviced by a Qualified / Licensed Plumber. The observations made to support the rendering of this opinion are listed but may not be limited to the following:
- There is no pan installed under the water heater.
- There is no condensation drain line installed on the tankless water heater. Per manufacture instructions, a condensation drain line should be installed.

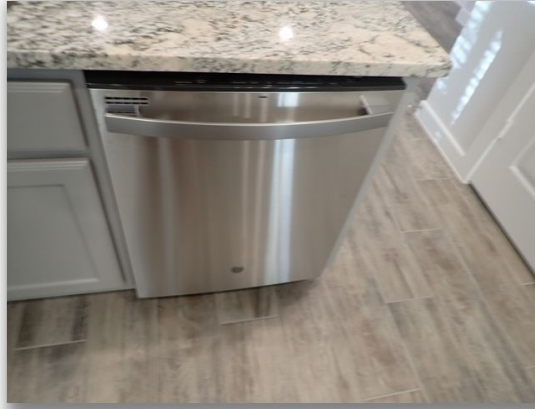
- The dishwasher is loose at the cabinetry and should be better secured.

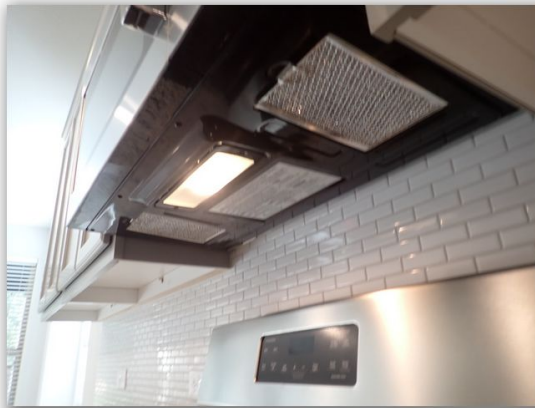
- The range exhaust vent is leaking into the cabinet area. Range exhaust vents should vent to the exterior of the house.

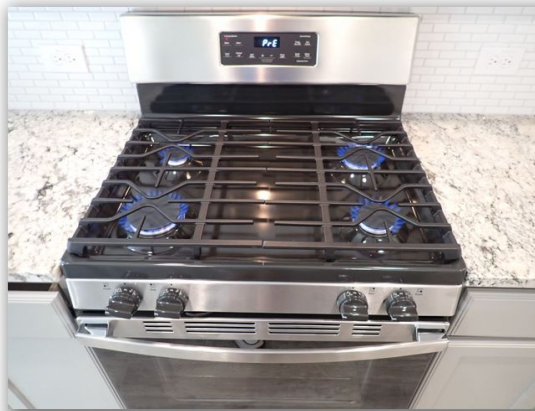
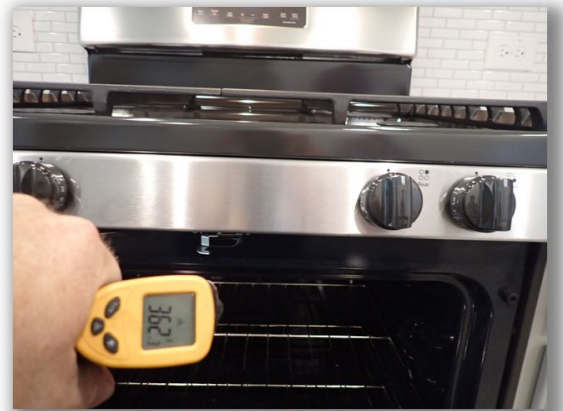
**Range Brand Name:** General Electric – GE

This component appears to be performing adequately at the time of this inspection.

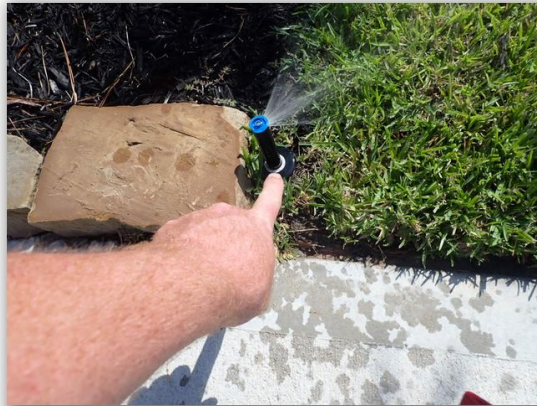
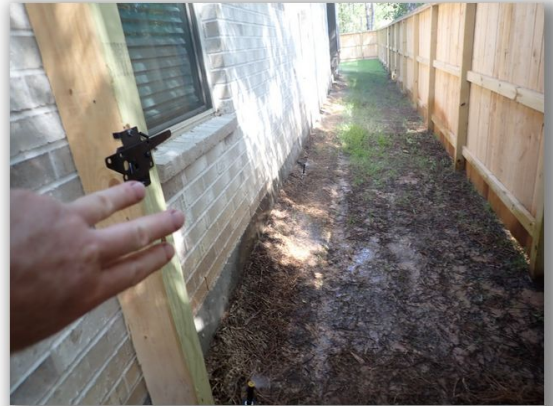
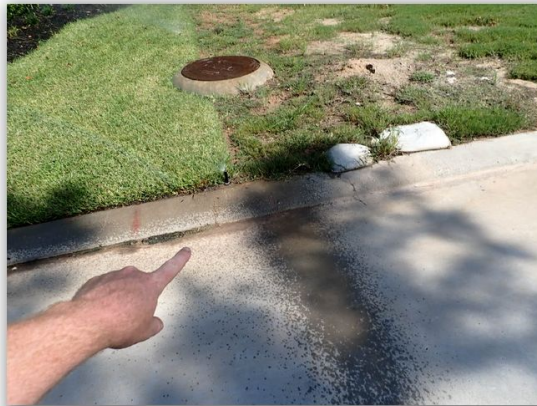
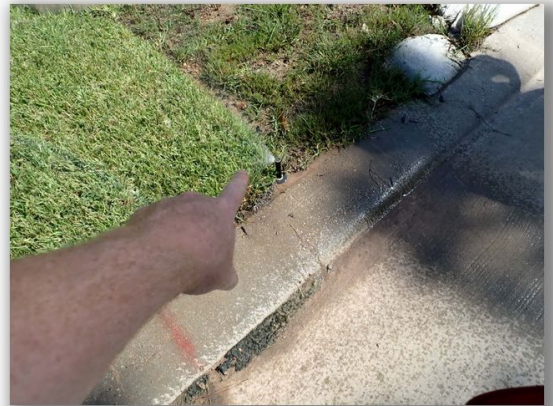
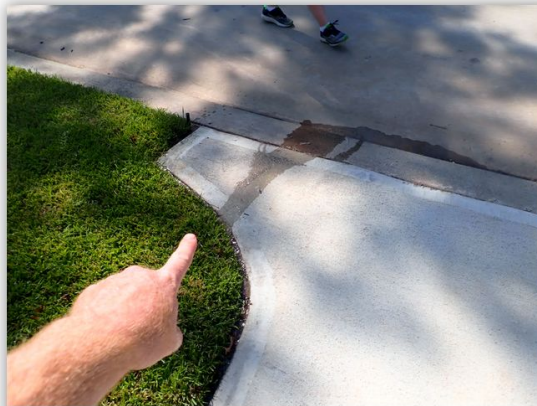
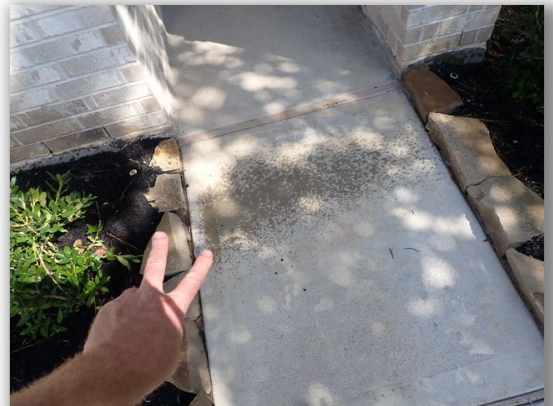
- One or more of the sprinkler heads need to be adjusted so not to disperse water onto concrete flatwork (such as; roadways, sidewalks, fences, porches, patios or driveways) in station(s); **1, 5, 3, 2.**
- One or more of the sprinkler heads need to be adjusted so not to spray water onto the exterior walls, surfaces or windows in stations; **3,4, 5.**
- There appears to be a sub-surface leak or damaged water lines in station(s); **1.** The cause and remedy should be further evaluated and corrected as necessary.
- One or more of the sprinkler heads appear to be leaking at the base of the head in station(s); **1.** The cause and remedy should be further evaluated and corrected as necessary.
- One or more of the sprinkler heads do not pop-up high enough to disperse water properly in station(s); **5.**

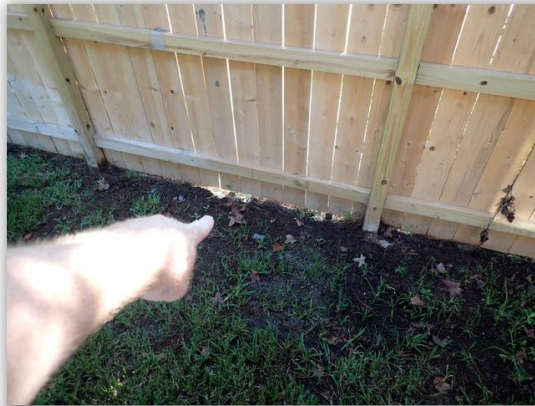
**C. Fences**

- There are large gaps under the fence and repairs are recommended.
