Residence is a two-story wood frame structure.
For the purpose of this report, residence faces north.
Residence was occupied at the time of the inspection.

PROPERTY INSPECTION REPORT

Concerning: 22615 Arbor Stream Dr, Katy, TX 77450
(Address or Other Identification of Inspected Property)

By: David Terry, Lic #10562 05/14/2018
(Name and License Number of Inspector) (Date)

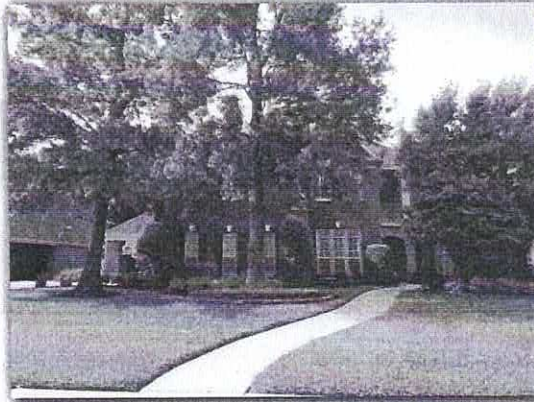
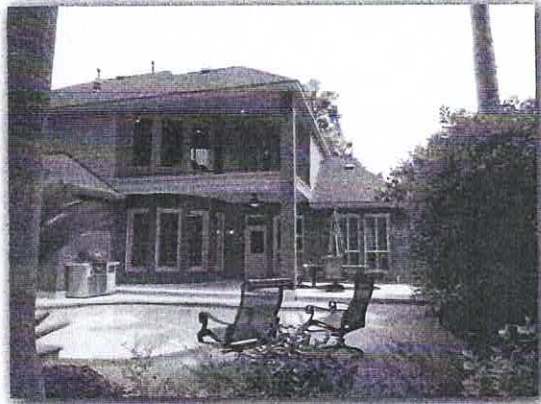
The residence was observed as having a concrete post-tension slab on grade foundation. The foundation appears to be functioning as designed and intended at this time. The structure did not exhibit visible indications of excessive shifting or settlement damage typically associated with foundation problems. No structural shifting cracks on interior or exterior walls were observed or visible at the time of the inspection. The structural members and load bearing walls appeared unremarkable at this time. The foundation appears to be reasonably level.

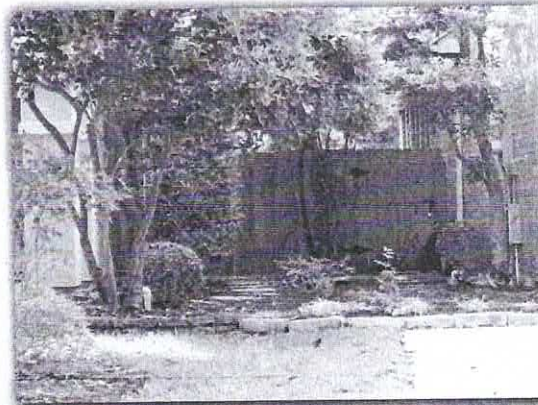
The grading on the property appears satisfactory at this time. The slope and drainage was considered typical and normal. It is recommended that 3-5" of foundation exposure be kept around the perimeter of the foundation and that a consistent moisture content be maintained. Improper grading and moisture control can lead to possible foundation problems.

It is recommended to lower the soil level of the flower beds along the perimeter of the foundation, as needed, to expose 3-5" of the foundation wall and provide proper drainage away from the foundation.

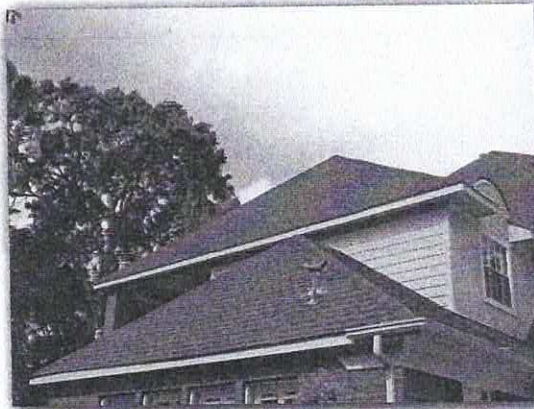
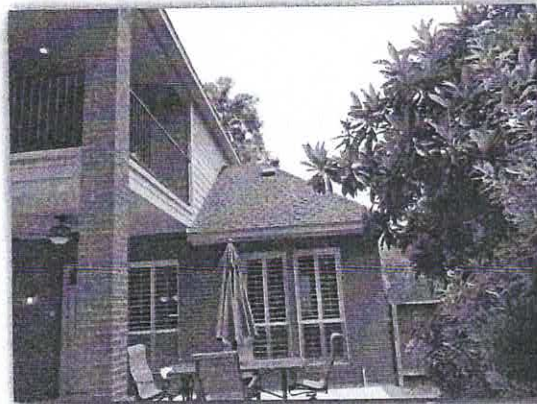
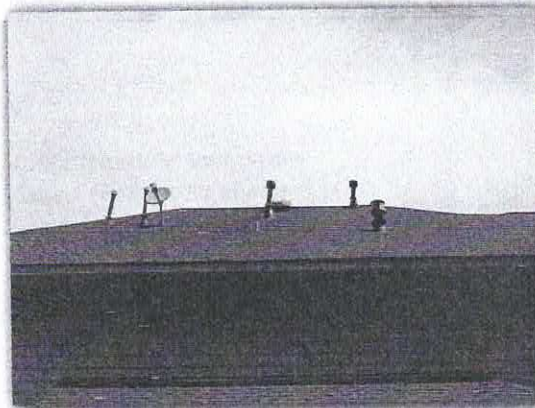
The residence was observed as having a hip and gable framed roof with a composition shingle cover. The roof was observed and inspected from ground level using visual aids. The overall visible shingle cover, associated flashing, and roof venting jacks appeared in satisfactory condition at this time with no physical damage noted. No water penetration was observed from the visible areas of the interior roof or interior ceilings. The typical life expectancy for a similar shingle roof system is approximately 15-20 years.

Recommend necessary repairs be made to secure and seal the base flashing above the lower roof on the northeast and southeast areas of the residence.

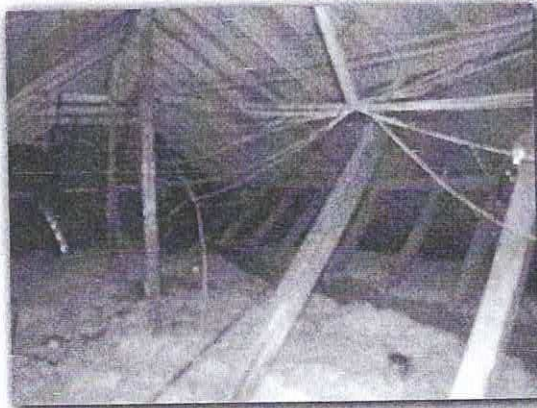
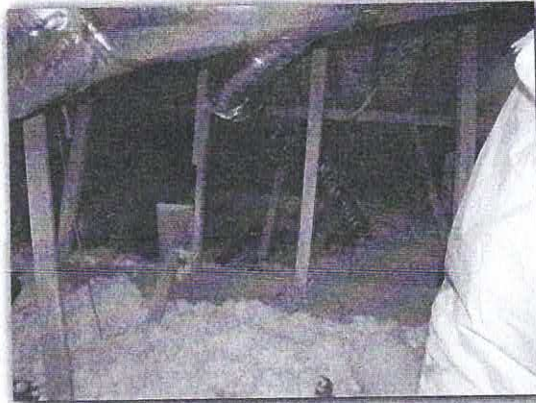
The accessible portions of the attic area of the residence was visually inspected. The overall condition of the visible interior rafters, framing, supports and radiant barrier painted decking appear sound at this time. Insulation in the attic area was observed at a depth of approx. 10-12". Attic ventilation was observed to be soffit vents at the roof edge with power and ridge vents at the ridge. Attic ventilation appears to be adequate at this time.

The power vents were not in operation at the time of the inspection. Recommend further investigation and any necessary repairs be performed by a licensed HVAC contractor.

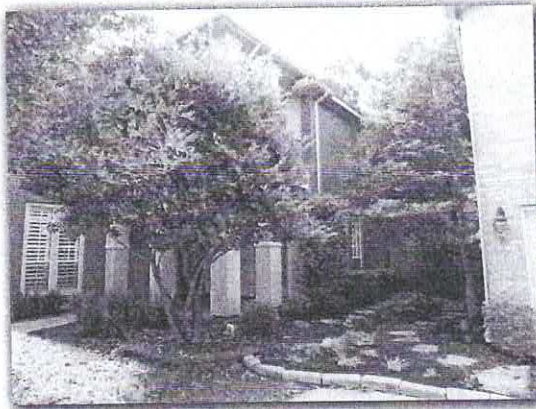
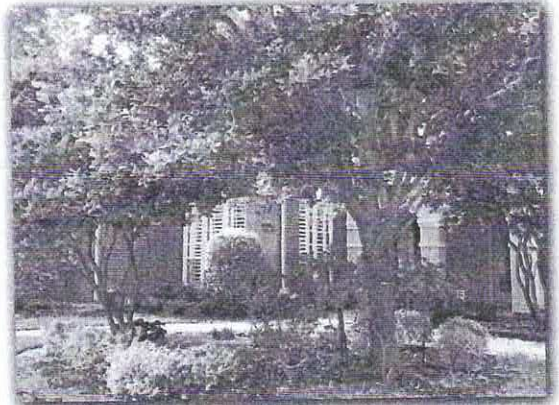
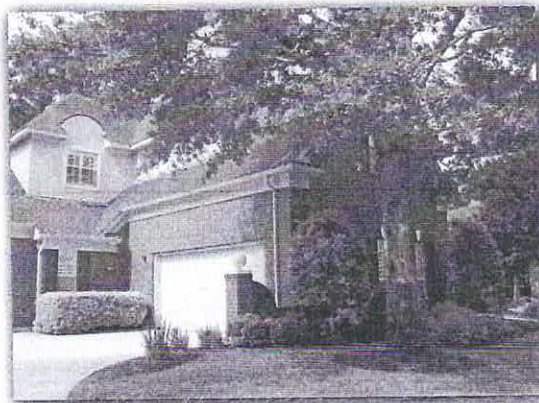
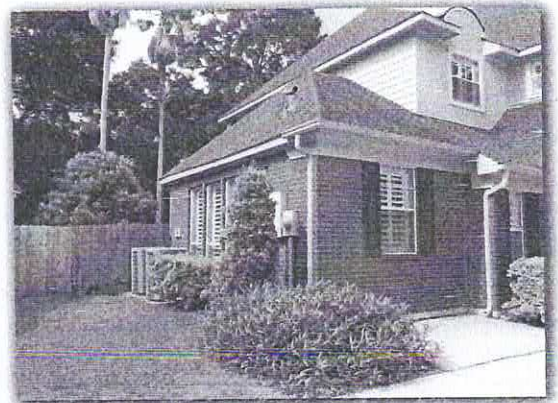
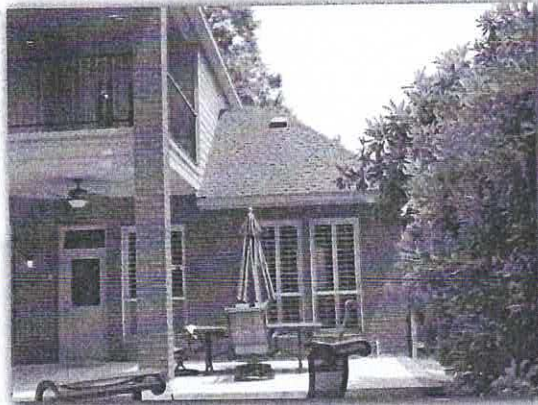
E. Walls (Interior and Exterior)

The masonry wall areas with stucco, composition wood and fiber cement sided walls on frame construction were observed to be in overall good condition at this time. Interior and exterior walls showed no indication of shifting and no settlement cracks to wall areas were observed at this time.

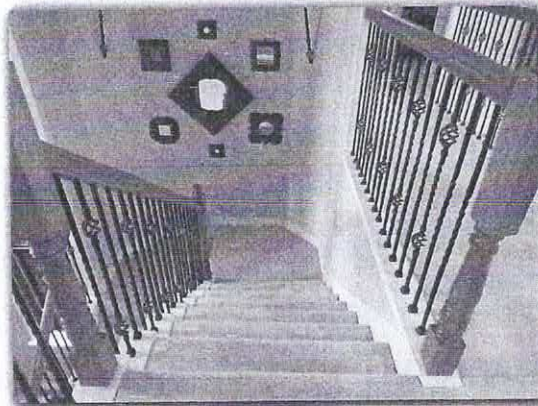
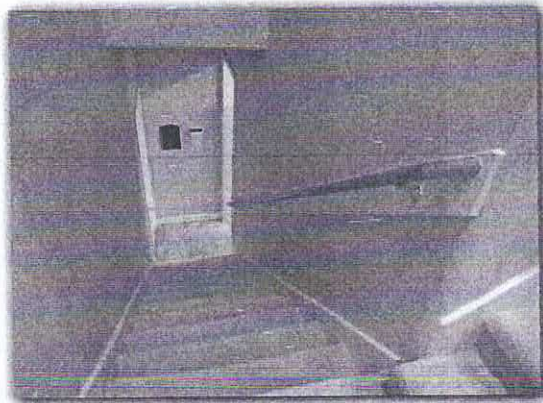
I. Stairways (Interior and Exterior)

The carpeted stairways and handrails were observed to be in good condition and compliant with stair construction regulations.

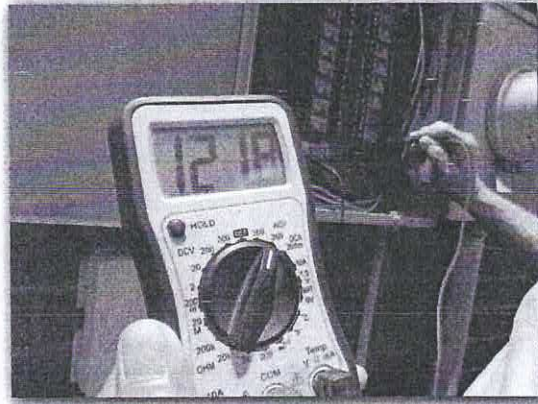
A. Service Entrance and Panels

200amp service panel-150amp main- 120/240v copper wired breaker service. Breaker wiring, buss bar shields and breakers showed no indications of over heating or arcing and were observed to be in good condition at this time.

Voltage readings of 120+v were measured on all breaker lugs at the service panel and were considered normal.

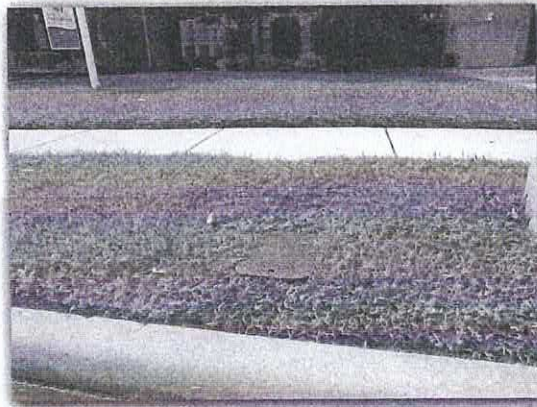
The plumbing in the residence appears to be constructed of COPPER piping. No plumbing leakage from the visible or accessible piping was observed at this time. While no piping leakage was observed, it should be noted that the majority of the piping is concealed by interior walls and insulation in the attic and is not visible.

Recommend installing backflow prevention on the exterior hose bibbs as needed.

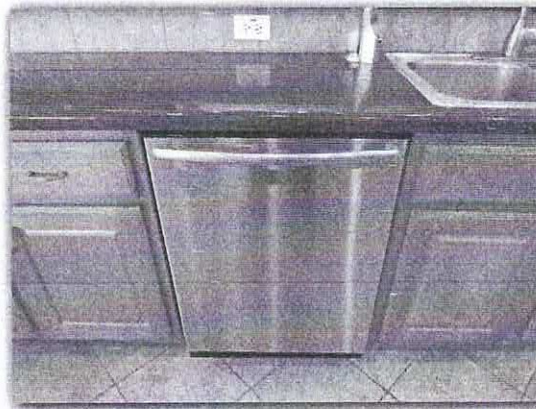
A. Dishwashers

The BOSCH dishwashing unit was found to be operational, no leakage or cycling problems were observed at this time.

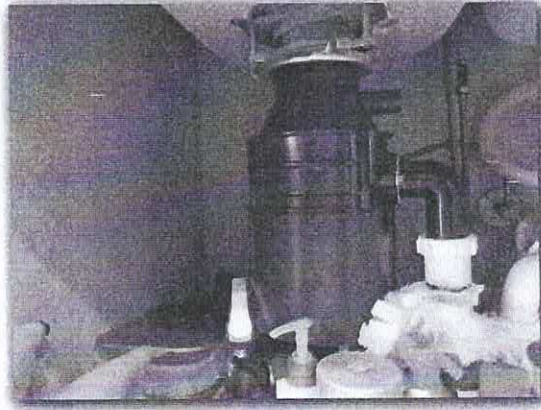
B. Food Waste Disposers

Disposal was operational at the time of the inspection.

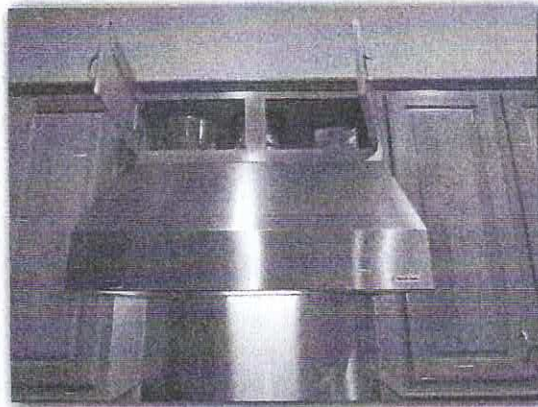
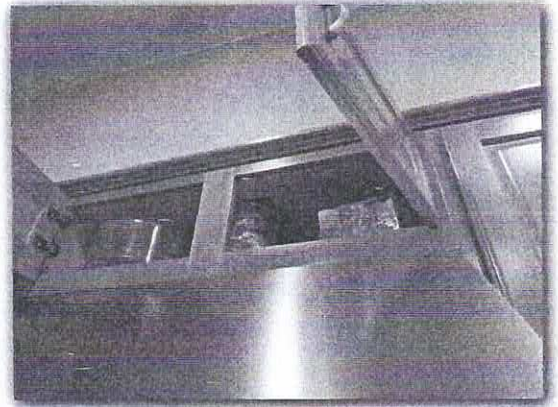
C. Range Hood and Exhaust Systems

The VENT-A-HOOD range hood is operational and vented properly to the exterior.

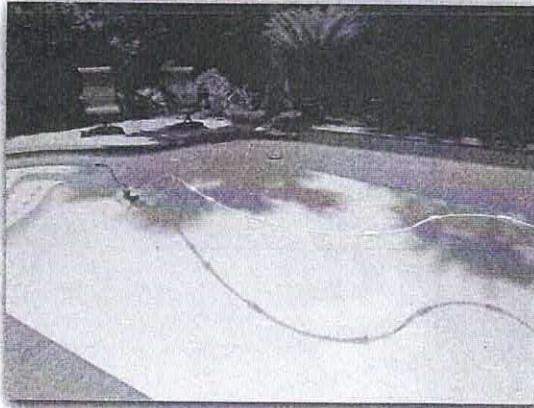
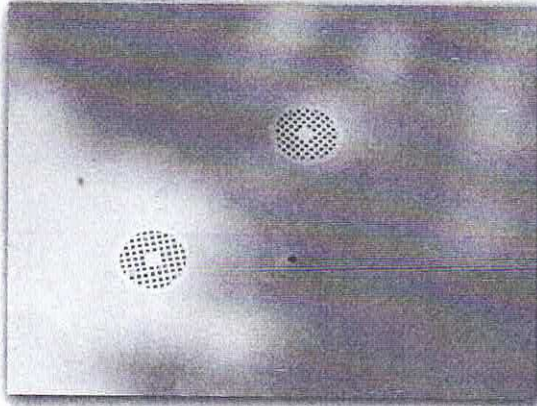
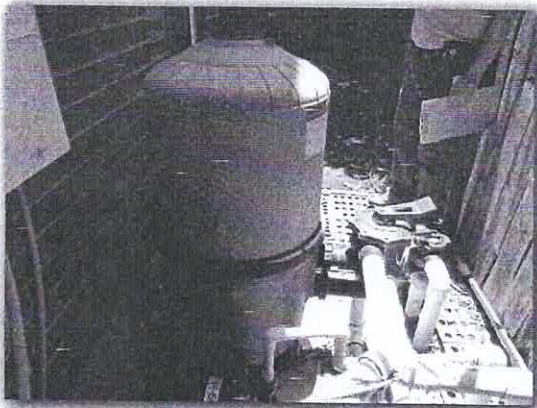
In-ground gunite constructed pool was observed to be structurally sound, no visible cracks in the surfacing or tiling was present at this time. The pool equipment was operated using the timer controller at the equipment area.

The 2HP main pump appeared to be seized and inoperable at the time of the inspection. Repairs are called for to replace the pump.
