7126 Kings Dr
Baytown, TX 77521

PROPERTY INSPECTION REPORT FORM

James Manuel <i>Name of Client</i>	04/05/2022 <i>Date of Inspection</i>
7126 Kings Dr, Baytown, TX 77521 <i>Address of Inspected Property</i>	
Arturo Marquez <i>Name of Inspector</i>	TREC 2685 <i>TREC License #</i>
 <i>Name of Sponsor (if applicable)</i>	 <i>TREC License #</i>

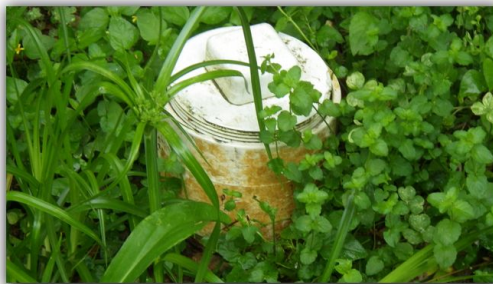
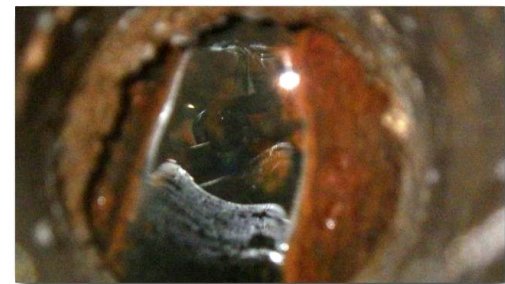
Comments: Interior faucets were opened for approximately 5 minutes; no video or pressure test performed. Visible components were observed currently operable.

Note: Cast iron pipes do fail over time. Rust can develop leading to slow drainage. Tree roots can be detrimental to cast iron pipes. If this is a concern, a proper video and/or pressurized evaluation should be performed by a qualified plumber.
