Lone Star Stucco, LLC

Moisture Assessment Report

1931 Indiana Street

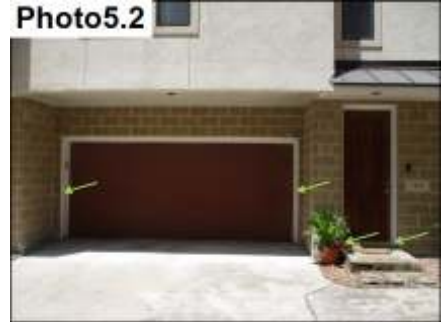
Photo5.2

- The door trim sealants are missing, aged or separated. The inspector suggests to have a qualified waterproofing contractor seal this area with a low modulus sealant in an effort to prevent moisture intrusion. These types of sealants are of high quality and compatible with stucco and other termination points. Please refer to photos #5.2, #5.3, #5.4, #5.5 and #5.6 for more detail.

Door Sealant Separation / Seal

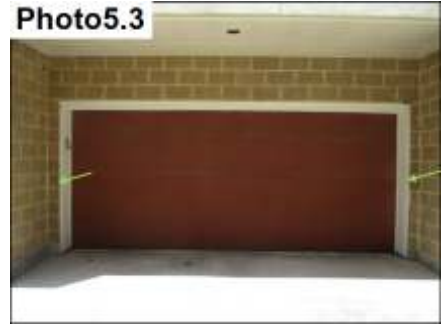
Photo5.3

Door Sealant Separation / Seal

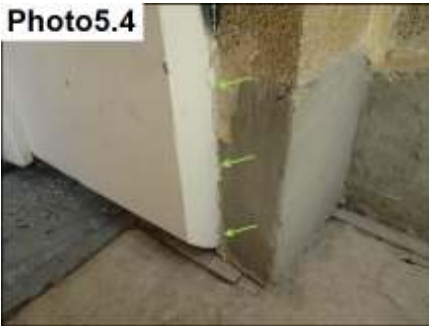
Photo5.4

Door Sealant Separation / Seal

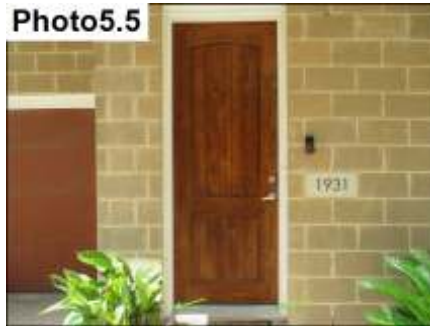
Photo5.5

Door Sealant Separation / Seal

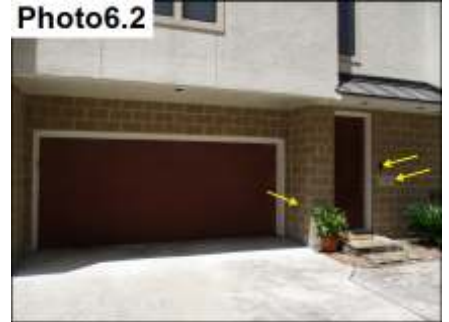
Photo6.2

- The penetration sealants are aged and separated. The inspector suggests to have a qualified waterproofing contractor seal this area with a low modulus sealant in an effort to prevent moisture intrusion. These types of sealants are of high quality and compatible with stucco and other termination points. Please refer to photos #6.2, #6.3, #6.4, #6.5, #6.6, #7.1, #7.2, #7.3 and #7.4 for more detail.

Penetration Sealants / Seal

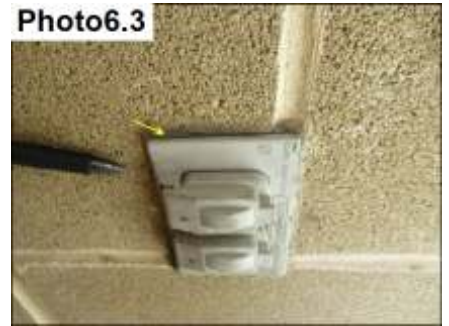
Photo6.3

Penetration Sealants / Seal

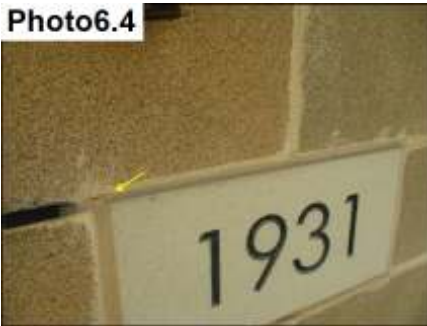
Photo6.4

Penetration Sealants / Seal

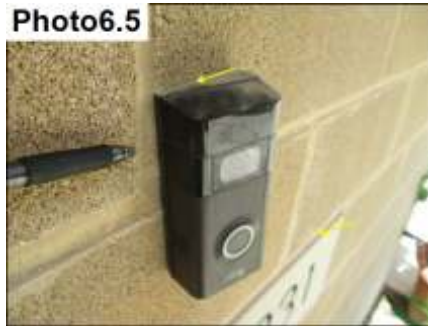
Photo6.5

Penetration Sealants / Seal

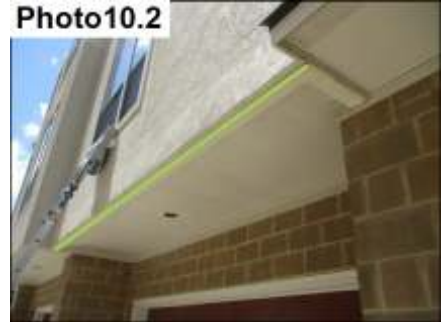
Photo10.2

- The bottom of the bump out wall does have a reglet vent. For the time of construction, this was an acceptable detail, but it has been realized that it still has the potential to obstruct proper moisture evacuation. At the time of inspection, the substrate was firm, and the inspector recommends no modification at this time as the system is properly functioning. It is suggested to maintain all window sealants above. Please refer to photos #10.2, #10.3, #10.4, #10.5 and #10.6 for more detail.

Reglet Vent Installed / No Modification

Grid Location	Item Description	Moisture Readings	Substrate Condition	Observations
Green Lines	Reglet Vent			The bottom of the bump out wall does have a reglet vent. For the time of construction, this was an acceptable detail but it has been realized that it still has the potential to obstruct proper moisture evacuation. At the time of inspection, the substrate was firm and the inspector recommends no modification at this time as the system is properly functioning. It is suggested to maintain all window sealants above. Please refer to photos #10.2,#10.3, #10.4, #10.5 and #10.6 for more detail.

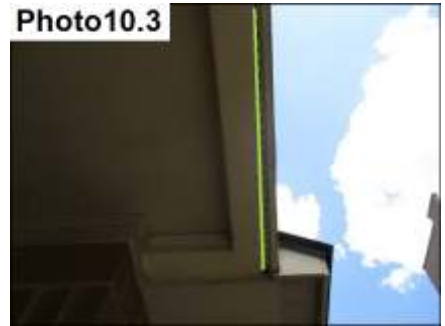
Photo10.3

Reglet Vent Installed / No Modification

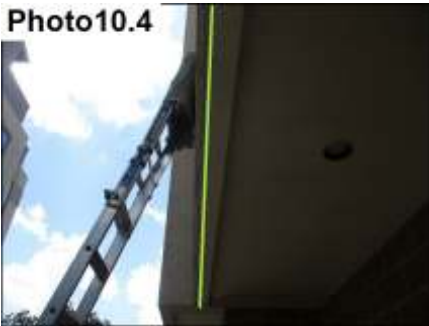
Photo10.4

Reglet Vent Installed / No Modification

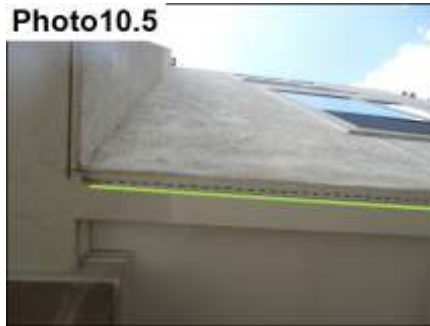
Photo10.5

Reglet Vent Installed / No Modification

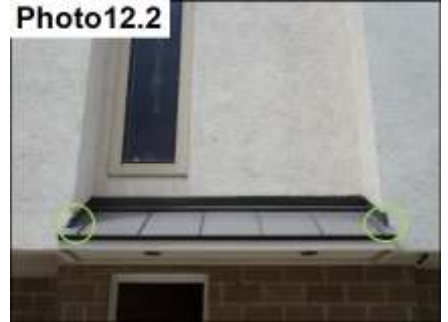
Photo12.2

- Roof diverter flashing sealants are separated. The inspector suggests to have a qualified waterproofing contractor further assess and seal this area with a low modulus sealant in an effort to prevent moisture intrusion. These types of sealants are of high quality and compatible with stucco and other termination points. Please refer to photos #12.2, #12.3, #12.4, #12.5 and #12.6 for more detail.

Roof Diverter Flashing / Seal

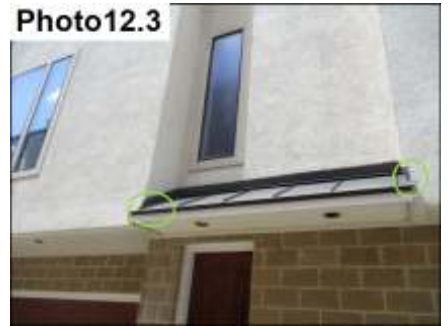
Photo12.3

Roof Diverter Flashing / Seal

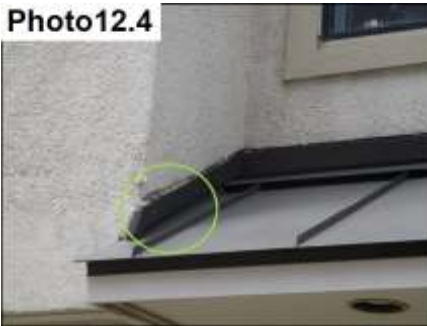
Photo12.4

Roof Diverter Flashing / Seal

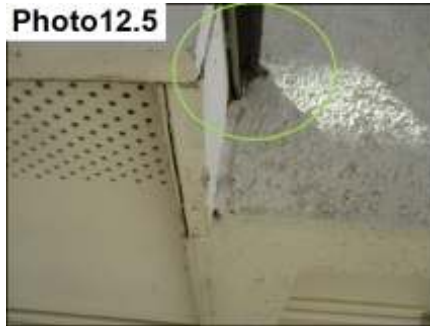
Photo12.5

Roof Diverter Flashing / Seal

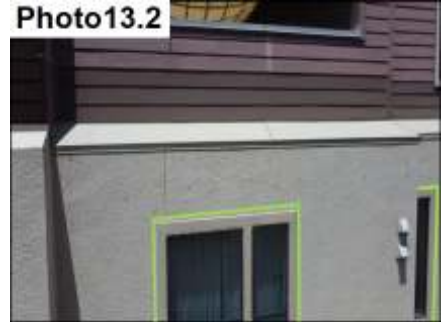
Photo13.2

- The window accents/stucco termination sealants are aged. The inspector suggests to have a qualified waterproofing contractor further assess and seal this area with a low modulus sealant in an effort to prevent moisture intrusion. These types of sealants are of high quality and compatible with stucco and other termination points. Please refer to photos #13.2, #13.3, #13.4, #13.5 and #13.6 for more detail.

Window Accent/Stucco Termination / Seal

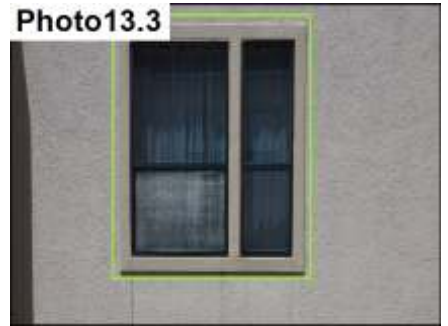
Photo13.3

Window Accent/Stucco Termination / Seal

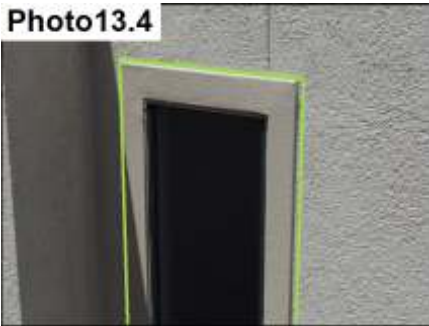
Photo13.4

Window Accent/Stucco Termination / Seal

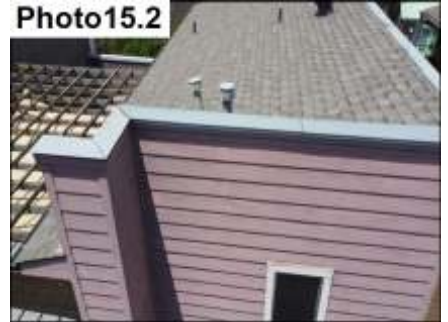
Photo15.2

Roof Flashing / Seal

Grid Location	Item Description	Moisture Readings	Substrate Condition	Observations
Blue Circles	Flashing			The metal cap flashing sealants are beginning to age at these locations. The inspector suggests to have a qualified waterproofing contractor further assess and seal this area with a low modulus sealant in an effort to prevent moisture intrusion. These types of sealants are of high quality and compatible with stucco and other termination points. Please refer to photos #15.2, #15.3, #15.4 and #15.5 for more detail.

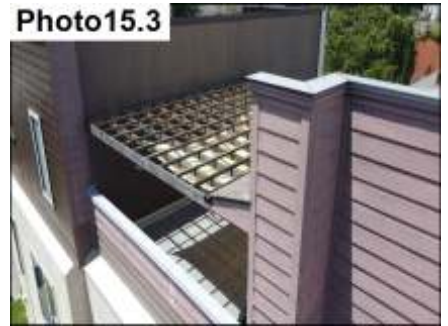
Photo15.3

Roof Flashing / Seal

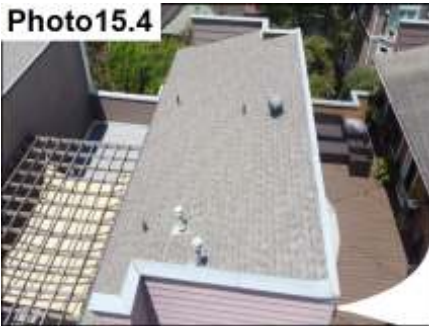
Photo15.4

Roof Flashing / Seal

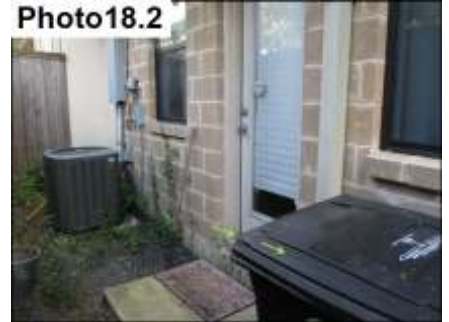
Photo18.2

Door Sealant Separation / Seal

Grid Location	Item Description	Moisture Readings	Substrate Condition	Observations
Green Arrows	Doors			The door trim and miter sealants are aged and separated. The inspector suggests to have a qualified waterproofing contractor seal this area with a low modulus sealant in an effort to prevent moisture intrusion. These types of sealants are of high quality and compatible with stucco and other termination points. Please refer to photos #18.2, #18.3, #18.4 and #18.5 for more detail.

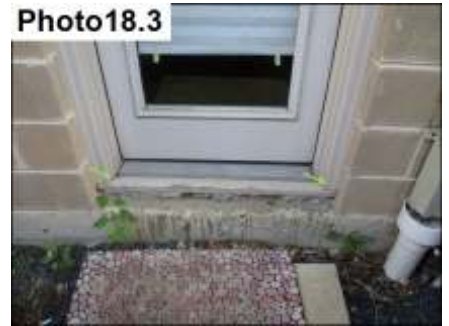
Photo18.3

Door Sealant Separation / Seal

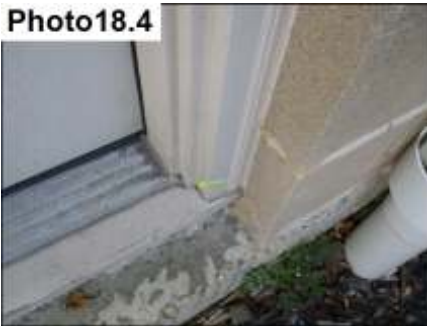
Photo18.4

Door Sealant Separation / Seal

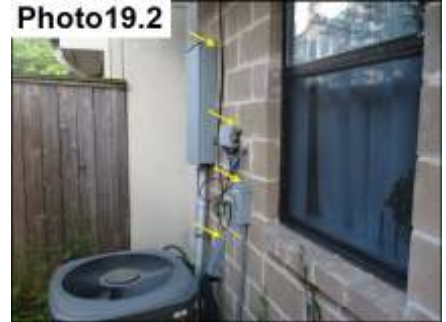
Photo19.2

Penetration Sealants / Seal

Grid Location	Item Description	Moisture Readings	Substrate Condition	Observations
Yellow Arrows	Penetrations			The penetration sealants are aged. The inspector suggests to have a qualified waterproofing contractor remove aged sealants then seal this area with a low modulus sealant in an effort to prevent moisture intrusion. These types of sealants are of high quality and compatible with stucco and other termination points. Please refer to photos #19.2, #19.3, #19.4, #19.5, #19.6, #20.1, #20.2, #20.3 and #20.4 for more detail.

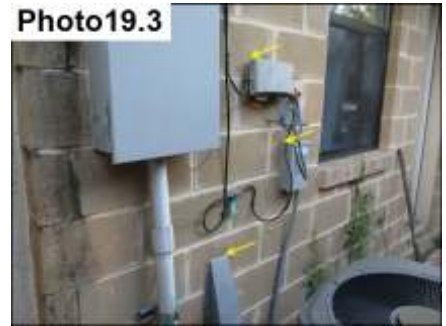
Photo19.3

Penetration Sealants / Seal

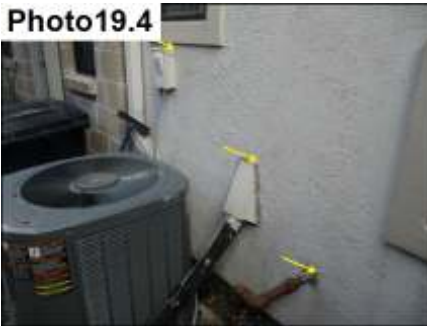
Photo19.4

Penetration Sealants / Seal

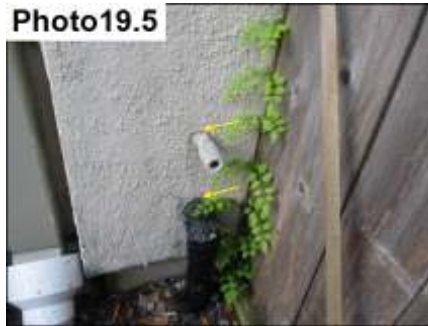
Photo19.5

Penetration Sealants / Seal

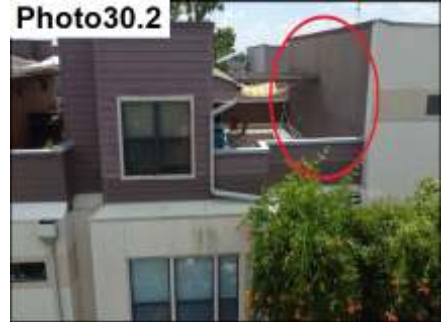
Photo30.2

- The cement fiber panels are separated. The inspector suggests having a qualified waterproofing contractor further assess this area and re-fasten and seal joints to prevent moisture intrusion. Please refer to photos #30.2, #30.3, #30.4, #30.5 and #30.6 for more detail.

Cement Fiber Panels Separated /
Re-Fasten and Seal

Grid Location	Item Description	Moisture Readings	Substrate Condition	Observations
Yellow Circles	Siding			The cement fiber panels are separated. The inspector suggests having a qualified waterproofing contractor further assess this area and re-fasten and seal joints to prevent moisture intrusion. Please refer to photos #30.2, #30.3, #30.4, #30.5 and #30.6 for more detail.

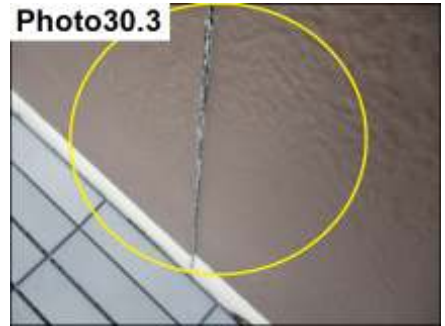
Photo30.3

Cement Fiber Panels Separated /
Re-Fasten and Seal

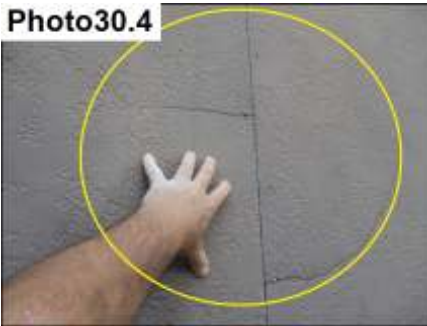
Photo30.4

Cement Fiber Panels Separated /
Re-Fasten and Seal

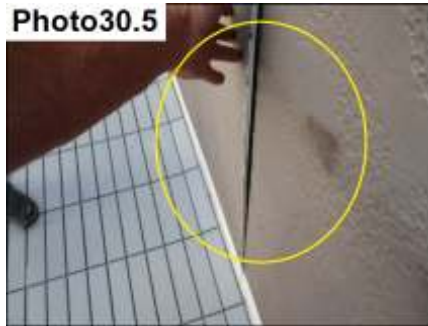
Photo30.5

Cement Fiber Panels Separated /
Re-Fasten and Seal
