PROPERTY INSPECTION REPORT

Concerning: 16342 Many Trees Ln., Conroe, TX 77305
(Address or Other Identification of Inspected Property)

By: Rudolph Depena & Martha Kaplan Lic. 5191/5863 04-21-2018
(Name and License Number of Inspectors) (Date of Inspection)

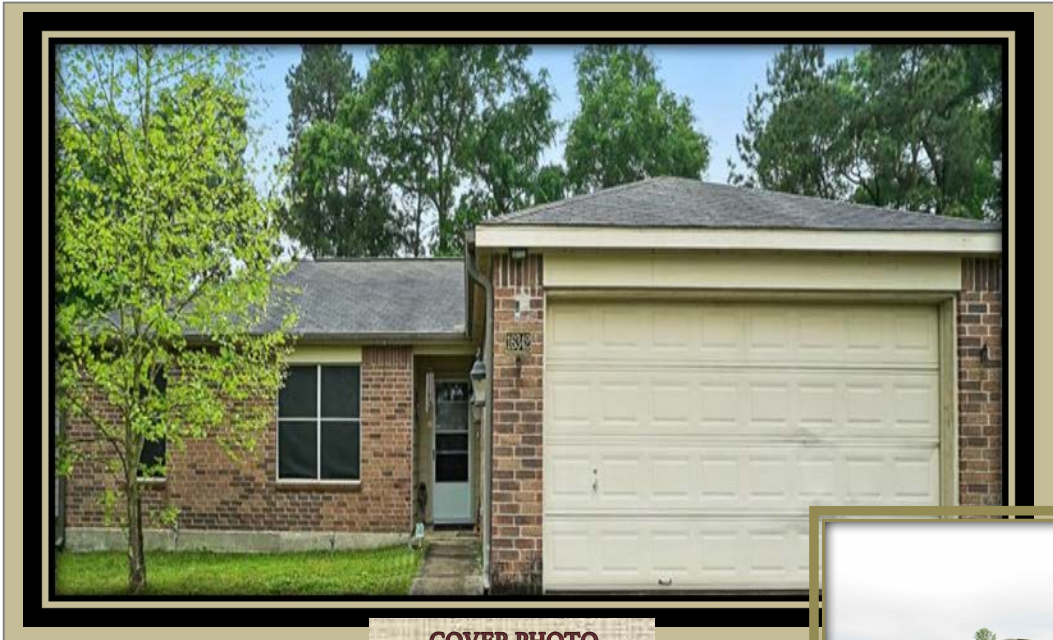
COVER PHOTO

Front and rear view of the inspected dwelling.

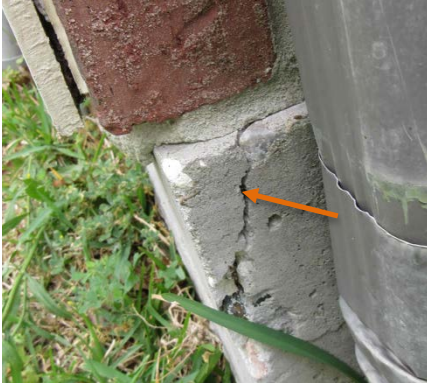
These areas with spalling effect in concrete structure (i.e., hairline crack, chips, corner pops) are common and are not necessarily related to foundation settlement. Cracking or chipping at those corner concrete slab location may occur since at time of construction 'forms' are used to pour concrete. With the forms, these corners retained excess of moisture not permitting the concrete to dry (cure), at the same rate causing differential thermal expansion of the concrete mix. Additionally, in this case the post tension reinforcement tendons start approx. 6" from corners at both sides of perimeter and when forces are applied to tense the cables it may create the cracks at this sensitive area.

It is understandable that the condition that causes the cracking has stabilized so that is no longer likely to cause additional cracking or encourage the propagation of existing cracks. The forces that create such crack conditions allow concrete to stabilize relatively quickly and typically do not lead to structural problem.

Recommended: Seal with proper concrete sealant the corners with crack or chip at the N.E. perimeter of the foundation wall of the slab. Avoid deterioration.

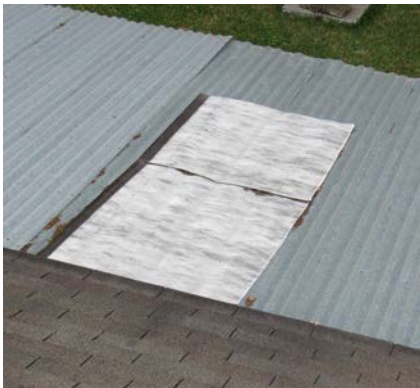
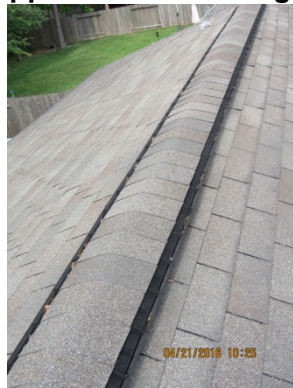
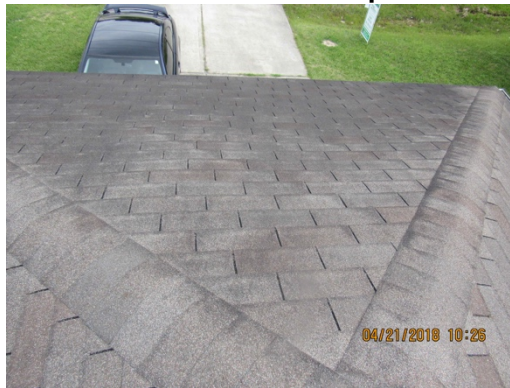
OBSERVATION:* Asphalt shingle lost granules is showing over the structure layer at the edges of the shingles elements of the roof inspected, condition was observed at different areas of the roof planes of the main structure and garage. Manufacturer adhesive is no longer functional. This inspector did not observe any possible indication of water penetration (stain or rot) within the limited visible roof decking area of the attic. Further evaluation of a Professional in the field is recommended. **Roof covering should be budgeted for the near future.*

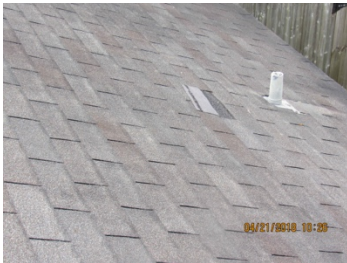
D - Broken shingle is present at the West roof slope. Restore/replace shingle, to prevent water penetration.

- Lifted shingles at the rear roof slope. Reseal shingle.

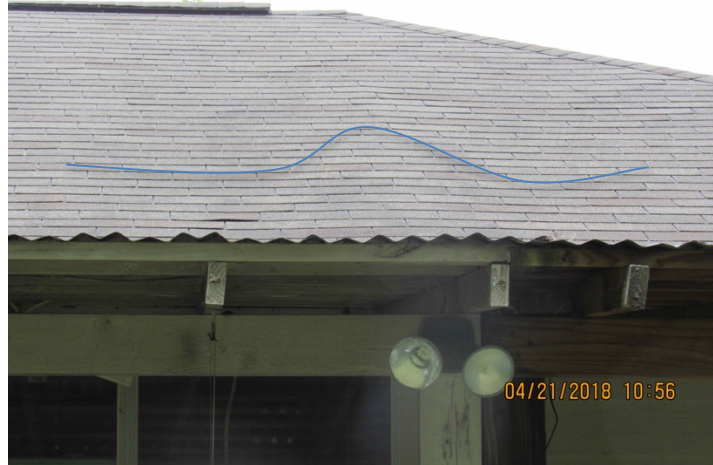
Deflection over the roof line visible at the south roof plane. This may be lifting from strut/bracers to the wood decking and/or type of wood grade used within this construction.

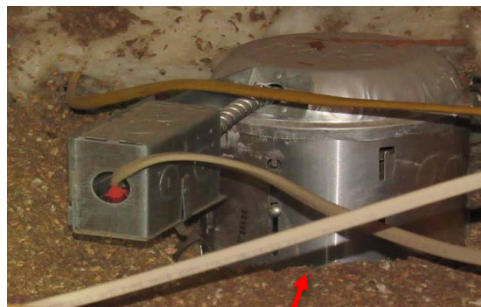
D - Insulation in contact with the recess light canisters is considered a Fire hazard. Canister should be verified if they are 'IC' rated ("insulation contact" rated) from manufacture to be in contact with the insulation, and if they need to be airtight preventing any HVAC air or heat lost to the attic space.

Non-IC rated canisters are required to have no contact with insulation and to be at least with a 3" (7.6cm) spacing from the insulation.

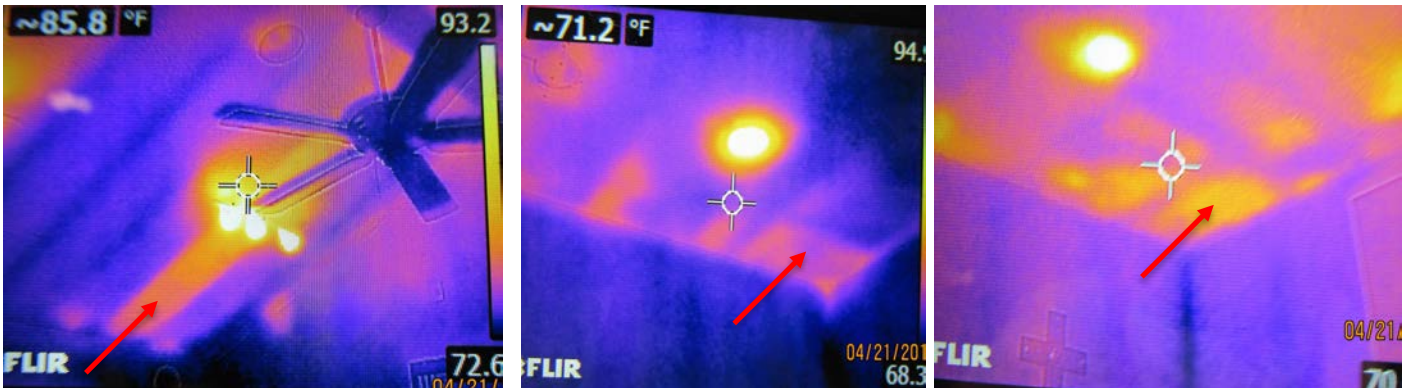
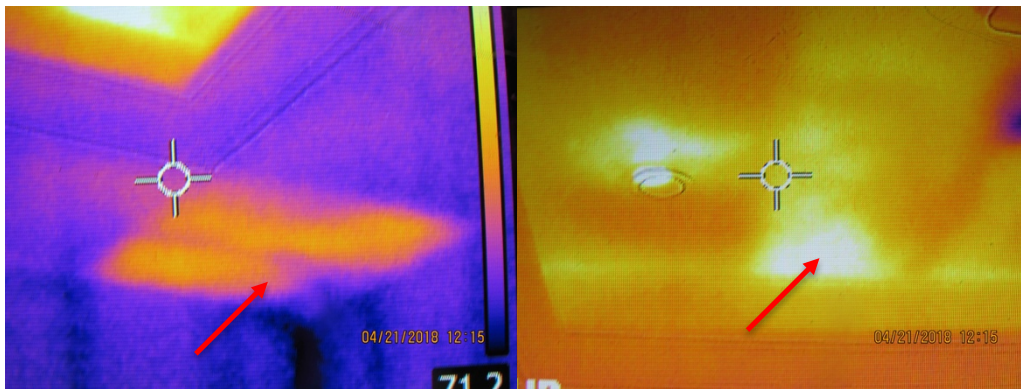
D - Insulation to ceiling spots in several rooms are noted with the infrared camera to have low or no insulation. These should be insulated if possible within the accessible attic areas. Insulation may have been removed when installation of new lighting fixtures or during electrical system alteration. **See electrical system for other comments.**

Typical inside corners have not been insulated properly in those transition areas from time of construction. **As certified thermographers, we can only read the emissivity of object surface temperatures as viewed with the infrared camera.**

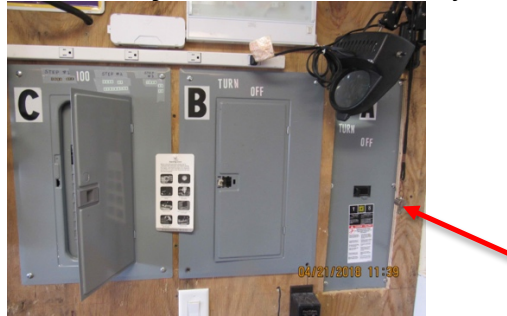
Note: Wall at the garage is with a plywood board as structure sheathing supporting multiple electrical panel installed at a point in time as alteration to system. See electrical system for additional comment.

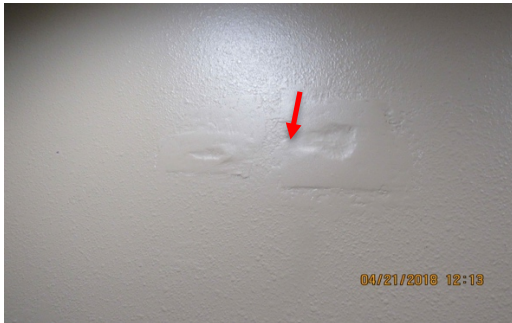
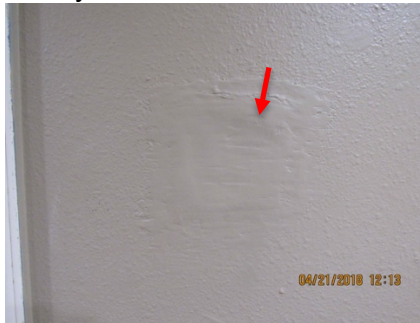
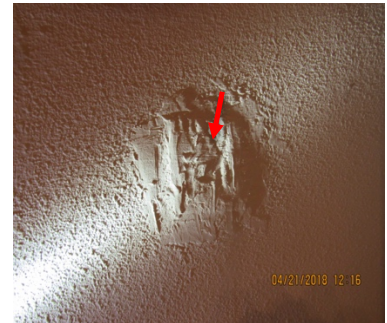
D - Sheetrock in several rooms where electrical alterations were may are noted with patches improperly finish. Restore as needed. See electrical system for additional comment.

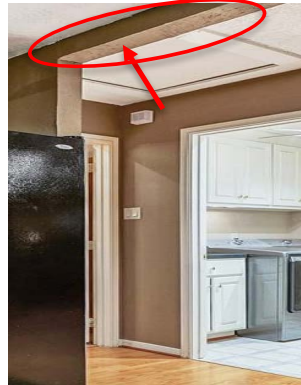
- Header to this wall opening into the kitchen is noted with deflection. This may not have proper beam/header. Original wall opening into the kitchen was altered at a point in time as per present home owner.

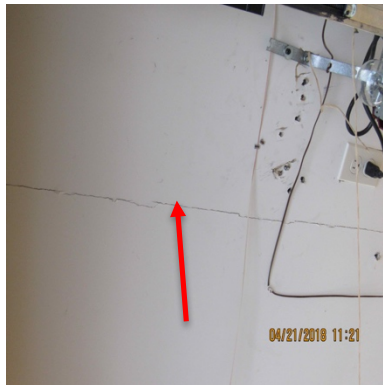
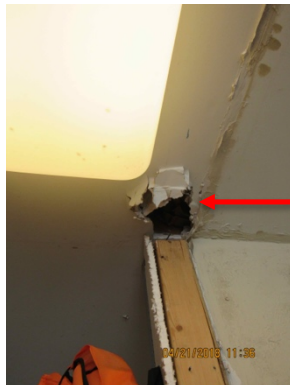
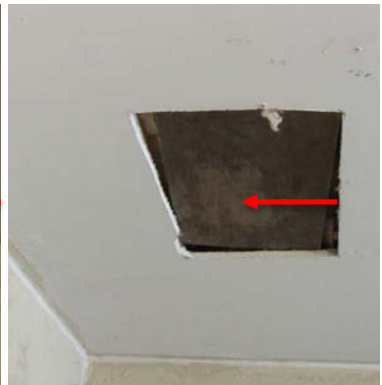
D - Garage ceiling with sheetrock tape joint fracture, perforation, holes and cut-outs. Recommend to restore all areas.

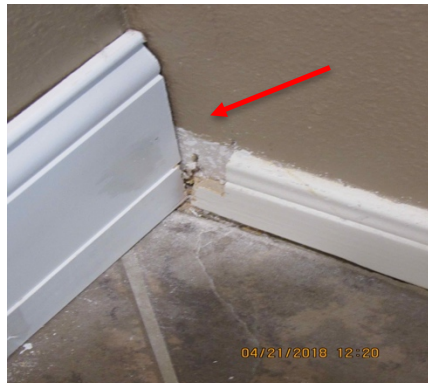
D - Baseboard at the dining room at the north wall is not consistent in size to the others in the room. Approx. size of 6" to 3" (original) is visible. Restore as needed for proper finish and aesthetics.

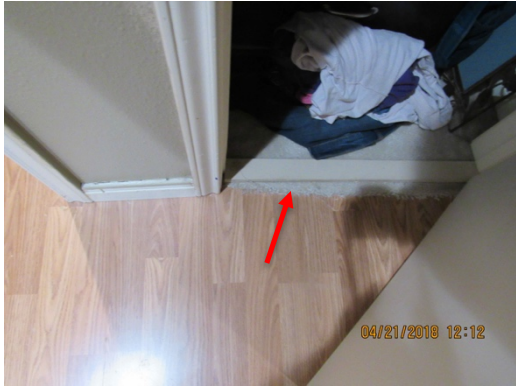
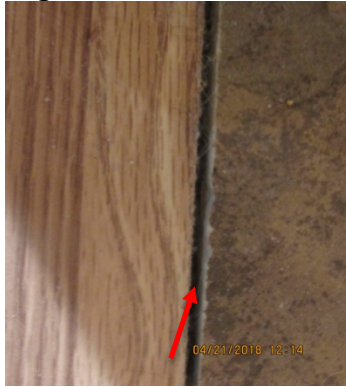
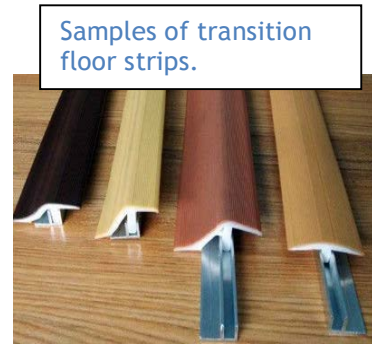
D - Proper transition floor strips are needed at carpet to wood laminate in a bedroom closet and living room tile to a hallway wood laminate flooring.

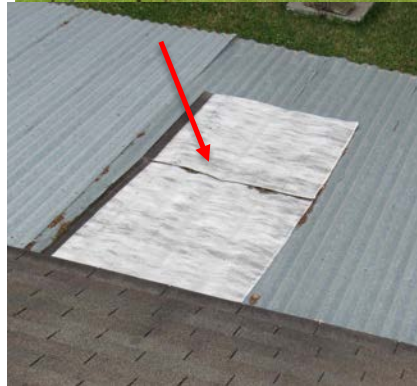
D - The rear attached canopy does not have the acceptable clearance height at the south end. This needs to clear at minimum 6'-8" to the rafter. In addition, the rafter size members for this canopy are not acceptable per code for the span present. Professional in the field to assess further size of the members, to prevent canopy from lifted with high winds.

Roof corrugated metal panels, within several areas permit water penetration visible to several rafter elements of the canopy. It appears that in some areas of the corrugated metal roof another type of adhesive cover has been placed over the panels, this maybe to control water leaks.

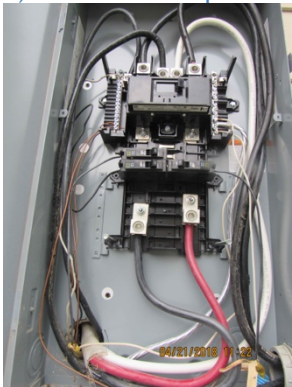
1) Exterior main panel

- 1) Main service rating 200 amps main disconnect. Breaker box has approx. 3 circuit breakers control.
- 2) a Sub panel next to the main at the east exterior wall has 8 breakers.
- 3) Sub Panel "A" at the interior wall of the garage has 125 amps as main disconnect. This appears to be for the electrical generator present.
- 4) Sub Panel "B" at the interior wall of the garage has 7 breakers.
- 5) Sub Panel "C" at the interior wall of the garage with a main disconnect of 100 amps and 6 breakers.

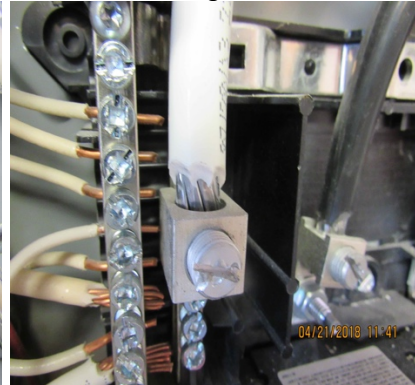
D - Antioxidant is needed at the AL (aluminum) conductors at the service entrance wires with entrance lugs. This is to prevent overheating or corrosion. Place antioxidant to the exterior main panel box and interior panel boxes aluminum wiring.

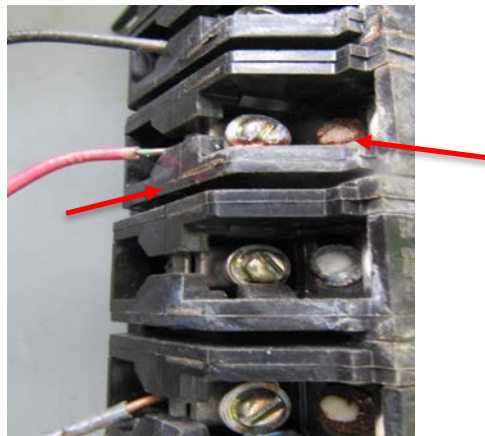
D - Rust/residue is visible over the bodies and screws to the breakers of the exterior panel box. These appear to be receiving water/moisture intrusion.

IRC E3404.7 Integrity of electrical equipment. Internal part of the electrical equipment, including busbars, wiring terminals, insulator and other surfaces, shall not be damaged or contaminated by foreign materials such as paint, plaster, cleaners or abrasive or corrosive residues. There shall not be any damage parts that might adversely affect safe operation or mechanical strength of the equipment

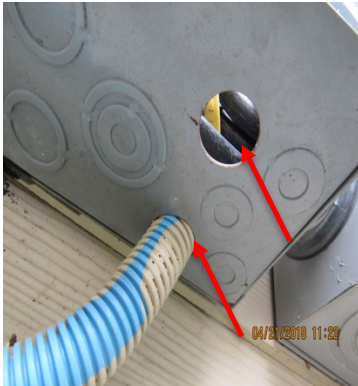
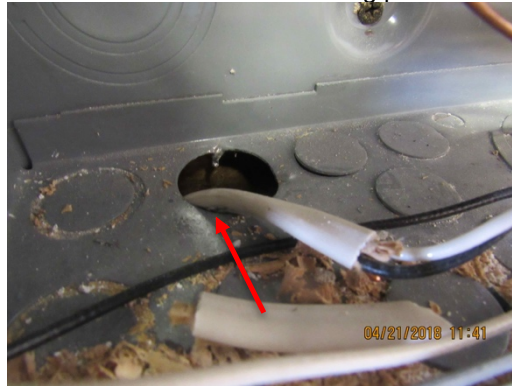
D - The main exterior panel box and Interior Sub-panels have no bushing protection at the bottom of the boxes where electrical wiring enter/exit the boxes. These should be protected from the sharp edges of the metal box knock-out.

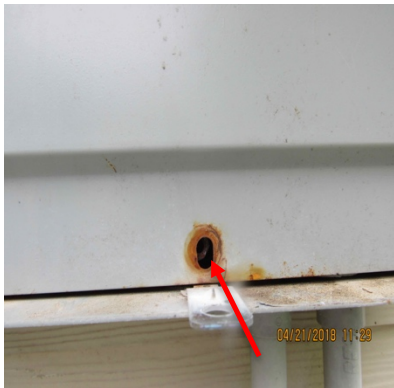
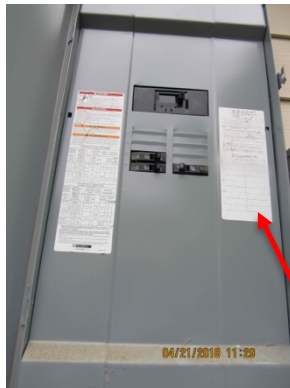
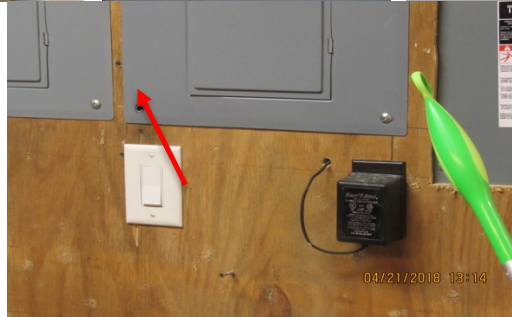
- Several blunt screws are missing at exterior panels and interior sub-panels dead front cover or present screws appear to be too short and not securing the panel cover.
- Locking clip to the interior "B" panel door cover is damaged/not present.
- Dead front cover (interior panel cover) of the electrical panels are in need of proper labels to show what circuits breakers control. Some have partial labels others do not have label.

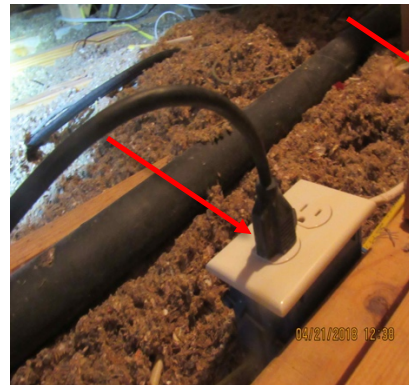
Multiple alteration to the electrical system require a full evaluation with a Licensed Electrician, for code violation, safety or fire hazard conditions.

- Loose wiring at the attic and around the Scuttle areas need to be strapped to the structure every 4' and 12 inches from junction boxes. Wires need to be a minimum 6' from any scuttle opening to attic. **Safety hazard.**
 - Electrical extension cords are viewed plug to outlets in the attic. For permanent use of fixtures, permanent acceptable wiring is required per code.
 - Wiring splices need a junction box, secure to the structure.
 - Some junction boxes viewed are not secured to the structure.
 - Wiring staples in some areas are viewed opened, in danger of puncturing the wire if moved. **Safety hazard.**
- See additional related photos on the next page.

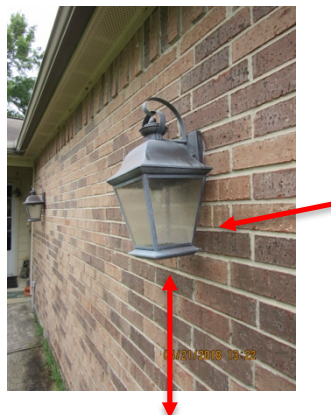
- The front exterior lights (2) at the main entry do not meet the require height of minimum of 6'-8". These fixtures are considered to be installed too low over the entrance walkway.

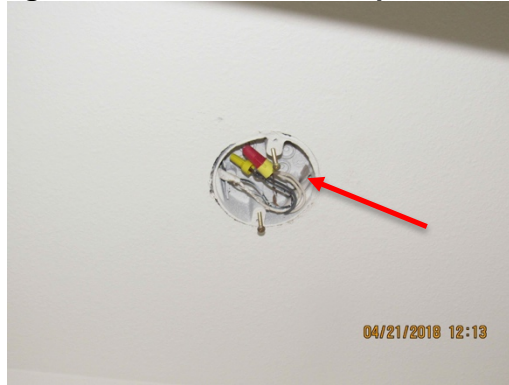
D - Open electrical box at the ceiling of the S.E. bedroom closet needs a light fixture and/or a blind plate if not in use.

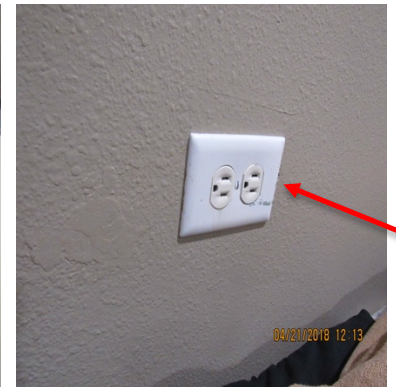
Additional alterations viewed: Light fixture within the soffit of the garage (cancelation of the original light fixture at the wall), additional outlets within the wall cabinet above the microwave (the original outlet has electrical current); outlets at S.E. bedroom above the beds, not with the standard height within the wall from the floor at this bedroom and at the living room area.

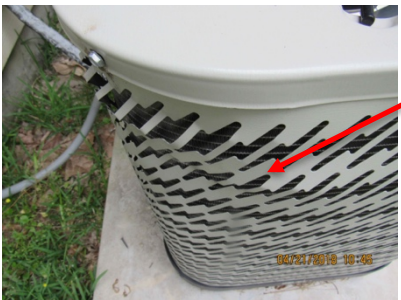
The “filter/dryer” too close to the evaporator coil at the air handler cabinet. It is recommended for the “filter/dryer to be installed in the liquid line close to the condenser for easy replacement when lines are restricted/contaminated. **There is no sight glass to determine restriction in the line under a restricted visual inspection; typically, this is determined when bubbles appear through the sight glass.** Contamination of the liquid line is possible from overheating line when the filter/dryer was installed (welded) to the soft copper line within a restricted space too close to the air handle housing. System was not viewed with an extra line coiled horizontally, near the evaporator as per standard acceptable installation.

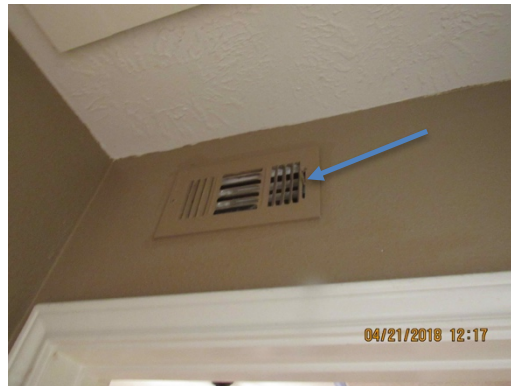
Return air pathway is viewed over the door header of the master bedroom only.

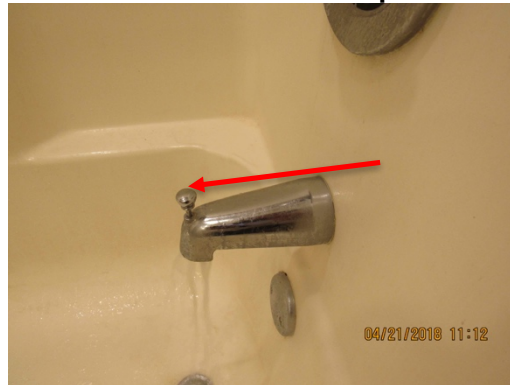
- Tub/shower diverter is not functioning at the master bath. No water can be diverted to the tub spout.

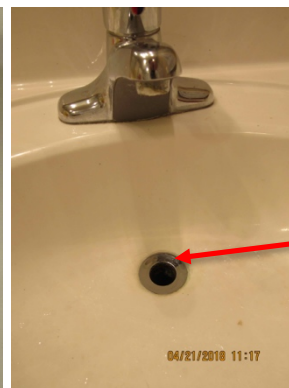
- No drain pop-up stopper at the right master lavatory and hall bath lavatory.

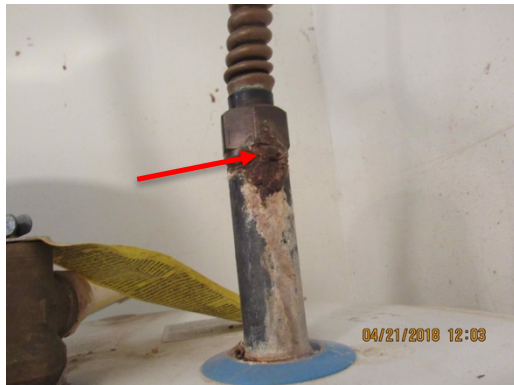
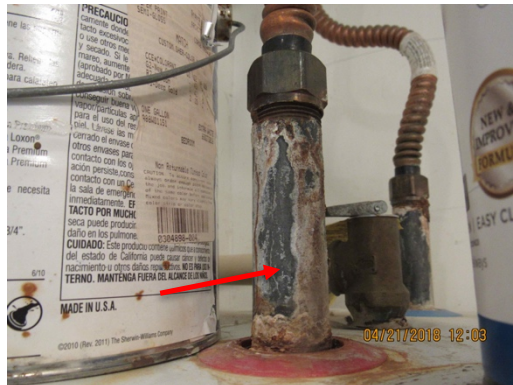
D - In need of repair to the cold and hot water Nipples fitting corroded at its thread to the water heater at top of this unit. (Dielectric nipples are recommended). Avoid leaks at any point.

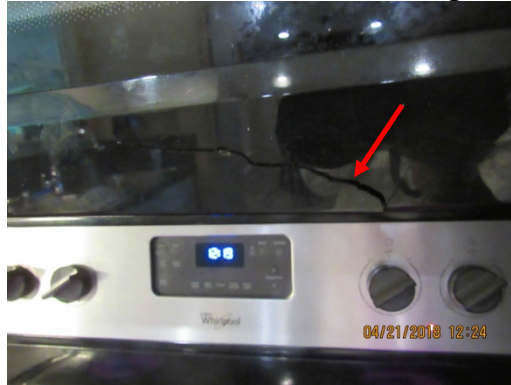
D - Frame of the Microwave door is broken. This possess danger of microwave leak without knowing. **Safety hazard.**

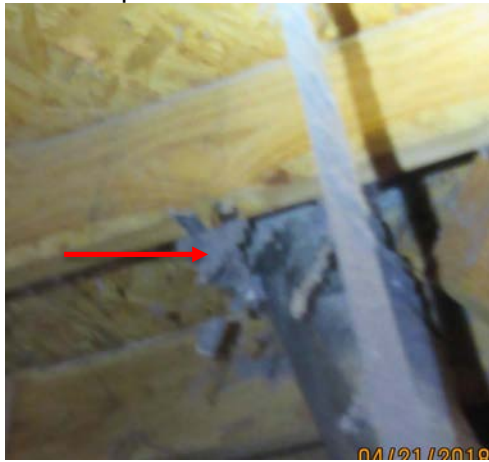
D - The Dryer exhaust pipe is permitting lint debris within the attic space. This is considered a Fire hazard. Cleaning/extending the pipe over the roof line may be recommended first and/or an exhaust boost fan. See sample below.

It is recommended to install and exhaust booster fan within the run of the vent pipe. This would aid to exhaust excess of moisture and lint as intended through a mechanical system "DBF 110 FAN TECH" due to the present conditions of the present exhaust pipe inspected at this dwelling. This system control automatically operates the booster fan whenever the dryer is running. Photo below is a sample of the type of booster fan recommended.

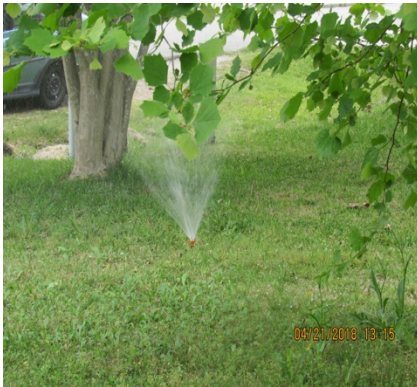
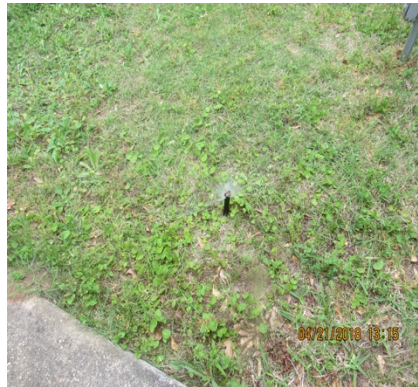
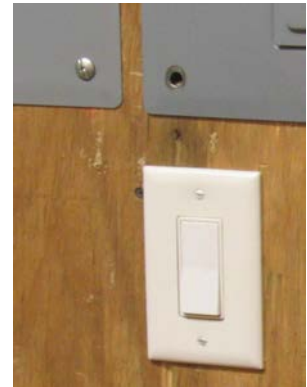
Currently the system in place does not have a panel control. It is controlled with a switch (ON/OFF) at the east wall of the garage under one of the Electrical panels. System does not have a vacuum breaker, one of the most important components of any sprinkler system.

D - Sprinkler system should have any one of the following types:

Atmospheric –type vacuum breaker, a pressure-type vacuum breaker or a reduced pressure principle backflow preventer. None of the above-mentioned vacuum breakers were visible.
