PROPERTY INSPECTION REPORT

Concerning: 7 Craven Park Court, The Woodlands, TX 77354

By: Todd Goodwin : TREC# 21218

10/16/2019

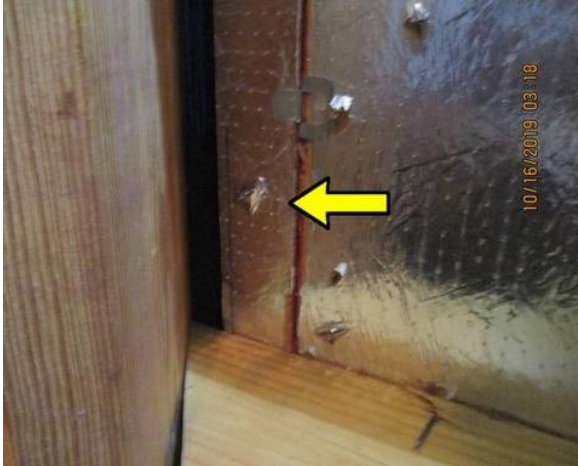
Deck board is too small at the ridge

The decking is too thin where it meets the ridge. Recommend qualified roofing company evaluate and correct as needed.

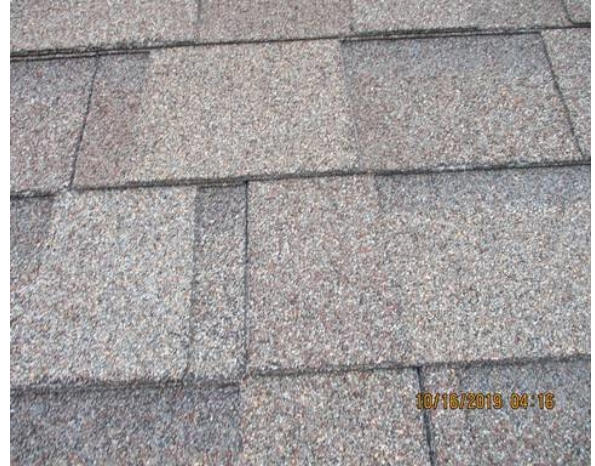
Condition of shingles

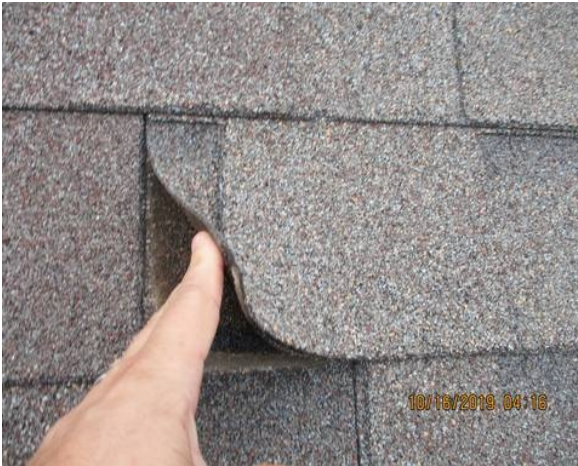
Shingles are still pliable

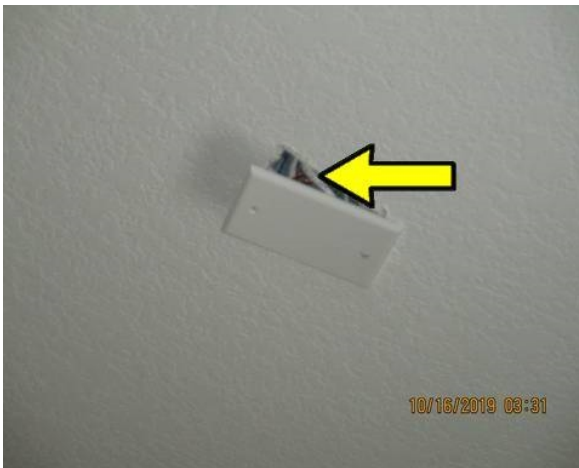
Secure speaker wires in ceiling at upstairs game room

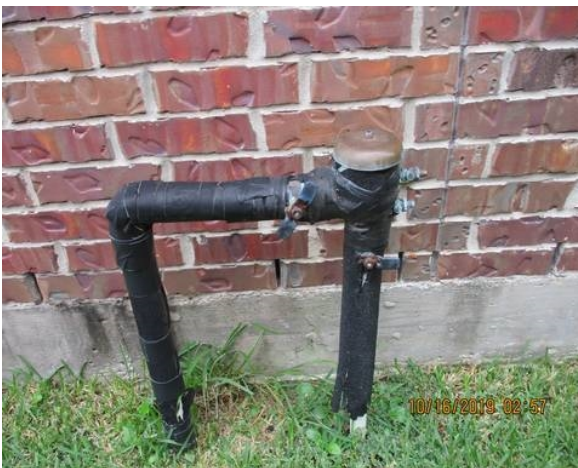
Handle is damaged at the backflow preventer valve. Recommend replacing this valve handle.

Backflow preventer installed
