# Inspection Report

**Property Address:**  
330 S Walnut St  
Kountze TX 77625

# PROPERTY INSPECTION REPORT

**By:** Joe Askew TREC # 10495 / Ethos Home Services dba Housemaster 9/17/2021

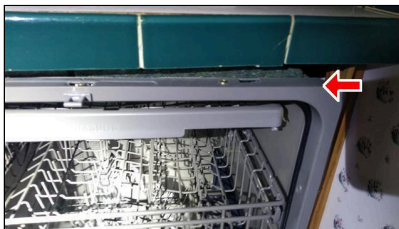
A. (Picture 1)

The dishwasher was not secured to the bottom of the counter-top. This can usually be corrected using a small wood screw to secure the washing machine housing under the counter.
