## **Mechanical and Structural Inspection Report**

**November 16, 2019**

**20 Campeche Estates Drive, Galveston, Texas 77554**

## PROPERTY INSPECTION REPORT

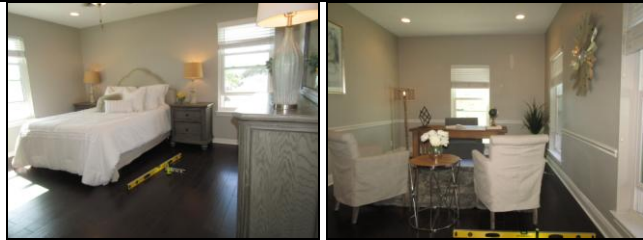
**Comments: Interior walls:** The [visible] interior walls were clad with textured/painted drywall/sheetrock and plywood “block” style paneling. The visible interior walls appeared to be appropriately installed and performing as intended on the day of the inspection.

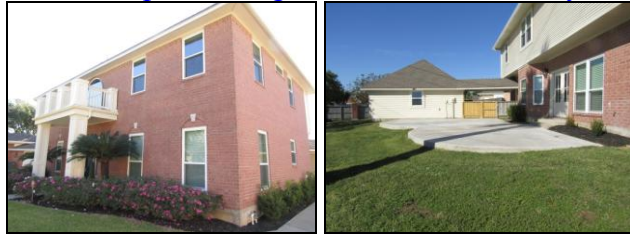
**Exterior walls:** The front and side exterior walls of the house were clad with brick and mortar [with wooden trim]. The exterior rear wall of the house as well as the entire garage were clad with vinyl style siding. All exterior walls appeared to be reasonably installed, well maintained and performing as intended on the day of the inspection.

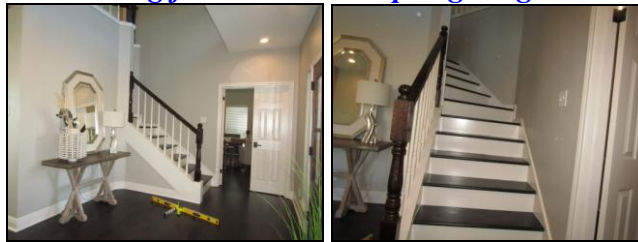
*#2: The “pull-down” attic access stairway (installed in the upstairs hallway) was missing fasteners at the spring hinge and corner brackets.*

*The interior stairway appeared to be reasonably installed and performed as intended on the day of the inspection. EXTERIOR STAIRWAYS: Not installed, not evaluated.*

*Recommendations: INTERIOR STAIRWAYS: (D-1) (As per the manufacturer’s installation instructions) install fasteners (typically 16-penny nails or ¼-inch lag screws) through the provided holes, into the adjacent attic framing at the spring hinge and corner brackets for the “pull-down” attic access stairway (installed in the garage). (D-2) (As per the manufacturer’s installation instructions) install fasteners (typically 16-penny nails or ¼-inch lag screws) through the provided holes, into the adjacent attic framing at the spring hinge and corner brackets for the “pull-down” attic access stairway (installed in the upstairs hallway). EXTERIOR STAIRWAYS: None.*

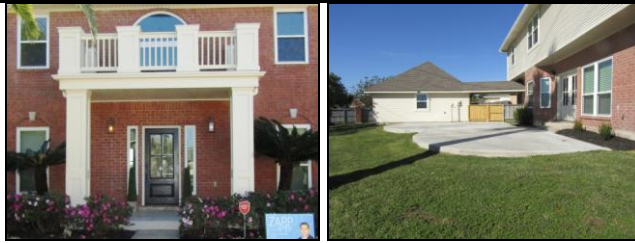
The front covered porch and rear breezeway and patio appeared to be reasonably installed and performing as intended on the day of the inspection.

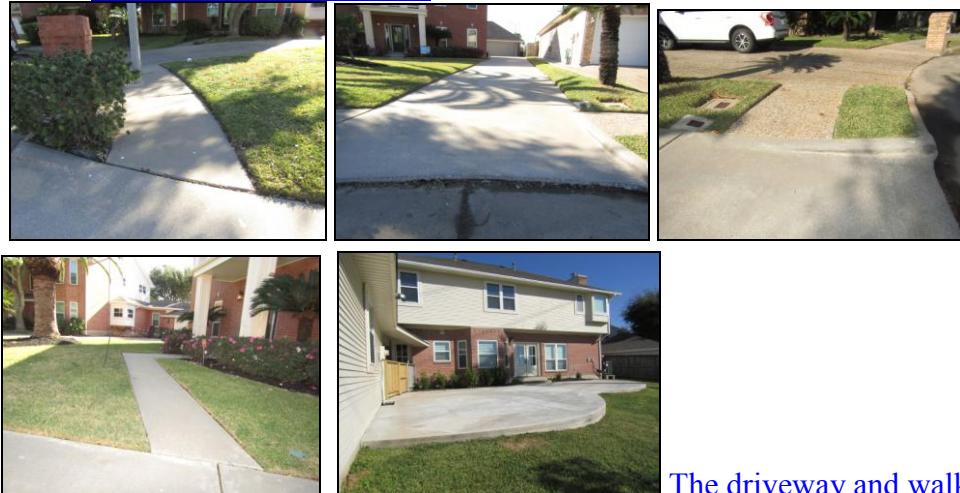
The driveway and walkways appeared to be reasonably installed and performing as intended on the day of the inspection.

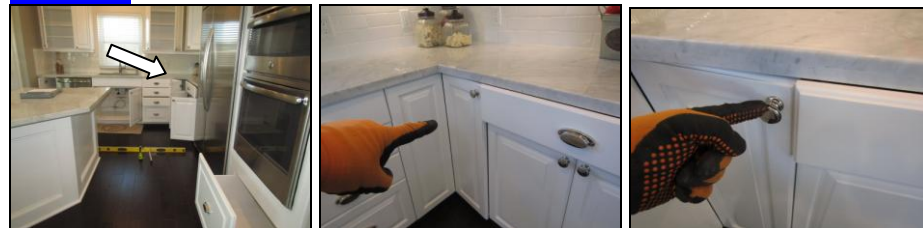
Most of the visible kitchen, bathroom and other bathroom cabinets [and closets] appeared to be reasonably installed and performed as intended on the day of the inspection. **Note #1:** *The door at the corner carrousel kitchen cabinet did not close properly (it strikes the adjacent cabinet drawer).* **Note #2:** *Evaluation of damage inside walls [behind cabinets] [like that caused by water, insects or structural abnormalities (like inappropriate sealing)] requires dismantling*

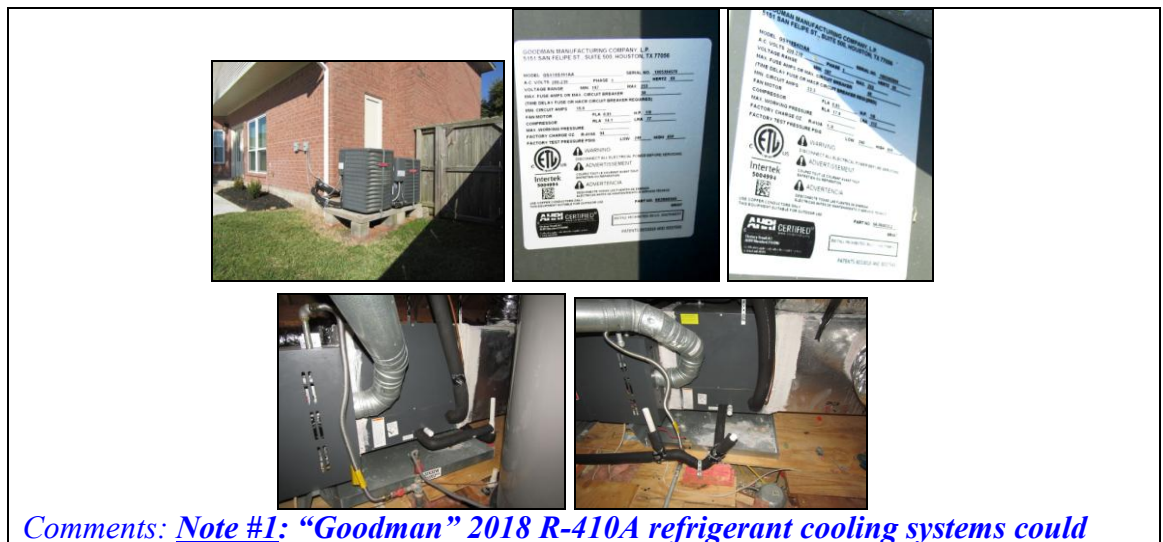
*Comments: Note #1: "Goodman" 2018 R-410A refrigerant cooling systems could*

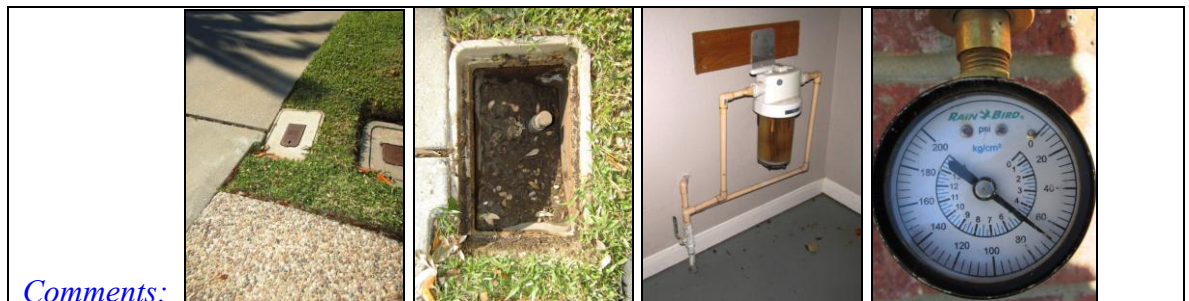
The (single) water meter was installed at the right side of the front yard, near the driveway. The static water pressure was about 65 to 70 PSIG. Pressure may vary depending on neighborhood usage. The main water “cutoff as well as a “whole house” water filter was installed at the right interior wall of the detached garage.  
***Note #1: Only water meter was present and an irrigation system was present.***

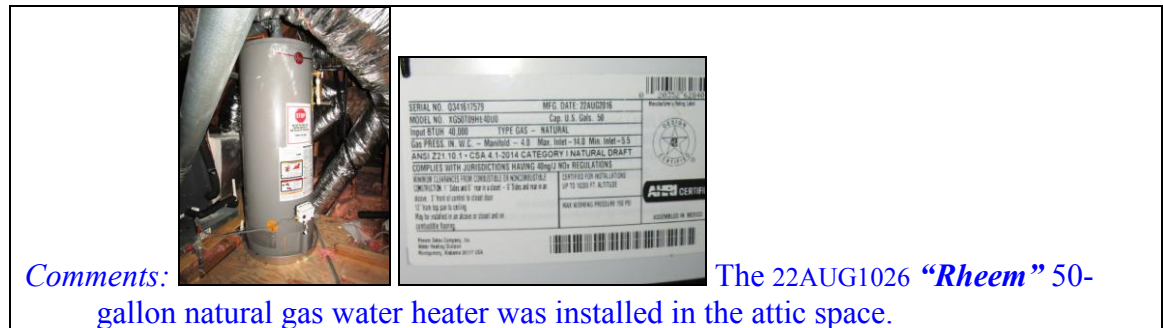
Comments: The 22AUG1026 "Rheem" 50-gallon natural gas water heater was installed in the attic space.

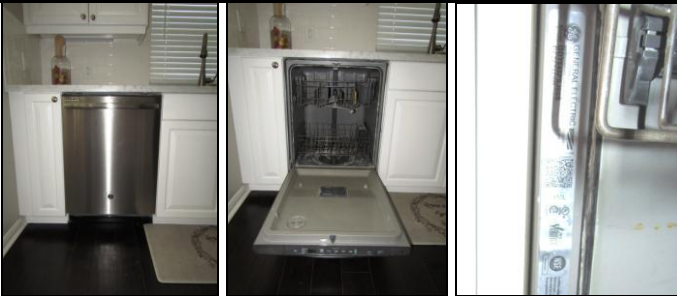
*Comments:* The 08/2015 **“General Electric”** dishwasher started and ran [“Normal” mode] on the day of the inspection.

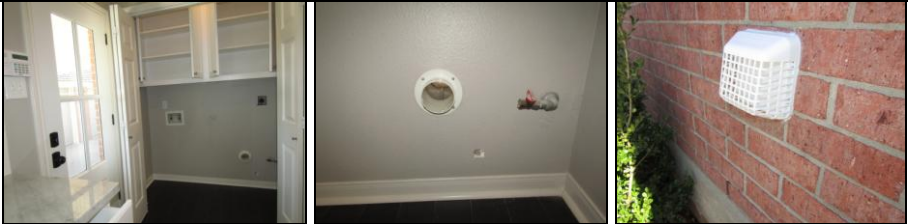
The clothes dryer vent appeared to be reasonably installed.
