PROPERTY INSPECTION REPORT

Concerning: 16842 BONNYTON DRIVE, RICHMOND, TX 77407

By: Dan Romero : Trec # 5674

10/16/2019

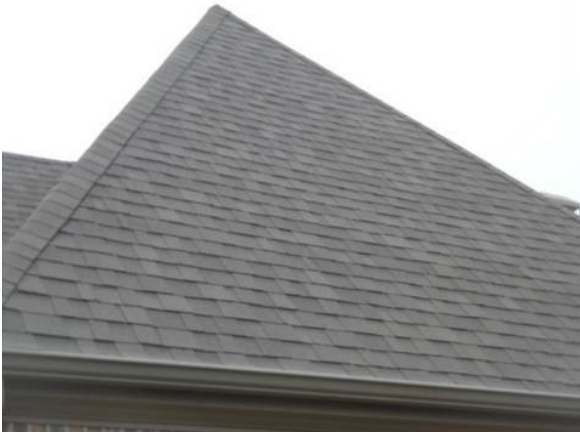
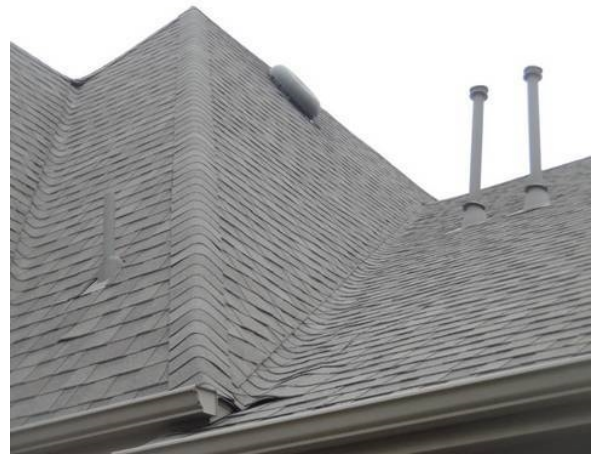
At the time of the inspection the roof was performing its intended function.

Observed no active water penetration.

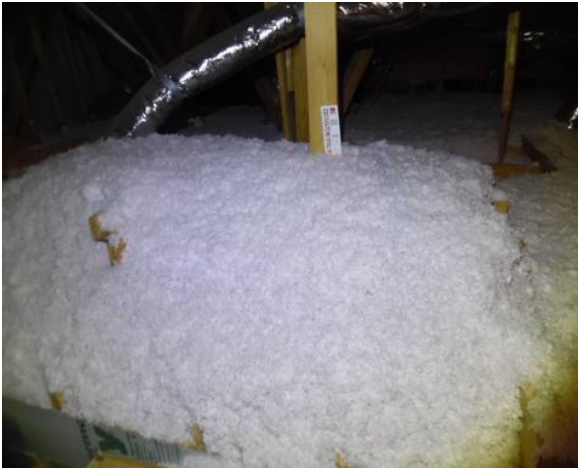
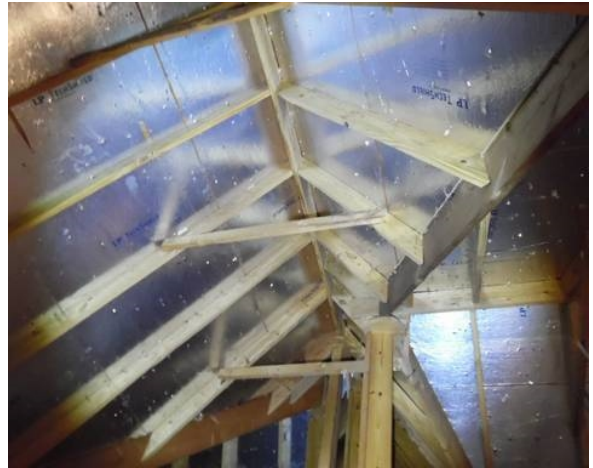
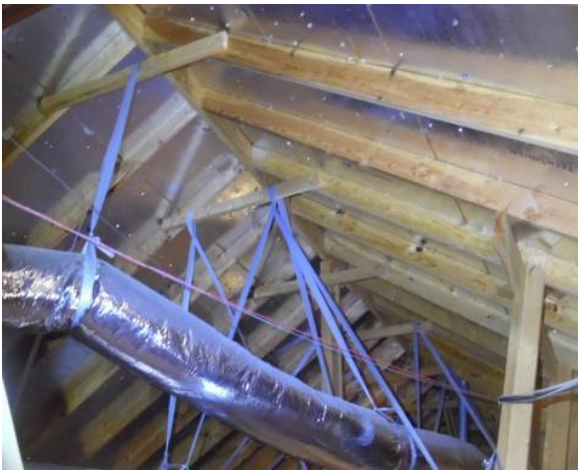
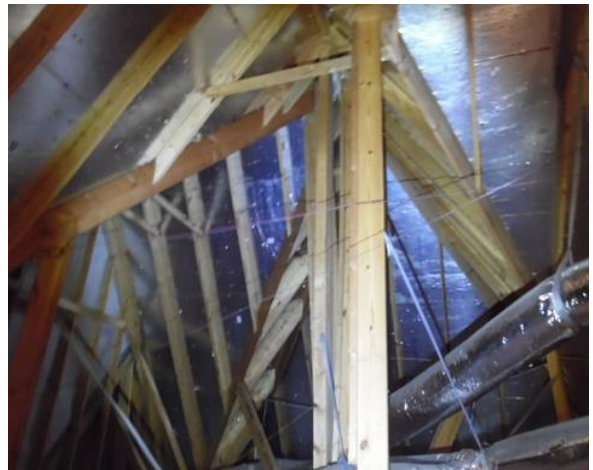
No deficiencies were noted at the time of the inspection.

Noted 2x 4 & 2x6 purlins at 2x 6 & 2x8 rafters, at 2x 8 & 2x10 ridge boards at 2x6 strong backs at 2x4 collar ties.

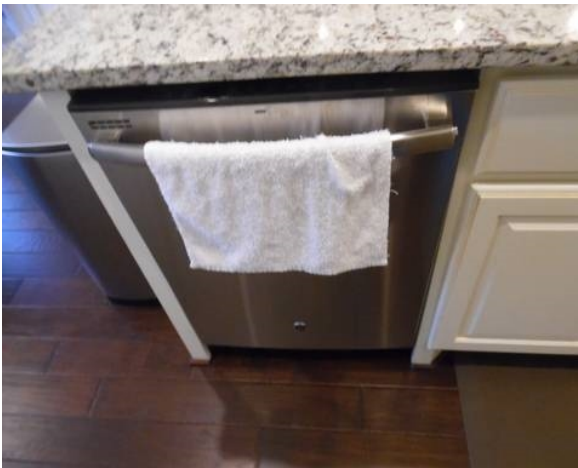
Dishwasher was operated in normal mode, run through a complete, normal cycle. Function and operation appear to be normal. Lower access panel not removed. At the time of the inspection the dishwasher did not leak. Care should be taken the first time the dishwasher is run after a period of inactivity because seals tend to dry out and can leak at first. If this happens dry the area inside the unit where the leak is occurring and then re-start the dishwasher. Also be sure to follow the manufactures recommendation for type of soap and amount as this can be the cause of leaking.
