HOUSTON INSPECTIONS

May 9, 2019

PROPERTY INSPECTION REPORT

Concerning: 14911 Bramblewood Dr, Houston, TX 77079
(Address or Other Identification of Inspected Property)

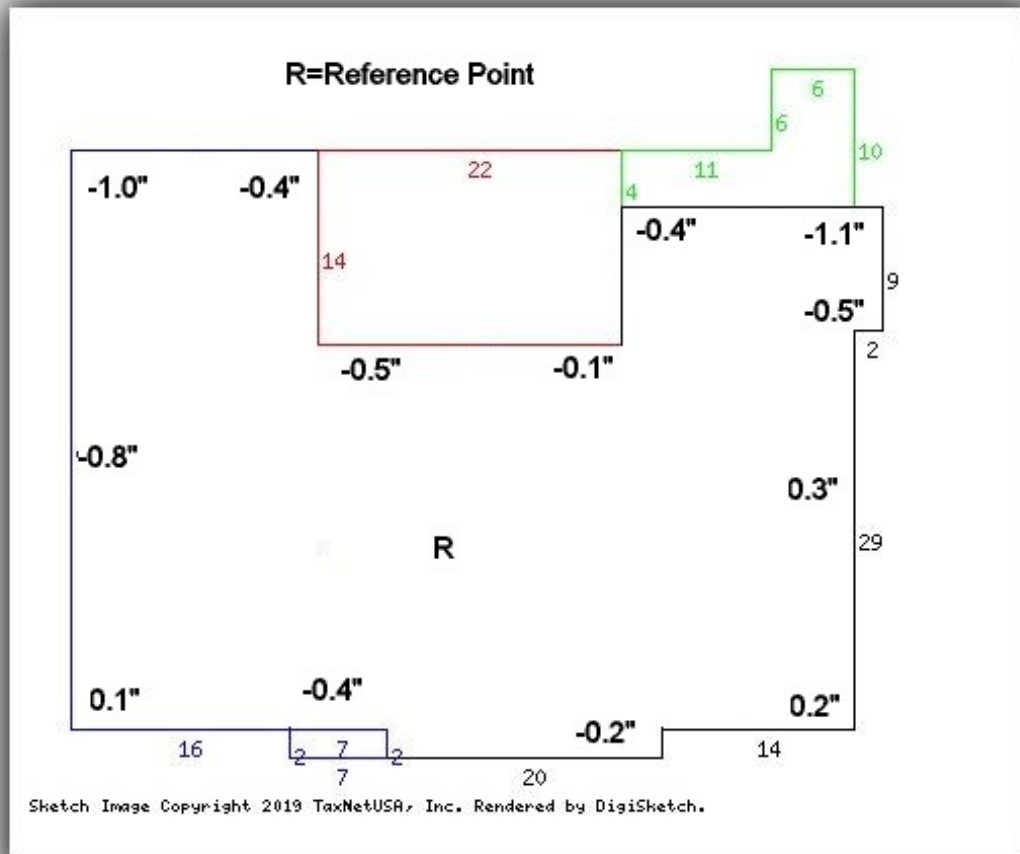
The below graph reflects measurements taken during the inspection to assist with determining the performance of the foundation. The outline / drawing is not to scale and does not accurately reflect every detail of the foundation walls.

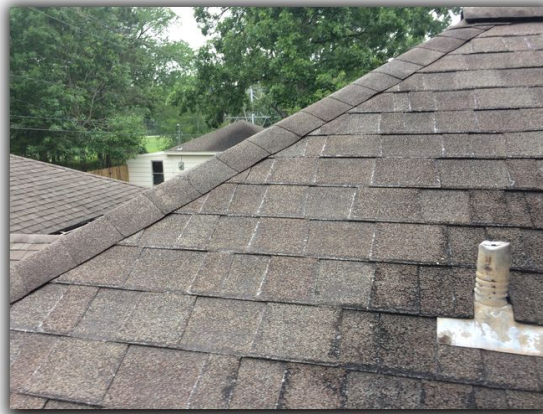
Damaged and / or missing shingles were found during the inspection of the roof covering. Recommend repairs by a qualified tradesman.

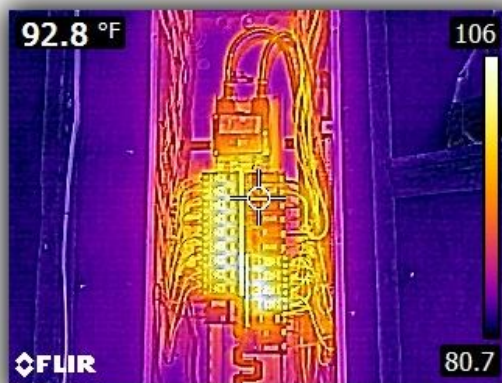
During the inspection of the electrical panel with a infrared camera significant abnormalities were not noted. The picture(s) below are a sampling of some image(s) taken during the inspection.

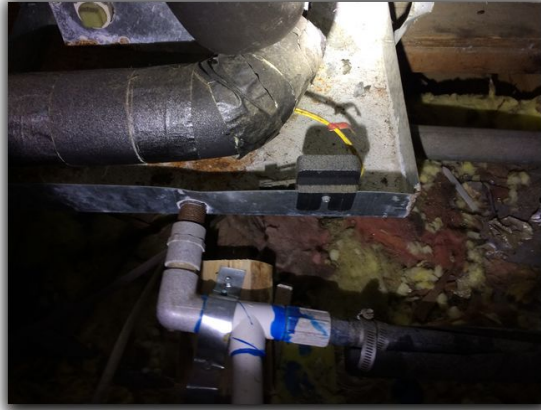
Float switch(es) have been installed at the emergency drain pan(s) located below the evaporator coil(s) in the attic. This is a feature that turns off the outside unit in the event water collects in the drain pan.

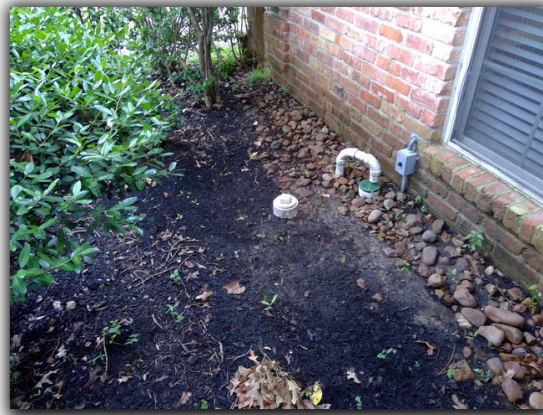
Main Sewer Cleanout Location: Front of Property

- PVC piping exposed on exterior not painted to protect from UV rays
