REDSTAR PROFESSIONAL HOME INSPECTION, INC

REDSTAR RESIDENTIAL INSPECTION REI 7-6

14114 Mary Sue Ct
Sugar Land, TX 77498

PROPERTY INSPECTION REPORT FORM

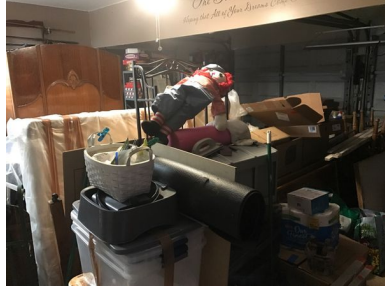
Excessive storage of materials or debris may limit the visibility of the wall structure, foundation and limit the inspectors visibility. Recommend removal of items stored near the structure for home health.

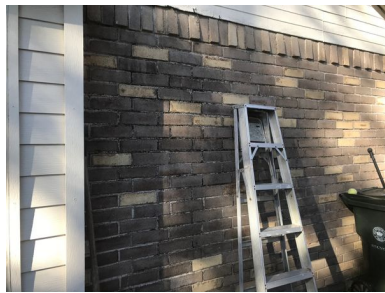
The above stated issues were observed at the home at time of inspection. These items are related to cosmetic issues or maintenance due to expected wear and tear. Recommend you budget for repair of these issues for cosmetic reasons, or to avoid further deterioration.

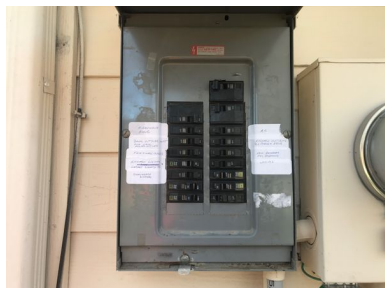
3: AC breaker oversized

The breaker in place for the AC condenser unit is oversized. The condenser calls for a maximum of a 35 amp breaker and a 50 amp breaker is currently in use. Recommend correction.

Recommendation: Contact a qualified electrical contractor.

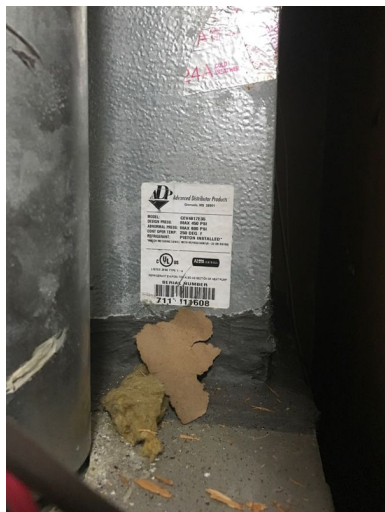
Areas around the penetrations through the evaporator coil need to be sealed properly to prevent air loss or condensation at the attic area. Recommend correction.

Recommendation: Contact a qualified HVAC professional.

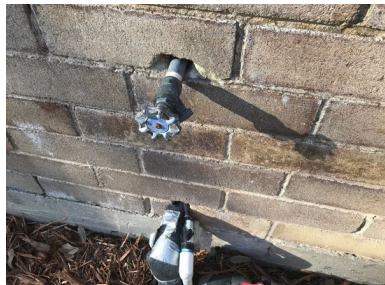
2: Hose Bibb: Valve stem Leaks

Valve stems for multiple hose bibs around the home would leak when operated. Repair as needed.

Recommendation: Contact a qualified professional.

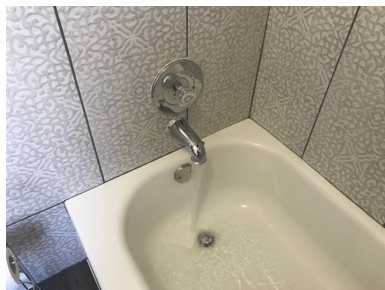
The hot/cold appears to be reversed at the master bathroom shower valve. Recommend correction as desired.

Recommendation: Contact a qualified plumbing contractor.

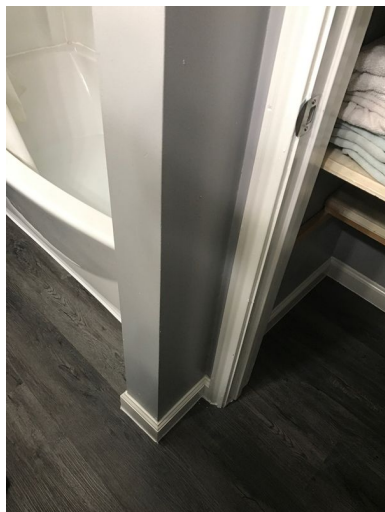
1: Hydro Test/Scope: Movement

Hydrostatic testing and/or scoping of the latent plumbing drain lines under the home is recommended due to signs of prior structural movement and/or foundation repairs. Recommend further evaluation by a plumbing contractor.

Recommendation: Contact a qualified plumbing contractor.

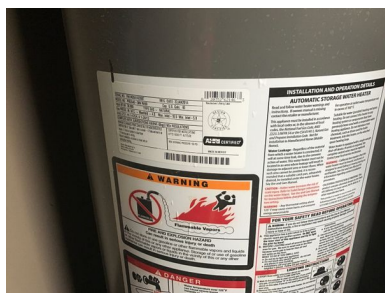
Data label:

Unit manufactured in 2014

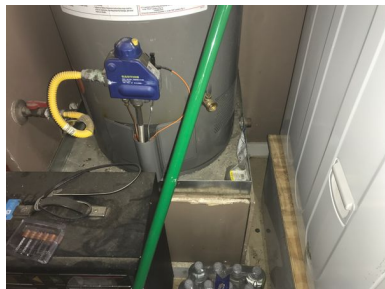
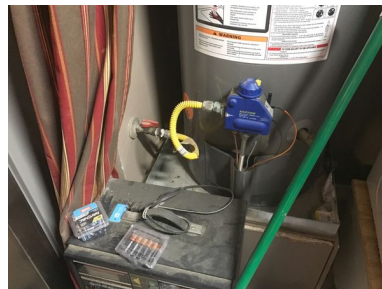
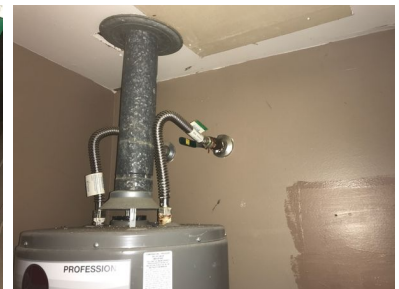
Several issues observed with the current condition and installation of the water heater unit. These issues include, but are not necessarily limited to:

1. No drain line attached to the pan under the unit. Building code requires a drain line to be present on the pan that is routed to the exterior of the home.
2. No trash leg on the gas line to the unit.
3. Excessive corrosion observed around the shut off valve and fittings at the unit that should be properly prepared to avoid leaking issues.
4. A portion of the exhaust duct in the attic space appears to have been spliced with a non-B-Tight vent and light was observed around the exhaust vent penetration through the roof line.

Recommend consulting with a qualified contractor to fully evaluate these conditions and determine the extent of necessary repairs.

Recommendation: Contact a qualified plumbing contractor.

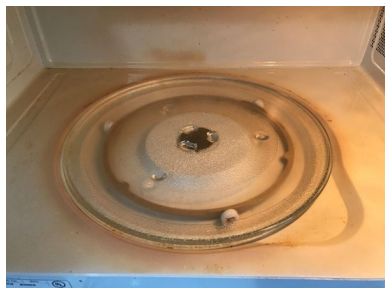
1: Interior finish damaged

The finish on the interior of the microwave it shows damage. Damage to the finish at the interior of the microwave can result in arcing or other malfunction. Recommend correction to prevent potential hazard.

Recommendation: Contact a qualified professional.

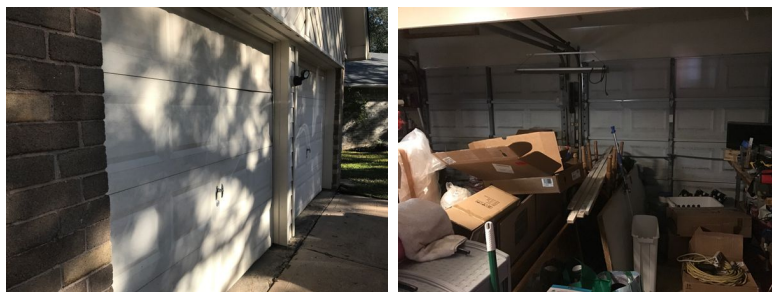
1: Garage Door: Damage

The garage door panels show damage. Recommend further evaluation to determine extent of necessary repairs.

Note: due to extensive stored items inspection of the overhead doors was limited. No garage door openers are currently in place. Recommend further evaluation and budgeting for repair and installation of garage door openers as desired.

Recommendation: Contact a qualified garage door contractor.

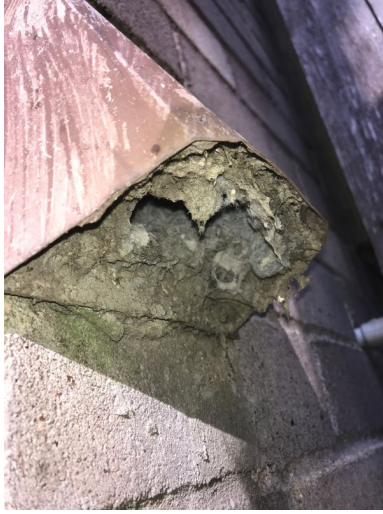
1: Clogged Vent

The dryer vent was observed to be clogged. Clogged dryer vent can pose a fire hazard. Remedy as needed.

Recommendation: Contact a qualified professional.

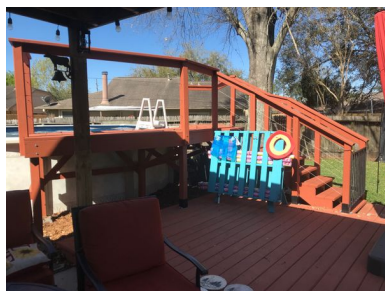
The stairway and deck balusters around the pool are not coat appropriate and the gaps around the wire balusters did have the potential for small children to fall. Recommend if you are concerned about the safety

issue that you budget for installation of code approved baluster system.

Recommendation: Contact a qualified professional.

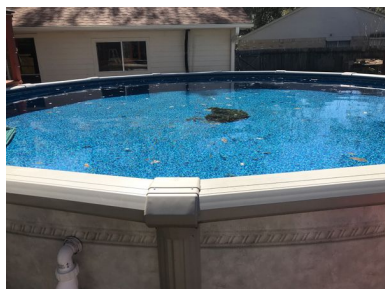
3: General cleaning

Excessive leaf build up and a need for general cleaning and maintenance were observed on the pool at the time of inspection. Recommend you ensure the pool is clean and that the water is properly balanced prior to use.

Recommendation: Contact a qualified professional.

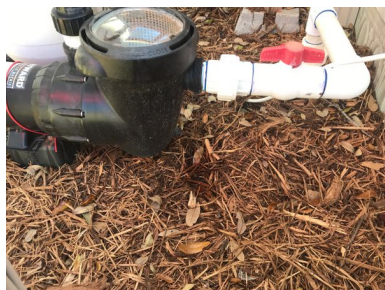
4: Small leak

Inspector observed a small leak around the fitting connection to the pump at the equipment. Recommend correction.

Recommendation: Contact a qualified professional.

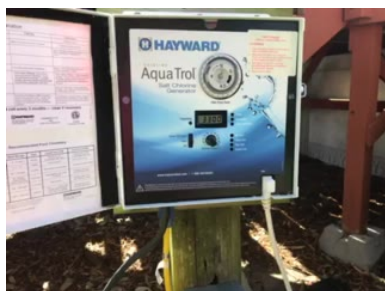
5: Inspect cell light

Inspector observed the “inspect cell” light to be on at the salt cell control box. Recommend further evaluation and proper service as needed.

Recommendation: Contact a qualified professional.

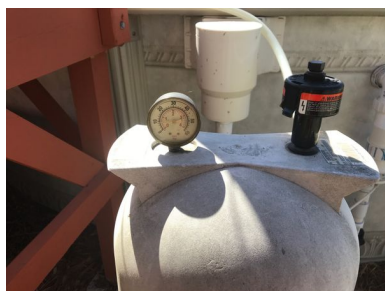
6: Gauge

The gauge and the filter for the equipment did not appear to be operating properly and was observed to display some pressure even when the system was turned off. Recommend further evaluation and ensuring that the gauge is operating properly.

Recommendation: Contact a qualified professional.
