BPG Inspection, LLC

**12043 Sela Lane
Houston TX 77072**

Client(s): Fuentes Vides
Inspection Date: 3/25/2022
Inspector: Ana Aponte , TREC #22375 (TX)

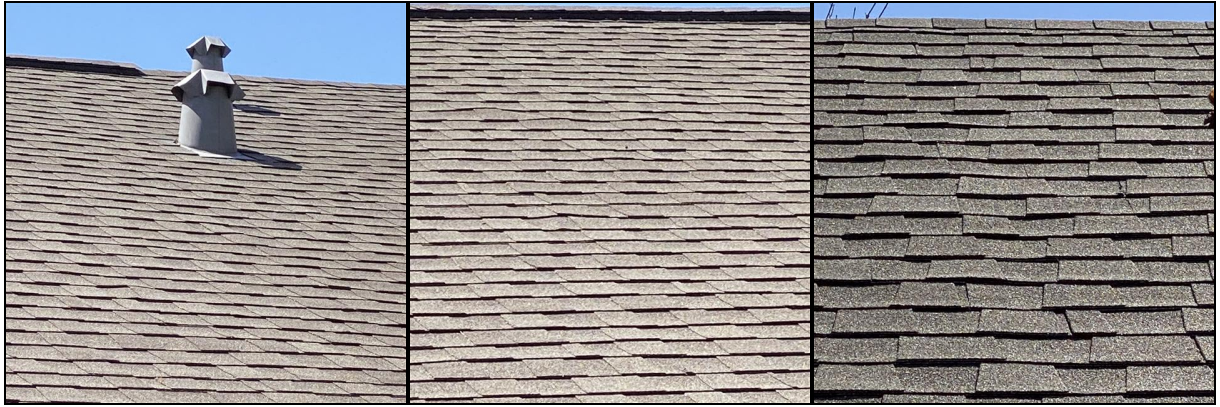
Tree limbs that are in contact with roof or hanging near roof should be trimmed back 3-5' to prevent any damage to the roof covering.

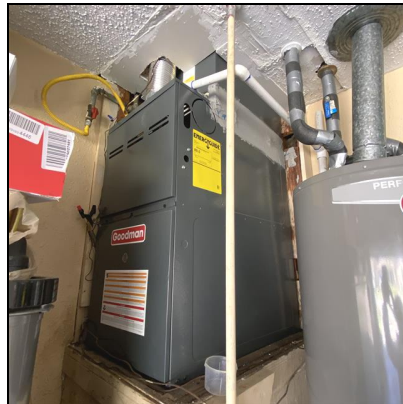
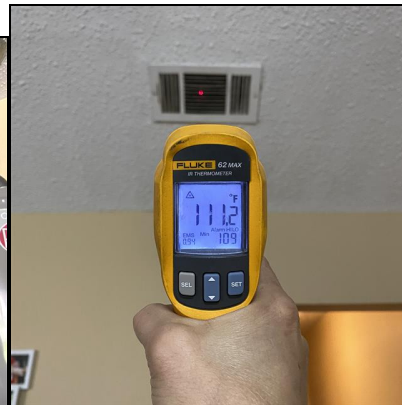
Supply temp

The flue from furnace as it terminates through roof is not strapped to rafters. Recommend properly securing flue to rafters with metal straps.

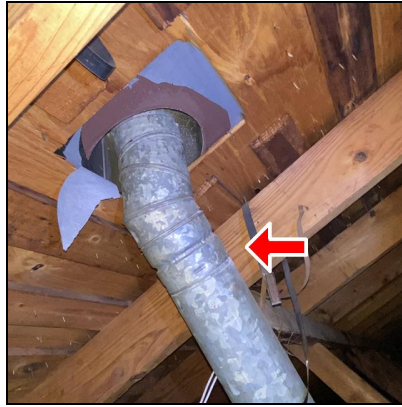
The heating system flue is in contact with building materials. Gas flues should have 1.5" of clearance surrounding the flue pipe. A heat shield should also be installed at the penetration.

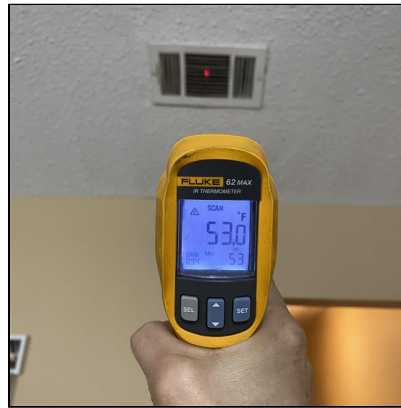
Supply temp

The condenser slab was observed to be out of level. Compressor oil may not properly lubricate the piston if compressor is not level causing premature failure. I recommend a qualified contractor make the necessary corrections.

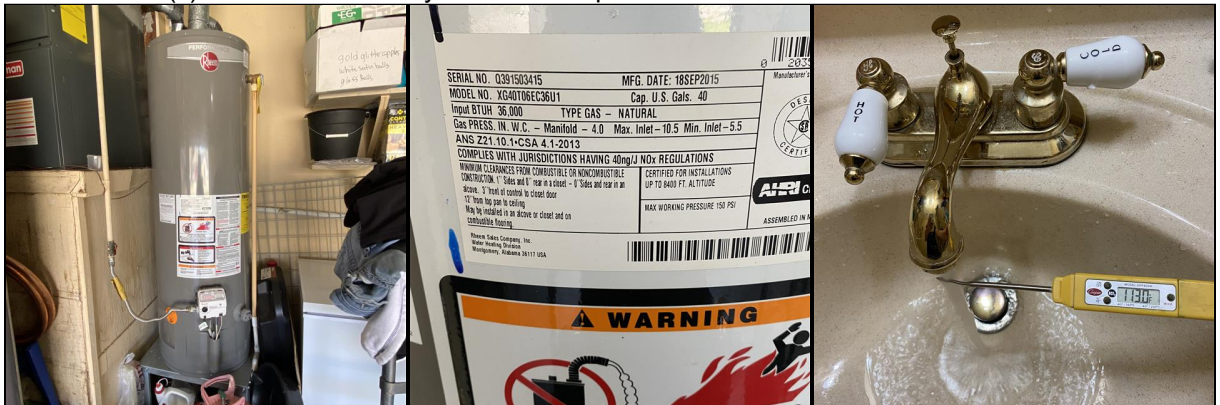
T&P valve does not drain to exterior as required. Injury may occur in the event of a high temperature/pressure discharge. Drains are required to discharge directly to exterior, directed downward to within 6-12" of grade. Drain lines must be high temperature rated (copper, CPVC etc).

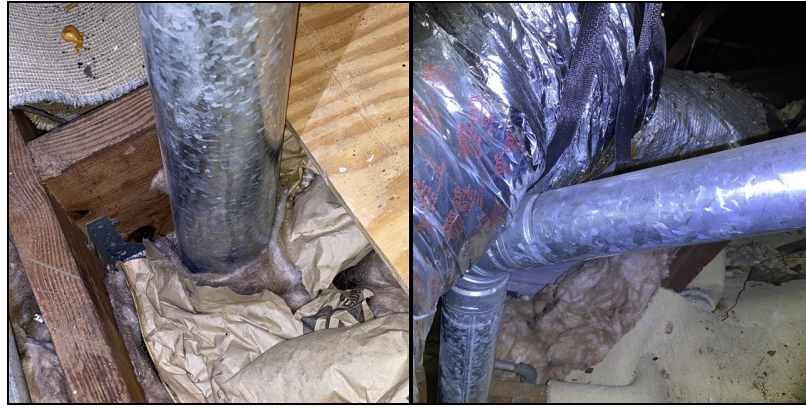
☒ The flue from water heater as it terminates through roof is not strapped to rafters. Recommend properly securing flue to rafters with metal straps at rafters.

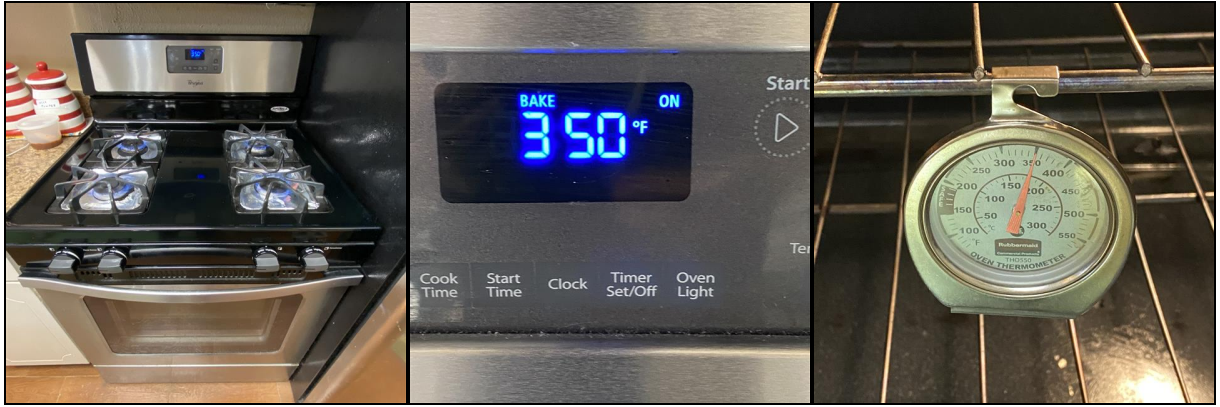
The distance between your range and the nearest sidewall should be twelve inches at a minimum, no matter the style of range you're having installed. This has to do with the heat coming from the cooktop. Gas range flames or intense heat from electric coils can pose some serious danger if they are close to a wall or another appliance.

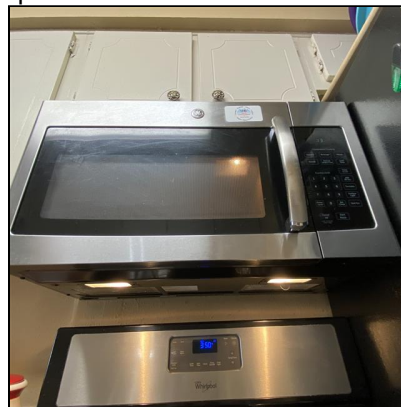
The National Kitchen and Bath Association recommends that the bottom of the microwave should be no higher than 54 inches above the floor, which would allow for **18 inches** of clearance between the microwave and the typical cooktop height of 36 inches. Reviewing your manufacturers specification is recommended.

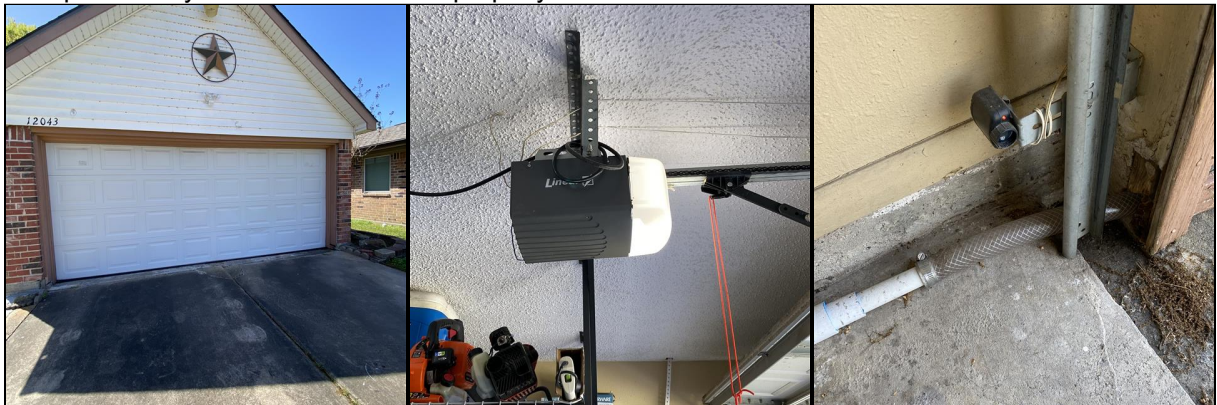
The garage door IR auto reversing sensors should be mounted no higher than 6" above the entry threshold
