Moisture Assessment Report

3011 Maxroy Street
Houston, TX 77008
02/18/2022

Summary Checklist

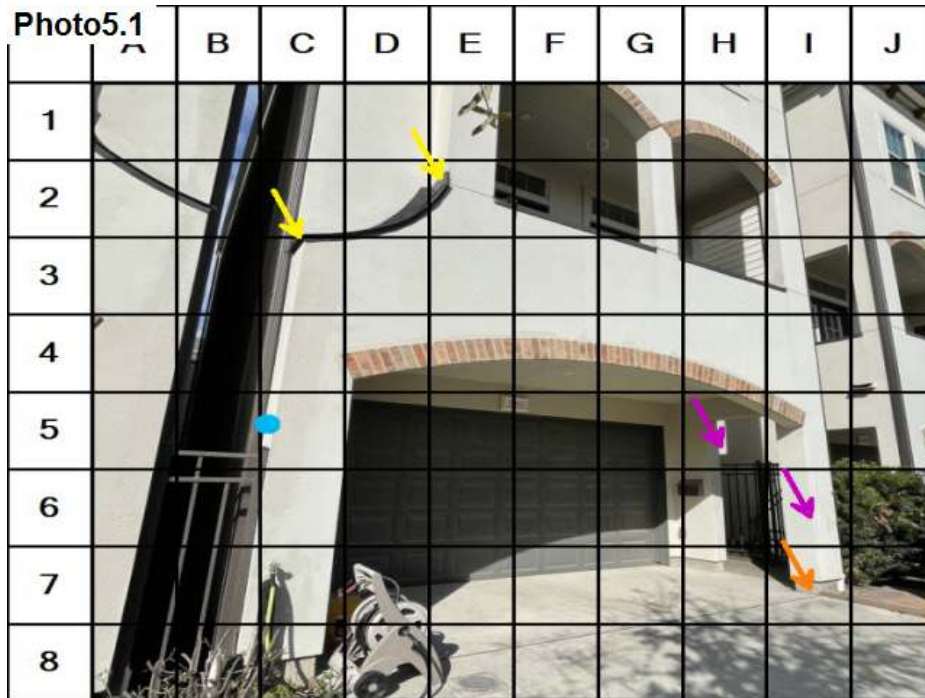
Column base is elevated on a concrete footing.

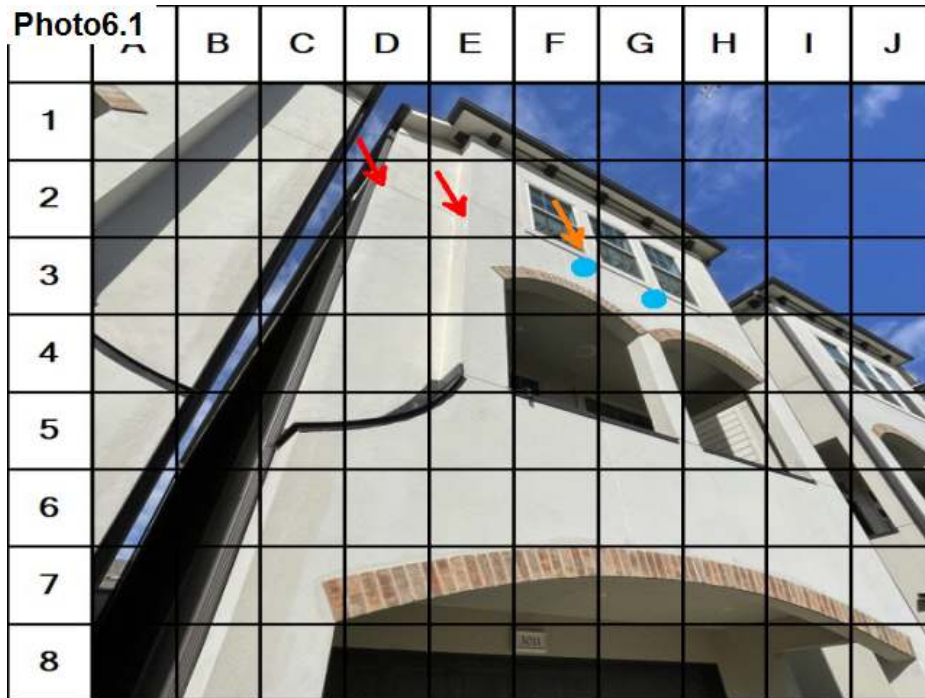
- Glue / adhesive noted on the stucco. This is a cosmetic concern. Seal / re-paint all as needed. See details #5.5 and #5.6.
- Cracking is present at the outside corners. It is suggested to seal all cracks at outside corners with polyurethane caulking as needed. See detail #6.2.

Cracking at outside corners noted.

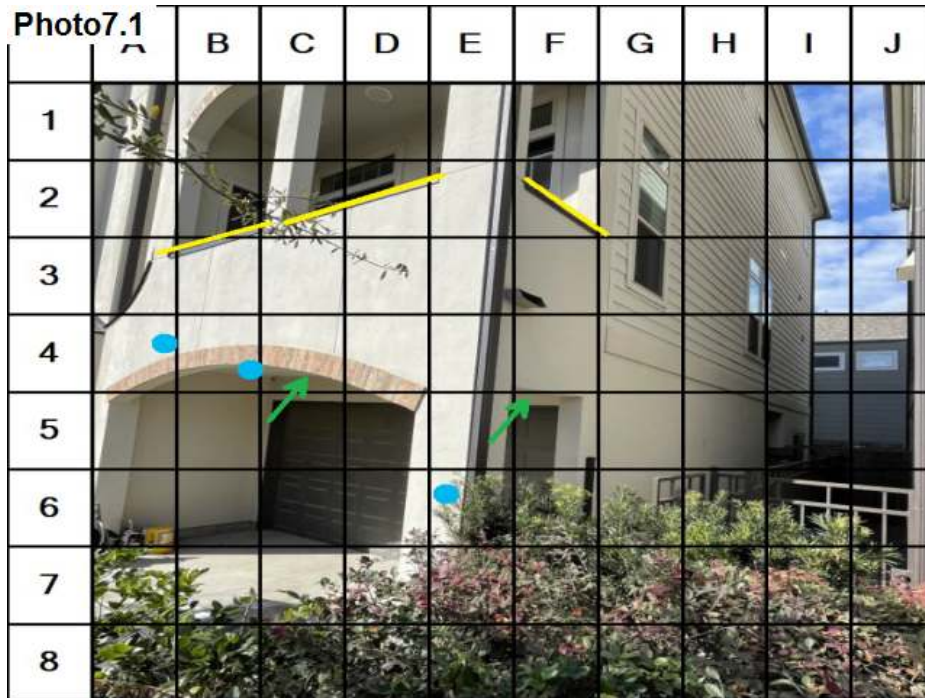
- Weep relief is present at bottom of walls but appears to be caulked shut. A weep relief is a favorable detail that allows for proper moisture drainage. Clear out relief and always leave weep relief at bottom of walls open as needed. See detail #7.2.

Photo7.2
 Weep relief is present at bottom of wall but is caulked shut.

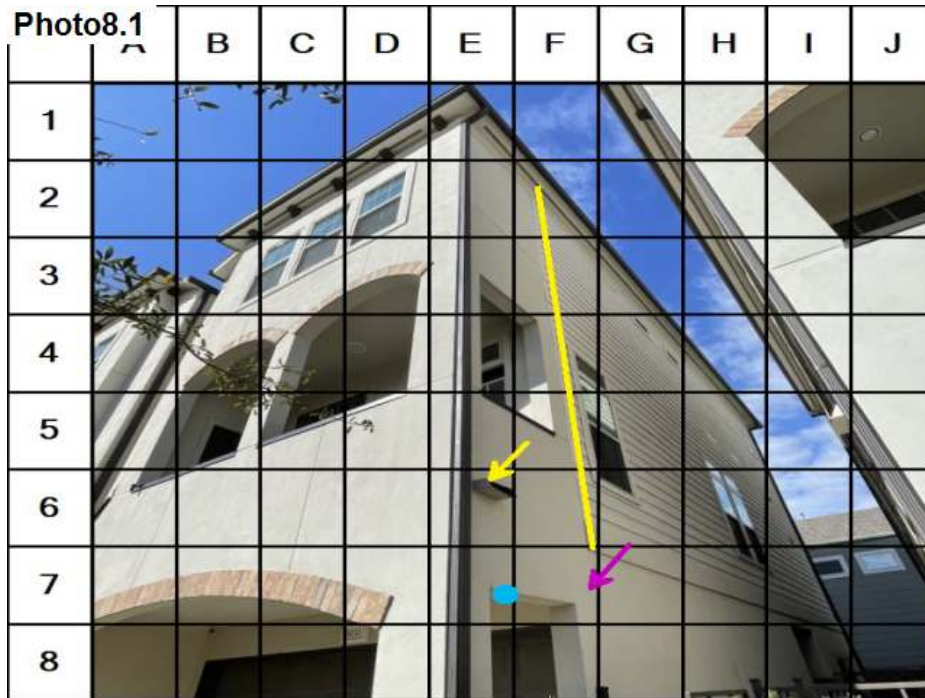
- Hairline cracks are present. To temporarily cover cracks, it is suggested in the future to re-paint the entirety of home with an elastomeric paint. Hairline cracks are a cosmetic concern. Elastomeric paint will help protect the cracks and prevent future cracking. See detail #8.2.

Hairline cracking is present.

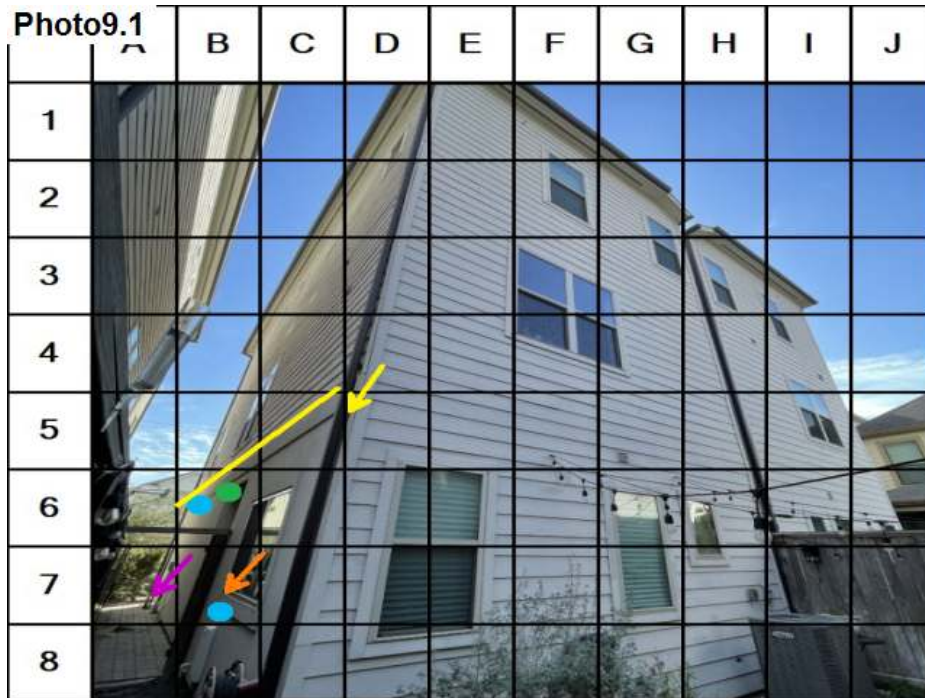
- Sealant separation noted around penetrations. It is suggested to reseal all with polyurethane caulking as needed. See detail #9.2.
- No horizontal transitional flashing noted. Reverse lap is occurring at the horizontal transition. It is suggested to install a proper horizontal transition flashing to prevent future moisture intrusion from occurring. See detail #9.3.

Sealant separation noted around penetrations.
