HouseCheck Property Inspection Report

33 Violet Sunset Ln, Tomball, TX 77375 Inspection prepared for: Rich Newhart Real Estate Agent: Jane Hardcastle - Jane Hardcastle Realty

> Date of Inspection: 10/28/2019 Time: 9:00 AM Age of Home: 2019 Size: 4000 Weather: 70F Clear Order ID: 1407

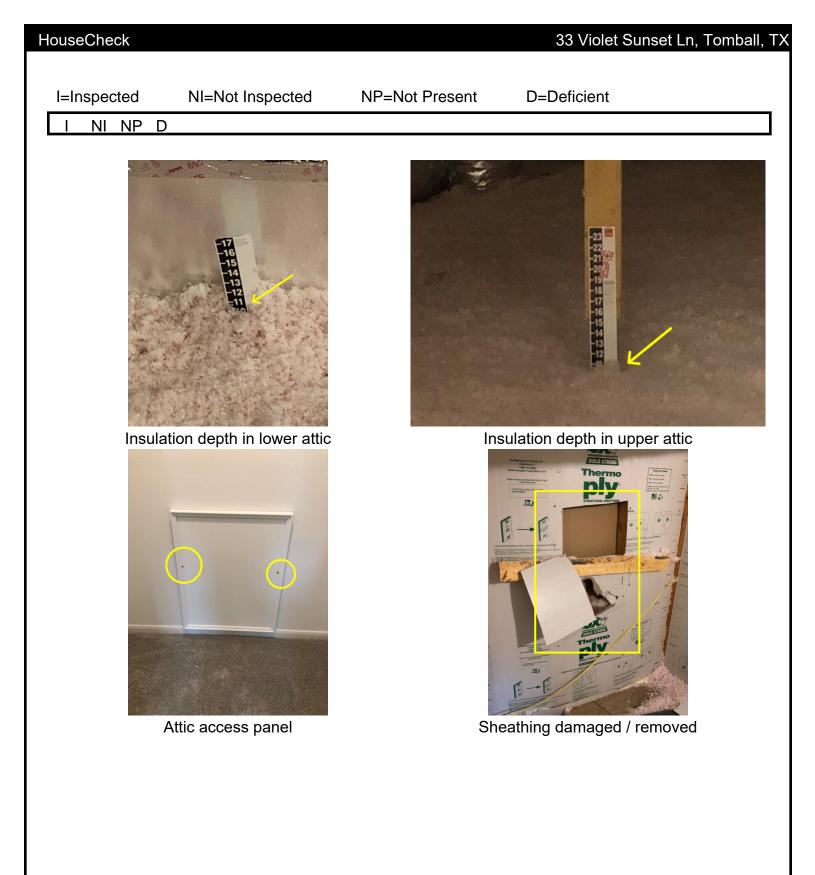
r view all areas of the attic due to a
			nt in the attic space per today's
	installed to allow home	eowners or service pers erior wall in lower attic h	Il screws.Doors should have hinges onnel to access attic without tools. has been damaged. This should be

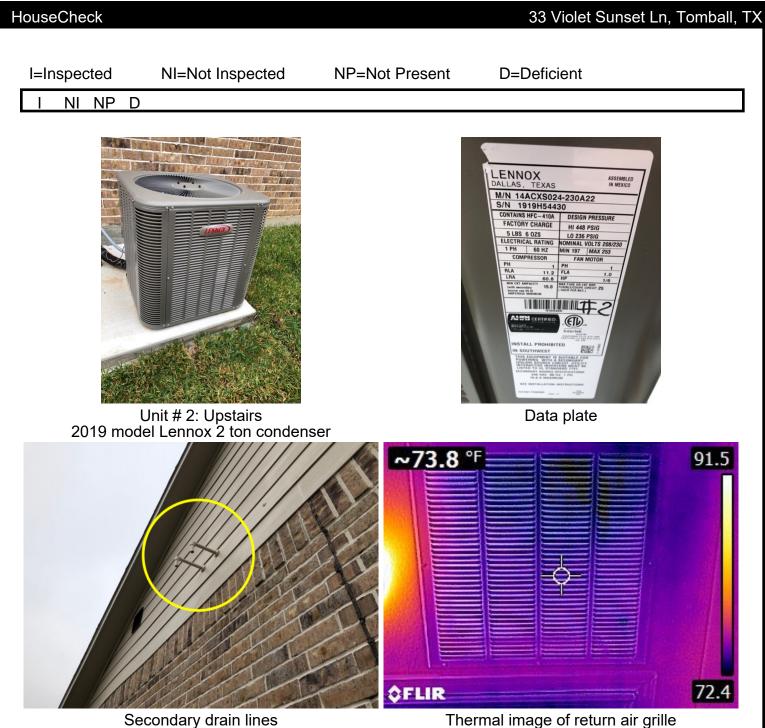
14 - 22 degrees for the Second floor air differe is 14 - 22 degrees for t Secondary drain lines 	cooling equipment.) ntial tested: Register = he cooling equipment.)	2// Return = 73. (Standard range is 55// Return = 73. (Standard range location. Drain lines are required to interior.
	ht # 1: Downstairs el Lennox 4 ton condens	er
