Inspection Report

Property Address:
105 Jordan Gage Ln
Lumberton TX 77657

PROPERTY INSPECTION REPORT FORM

Mr. Jeff Muckleroy	2/4/2022
<i>Name of Client</i>	<i>Date of Inspection</i>
105 Jorden Gage Ln, Lumberton, TX 77657	
<i>Address of Inspected Property</i>	
Joe Askew	TREC# 0010495
<i>Name of Inspector</i>	<i>TREC License #</i>
<i>Name of Sponsor (if applicable)</i>	<i>TREC License #</i>

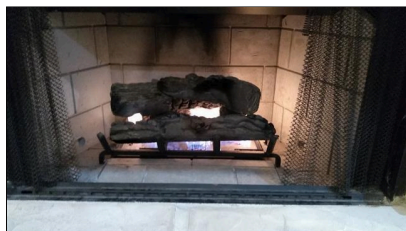
J. (Picture 1)

The gas shut off valve for the fireplace is located under the front service cover.

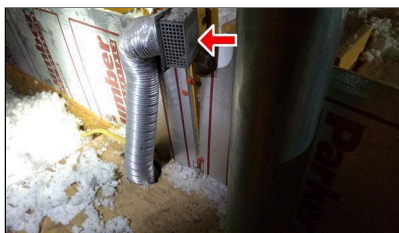
J. (Picture 3)

(2) **Note:** The fireplace has been installed with the make-up air supply vent pulling air from the attic (common installation). The manufacturer instructions usually recommend installing these supply vents to pull air from the exterior at the same level as the fireplace. The Texas Real Estate Commission has asked inspectors to point this out in the inspection report. This is for your information.

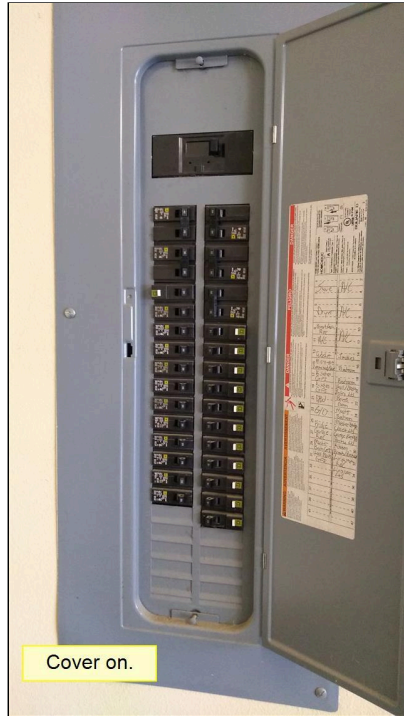
A. (Picture 1)

A 200 amp panel box was noted in the garage.

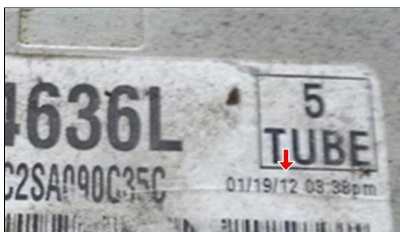
A. (Picture 1)

(3) **Downstairs:** A Maytag brand gas furnace was noted for the downstairs area. It was manufactured in 2012.

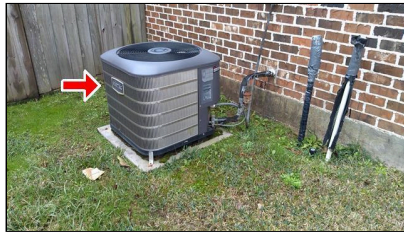
B. (Picture 2)

(3) A Maytag brand condenser unit was noted at the left side exterior. According to the serial number, it was manufactured in 2012.

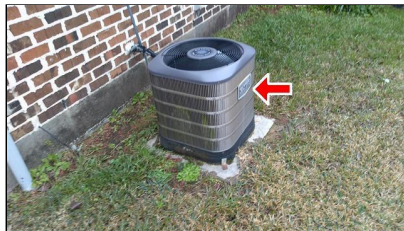
B. (Picture 4)

(4) A Maytag brand condenser unit was noted at the right side exterior. According to the serial number, it was manufactured in 2009.

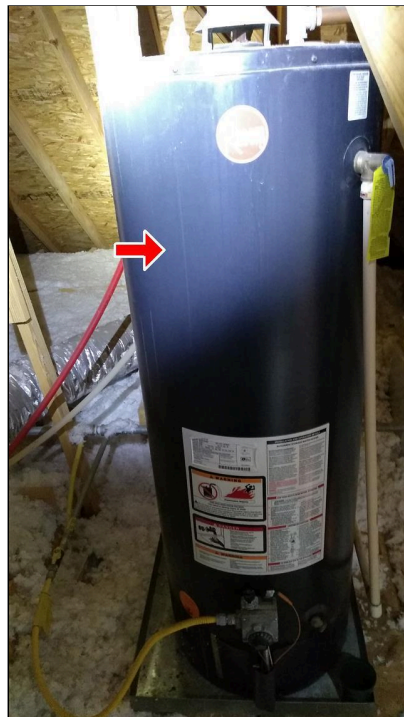
C. (Picture 1)

(1) A 50 gallon gas water heater was noted at the left side of the attic. It was manufactured in 2012.
