MECHANICAL INSPECTION

10818 Piping Rock Ln
Houston, TX 77042

PROPERTY INSPECTION REPORT FORM

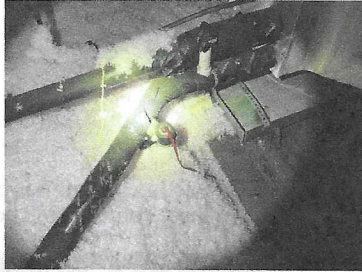
Overflow Pan - Water sensor present:

The overflow pan under the evaporator coil was equipped with a water sensor that is intended to shut off the air conditioning equipment if the pan fills with water.

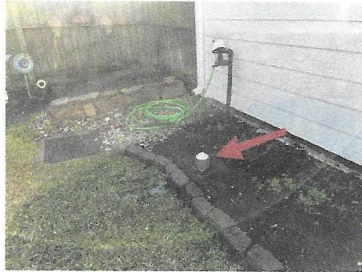
Sewer Piping - Evidence of repairs observed: PVC clean out present -

?? Any repairs made? Evidences of sewer line repairs and/or replacement were observed. It is noted that we could not determine the extent of the repairs to the sewer system or if any of the original cast iron piping is still active. Further investigation is recommended with the owner and/or a service company to determine the extent of the repairs and to determine if any further repairs are needed. A sewer inspection with a plumber to verify the extent of the repairs and the condition of the sewer piping and the repairs is recommended. The plumber should also determine if the washing machine drain riser is adequately sized to accommodate a modern washing machine.

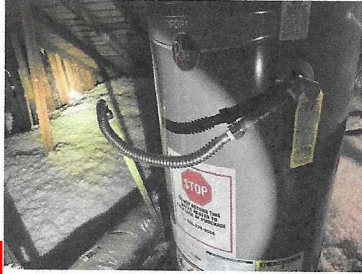
2: Vent pipe needs repair

Called
Plumber
Strapping
Handyman

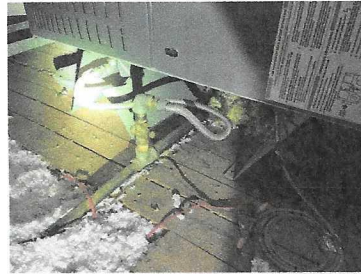
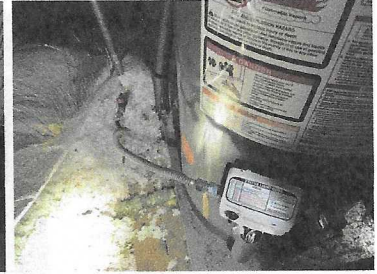
1: Sediment Trap - Missing

Obtain Cost Estimate

Recommendation: Contact a qualified professional.

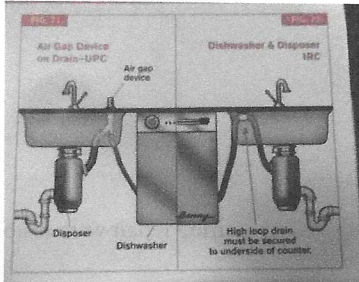
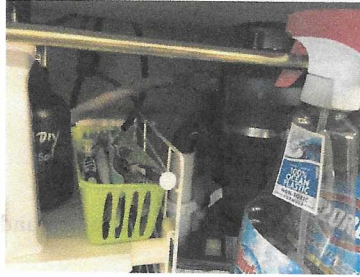
The drain line under the sink was not equipped with an anti-siphon device, nor was it looped up so that the top of the loop is at least six inches above the entrance of the drain line into the disposal. It is recommended at least that the drain line be looped to prevent the water from the garbage disposal from siphoning back into the dishwasher, or an anti-siphon device installed.

Obtain Cost Estimate

Handyman
Corrected
(Built in on new d/w)

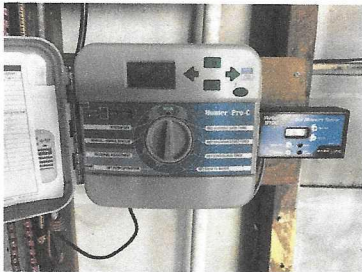
1: Adjust sprinkler head spray

Spraying rear of house -

The sprinkler head spray was in need of adjustment/repair.
Obtain cost estimate

Recommendation: Contact a qualified professional.
