RedFish Inspections

Property Inspection Report

4327 Croft Creek Dr, Spring, TX 77386
Inspection prepared for: Harold Andrew
Real Estate Agent: -

Date of Inspection: 12/12/2018 Time: 11:00 AM - 1:00 PM
Age of Home: New Size: 2738 sqft
Weather: Sunny

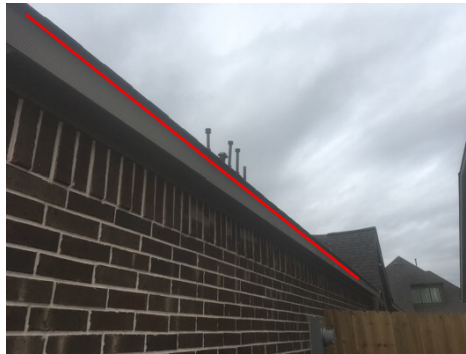
Incomplete gutter system

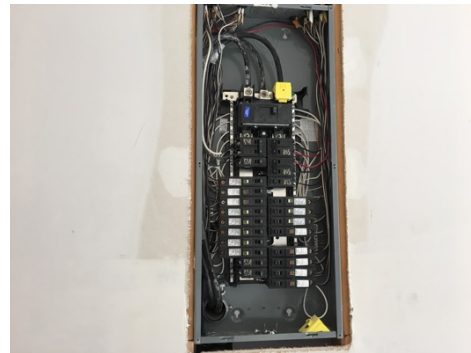
The service panel performed as designed at the time of inspection.

Service panel with deadfront removed
