HEDDERMAN ENGINEERING, INC.

REF: CONDITION OF PROPERTY SURVEY

3601 Wakeforest Street

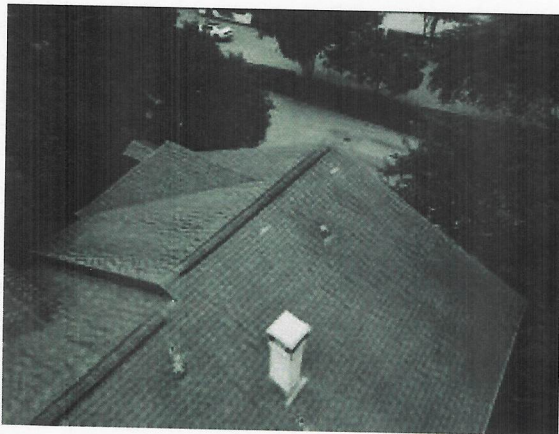
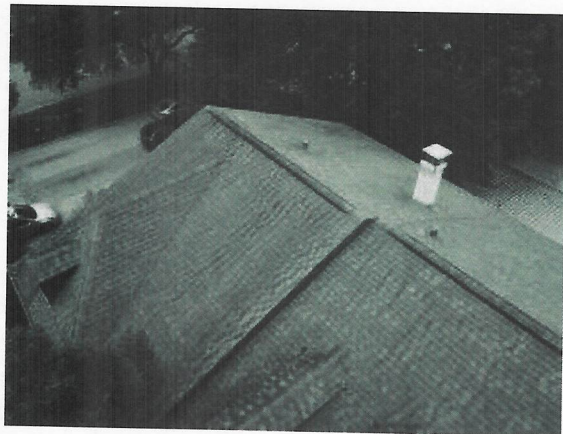
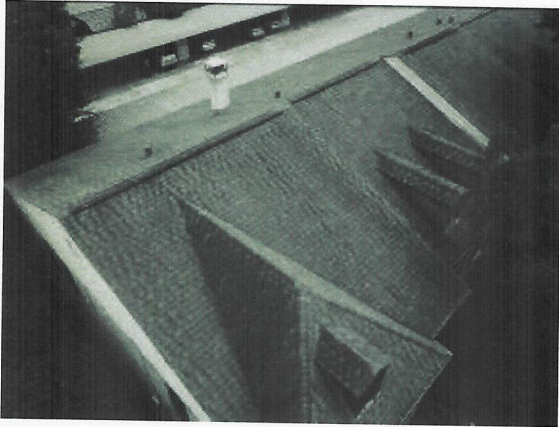
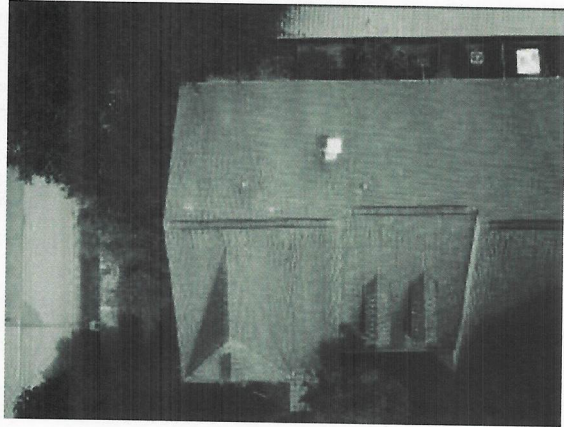
After observing the interior of the structure, evidences of roof leaks were visible in the attic, where the roof decking was rotted. It is recommended that a roofing contractor be contacted to find the source of the leaks, and to make any needed repairs.

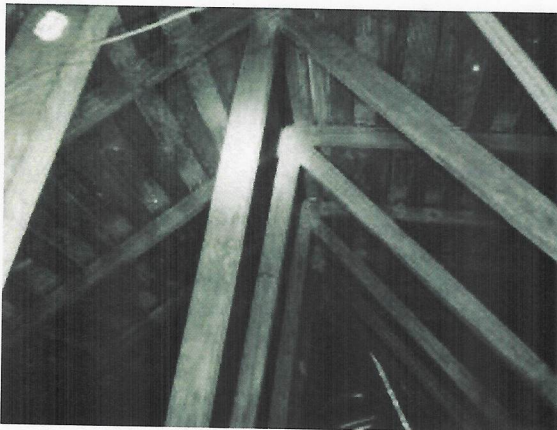
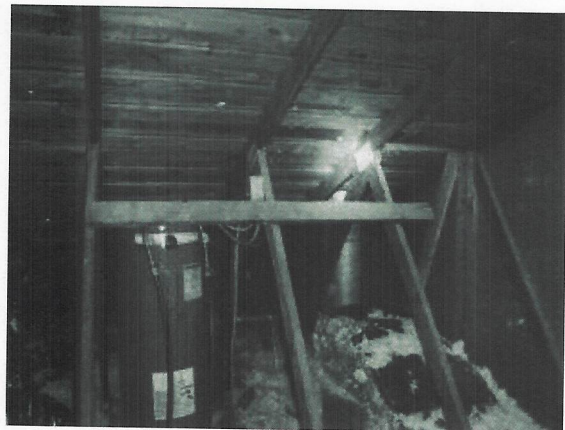
No deficiencies were observed in the primary load carrying members of the structural framing that were accessible and viewed at the time of the inspection, including the roof framing, load bearing walls, ceilings, and floors. No significant deflections were observed in the roof framing as we were able to look up the plane of the roof from the different sides of the house.

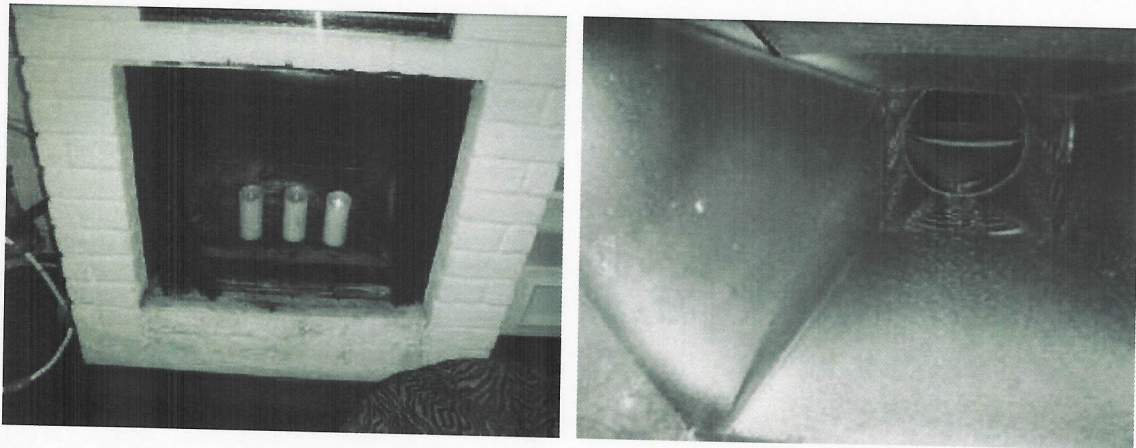
The damper was operational, and the firebox was properly sealed.

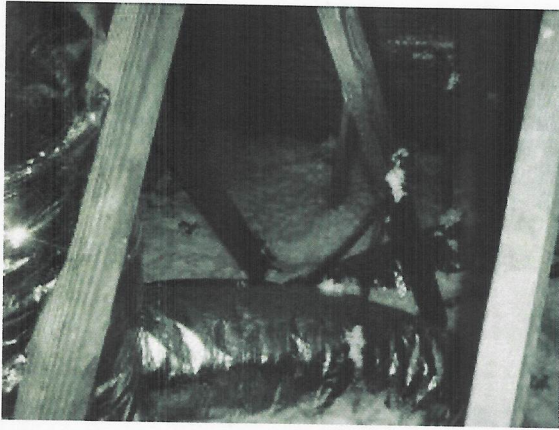
The insulation in the attic was average by today's standards. The normal amount of insulation for attics in this area is 12 inches or an R30 energy rating. This attic appeared to have approximately 12 inches of fiberglass blown-in insulation in the ceiling.
