PROPERTY INSPECTION REPORT

Concerning: 3601 Wakeforest Street, Houston, TX 77098
(Address or Other Identification of Inspected Property)

By: Daniel Koteles #21157 05-29-18
(Name and License Number of Inspector) (Date)

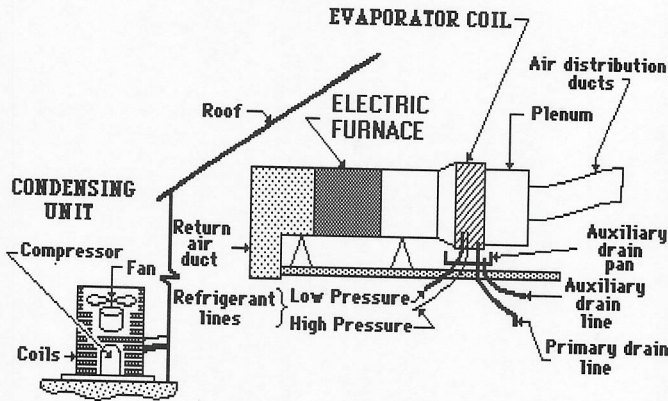
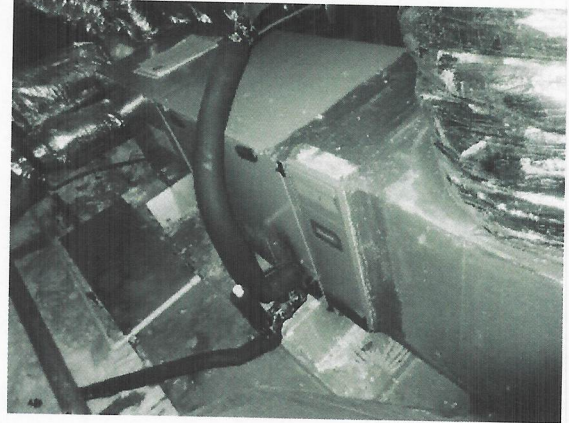
Heating, Ventilation, and Air Conditioning

The heating for the house was provided by a electric horizontal furnace located in the attic. The equipment was as follows:

No items requiring repair were observed at the time of the inspection for the heating performance of the electric furnace.

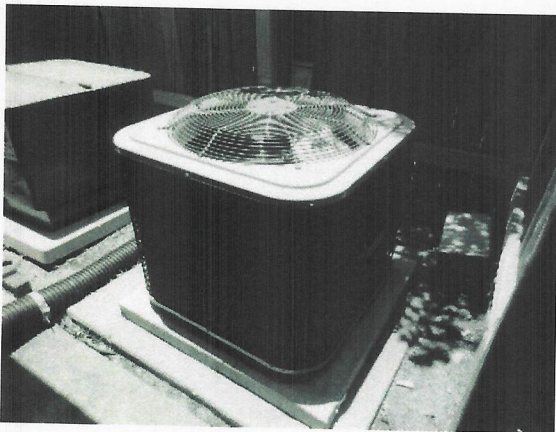
The air conditioning for the house was provided by one forced air split system. The equipment included the following:

Zone	Condensing Unit	Date	Evap. Coil	Date	ΔT (degrees)
House	4-ton Comfortmaker	2016	4-ton	2016	20

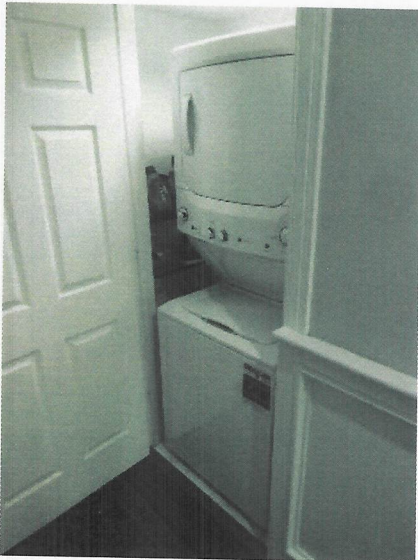
Washer/Dryer

The utility room contained a washing machine and dryer. Neither the washing machine nor dryer were operationally checked at the time of the inspection. No water was run down the drain line for the washing machine.
