9515 Chaddington Ct
Tomball, TX 77375

PROPERTY INSPECTION REPORT

Concerning: 9515 Chaddington Ct, Tomball, TX 77375
(Address or Other Identification of Inspected Property)

By: Joe Budzinski, Lic #23245 06/17/2019
(Name and License Number of Inspector) (Date)

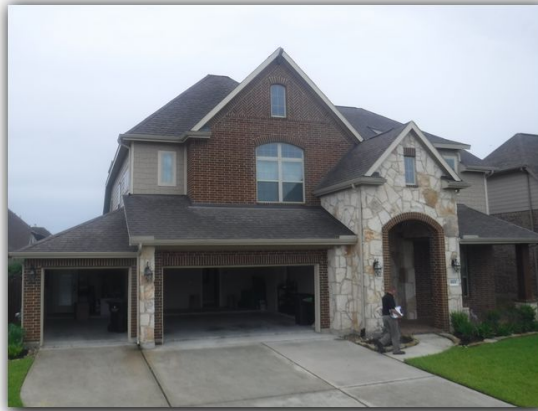
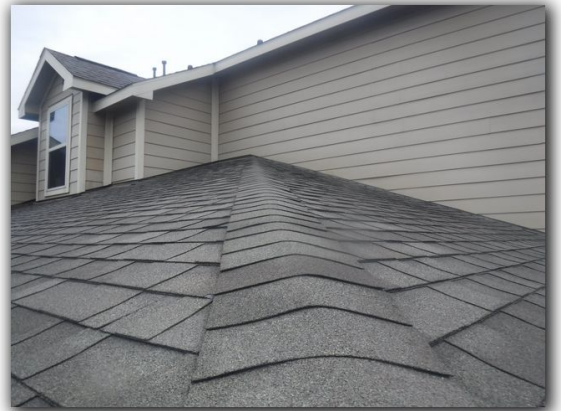
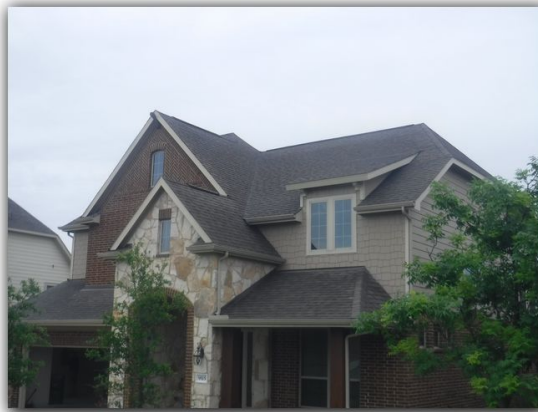
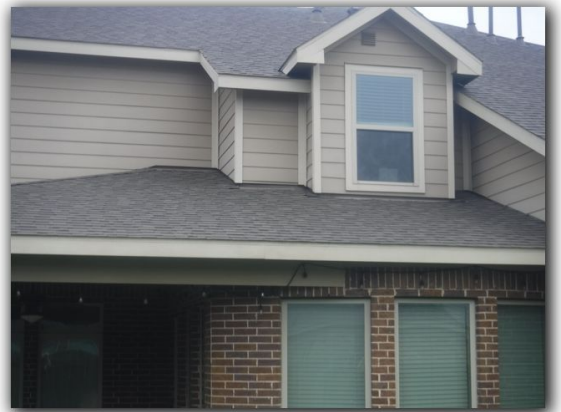
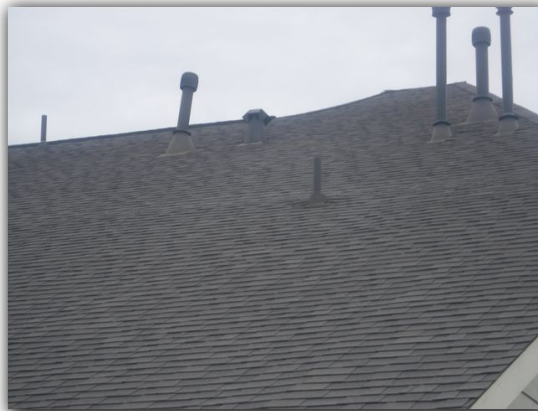
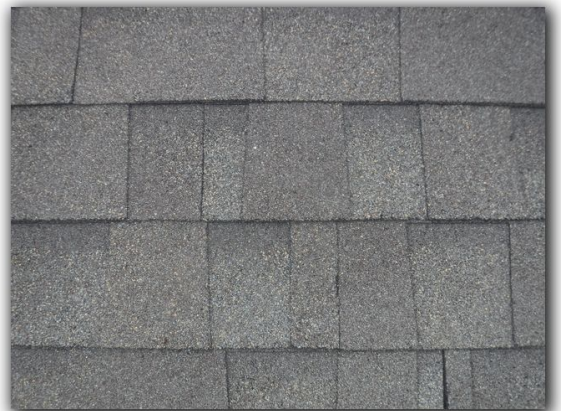
Type of roof covering observed to be composition over solid decking.

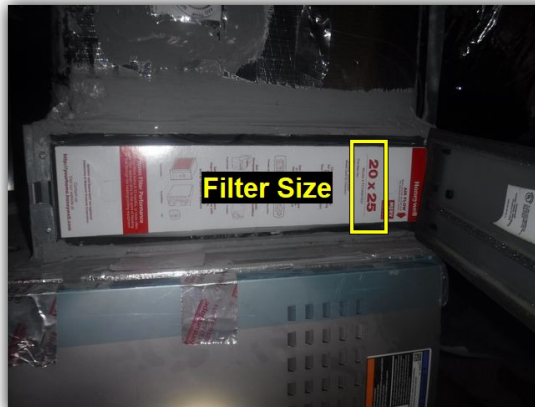
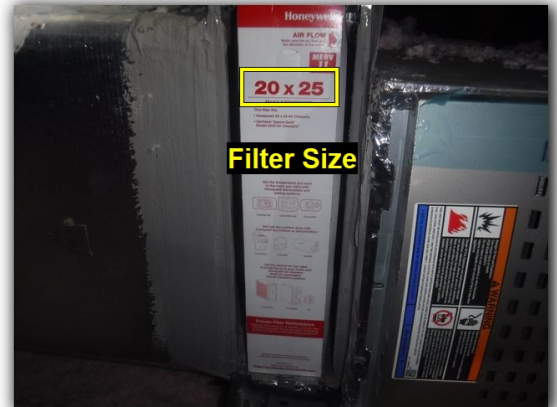
Observed the AC / Heating system is equipped with a whole home filter system. Recommend changing the filter as directed by the manufacturers recommendations. Filter Size: 20 X 25 X 4
