NationSpec Home Inspection

23615 San Servero Dr, Katy, TX 77493

Date of Inspection: 4/13/2022 Time: 2:00 PM

PROPERTY INSPECTION REPORT

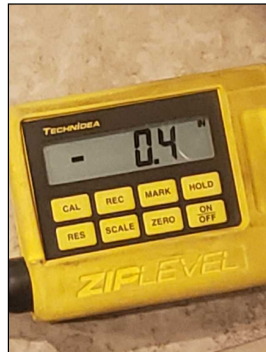
Kitchen, near refrigerator -0.4

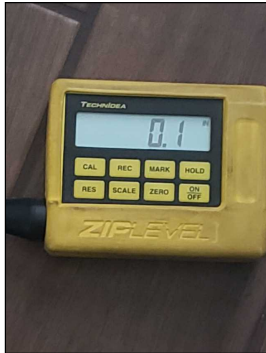
Primary bedroom, back right corner 0.2

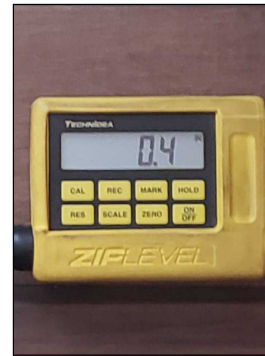
Front right bedroom, front right corner 0.4

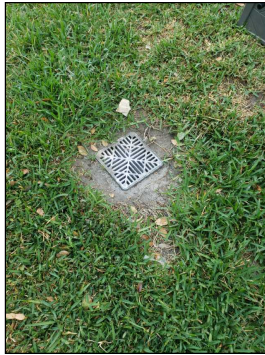
Drainage system noted

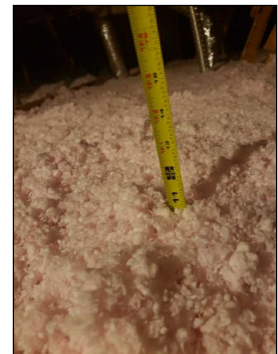
Insulation is 10 to 11 inches deep

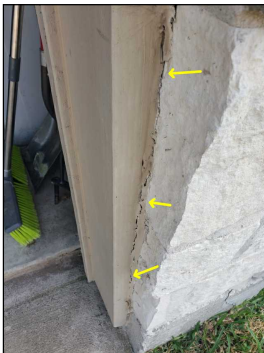
Front, needs caulking improvements
REI 7-5 (05/4/2015)

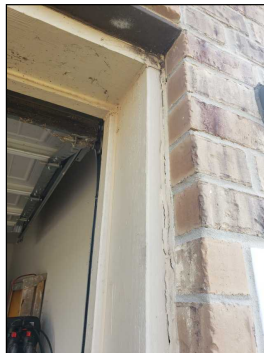
Front, needs caulking improvements

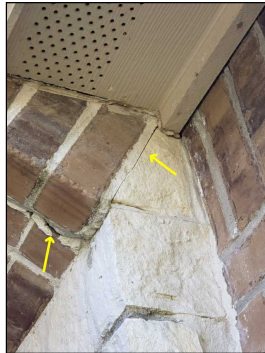
Front, needs mortar pointing

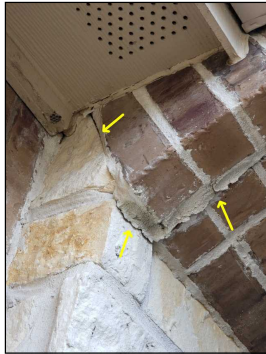
Front, needs mortar pointing

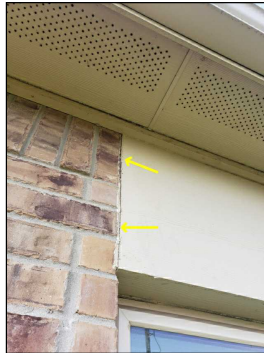
Back side, needs caulking improvements

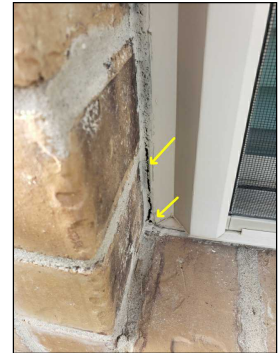
Back side, needs caulking improvements

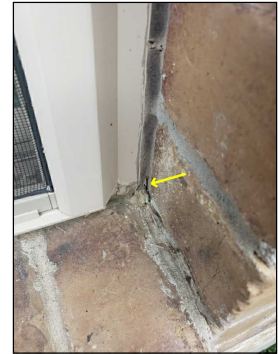
Right side, needs caulking improvements

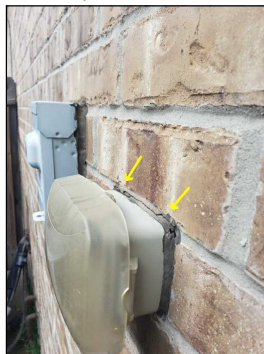
Right side, needs caulking improvements

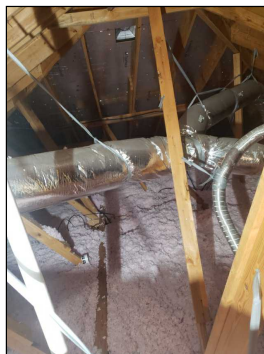
Ductwork was properly hung from roof structure and not touching each other

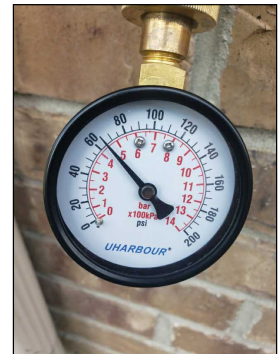
Static water pressure is approximately 65 psi

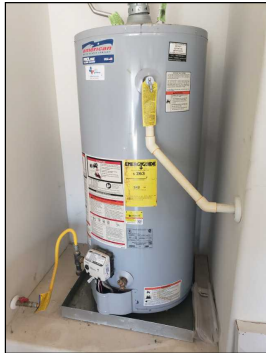
American 40 gallon gas water heater manufactured in 2015. TPR valve/drain, gas shutoff valve, sediment trap, heat controls, pan and pan drain

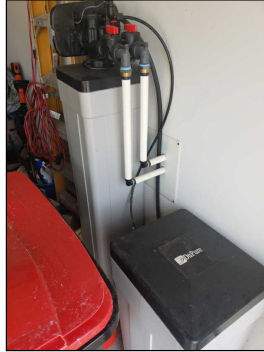
DuPure water softener. We do not inspect this item

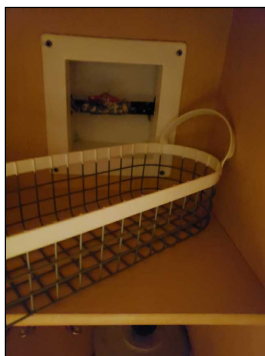
Gas shutoff valve in bottom left cabinet
