1st Rate Inspections

Property Inspection Report

13292 Morgan Dr, Splendora, TX 77372
Inspection prepared for: Daniel Maestas
Real Estate Agent: David Kelley - AVO Realty, LLC

Date of Inspection: 5/22/2021 Time: 1:30 PM
Age of Home: 1960 Size: 2700
Order ID: 18397

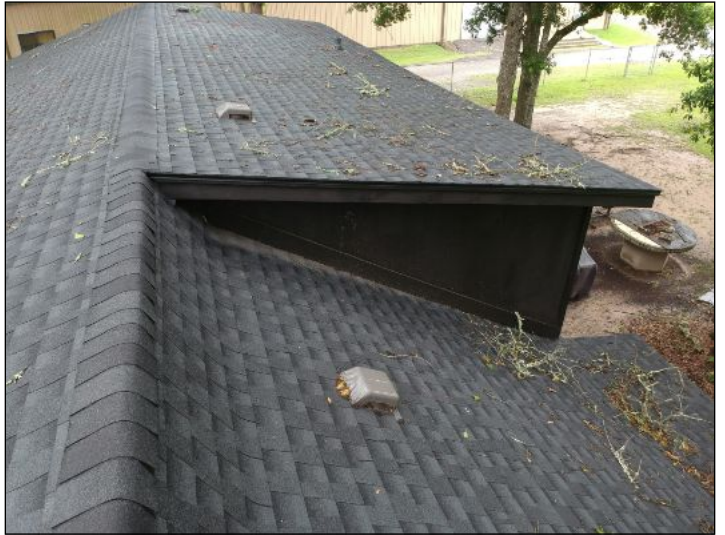
Overview of roof

-The decking is buckling on the roof, this is often caused by an improper gap for expansion of the decking materials, recommend consulting a roofing contractor for evaluation and repairs as needed.

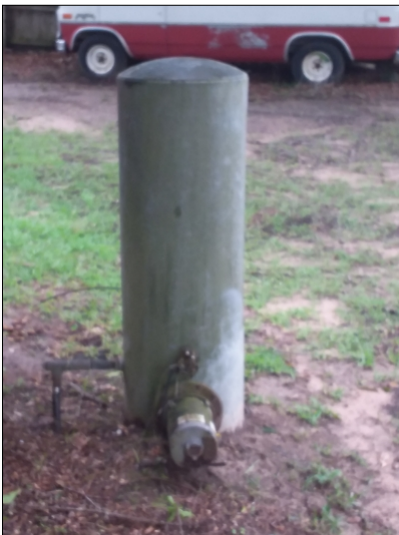
Existing water well system currently not in use, house is currently on city supplied water.

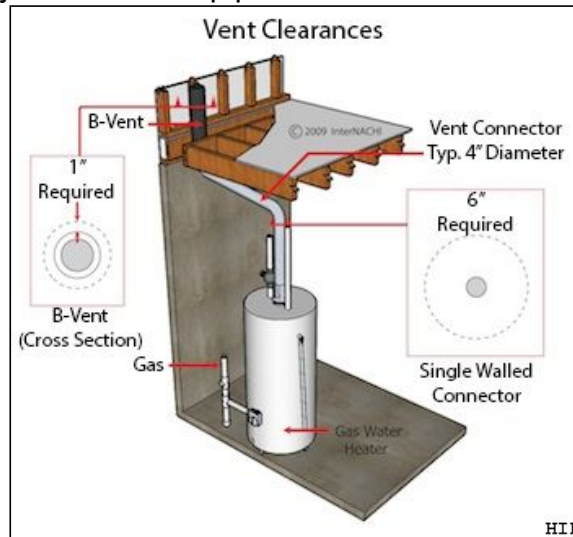
-Improper clearance to combustibles at flue pipe.
 Recommend cutting wood or other combustible material back at least 1" away from the flue pipe.

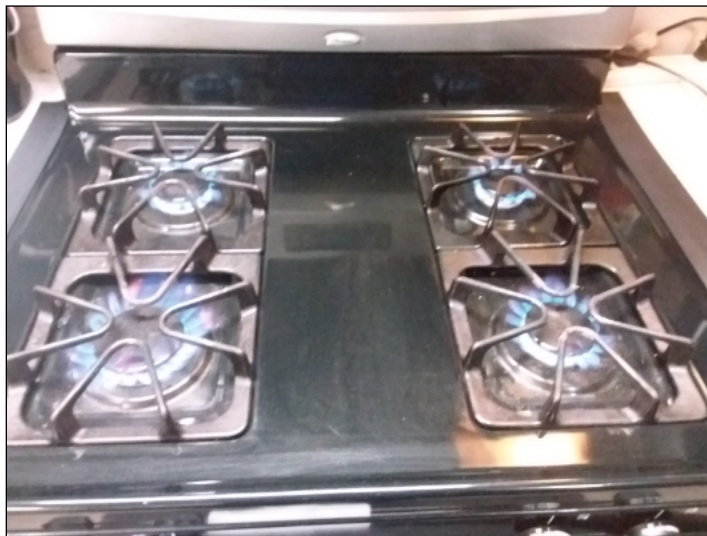
-The range is operating as intended.
