Mimi Fang
4329 Eigel St
Houston, TX 77007

April 21, 2022

PROPERTY INSPECTION REPORT FORM

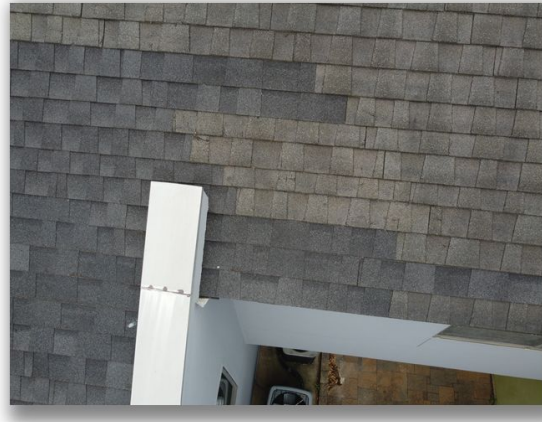
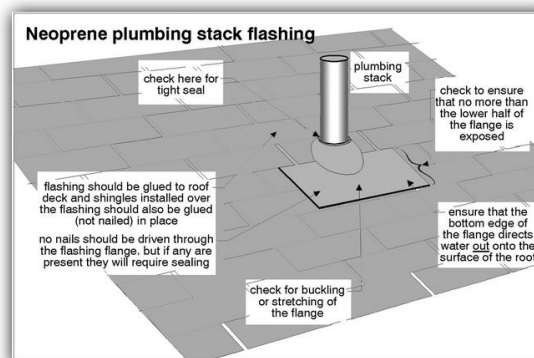
Flashing Details

The flashing details needs to be checked, reset or repaired as necessary. The observations made to support the rendering of this opinion are listed but may not be limited to:

- One or more of the roof level plumbing vent stack flashing details have some damage to the rubber seal around the stack. This condition could allow water penetration at this point. It is recommended to replace 1 rubber seals.
- The exterior flashing needs to be painted to prevent UV/ Rust damage .
- Some of the metal flashing details were observed to be rusted and should be corrected as necessary.
- The flashing is lifting and/or pulling loose and should be re-secured on the east side of the roof structure.

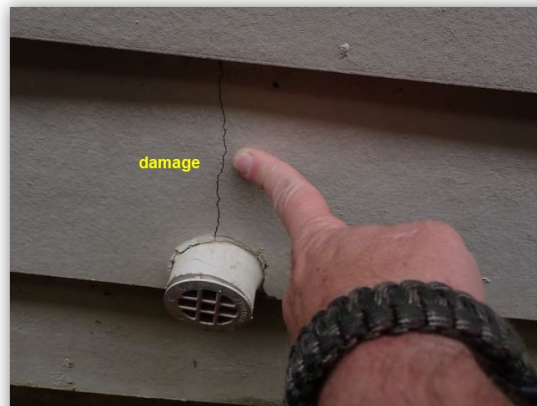
- Caulking improvements are recommended for the area between the exterior veneer and the window frames. It is recommended to use an elastomeric caulking.
- The area between the exterior cladding / veneer and all of the wall penetrations / openings need to be properly sealed. Areas such as utility connections, downspouts, hose bibbs, lighting fixtures, receptacles etc. It is recommended to use an elastomeric caulking / sealant.
- All joints between two different types of siding should be properly sealed. It is recommended to use elastomeric sealant.
- The exterior veneer / cladding has some deterioration and/or damage on the west side of the structure.

Note: The heavy foliage growing on, over or around the exterior walls of the structure should be trimmed back at least 18-inches. The heavy foliage will limit the inspectors visual observation of the exterior surfaces.

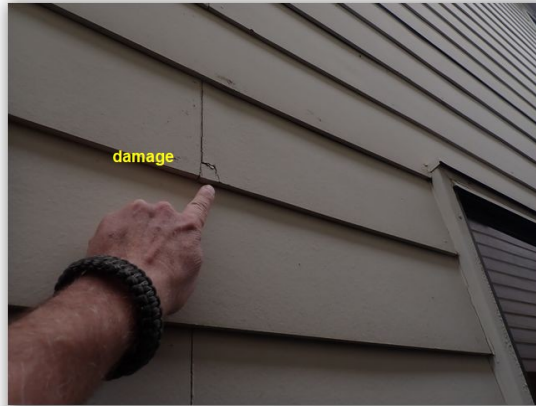
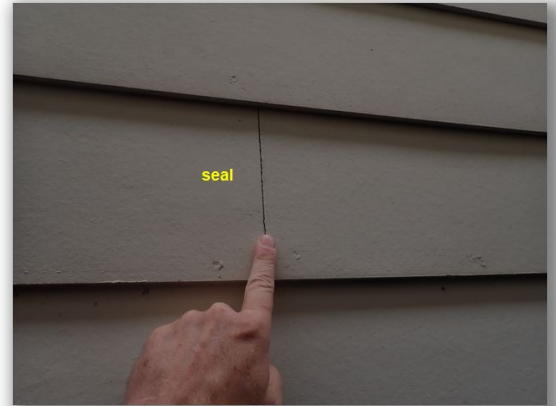
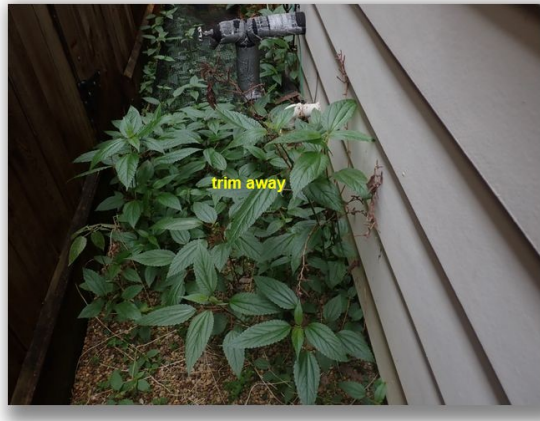
- The area between the exterior cladding / veneer and all of the wall penetrations / openings need to be properly sealed. Areas such as utility connections, downspouts, hose bibbs, lighting fixtures, receptacles etc. It is recommended to use an elastomeric caulking / sealant.

- All joints between two different types of siding should be properly sealed. It is recommended to use elastomeric sealant.

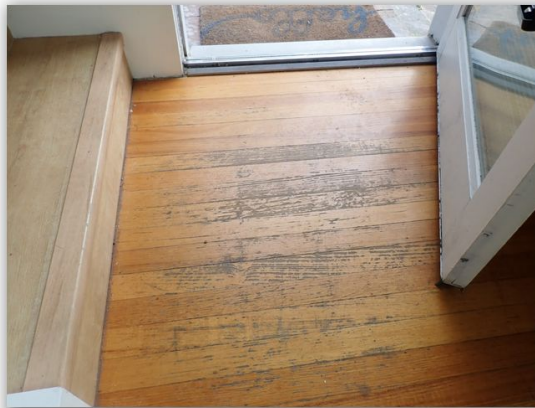
Floors

- The floor covering is worn and/or damaged in one or more locations of the home.
- The floor covering was observed to be water damaged in the half bathroom.
- The floors were observed to be out-of-level in some areas of the house.

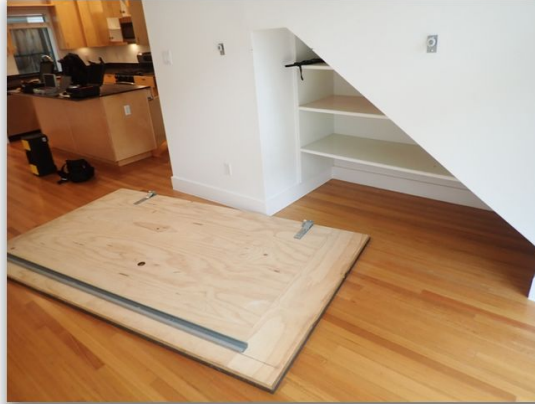
Interior Doors

- The door is not latching properly to the half bathroom, guest bathroom.
- The exterior door frame has some deterioration and/or damage to the front entry door(s).
- The door is missing to the front entry closet.

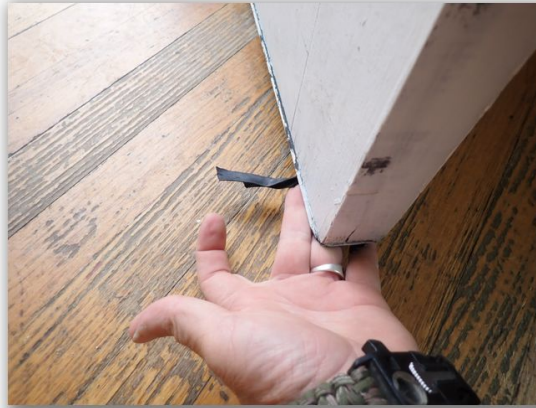
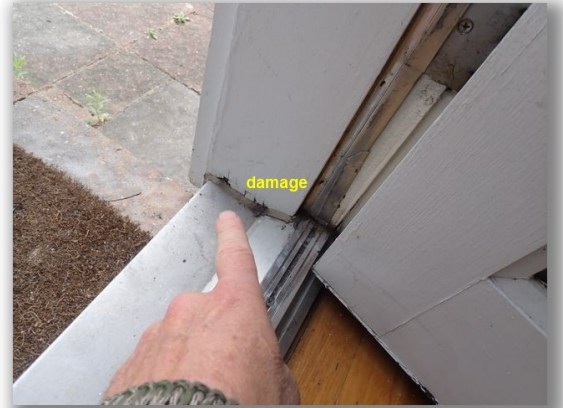
Overhead Garage Door

- The weather-stripping at the bottom of the overhead garage door is damaged and repairs or replacement may be necessary.
- The overhead garage door panel(s) and/or panel trim has some deterioration and/or damage.

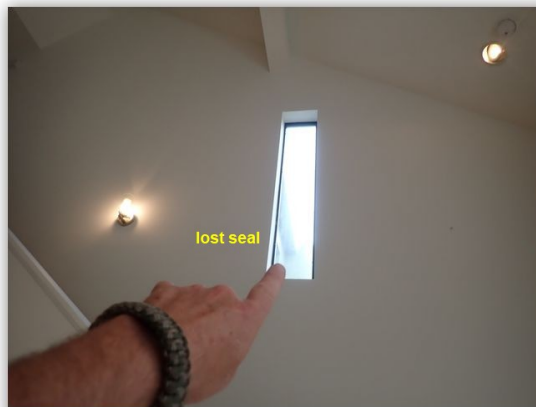
- One or more of the thermal pane windows were observed to have lost their seals. This has resulted in condensation or a fog like film to develop between the panes of glass. The thermal pane windows no longer function as designed when they lose their seal and replacement may be necessary. The windows that have noticeably lost their seals are listed but may not be limited to the following:
stairway.

- The window weather-stripping is damaged and/or missing at one or more of the windows and improvements are recommended.
- The window sill(s) have some deterioration and/or damage to the primary bedroom.
- One or more of the window blinds were observed to be damaged in the primary bedroom.

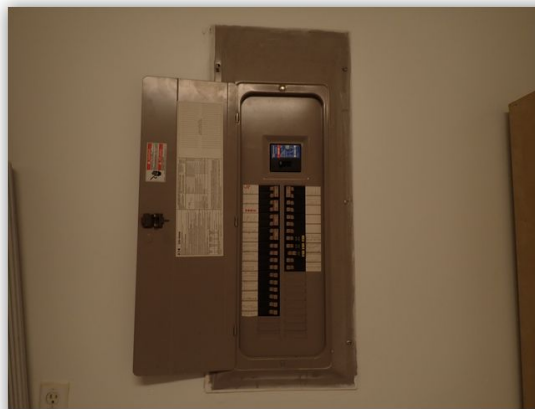
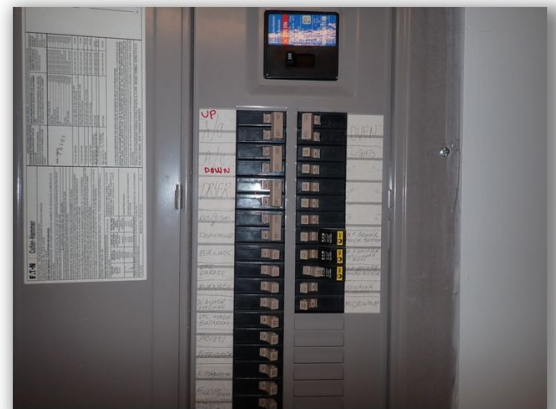
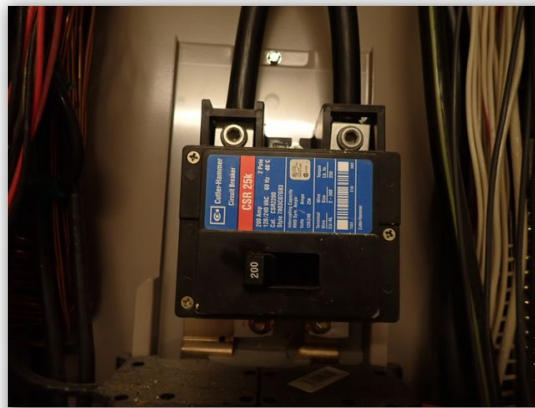
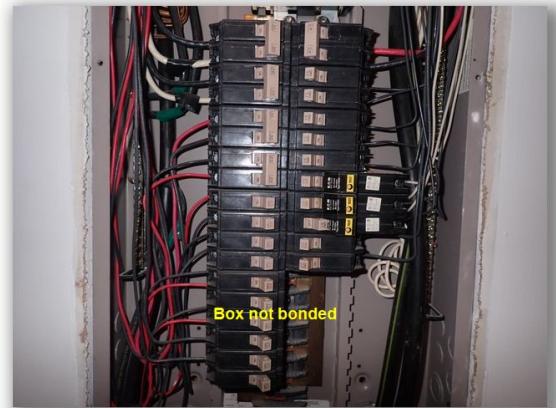
- The electrical cabinet does not appear to be properly bonded to the electrical system.

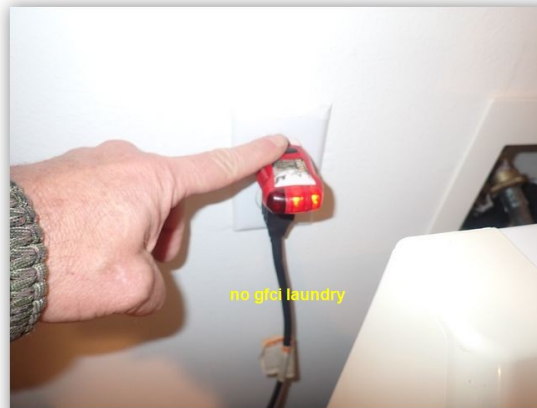
Receptacle Outlets

- There are no tamper resistant receptacles installed at the time of inspection. Under current building standards, all receptacles that are less than five and a half feet above the floor should be tamper resistant. This is an "as built" condition, but per TREC standards of practice, we are required to report this condition as deficient. Tamper Resistant outlets are required per the 2008 National Electric Code. You may consider corrective measures for improved safety.
- The laundry room area receptacles do not appear to be connected to a ground fault circuit interrupter (GFCI) device. Under current electrical standards, all of the receptacles in the laundry room area should have GFCI protection.

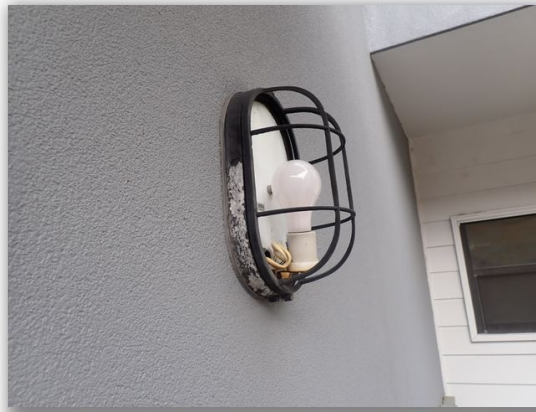
Fixtures

- The ceiling fan appears to be inoperative in the family room.
- One or more of the light fixtures appear to be inoperative in the front porch. This may be due to a bad bulb or some other unknown condition. This condition should be further evaluated and corrected as necessary.
- One or more of the light fixture globes and/or covers are missing in the front porch.

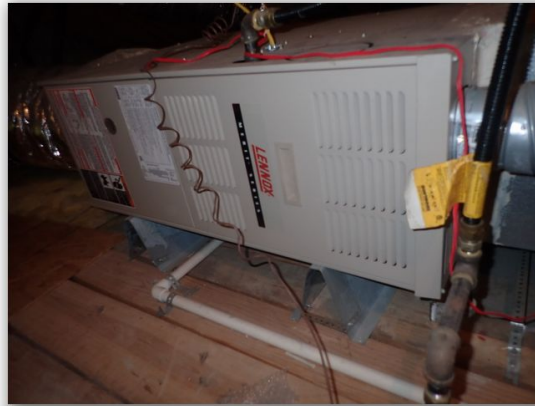
- The heating equipment appears to be inoperative at the time of the inspection.

Note: The gas service was turned off to the structure at the time of this inspection. I was unable to check the gas operation of this component at this time. A limited visual survey will be performed and if any deficiencies are found they will be listed within this section.

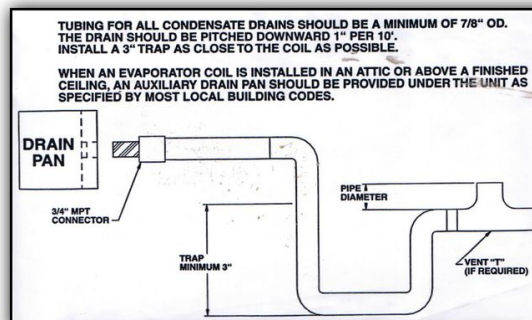
- The secondary drain line on the coil housing is capped at the time of this inspection. It is recommended to remove the cap on the secondary drain line to allow for the drain to function properly when necessary.
- Water was observed to be leaking from the base of the coil housing. The cause and remedy should be further evaluated.
- The auxiliary/secondary drain pan under the coil housing is holding water at the time of this inspection. The cause and remedy should be further evaluated and corrected as necessary.
- The inspector identified rust stains on the exterior wall due to **current** water leaking from the secondary drain line in the attic space.
- The primary condensate drain line is not equipped with a p-trap. Under current mechanical installation standards, the manufacturer requires a p-trap be installed in the primary condensate drain line within 6-inches of the coil housing.

Note: The auxiliary/secondary drain pan under the coil housing has some water staining and/or a rust build-up. This would indicate that the pan has held water in the past and should be closely monitored.

Note: Previous water leakage was observed from around the base of the indoor coil housing. This condition should be closely monitored and corrected if necessary.

Notice: The AC system condenser/coil components are not from the same manufacture. When this type of installation occurs, it may void the manufacture warranty on one or more of the system components. It is recommended to obtain documentation as to whether the manufacture warranty has been voided due to the mismatched manufacture installation.

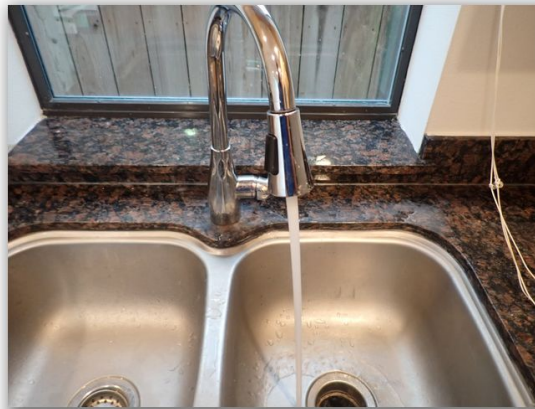
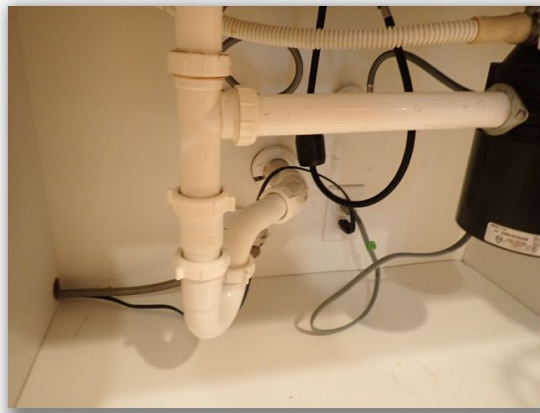
Note: Previous water leaks were observed at and/or around the drain connections under the sink. This would indicate previous problems and should be closely monitored and corrected when necessary.

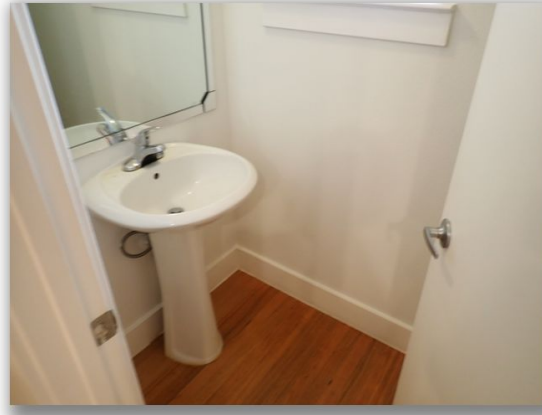
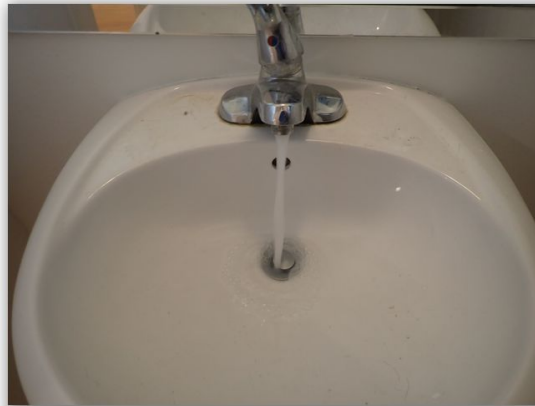
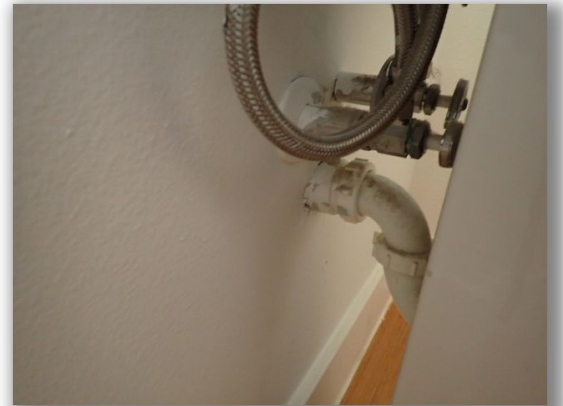
Guest Bathroom

- Cracked, deteriorated and/or missing bathtub enclosure grout and/or caulking should be repaired or replaced as necessary.
- The faucet assembly is not sealed at the wall. This condition has the potential to allow water to leak back into the wall cavity.

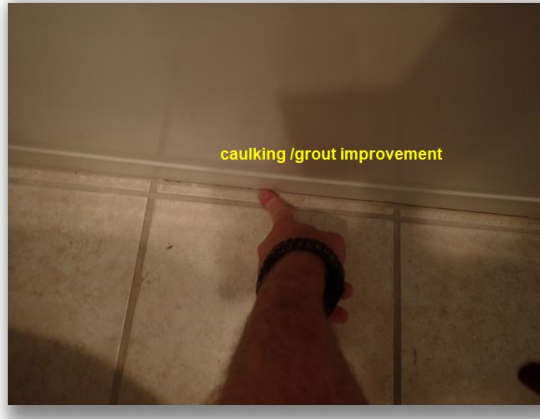
Primary Bathroom

- The faucet assembly is not sealed at the wall. This condition has the potential to allow water to leak back into the wall cavity.
- Cracked, deteriorated and/or missing shower stall grout and/or caulking should be repaired or replaced as necessary.
- The shower door weatherstripping is damaged/missing.

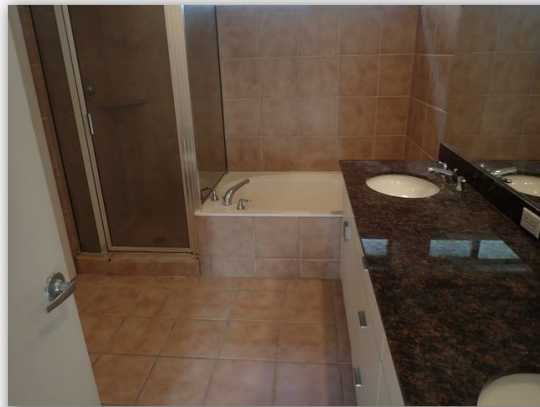
Right Lavatory / Sink

- The faucet handle is damaged.
- The stopper does not appear to be functioning properly.

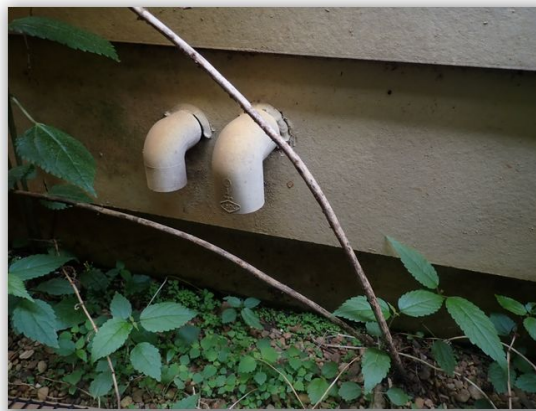
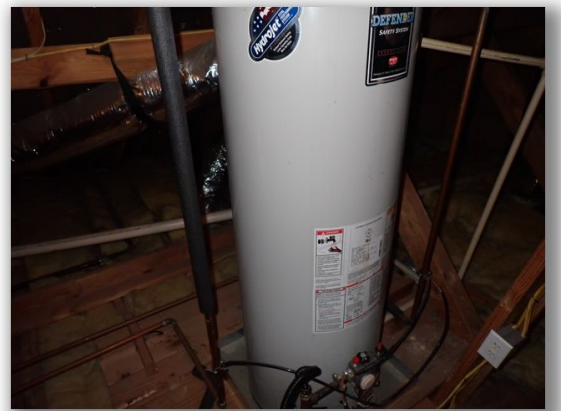
- The temperature and pressure relief (TPR) valve discharge pipe is running in an upwards direction in one or more locations. The TPR discharge pipe should run gravitationally downwards at all points.
- The fittings at the top of the water heater are made of dissimilar metals (galvanized steel connected to copper and/or brass). It is recommended to replace the galvanized steel fittings with brass or copper fittings or install a dielectric union between the two dissimilar metals to prevent electrolysis from occurring.
- Some corrosion was observed at the water supply connections at the top of the water heater.

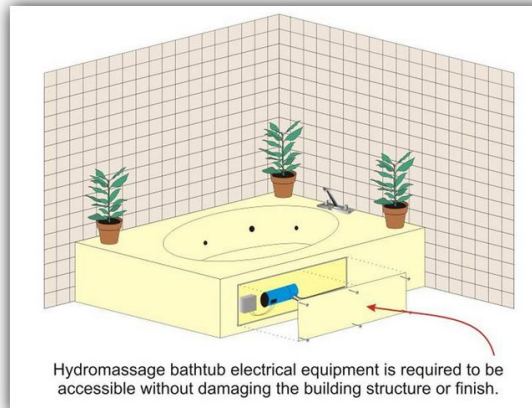
- The access to the hydro-massage therapy equipment motor is not readily accessible and inspection of the equipment lines and motor could not be performed. This does not meet current installation standards.

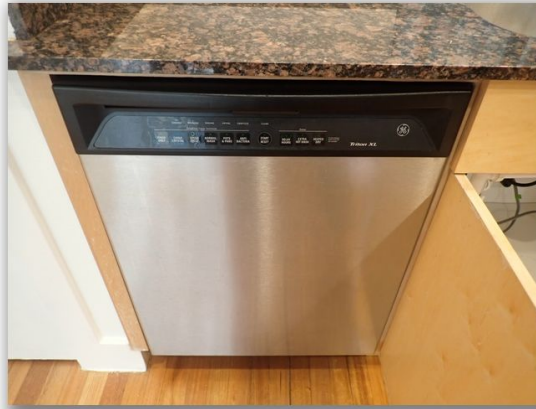
- Some rusting of the dishwasher interior components was observed.

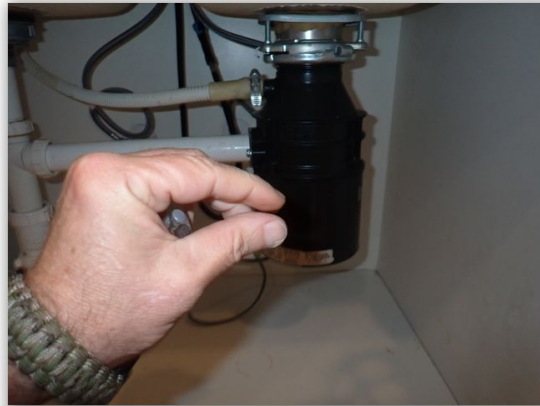
- The food waste disposer was unusually noisy at the time of the inspection.

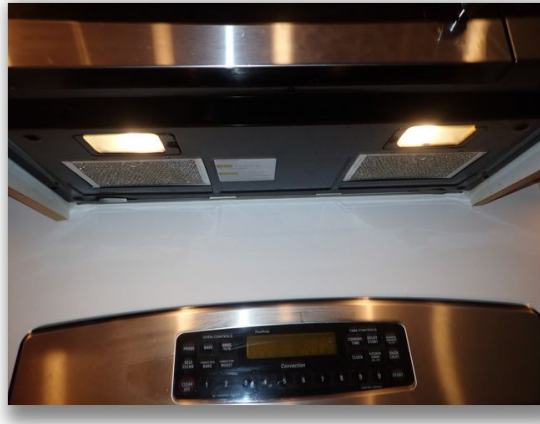
- The range hood in place is ductless. The range hood does not terminate outside and is dependent on the charcoal filter installed. It is recommended to regularly clean your filter system to prevent damage to the structure.

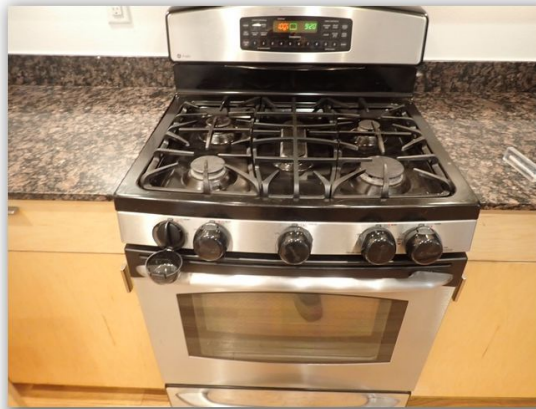
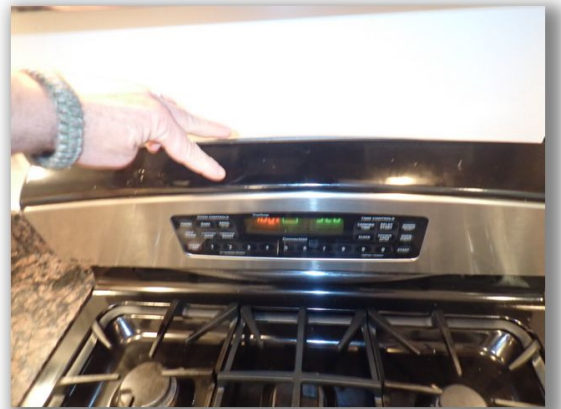
- The range can be easily tipped over and should be equipped with an anti-tip device, for safety.
- The gas shutoff valve is in a poor location and is hard to reach.
- One of the door handles is damaged.
- The oven control panel housing is damaged and/or missing.
- **The range appears to have reached the end of its serviceable life expectancy.**

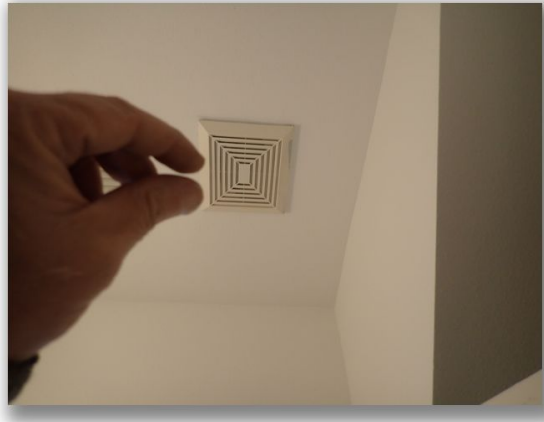
- One or more of the mechanical exhaust vent systems was observed to be terminating to the soffit / eave area. This is an "AS Built" condition that does not meet current manufacturers or mechanical installation standards.
- The mechanical exhaust vent fan was unusually noisy in the half bathroom.

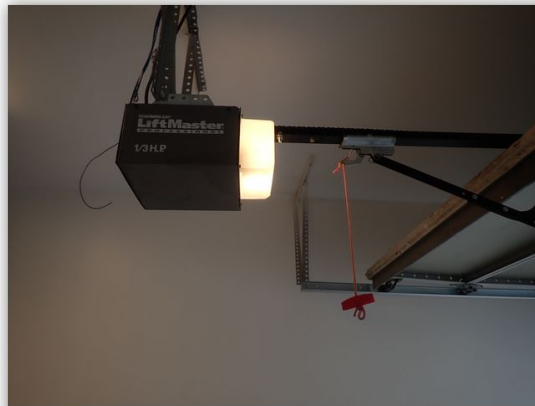
- The garage door opener chain is loose and needs to be better secured and/or adjusted.
