## HEDDERMAN ENGINEERING, INC.

REF: CONDITION OF PROPERTY SURVEY

**10907 Leigh Woods Drive**

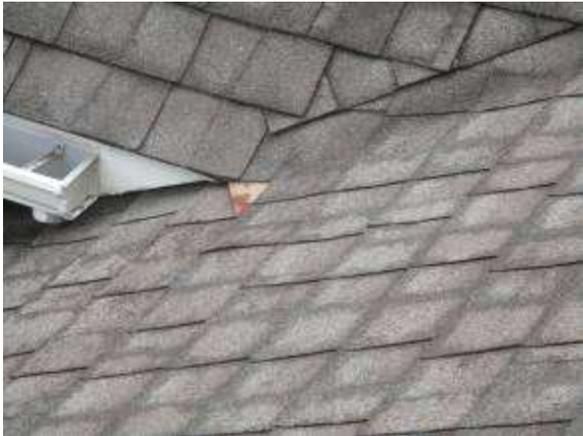
We observed rust on some of the metal roof accessories, and although the accessories are still performing their intended function, it is recommended that the rust be removed. Locations included: Metal valleys

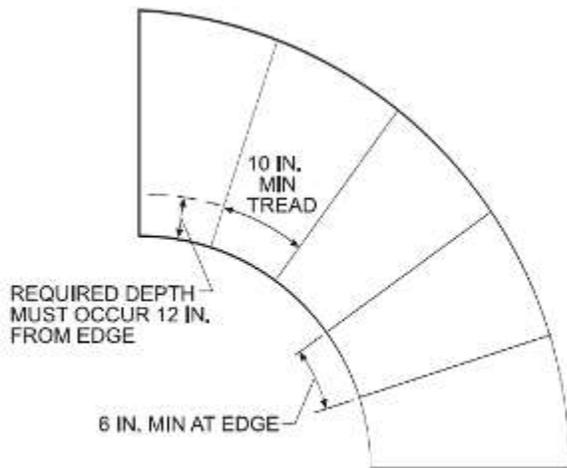
Figure R311.7.5.2.1(2)  
WINDERS USED FOR CIRCULAR STAIRWAY

The stairs were not constructed to the latest revision of the building code, and had steps with treads that were less than six inches wide at the narrowest point.

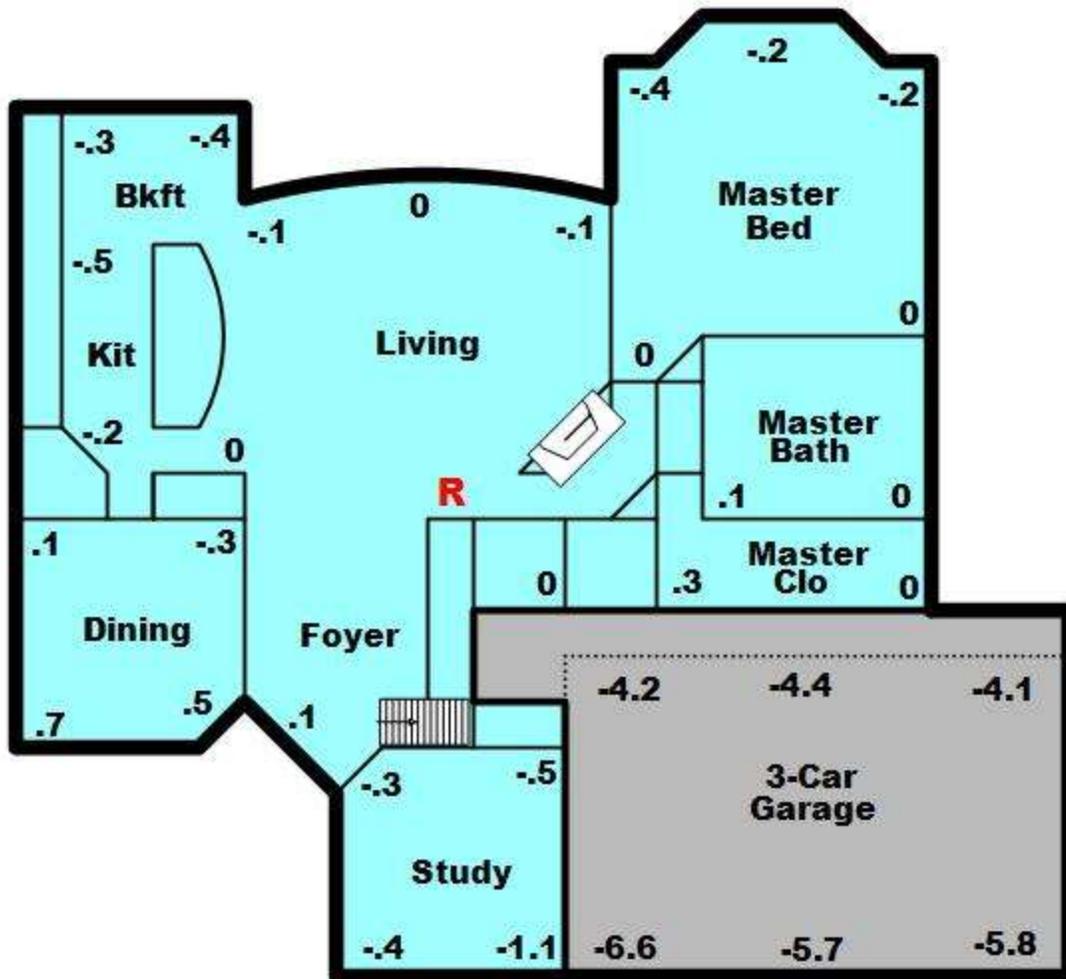
**Elevation Readings  
10907 Leigh Woods Drive**

The floors were checked with an electronic level, and were observed to be sloping generally from the dining room to the rest of the house. The difference in elevation between the high point and low point was 1.8 inches. The high point was located at the dining room, and the low point was located at the study. The unlevelness takes place over a horizontal distance of approximately 35-40 feet.
