## **Property Inspection Report**

3010 Heather Lake Ct.  
Kingwood, TX 77345

**Concerning:** 3010 Heather Lake Ct., Kingwood, TX 77345  
(Address or Other Identification of Inspected Property)

**By:** Larry Fleming, Lic #4860 06/17/2019  
(Name and License Number of Inspector) (Date)

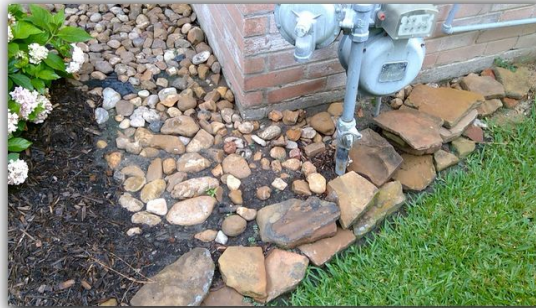
- Shovel Cracks observed at slab brick ledge corners at one or more locations

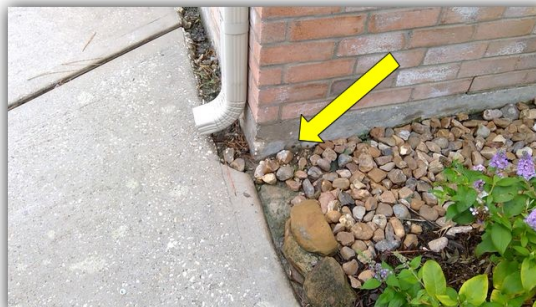
- Post-tension cable ends (foundation reinforcement) exposed / need to be grouted at one or more locations.

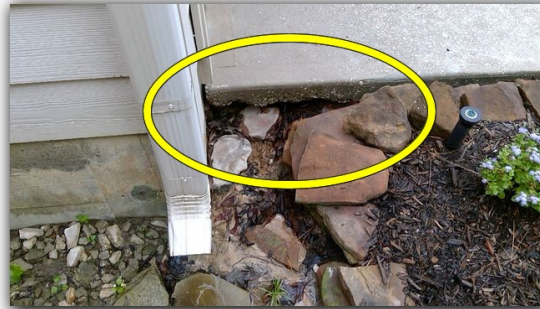
Dirt missing from under front corner of driveway concrete flatwork. Not related to foundation of structure but noted on report for potential buyer to be fully informed

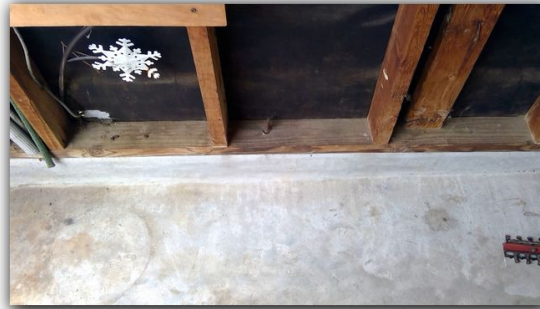
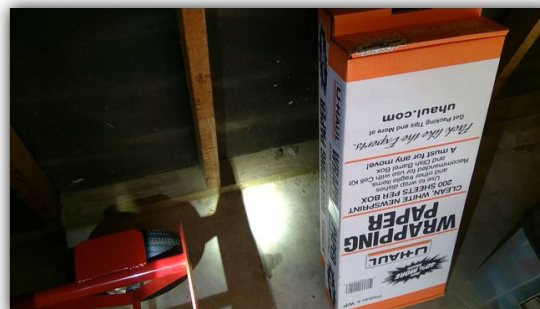
Nuts and washers need to be installed on j-bolts connecting the sill plate to the concrete foundation (multiple locations). (IRC 2015, R403.1.6)

Would recommend that a licensed and / or qualified contractor be consulted to make any further recommendations and / or repairs

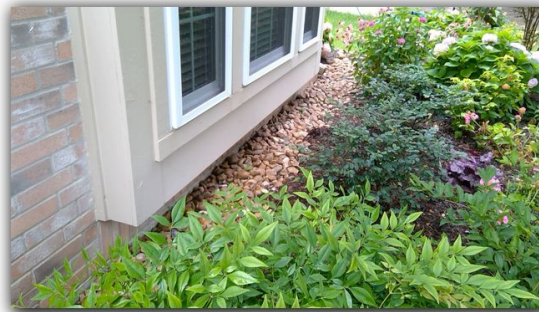
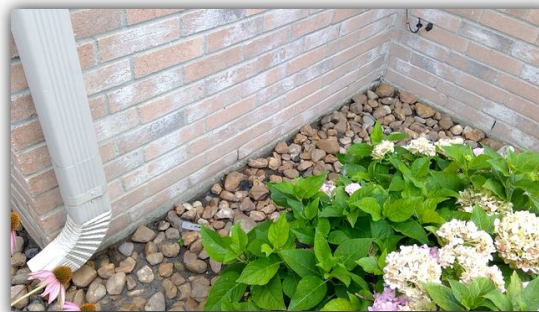
requiring a 4" slab exposure between the finished grade and exterior brick

Would recommend that a licensed and / or qualified contractor be consulted to make any further recommendations and / or repairs

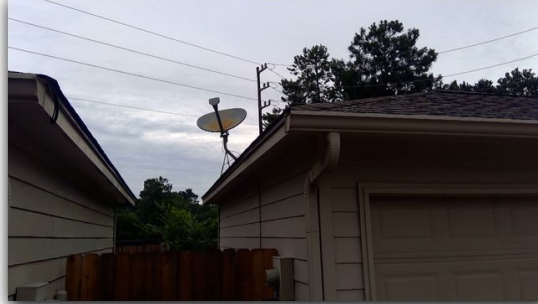
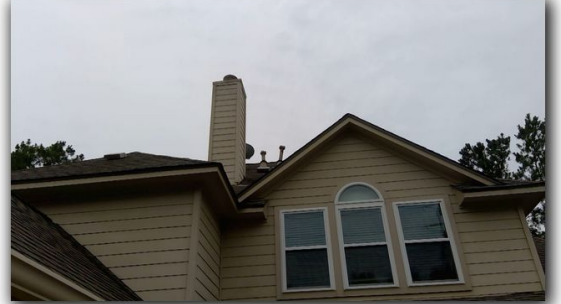
- Satellite dish screwed into the roof covering

**Would recommend that a licensed and / or qualified contractor be consulted to make any**

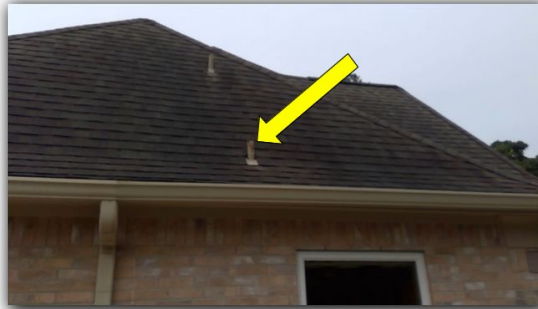
- Vent roof jacks appear to have been gnawed / damaged

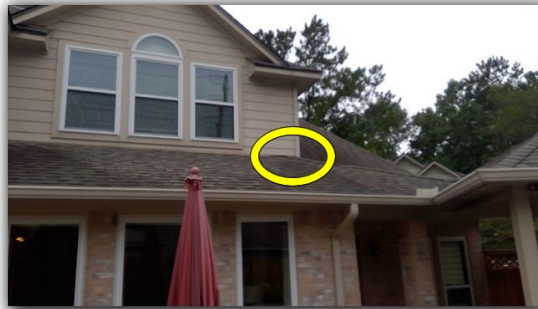
- Flashing is lifting, ill configured, or missing

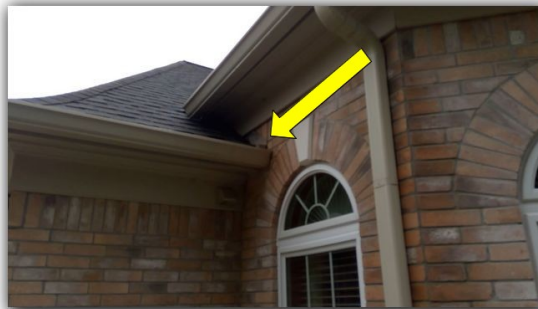
- Flashing / counterflashing not properly caulked

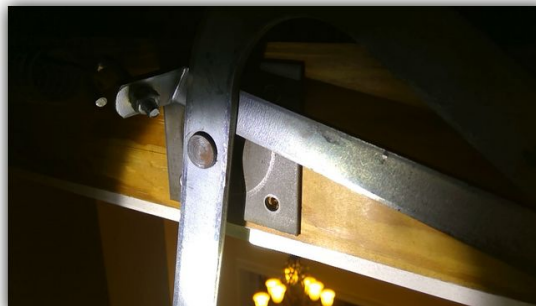
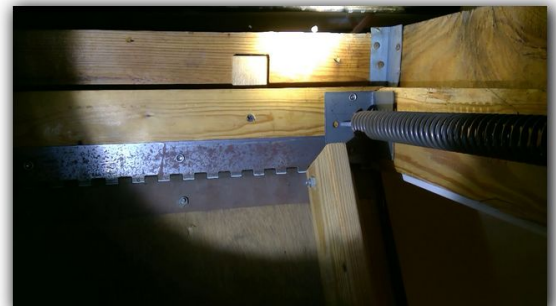
- Attic access fold down ladder not installed per manufacturer's specifications / proper fasteners

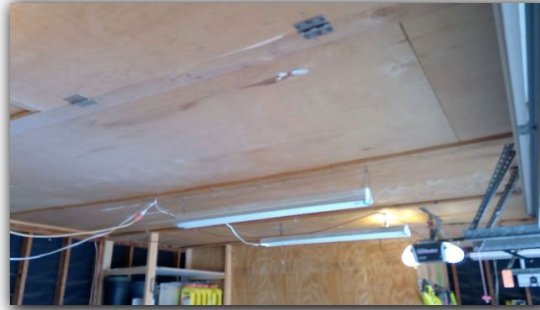
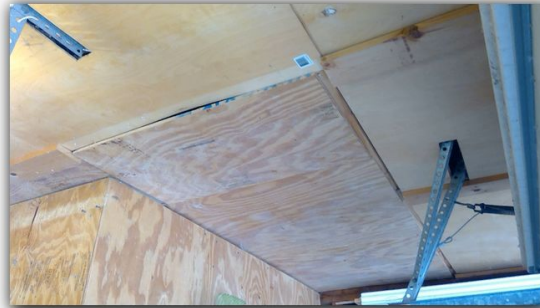
- Proper fire separation needed between garage and attic space. Wood present in the ceiling of the garage is not appropriately fire rated.

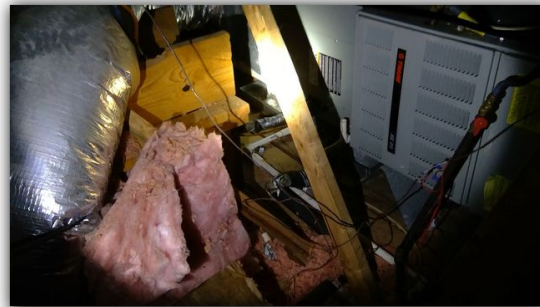
Proper 30" working clearance and level platforms needed in front of equipment located in attic space at one or more locations.

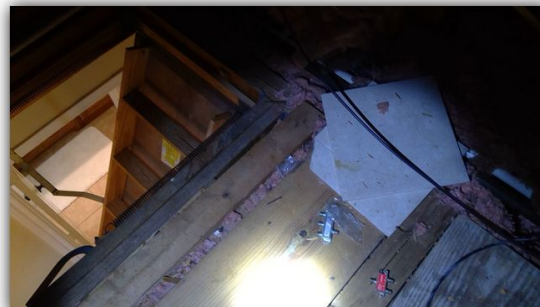
Attic does not conform to current code requiring a continuous / solid and unobstructed 24" wide catwalk

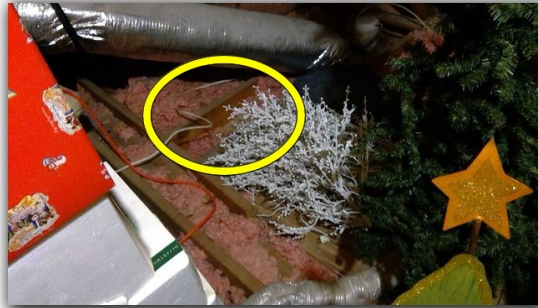
Voids observed in insulation in attic space at one or more locations.

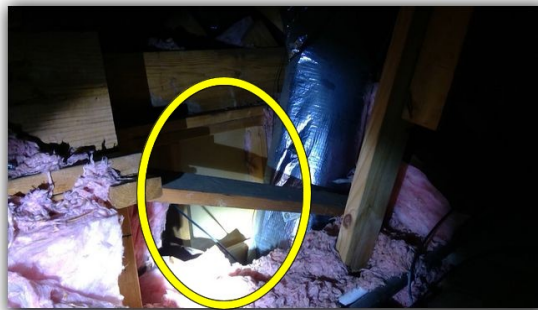
Voids observed in insulation at knee walls in attic space at one or more locations.

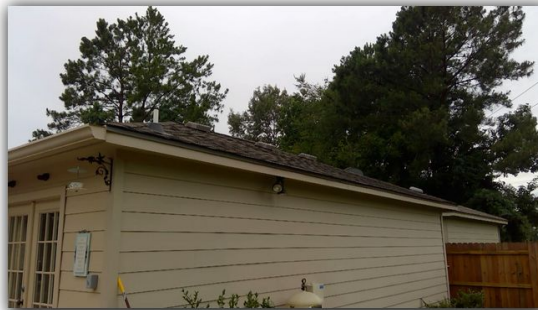
Both air haucs and ridge venting is being used at the same time to ventilate the attic space in some locations. No soffit ventilation is present at the garage and breezeway areas. The use of air haucs and ridge venting at the same time is not an effective ventilation system as air can be drawn from the air haucs into the ridge vents without proper cross ventilation in the attic spaces.

Would recommend that a licensed and / or qualified contractor be consulted to make any further recommendations and / or repairs

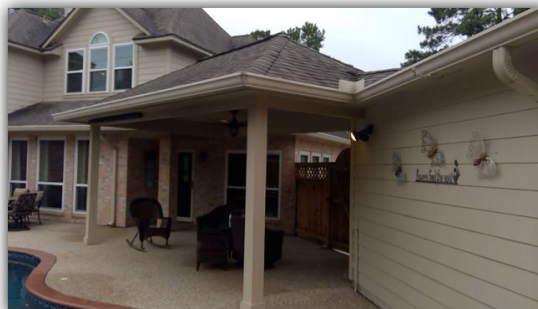
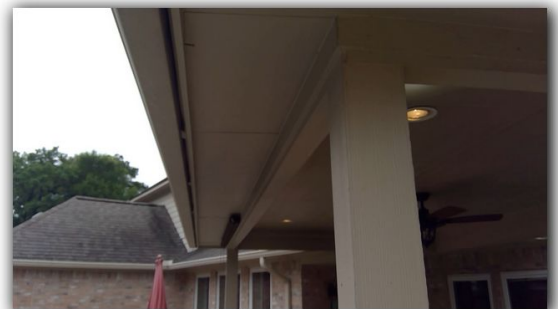
Ridge venting present at the patio (breezeway) without soffit venting to draw from. A minimum of 1 square ft. of ventilation needed per 150 sf of attic space.

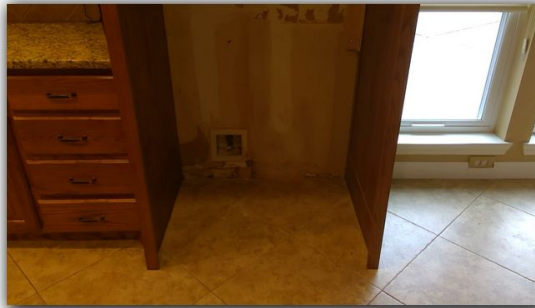
Evidence of previous termite damage / trails observed in wall behind the refrigerator area. Consult pest control professional and independent WDI report for further recommendations.

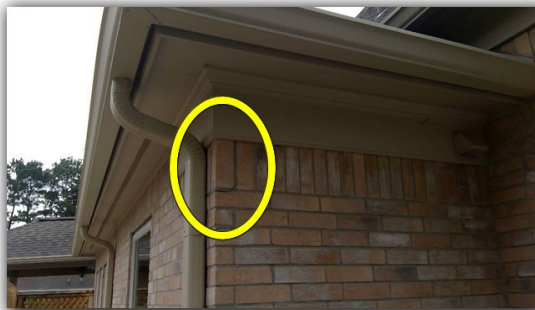
Mortar is separated, cracked or missing in some areas. See left front corner of house.

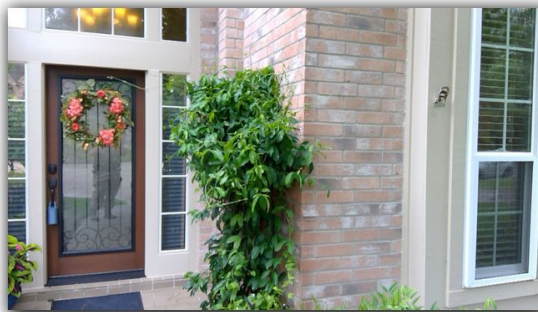
Heavy vegetation needs to be trimmed from touching exterior walls

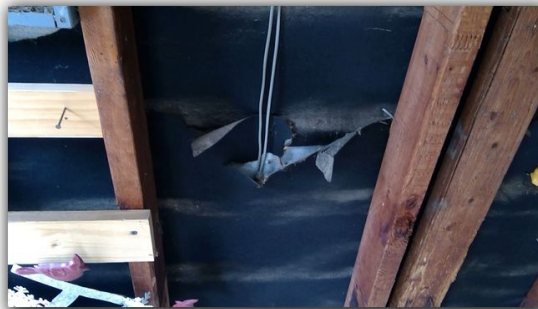
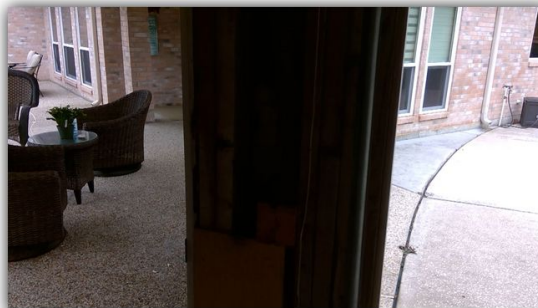
Moisture barrier damage observed behind the exterior siding of the garage. Observable from the garage space.

**Would recommend that a licensed and / or qualified contractor be consulted to make any further recommendations and / or repairs.**

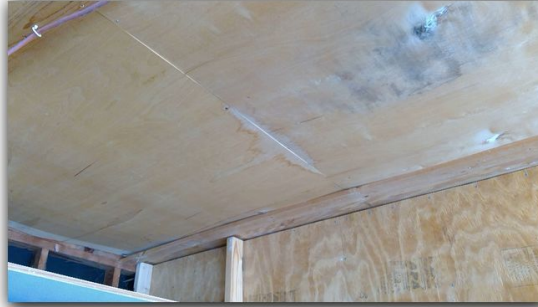
Water stains on ceiling in one or more locations. See garage ceiling.

**Would recommend that a licensed and / or qualified contractor be consulted to make any further recommendations and / or repairs**

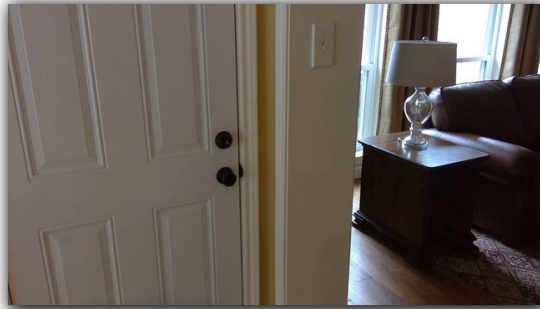
Double cylinder locks requiring the use of a key to open pose safety consideration. See rear exit door.

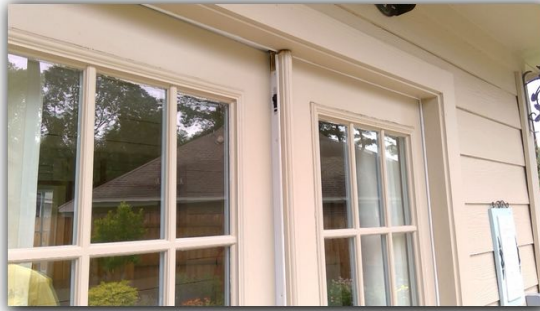
Doors rub, stick or hit frames: See pool double door unit.

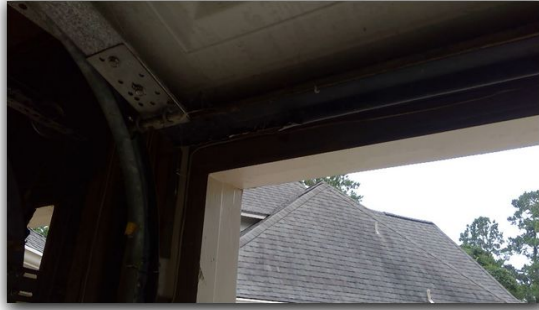
Weatherstripping at the bottom of the garage door is torn / damaged / missing.

**Would recommend that a licensed and / or qualified contractor be consulted to make any further recommendations and / or repairs**

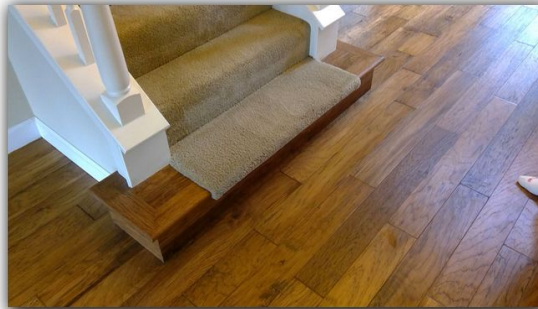
- Improper dimensions of stair risers: maximum riser height is 7 3/4" per current code. (See IRC 2015, R311.7.5.1)

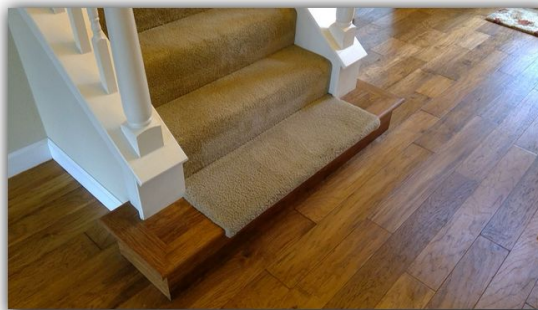
- Improper dimensions of stair risers: riser height cannot vary more than 3/8" from the lowest riser to the top riser per current code. (See IRC 2015, R311.7.5.2)

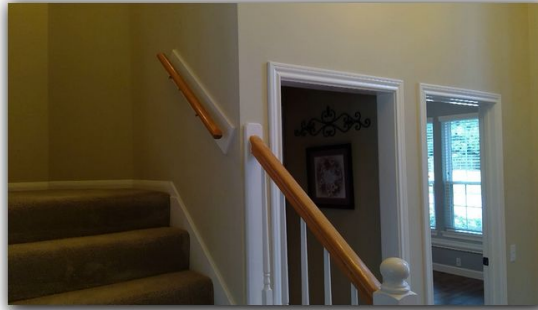
- Hand railing is not continuous. Current code states that the handrail can only be interrupted by a newell post at a turn. (See IRC 2015, R311.7.8.2, Exception 1.)

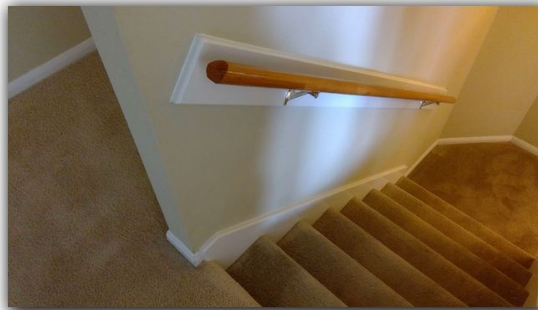
Hand railing does not properly terminate by turning into the wall at handrail ends per current code. (See IRC 2015, R311.7.8.2)

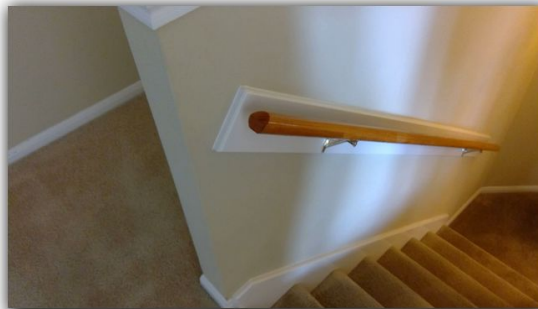
Hand railing not at proper height: Current code requires handrail to be installed 34" to 38" measured vertically from the bullnose of the stairs. (See IRC 2015, R311.7.8.1)

**Would recommend that a licensed and / or qualified contractor be consulted to make any further recommendations and / or repair**

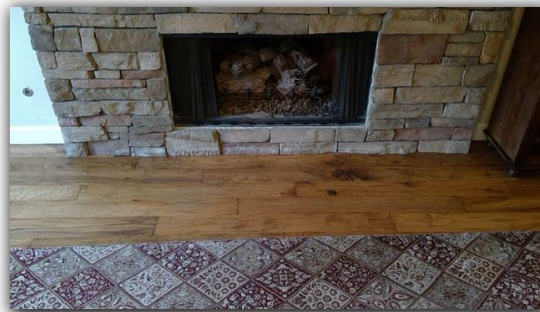
Hearth extension not present at the fireplace. Consult fireplace manufacturer specifications for hearth extension requirements. Wood flooring below fireplace appears to be combustible.

**Would recommend that a licensed and / or qualified contractor be consulted to make any further recommendations and / or repair**

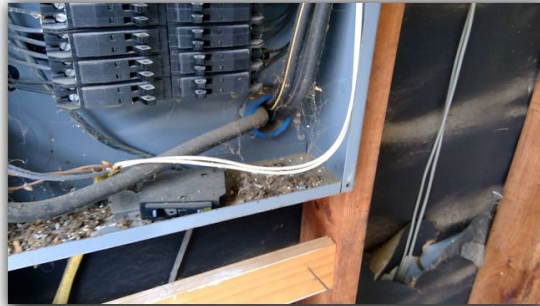
Bonding / grounding / wiring / ground clamp not present at the electrical service entrance panel box per current standards.

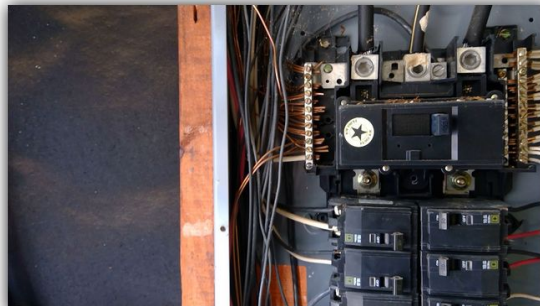
Ground and neutral wiring intermingled on the same buss bar in panel box at one or more locations.

**Would recommend that a licensed and / or qualified contractor (Electrician) be consulted to make any further recommendations and / or repair**

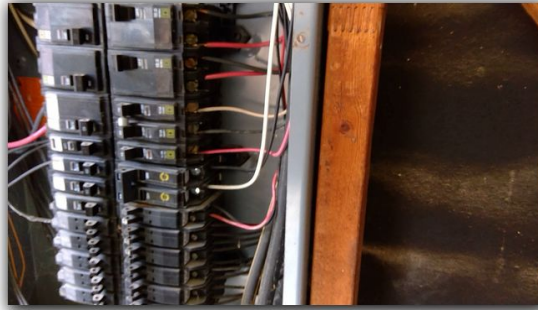
White "neutral" type wiring used as "hot" needs to be properly identified as "hot" in panel box at one or more locations. White wiring should be wrapped with black tape or marked with a black (or other appropriate color that is not white, grey or green) marker.

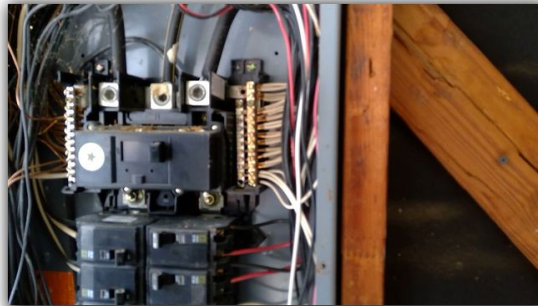
White "neutral" type wiring is required by current code to be individually secured into individual holes in "neutral" buss bar. Double wiring and securing two or more wires to a single set screw is not allowed per current code on the "neutral buss bar."

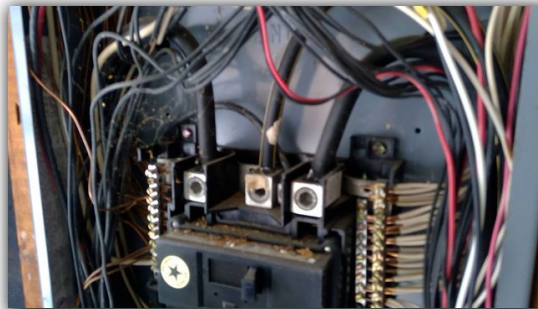
Lack of anti-oxidants on aluminum conductor terminals in panel box at one or more locations.

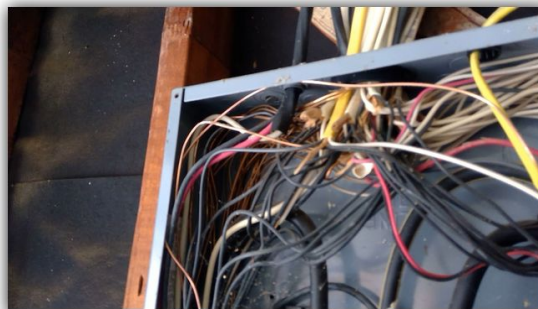
Panel covers, knockouts, cable clamps missing/ loose in panel box at one or more locations.

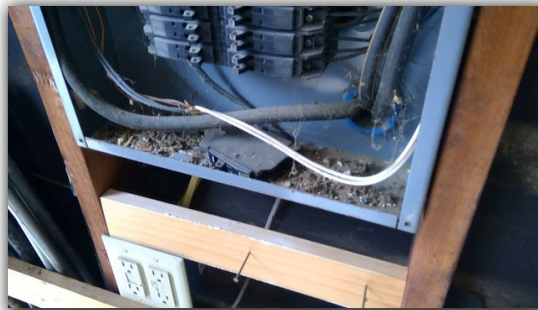
Debris present in the bottom of the panel box

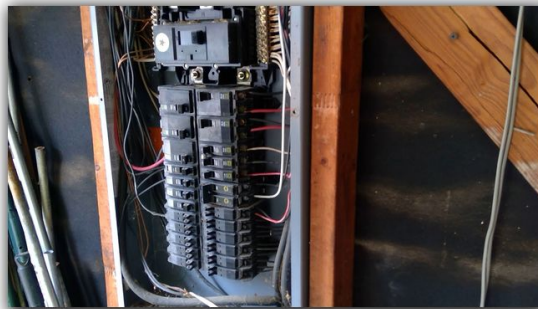
Panel box does not conform to current code regarding the proper presence of arc fault protection. Arc fault protection did not enter the NEC code until 2002.

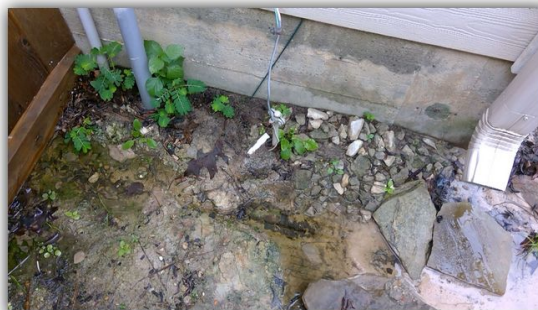
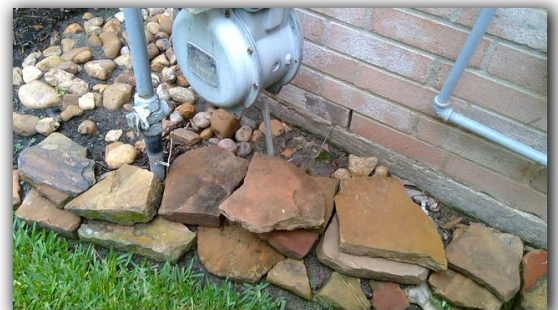
Grounding rod is not flush to grade per current code.

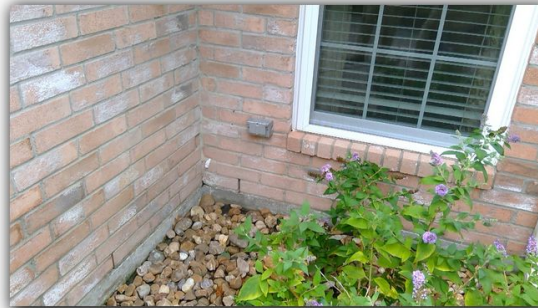
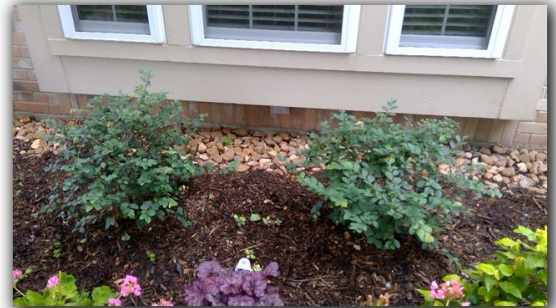
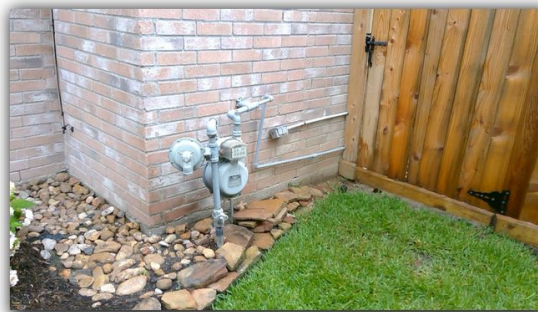
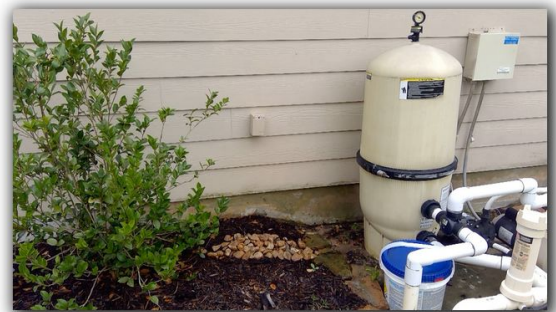
- Exterior receptacles do not conform to current code requiring "bubble" style covers at exterior "wet" locations

Would recommend that a licensed and / or qualified contractor (Electrician) be consulted to make any further recommendations and / or repair

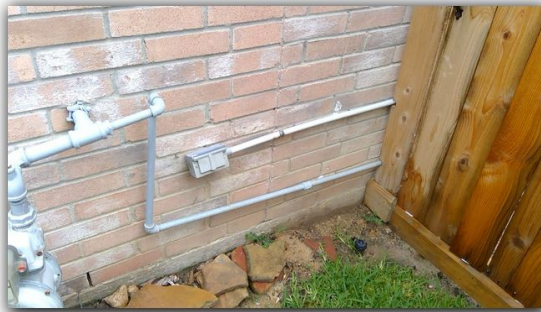
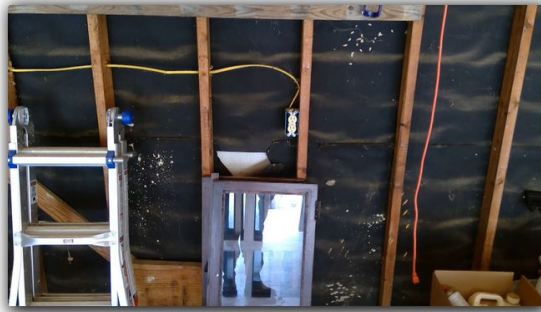
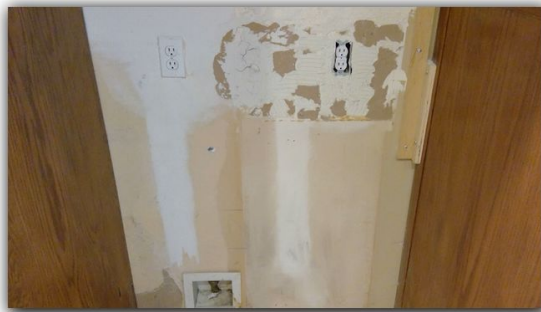
Loose, damaged, missing outlets / switches / covers at one or more locations.

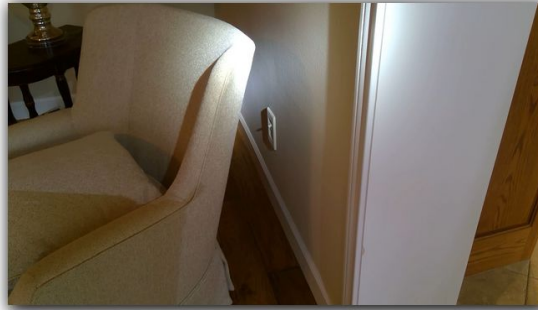
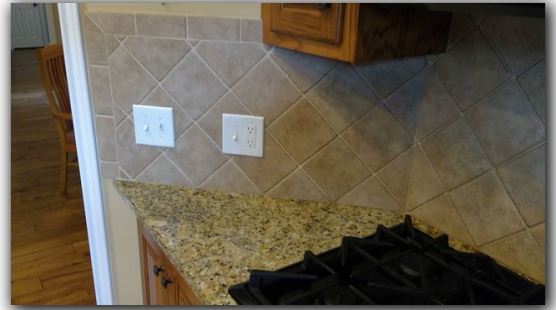
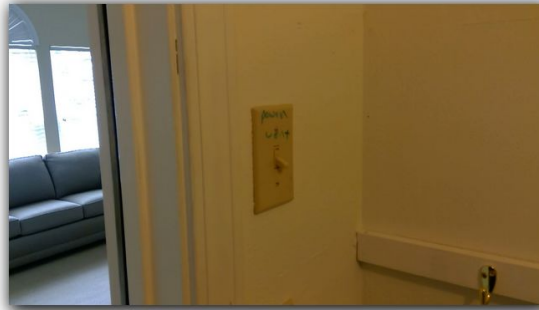
Switch(s) could not be determined for proper operation at one or more locations.

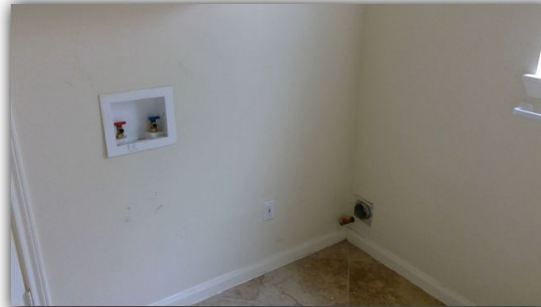
- It appears that the utility room has been relocated to the master closet area from another location. It does not appear the washing machine area and the dryer area are serviced with an appropriate electrical circuit. It appears that the dryer connections are gas only and that the plug for the master hydro-massage therapy equipment is being used to ignite the dryer. The washing machine appears to be using the same circuit as the hydro-massage therapy equipment also.

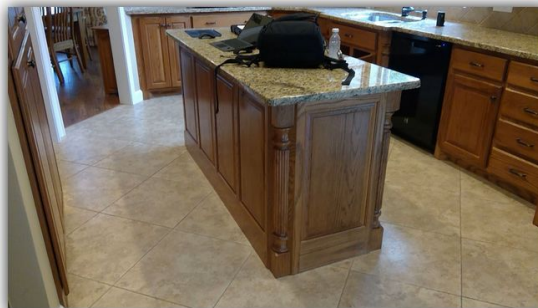
- Current code requires a minimum of one receptacle at a kitchen island. No receptacle was observed at the time of the inspection.

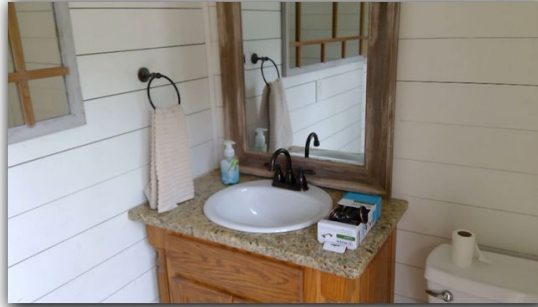
- House does not conform to current code regarding proper receptacle placement: Receptacles required on wall space 24" or greater per current code.
- House does not conform to current code regarding proper receptacle placement: Receptacles required within 36" of bathroom sink basin.

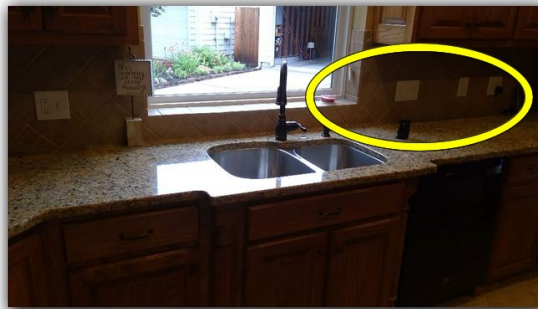
- House does not conform to current code regarding proper receptacle placement: Current code requires receptacles within 6' of doorway and every 12' thereafter. Other stipulations / criteria are noted in code that are not mentioned in this report and this inspection is not intended to be a code inspection, but determinations are made based on code requirements. Consult electrician for further details.
- House does not conform to current code regarding proper receptacle placement in kitchen area. Current code requires receptacles within 2' of both sides of sink and every 4' thereafter. Other stipulations / criteria are noted in code that are not mentioned in this report and this inspection is not intended to be a code inspection, but determinations are made based on code requirements. Consult electrician for further details.

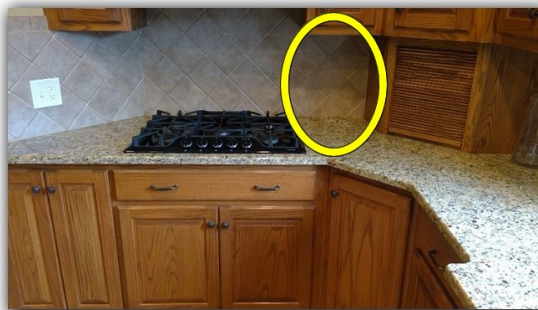
- House does not conform to current code regarding proper receptacle placement: Receptacles required servicing countertop space 12" or greater per current code.

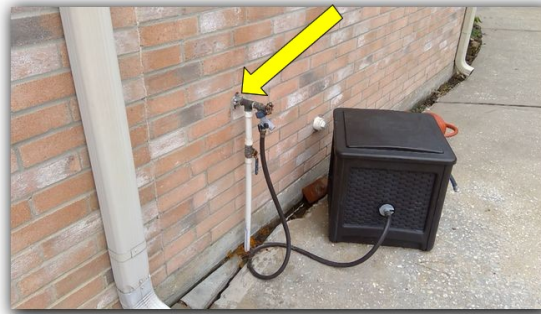
- Ground wiring connected to hose bib on the left side of the house does not actually ground due to the hose bib being connected to PVC (plastic) piping.

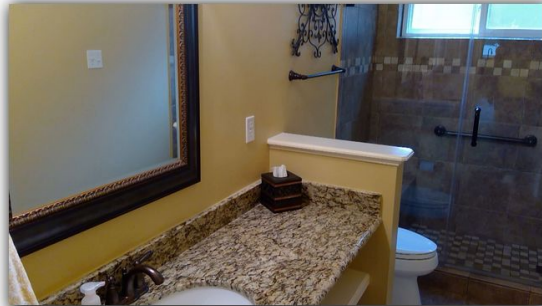
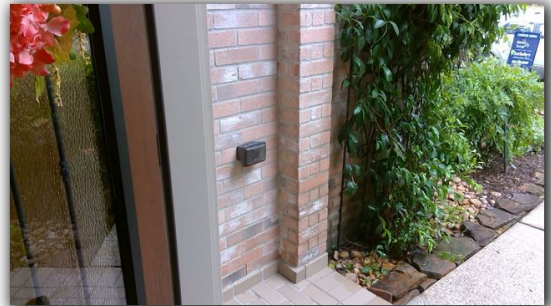
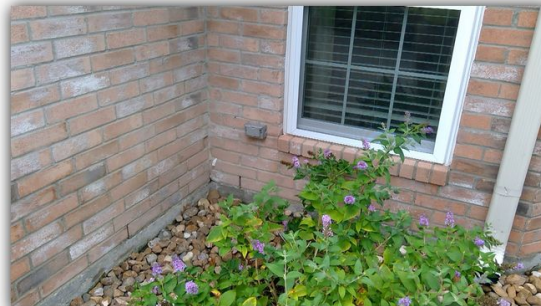
No GFCI protection at one or more location. This is considered a recognized safety hazard: All kitchen, bathroom, garage, exterior, washing machine, dishwasher, disposer and wet bar locations are required by current code to be GFCI protected.

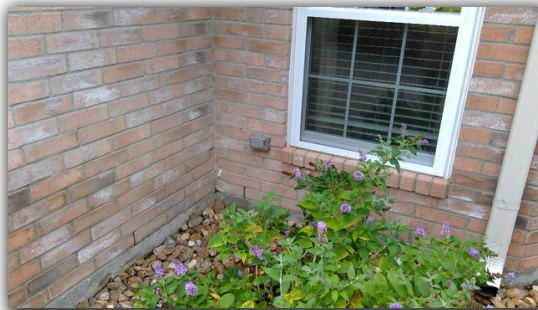
GFCI are not properly installed or operate properly at one or more locations.

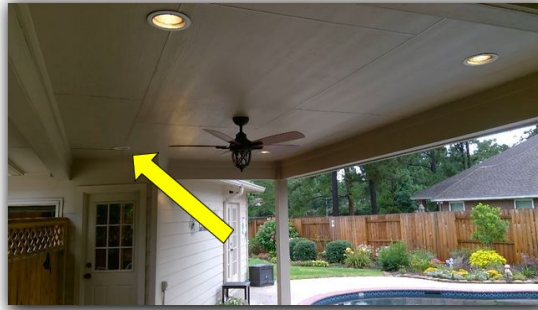
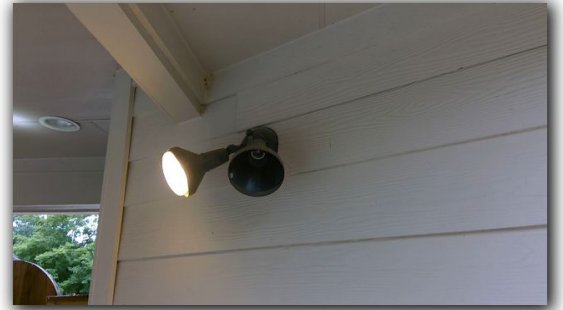
Bulbs appeared to be burned out and / or not operating in one or more fixtures

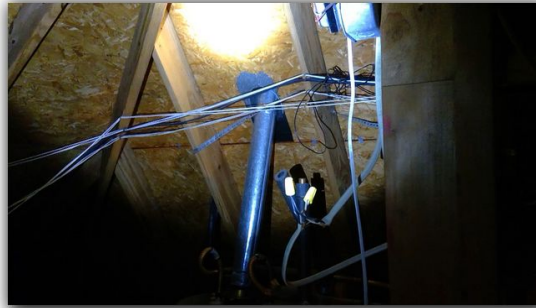
Electrical Romex type wiring has not been properly stapled above panel boxes and junction boxes at some observable locations

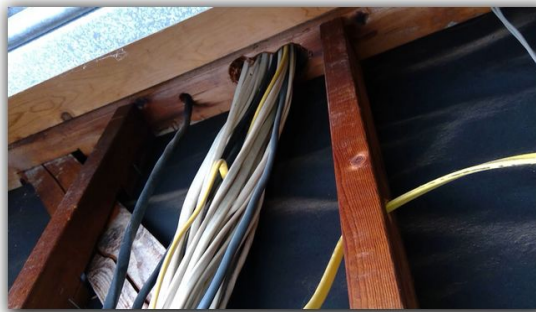
Improper use of extension cords as permanent wiring observed in one or more locations. Permanent use of extension cords for permanent wiring is considered a safety hazard by current standards.

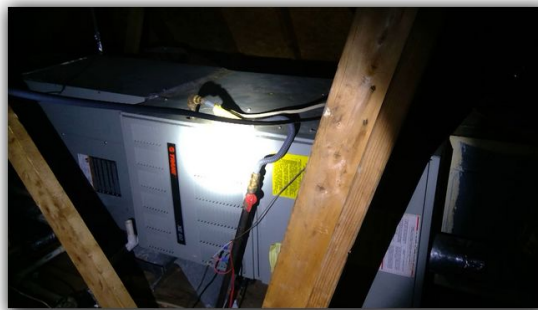
- No sediment trap observed in gas line of HVAC system

Would recommend that a licensed and / or qualified contractor be consulted to make any further recommendations and / or repair

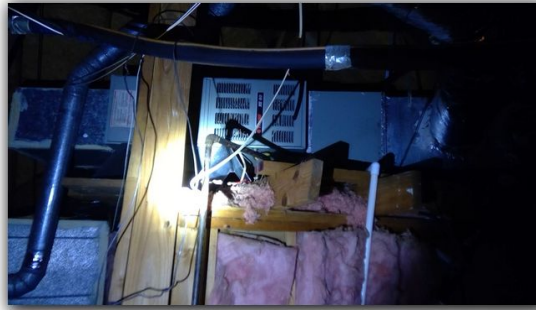
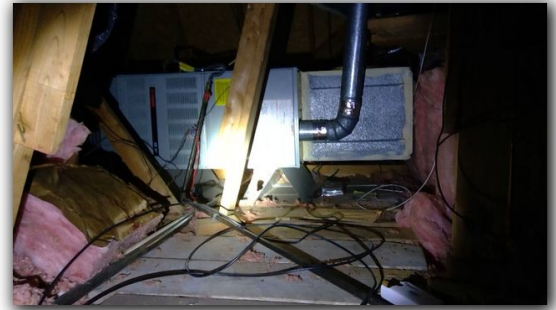
- 30" unobstructed working clearance and level platform needed in front of the HVAC furnace unit.

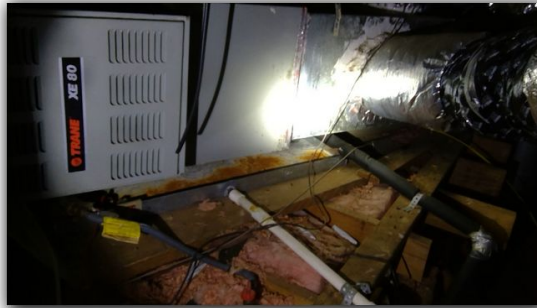
Secondary drain pan for the smaller HVAC evaporator coil in the attic space is not properly located. The pan should extend a minimum of 2" past the evaporator coil on all sides. Pan should be properly located to catch any condensation from the evaporator coil if needed.

**Would recommend that a licensed and / or qualified contractor be consulted to make any further recommendations and / or repair**

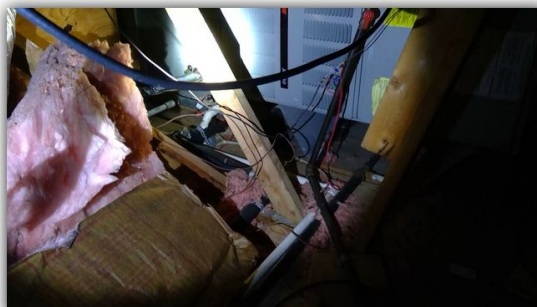
Refrigerant lines not properly insulated at evaporative coil (wrong thickness per current code)

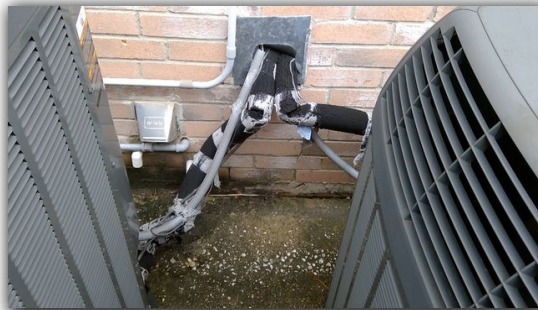
Conduit is not properly connected / installed at exterior brick wall

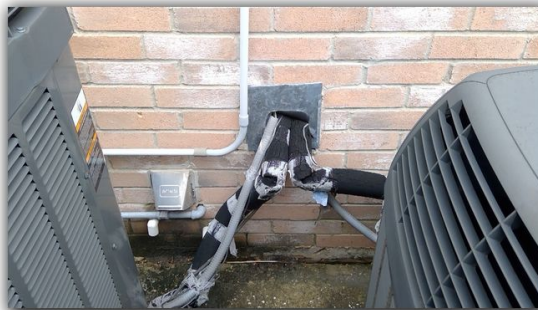
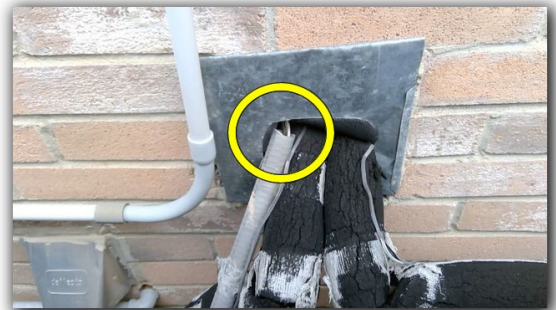
Dryer vent is installed too close to exterior HVAC condensing unit. Lint from the dryer unit can potentially block the ventilation fins of the condensing unit.

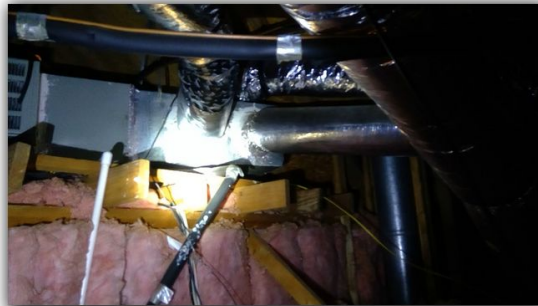
HVAC duct system does not conform to current code regarding proper sealing / mastic

**Would recommend that a licensed and / or qualified contractor be consulted to make any**

further recommendations and / or repair

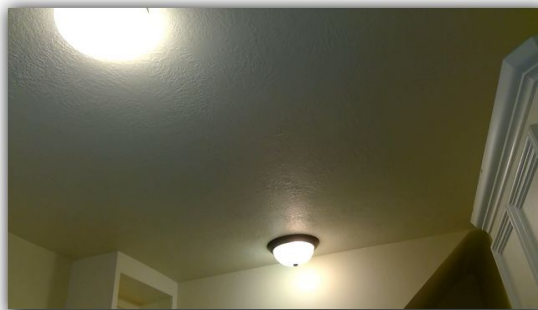
Master closet is a "walk in" type closet but is not serviced (ducted) with a supply register. While this is not a "design" inspection. It is a usual and customary building practice to supply air conditioning and heating to these spaces.

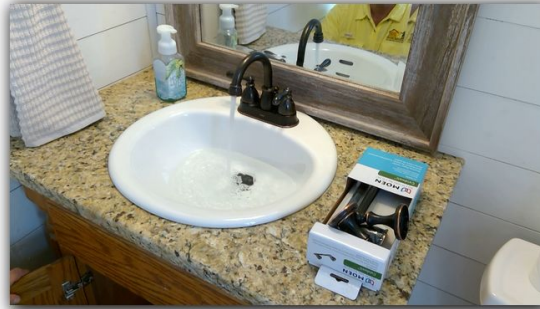
- No hot water present at the pool bathroom.

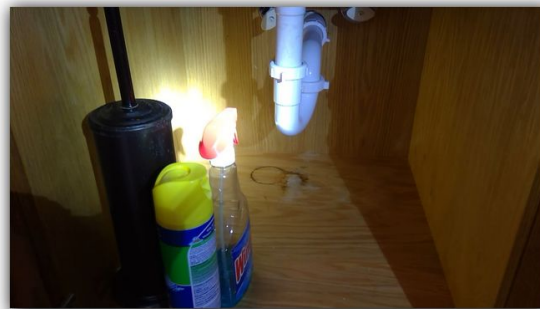
- Evidence of previous water leaks present under bathroom sink locations.

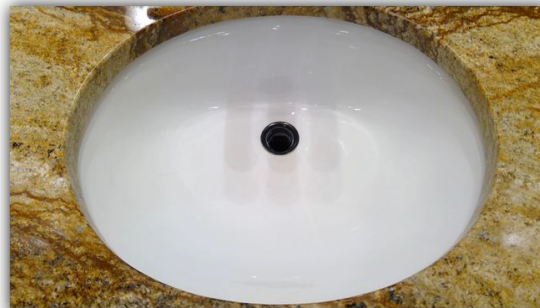
- Sink stopper missing or damaged in master bath sink right side

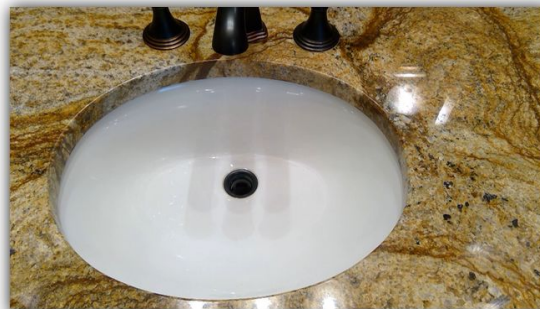
- Sink stopper missing or damaged in master bath sink left side

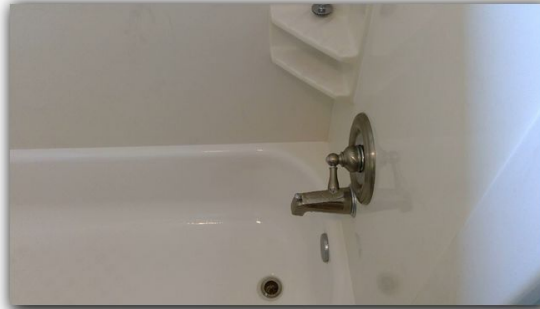
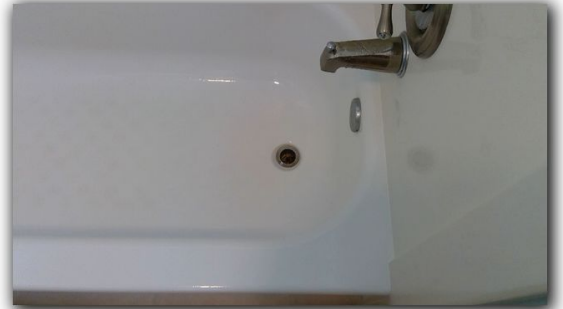
- Drain stop not properly installed in upstairs hall bathroom tub.

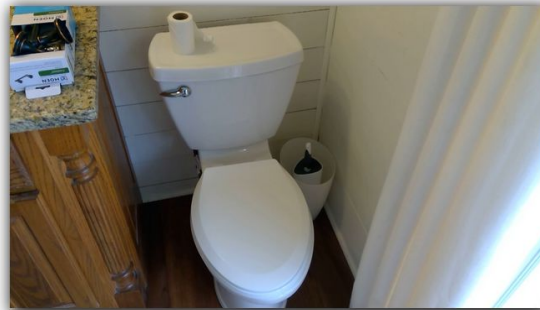
- Loose toilet seat at pool bathroom toilet.

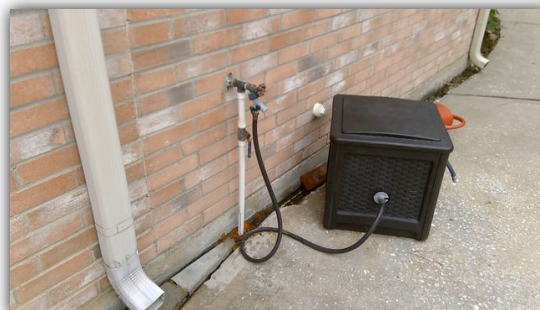
- Exterior hose bibs do not have back-flow prevention at one or more exterior hose bib locations.

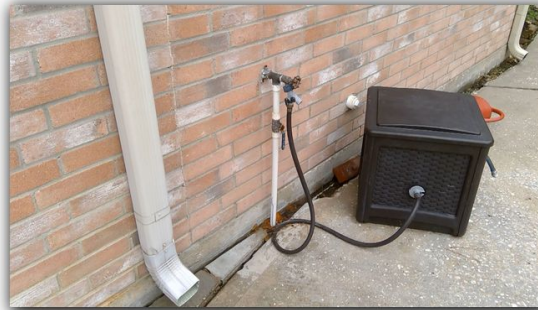
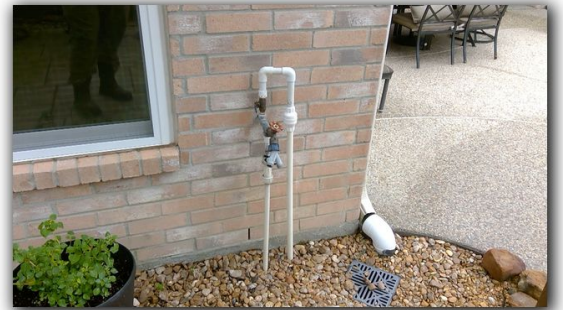
- Proper insulation needed on exterior exposed water lines / plumbing

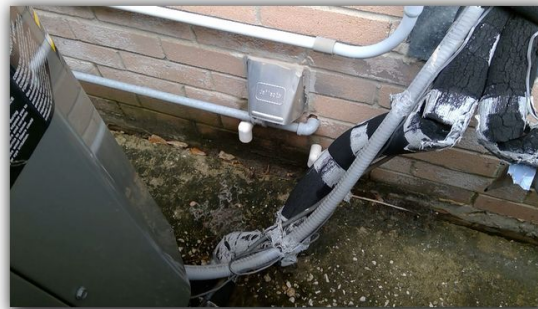
Gas supply line is installed on the exterior side of the brick wall on the right side of the house. It appears that the line is designed to service the dryer equipment. This is not a usual and customary building practice.

**Would recommend that a licensed and / or qualified contractor be consulted to make any further recommendations and / or repair**

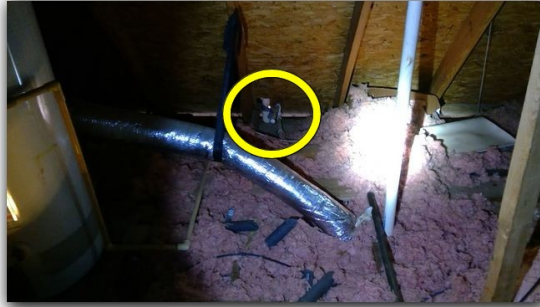
Vent piping damaged in attic space where it appears that the HVAC drain line may have once terminated into the side of the piping. A hole appeared to be observed in the side of the pipe.

**Would recommend that a licensed and / or qualified contractor be consulted to make any further recommendations and / or repair**

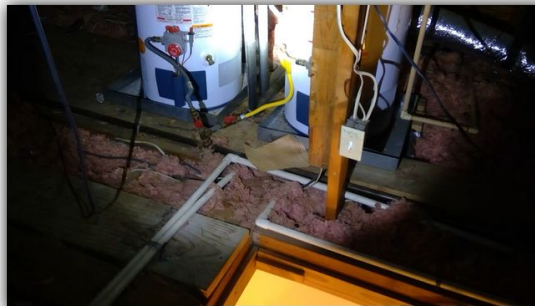
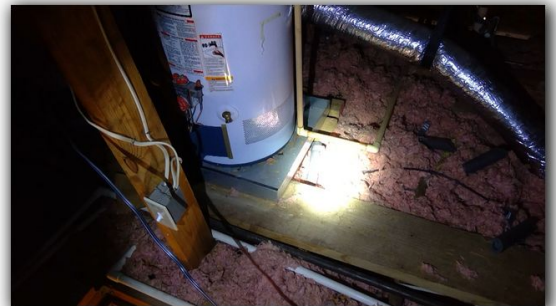
- Debris present in the drain pan of the water heating equipment

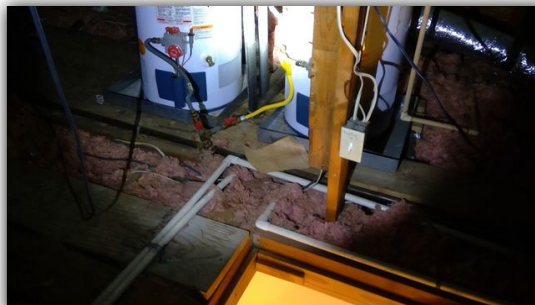
- Sediment trap not present in gas line at water heating equipment

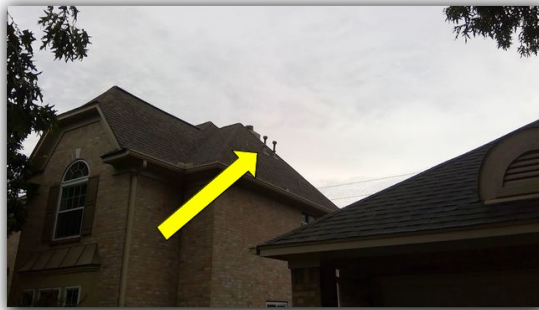
Flue/Vent collar is not properly installed on the front water heating vent pipe terminating through the roof observable from the right side of the house.

**Would recommend that a licensed and / or qualified contractor be consulted to make any further recommendations and / or repair**

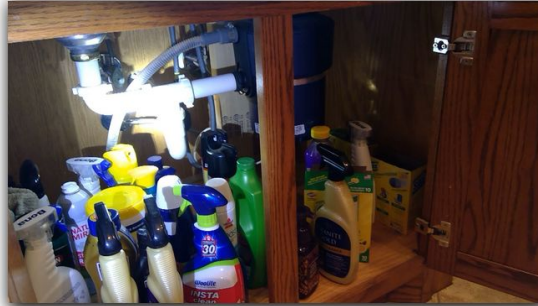
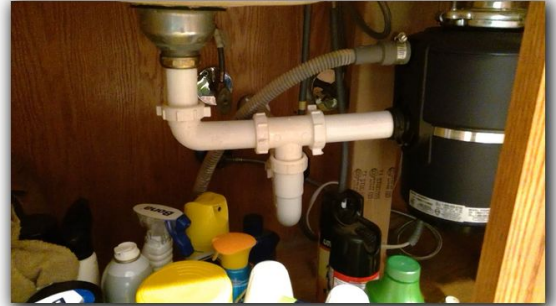
No anti-siphon loop observed at the drain line of the dishwashing equipment per current code standards.

Would recommend that a licensed and / or qualified contractor be consulted to make any further recommendations and / or repair

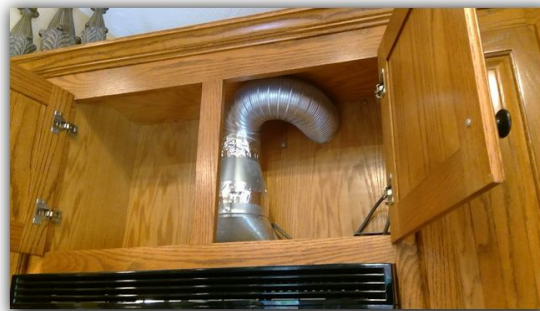
Range hood vent must have a smooth interior finish and be constructed of metal per current code. See IRC 2015, M1503.1.

**Would recommend that a licensed and / or qualified contractor be consulted to make any further recommendations and / or repair**

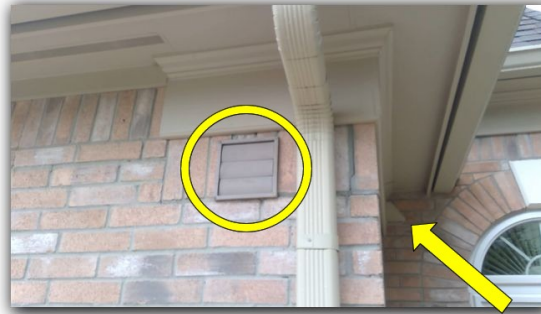
Range hood / exhaust vent appears to be cracked / broken.

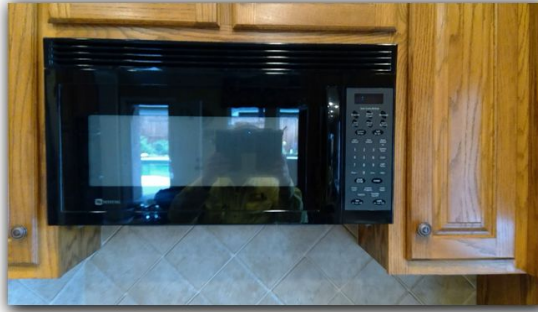
Metal rack(s) missing from interior of microwave.

**Would recommend that a licensed and / or qualified contractor be consulted to make any further recommendations and / or repair**

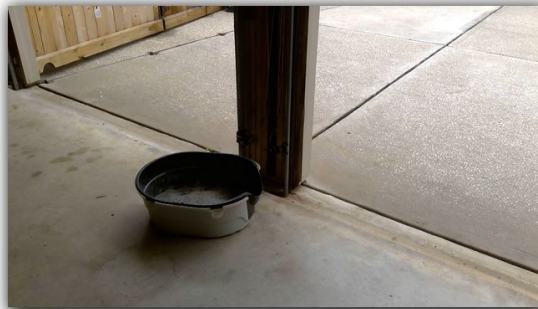
Laser reverse system (electronic sensors) is / are installed at improper height for garage door operator. TREC standards require that the sensors be labeled as Deficient if the sensors were installed higher than 6" from floor.

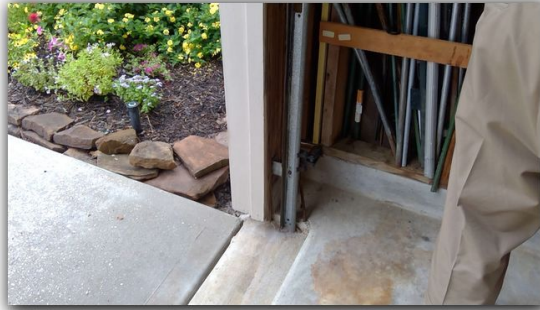
Garage door operator light was missing / did not operate properly.

**Would recommend that a licensed and / or qualified contractor be consulted to make any further recommendations and / or repair**

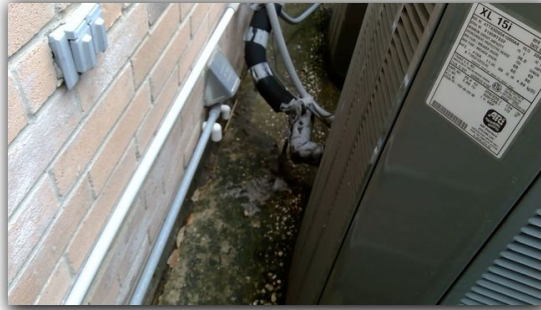
Dryer vent terminated next to the exterior HVAC condensing unit. Dryer vent lint can block the coil of the HVAC condensing unit.

**Would recommend that a licensed and / or qualified contractor be consulted to make any further recommendations and / or repair**

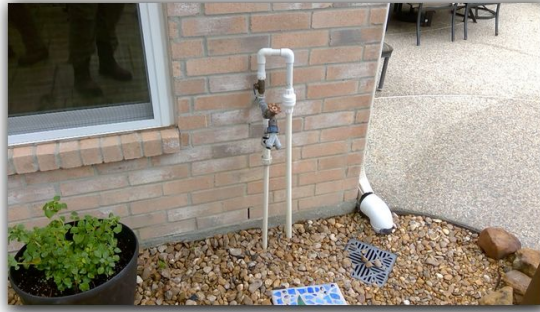
**EXIT ALARM:**  Absent. Current standards require an exit alarm at all exterior doors that enter the pool area.  
 Water leaks in above-ground pipes and/or equipment. See valve to the spray heads on the pool equipment.

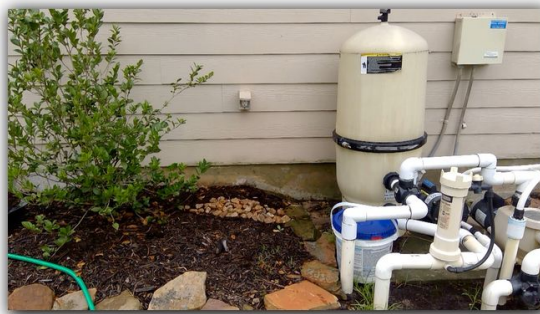
Deficiencies in lighting fixtures of the swimming pool observed. Swimming pool light(s) do not appear have GFCI protection (GFCI receptacle does not appear to be operating at the time of the inspection).

The lack of failure of required ground-fault circuit interrupter protection in the swimming pool equipment observed.

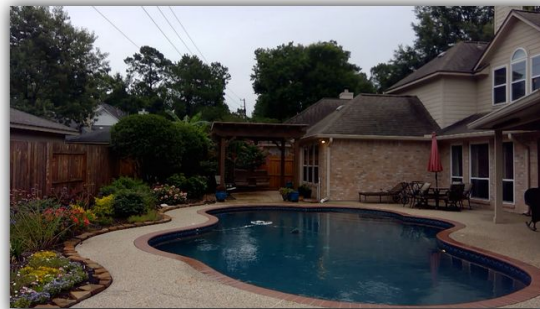
**C. Outbuildings**

**Exterior pergola present but not a part of this inspection.**
