Inspection Report

Property Address:
13127 Hollowcreek Park Dr.
Houston TX 77082

GOLDEN SCOPE INSPECTION SERVICES

PROPERTY INSPECTION REPORT

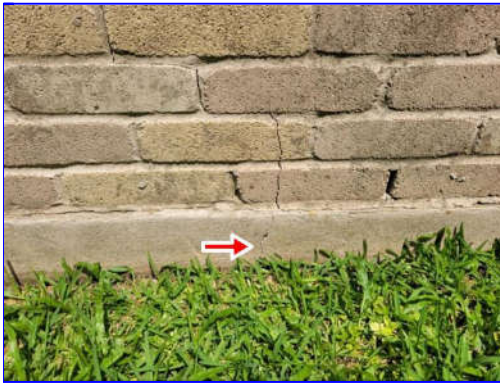
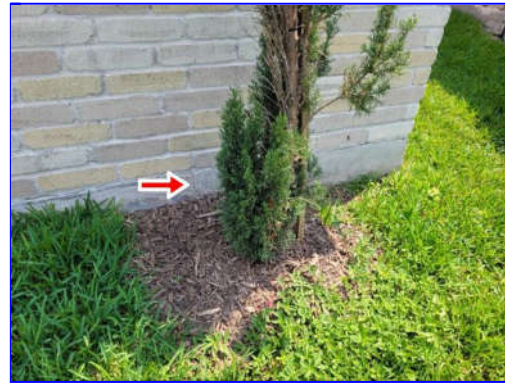
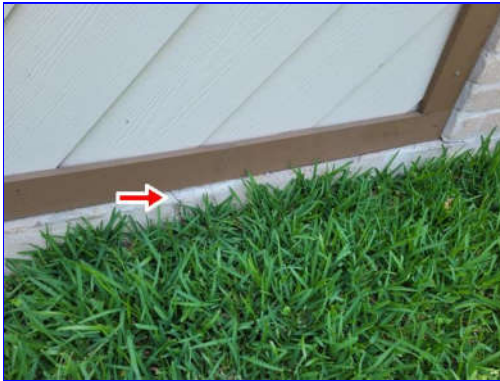
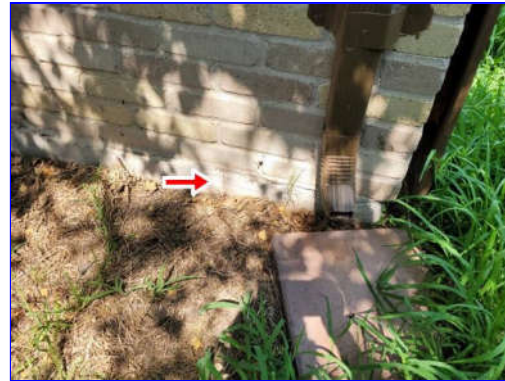
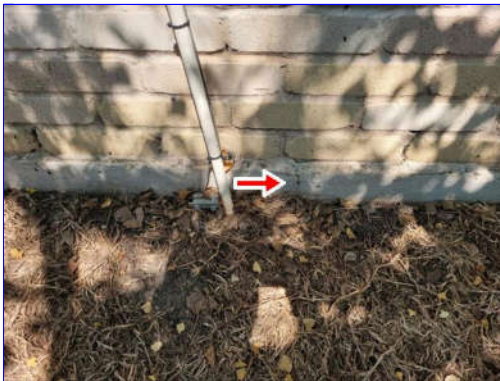
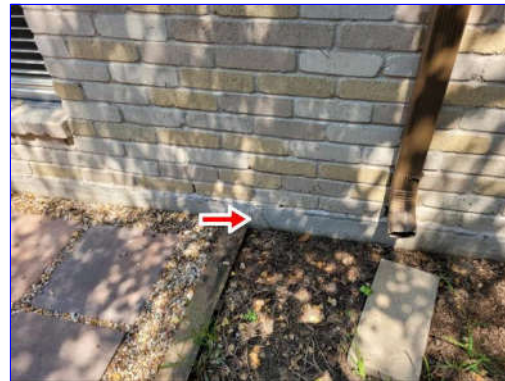
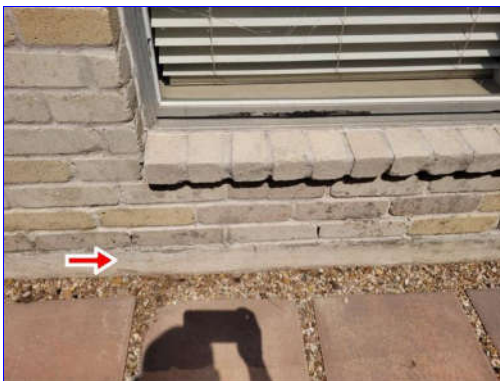
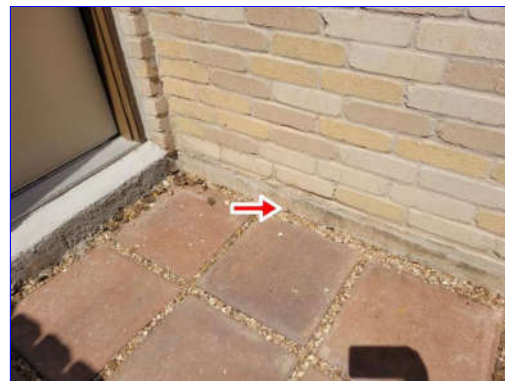
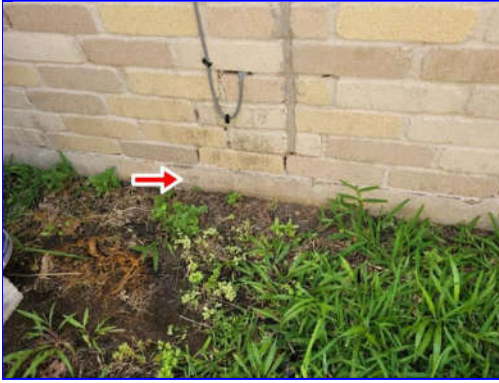
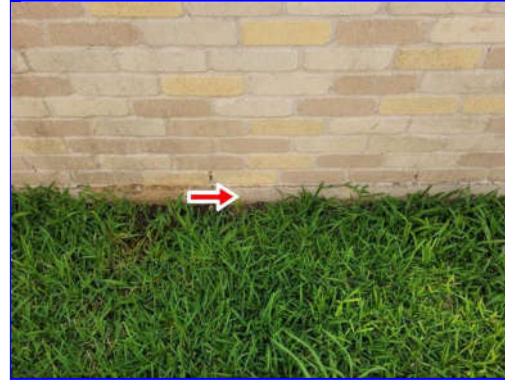
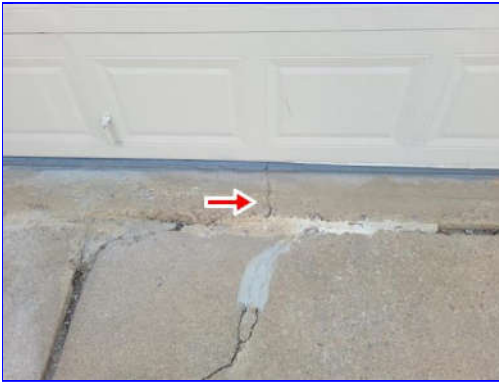
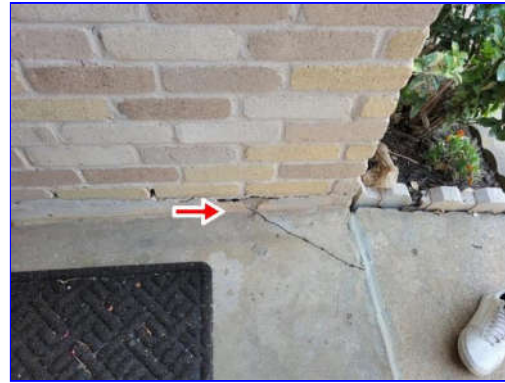
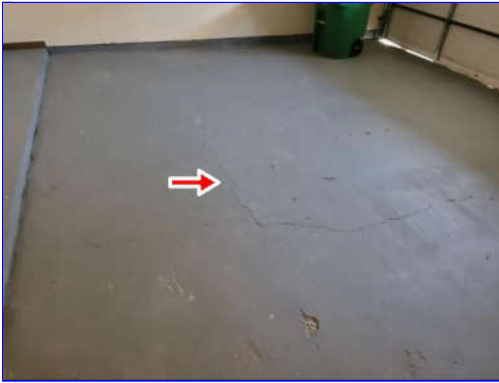
Evidence of previous foundation repair was observed. This inspection was performed without any data regarding the extent or final results of these repairs. Foundations repairs may not leave the foundation completely level and often the indications of excess movement before the repairs are still visible. In my opinion this foundation is not currently demonstrating evidence of defects that will adversely affect the overall performance of the foundation or evidence that suggests recent excessive movement. I do recommend that prospective buyers obtain as much documentation as possible regarding previous repairs and warranty information. The future performance of foundation is difficult to predict and other foundation inspectors, structural engineers or foundation experts may form a different opinion when evaluating this foundation. It may be advisable to consult with a structural engineer or foundation specialist before purchasing the home, regarding both its current condition, and the best measures to prevent further movement in the future.

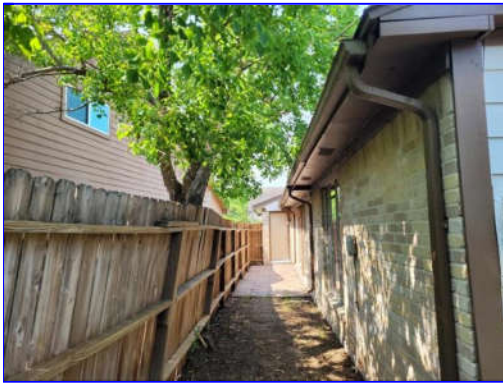
A. Item 15(Picture)

Tree(s)/tree root(s) was/were observed near the foundation. Opinions vary regarding the minimum allowable distance between trees and a foundation. The size and species of the tree should be considered. It should also be noted that some experts believe tree removal may negatively affect the foundation. If concerned with this condition, a structural engineer and/or a professional arborist should be consulted. This is a link to find arborists near you, should one be needed now or in the future <http://www.asca-consultants.org/>.

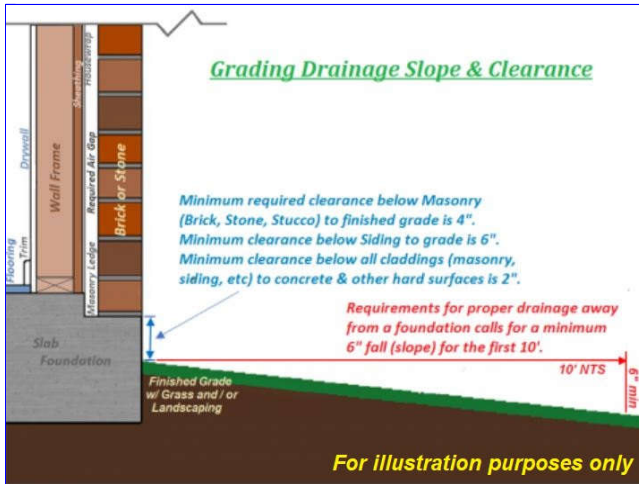
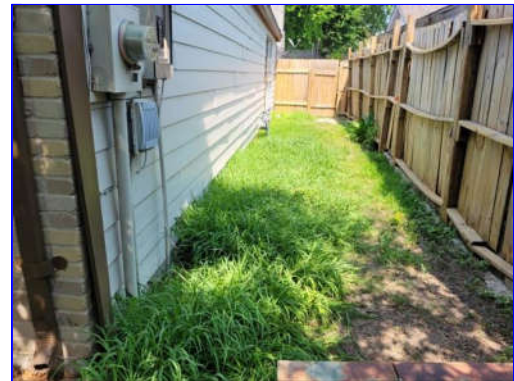
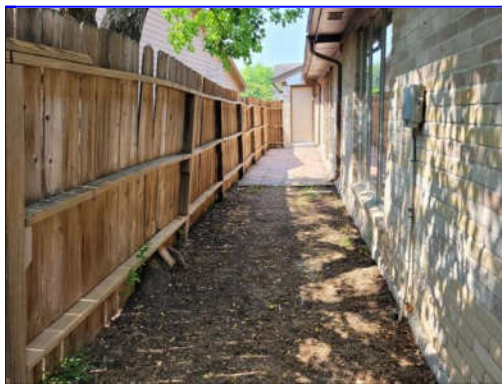
The downspout need an extension with splash block to carry water away from the foundation. Failure to add these extensions may potentially adversely affect the foundation performance long term.

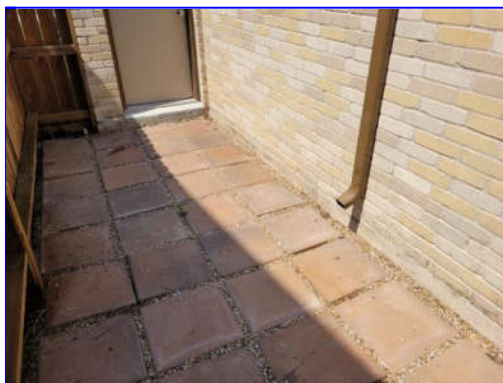
B. Item 8(Picture)

The gutters were observed to be in need of repair(s). Loose gutters should be properly secured and checked for proper slope to drain. Any damaged or deteriorated sections of gutter and down spouts should be replaced on as needed bases. Defective gutters may create leakage into the roof eave causing structural damaged into the home.

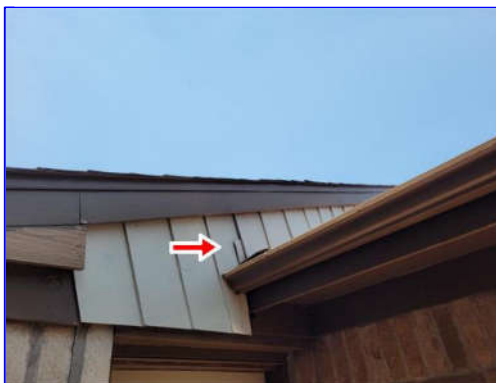
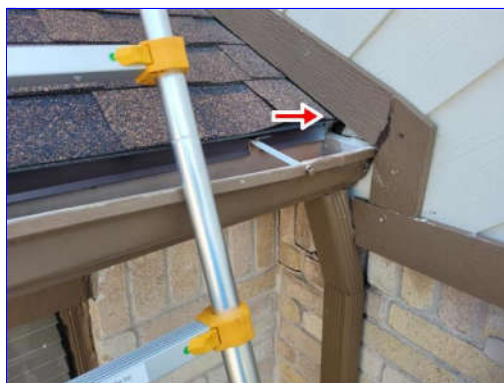
Flashing was observed to be missing at the front roof. Additional flashing to be installed

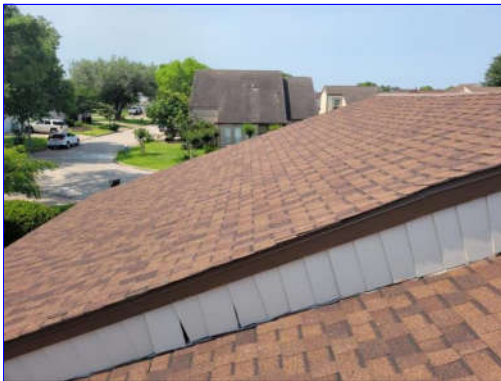
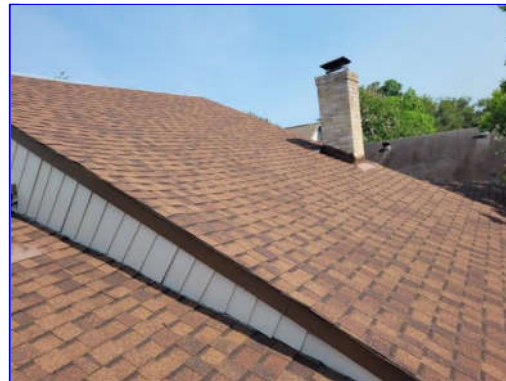
The clearance of the siding and/or trim at the flashing was observed to be insufficient. This condition leaves the siding and/or trim vulnerable to rot. This detail is usually repaired when siding and/or trim needs repair or replacement or when re-roofing work is performed.

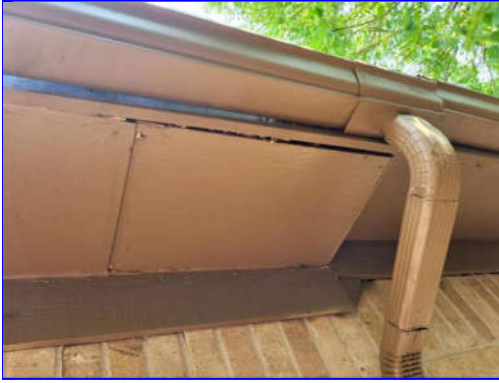
D. Item 14(Picture)

Accessibility and Limitation Notice: Some of the attic areas were not reasonably accessible due to low clearance, plumbing lines or A/C-Heating ductwork. No solid surface walkway has been installed, and it also has a low ceiling. This inhibits the inspector's ability to fully inspect different components of the attic. Excessive air gap was detected along the eave and soffit. Repair is needed to prevent insect intrusions.

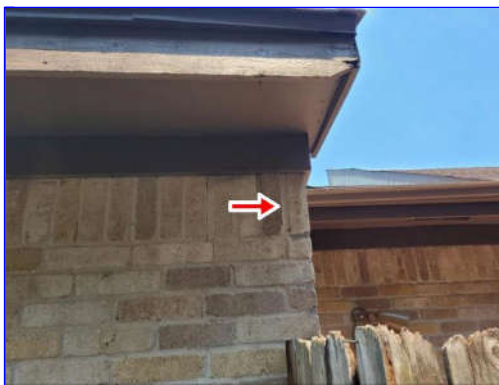
E. Item 2(Picture)

Masonry (brick / stone) cracks were observed. These cracks are potentially related to structural movement. Cracks should be repaired and/or monitored over time for further movement.

Brick/mortar cracks should be repaired by a qualified, verified mason. Moisture intrusion may occur if not repaired.

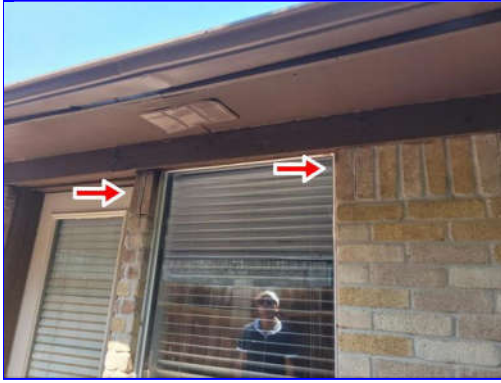
E. Item 15(Picture)

The siding and/or trim was/were observed to have the following defect(s): missing and damaged. I recommend repair as needed.

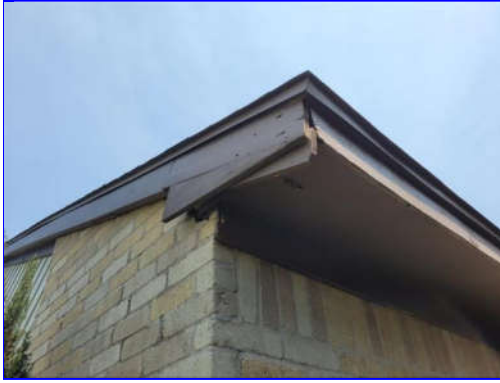
E. Item 19(Picture)

Many vertical trims are not properly installed leaving excessive open gap at various locations. Repairs are needed

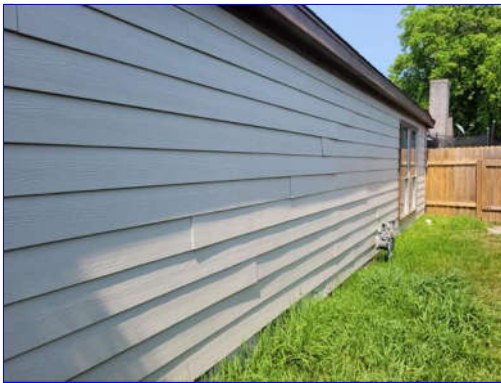
E. Item 30(Picture)

The siding at the rear of the house are not properly installed, loose and falling off. A qualified, verified exterior/interior contractor should be consulted regarding this condition and possible repair or replacement.

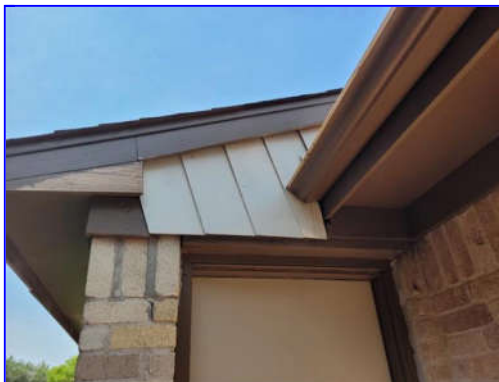
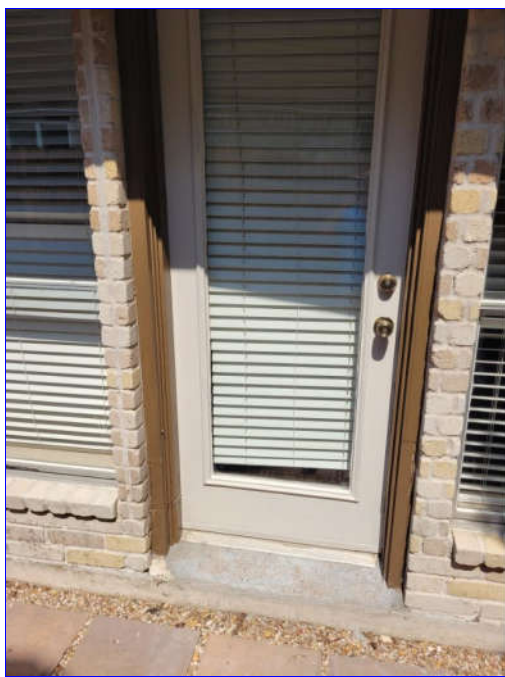
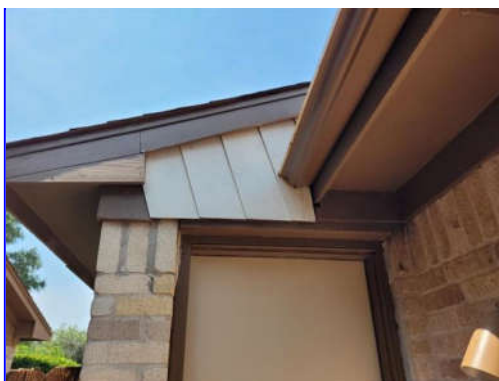
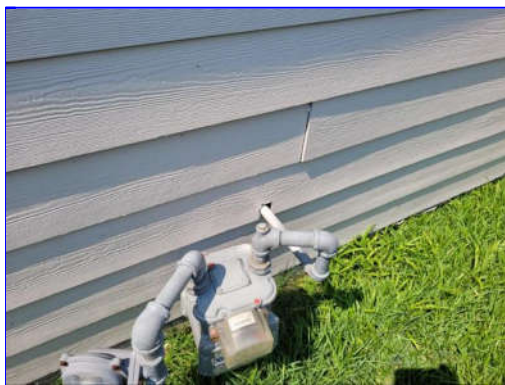
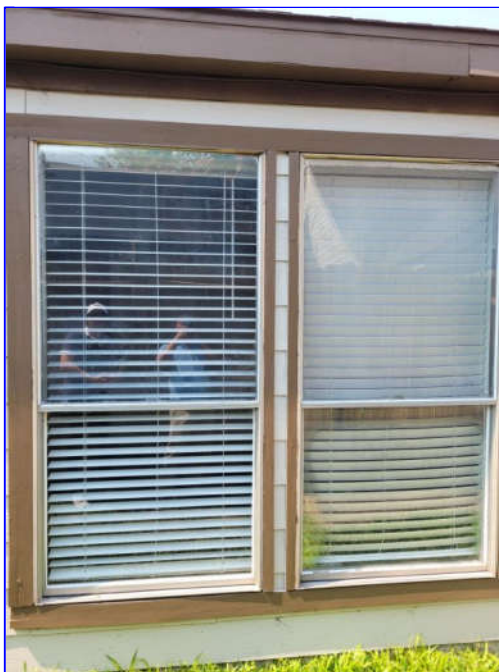
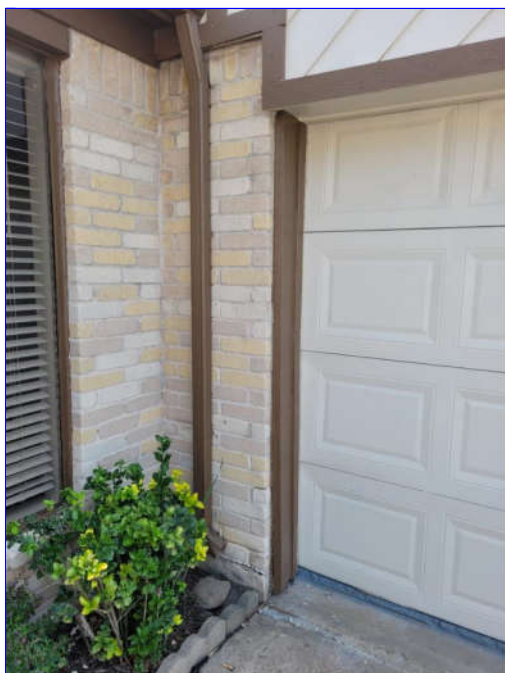
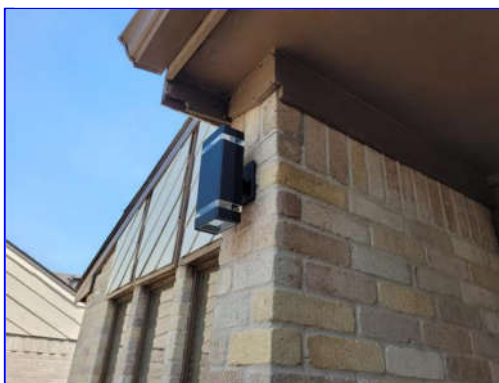
Caulking at the brick, siding, doors, expansion joints, exterior light(s), exterior penetrations into home, fascia, garage door, trim, hose bib penetrations, vent terminations and windows in various locations, was observed to need improvement. Make improvements as needed.

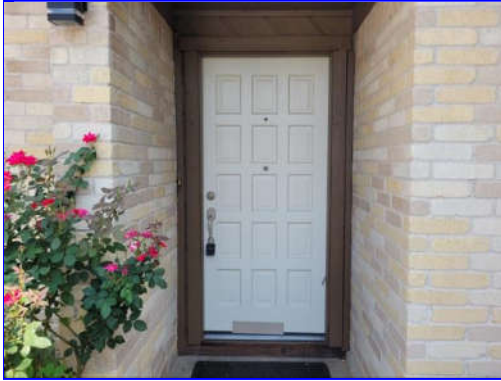
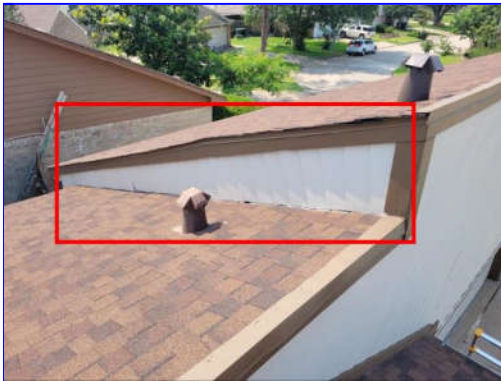
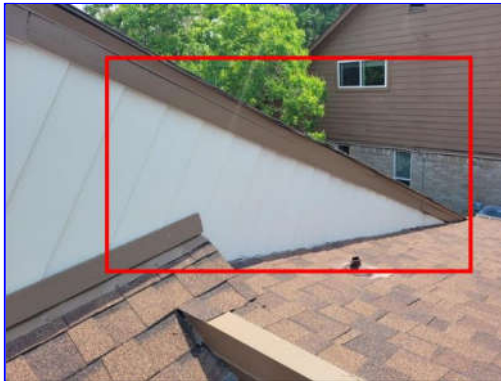
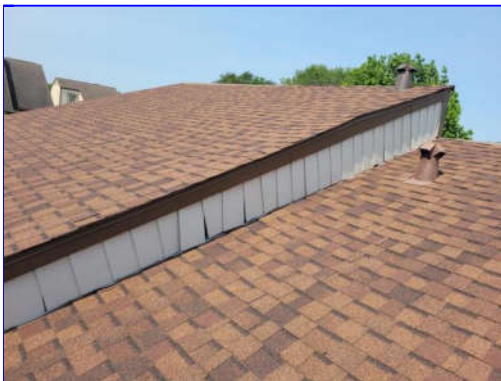
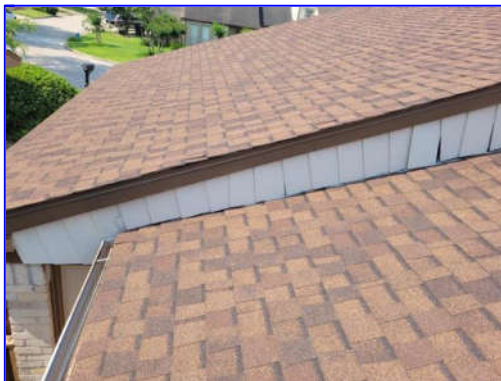
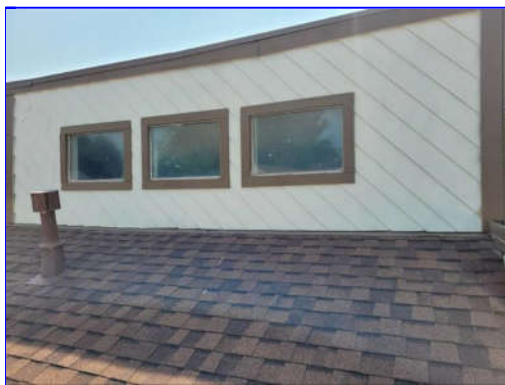
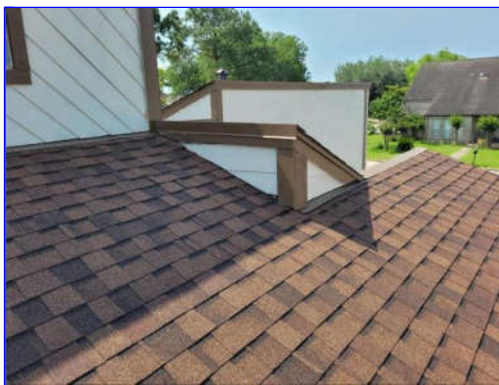
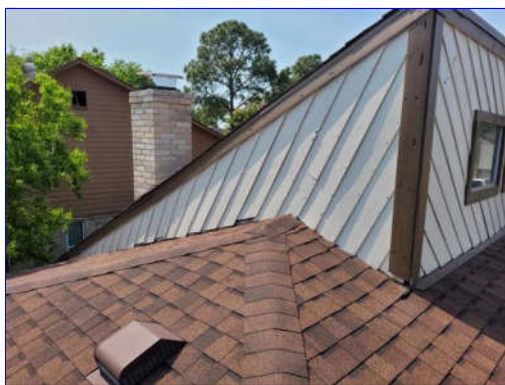
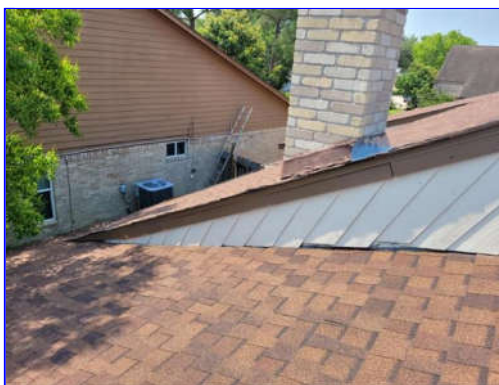
Hardie Planks siding were observed to be installed vertical. This type of siding is not suitable for vertical installation. Repairs are needed

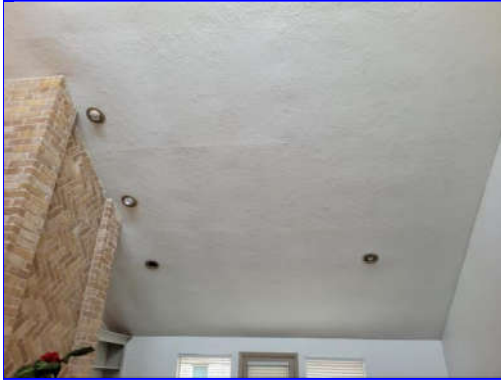
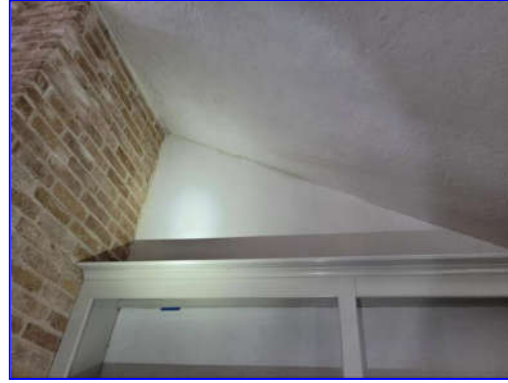
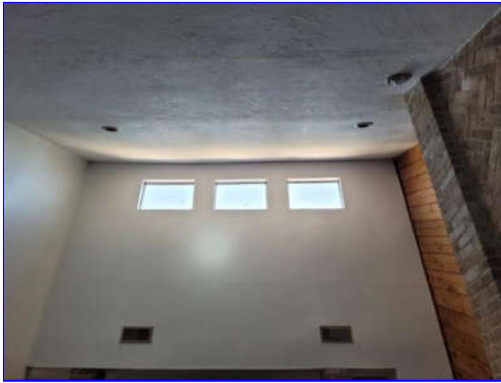
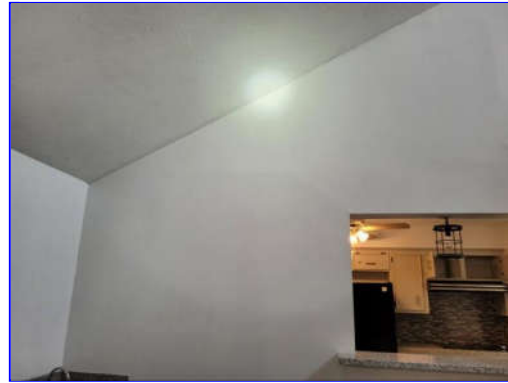
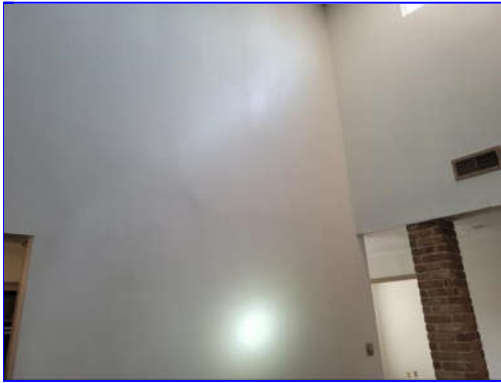
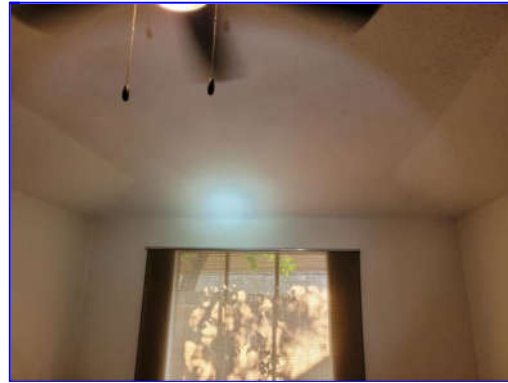
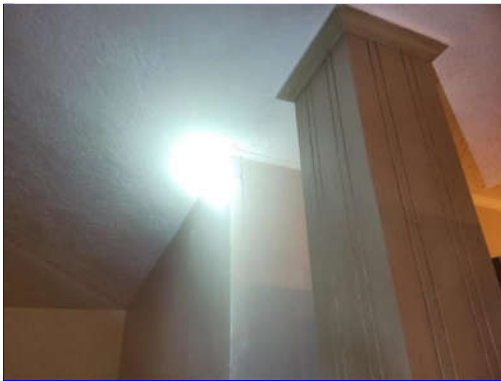
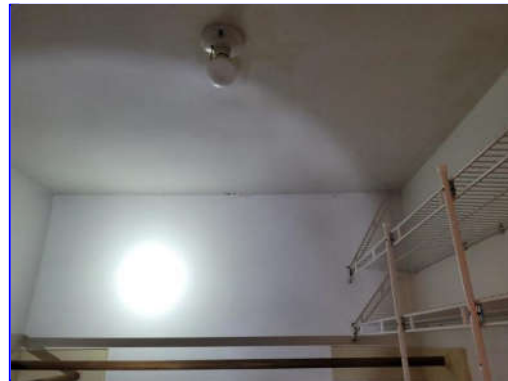
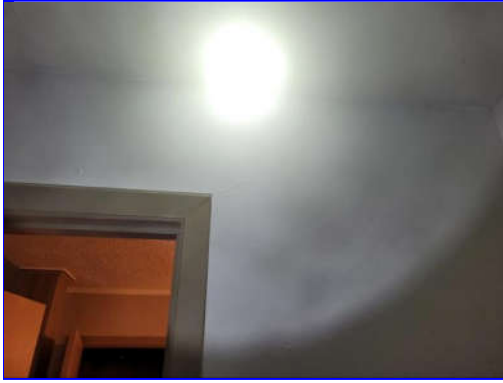
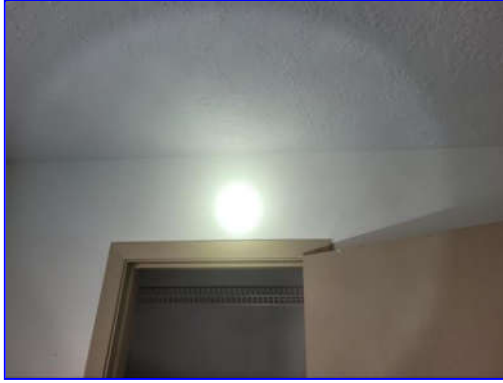
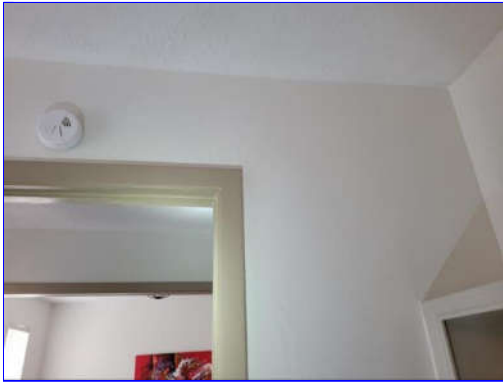
Wall cracks and/or twisting drywall tape were observed in various locations. These cracks are related to foundation settlement. See section 1A Foundations for more information. Repairs are needed

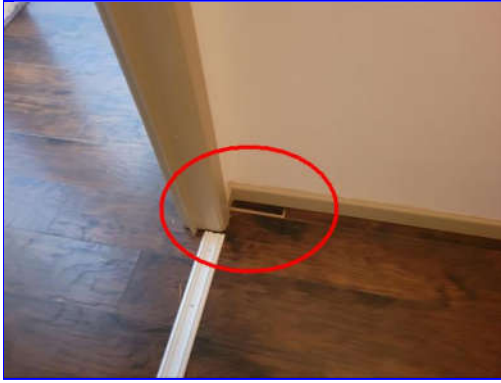
F. Item 1(Picture)

The floor covering is not fully installed at the hallway. Repair is needed

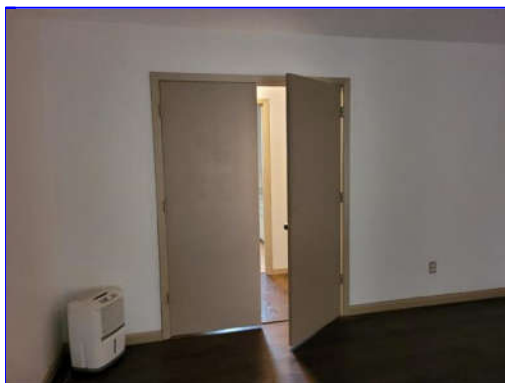
G. Item 2(Picture)

The double doors at the primary bedroom are not equip with a locking device. Repair is needed

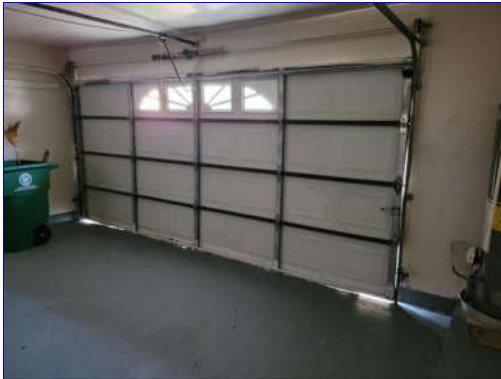
G. Item 6(Picture)

Excessive air gap was detected at the garage door. Repair is needed

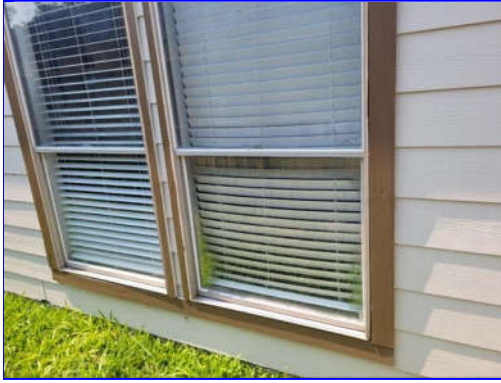
H. Item 1(Picture)

Plastic glazing strip(s) was/were observed to be damaged and/or missing at various windows.

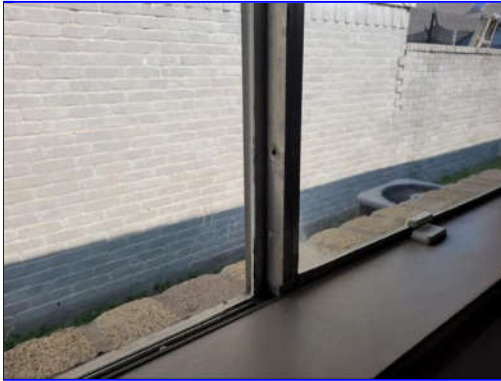
H. Item 2(Picture)

Window(s) was/were observed to have the following defect(s): broken latch(es). Broken or damaged hardware should be repaired or replaced.

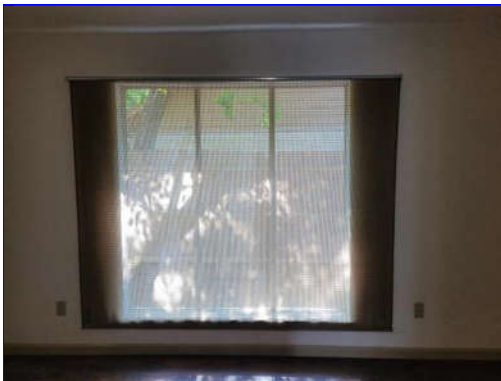
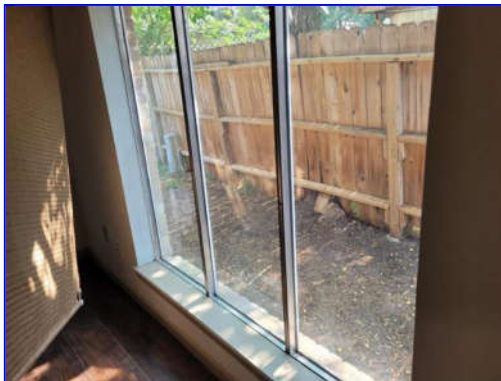
The window(s) in the primary bedroom are fixed widows and not openable. Windows generally serve as the required secondary means of fire egress from sleeping areas. At minimum, windows openings should be at least 20 inches wide, and 24 inches high. The minimum net clear opening space should be 5.7 square feet. The windows to be replaced.

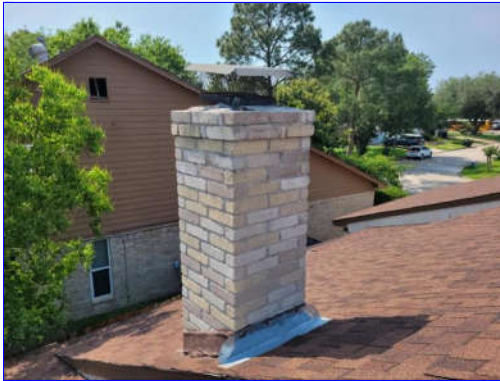
J. Item 1(Picture)

The chimney cap is loose and should be secured

A qualified, verified chimney sweep should be consulted regarding the condition of the chimney or fire place prior to operation of this system. A licensed, qualified plumber may also be needed if the fire place is fueled by gas. Inspector is recommending these conditions be examined BEFORE use of the system.

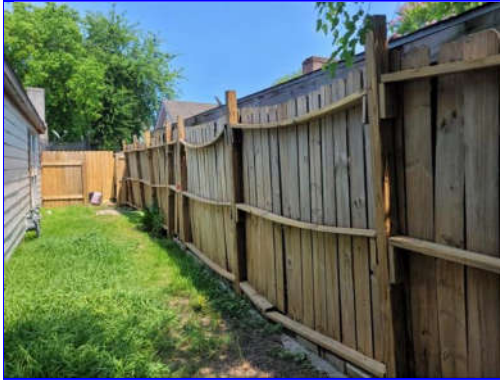
K. Item 1(Picture)

Fence was observed to be damaged or deteriorated. Repair or replacement should be made.

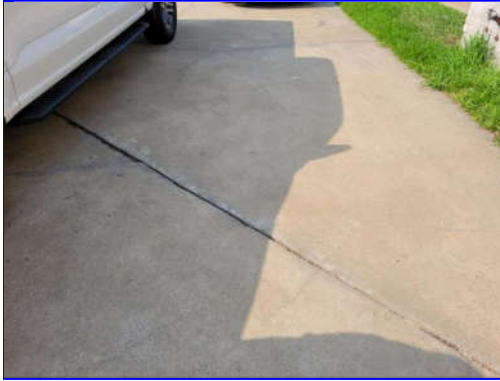
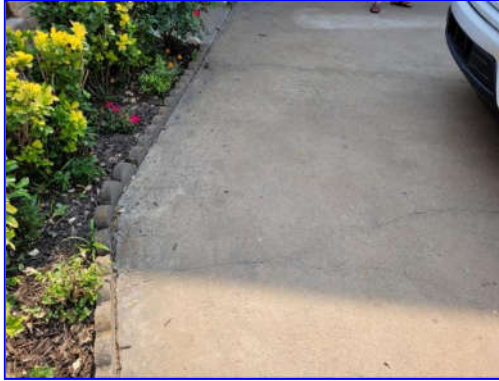
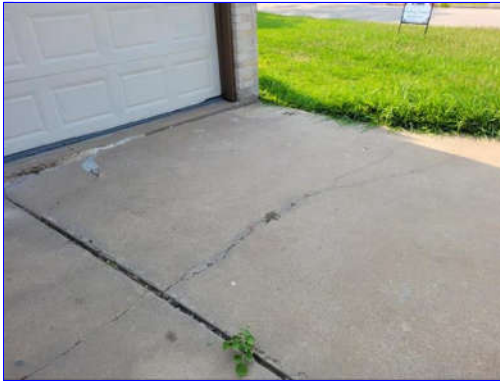
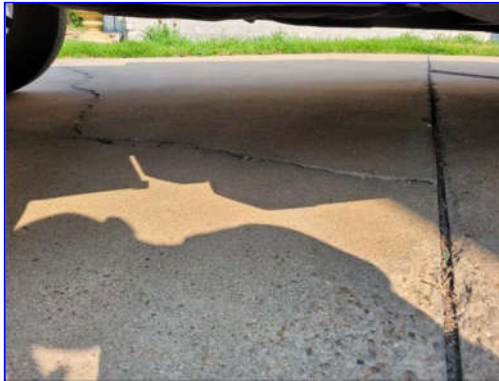
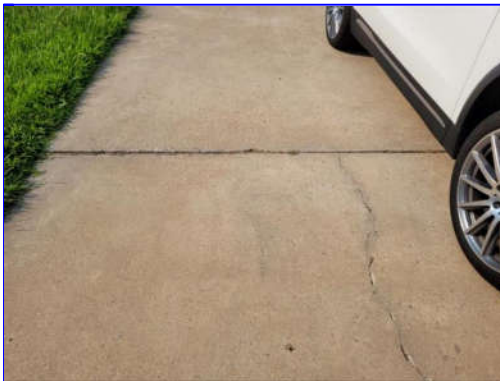
The concrete driveway at the front of the home was/were observed to have the following defect(s): settlement cracks., uneven and can be a tripping hazard. Water can cause further deterioration if not repaired and sealed properly.

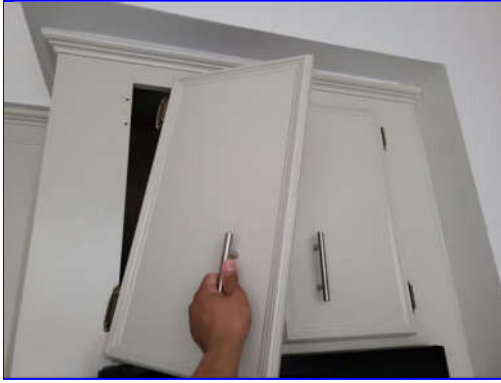
L. Item 1(Picture)

One cabinet door in the kitchen is detached. Repair is needed

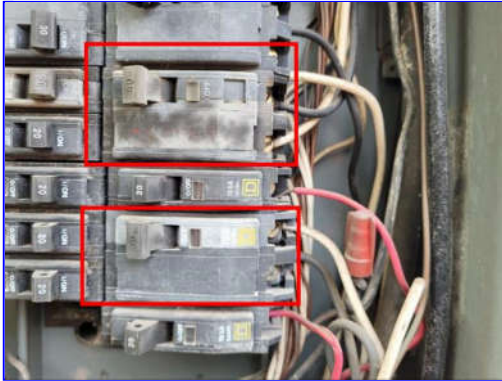
A. Item 7(Picture)

Two 40 and 50 amps breaker(s) that is/are oversized for the wire they protect was/were observed. This condition is a safety hazard that should be corrected by a licensed, qualified electrician.

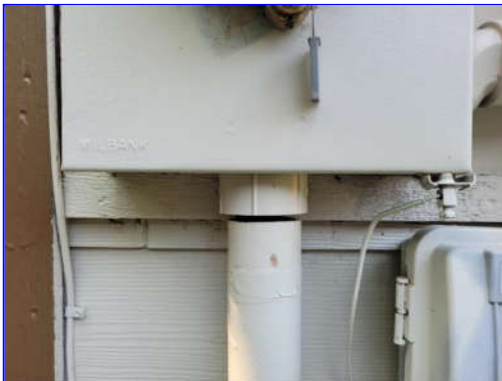
A. Item 8(Picture)

The protective conduit at the electrical meter is loose. Repair is needed

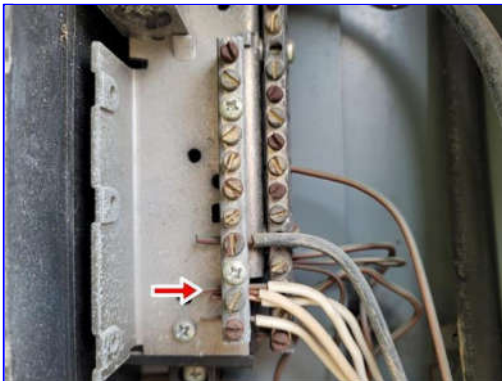
A. Item 10(Picture)

Double or over lugged terminals were observed. Only one conductor/wire is allowed per terminal.

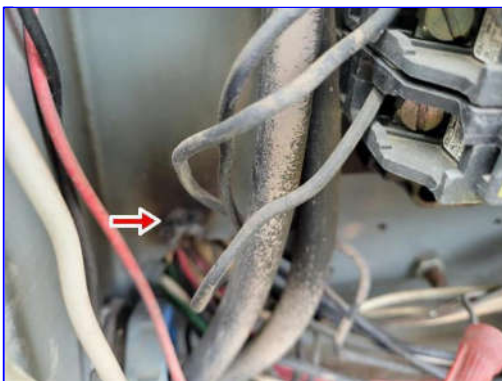
A. Item 11(Picture)

The electrical conductors entering the panel are not protected from the edge of the enclosure by a bushing. This may result in damage to the electrical conductors. A bushing should be installed to prevent damage.

The panel has evidence of overheating at the wire entrance area. It should be further evaluated by a licensed electrician for proper repairs.

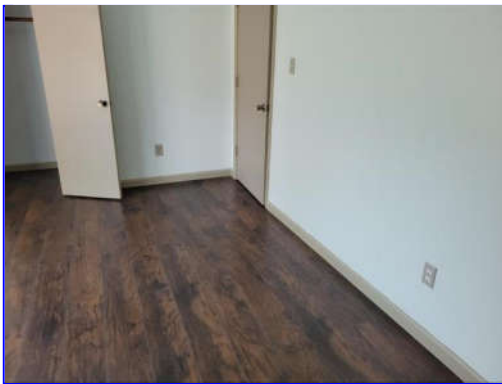
B. Item 2(Picture)

Most receptacle outlets in the rear bedroom are open grounded. Repairs are needed

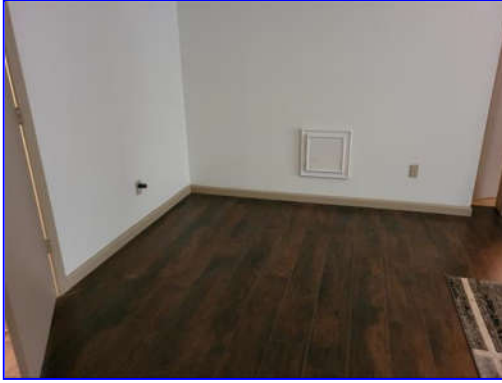
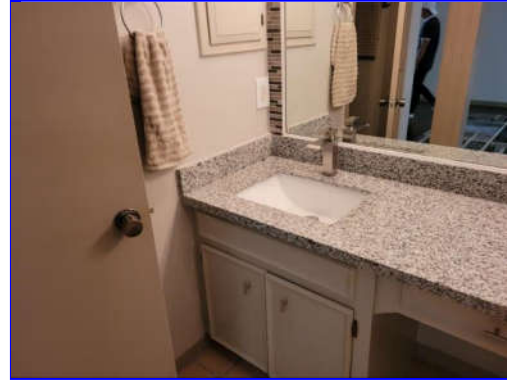
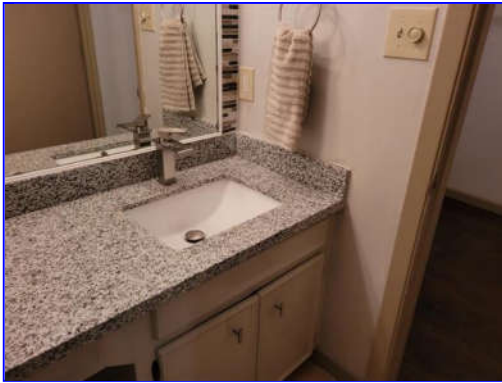
Several receptacle outlets are inoperative. They should be repaired

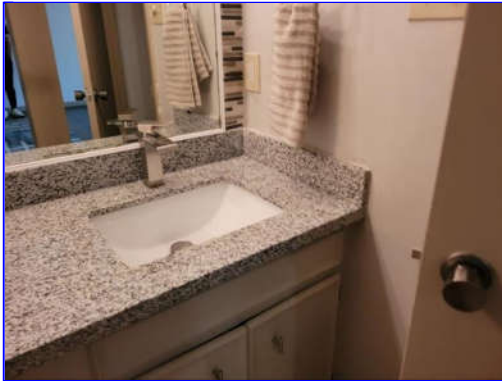
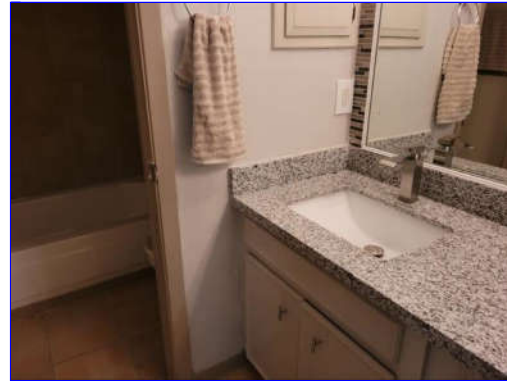
Two ground fault interrupt receptacle(s) in the primary bathroom was/were observed to have the following defect(s): is tripped and will not reset. A defective GFCI receptacle will affect other receptacles on this circuit, possibly in other rooms or in other locations requiring GFCI protection Repairs should be undertaken by a qualified, verified, licensed electrician.

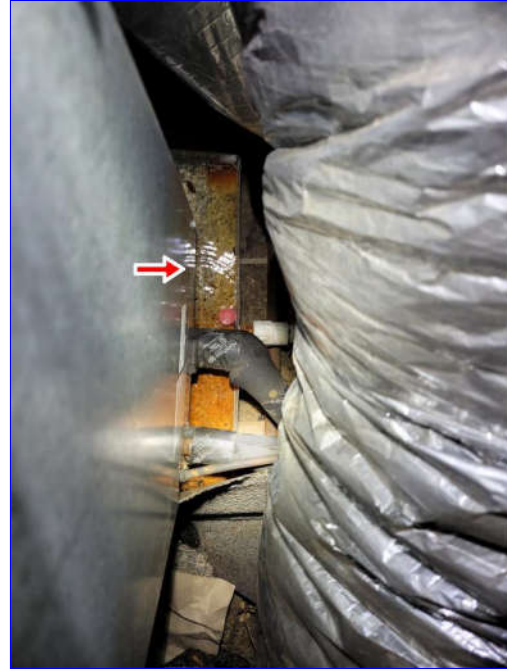
B. Item 14(Picture)

Excessive air was observed to be leaking at the evaporator unit/return air plenum in the attic. Repairs should be made to ensure the optimal performance of the HVAC system. A qualified, verified, licensed HVAC technician should be consulted regarding proper repairs.

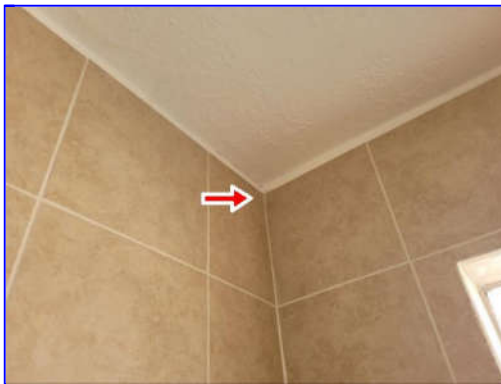
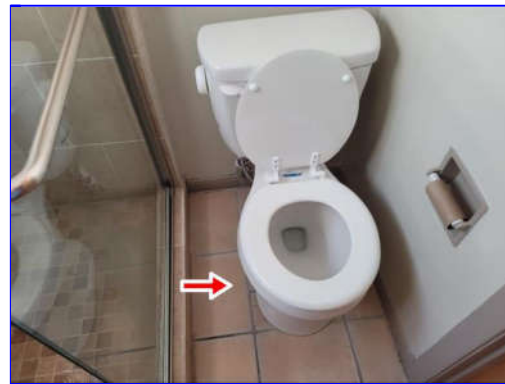
- The under mounted sink(s) was/were observed to have deteriorated caulking or not caulked at the counter top. In most cases the sink(s) will need to be removed to be caulked properly.
- The ceiling shower head continue to drip after turn off
- The toilet was observed to be loose at the floor. The toilet should be removed and reset. The toilet and flange should be inspected for damage. When a toilet leaks at the floor is is possible for the leak to go between the foundation and the flooring cover and cause damage that is not visible to the inspector at the time of inspection. Further repairs may be possible.

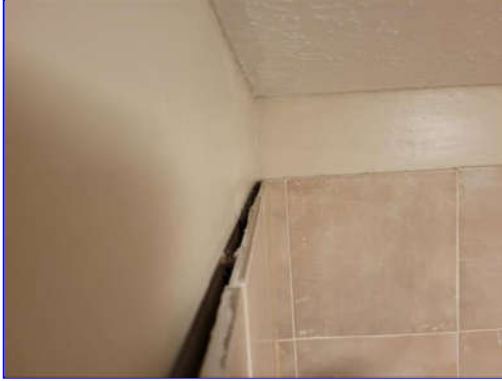
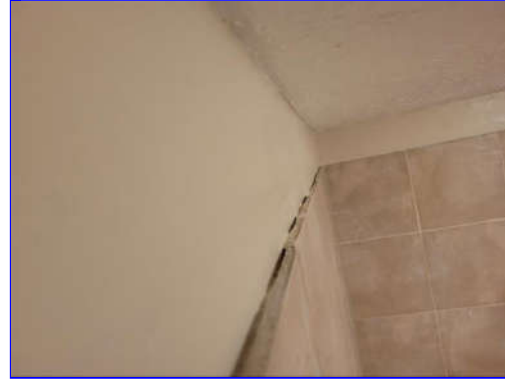
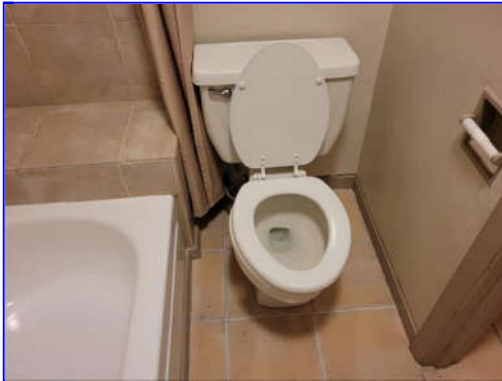
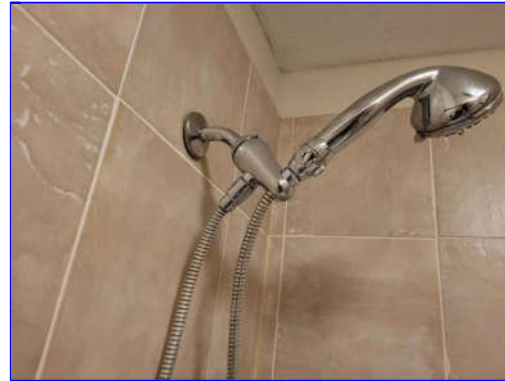
- The under mounted sink(s) was/were observed to have deteriorated caulking or not caulked at the counter top. In most cases the sink(s) will need to be removed to be caulked properly.

- The top edge of the enclosure should be sealed to prevent moisture from entering behind the enclosure.
- The toilet was observed to be loose at the floor. The toilet should be removed and reset. The toilet and flange should be inspected for damage. When a toilet leaks at the floor is is possible for the leak to go between the foundation and the flooring cover and cause damage that is not visible to the inspector at the time of inspection. Further repairs may be possible.

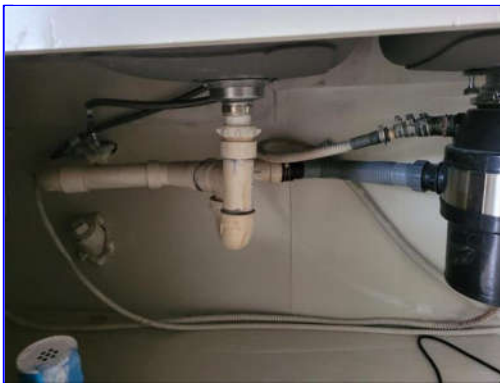
B. Item 1(Picture)

Ponding water was detected on the floor in the living room. The water appears to be coming from the ground behind the kitchen drain. This condition could indicate a possible kitchen sewer leaks. The sewer system should be further investigate and repaired

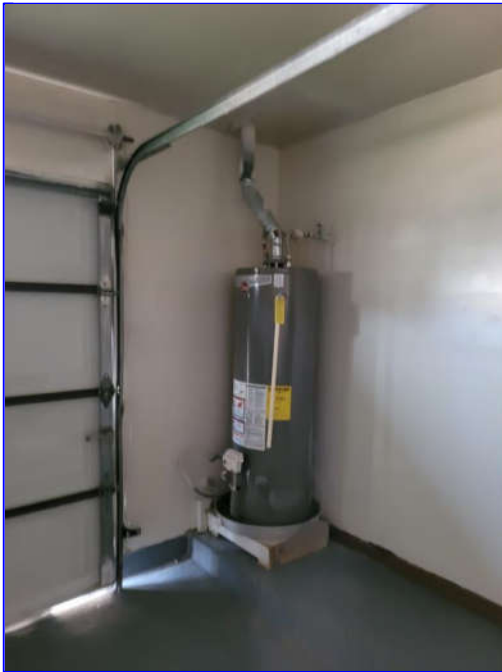
C. Item 1(Picture)

The water heater is not properly elevated off the floor. Under current mechanical installation standards, water heaters located in the garage should be a minimum of 18-inches above the lowest garage floor elevation. The water heater should also have protection from mechanical damage.

The water heater gas supply line was observed to not be equipped with a sediment trap just before the appliance connector. This condition does not meet current installation requirements and should be corrected. Sediment traps prevent debris from entering the gas controls and causing hazardous malfunctions. A licensed, qualified plumber should be consulted regarding this condition.

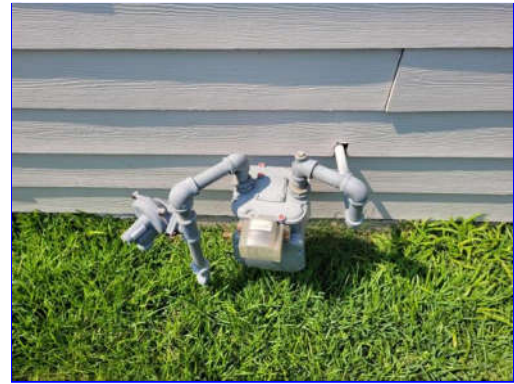
E. Item 2(Picture)

Gas Meter was observed to not be bonded. Proper bonding should be metal to metal. Paint may have to be removed to ensure proper bonding. The utility company should be contacted regarding this condition.

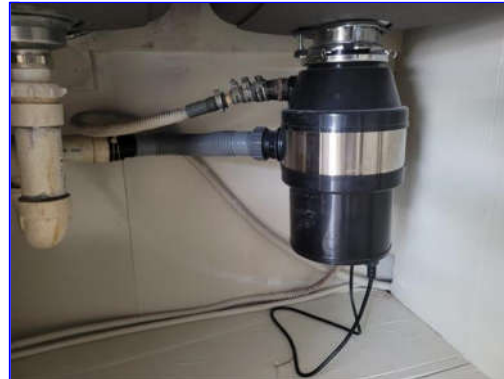
A. Item 4(Picture)

The dishwasher was observed to not be equipped with an air gap valve or high loop. Air gap valves/high loops prevent contaminated water from the sink from passing down the drain line and into the dishwasher.

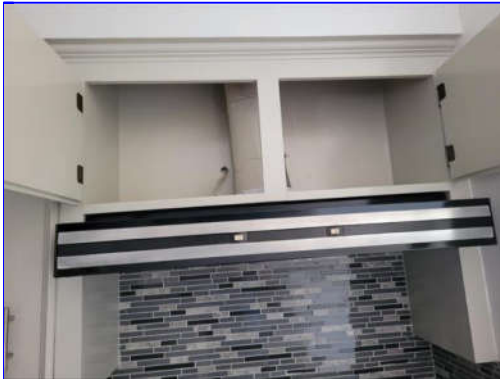
C. Item 3(Picture)

The range hood is not evenly installed. It should be improved.

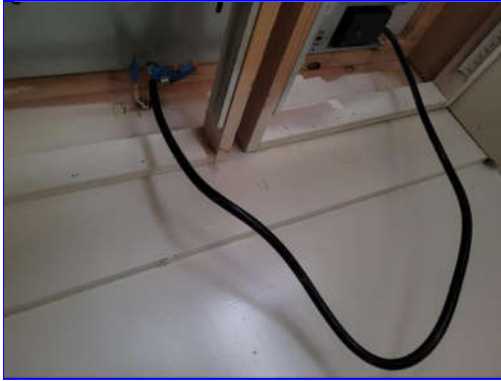
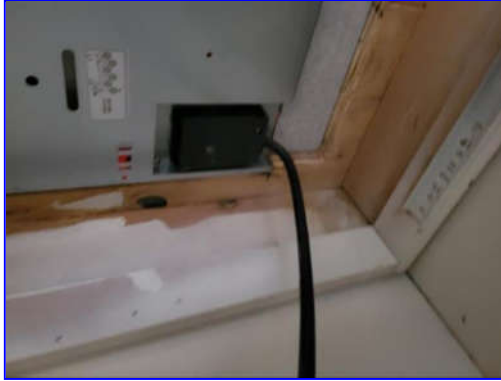
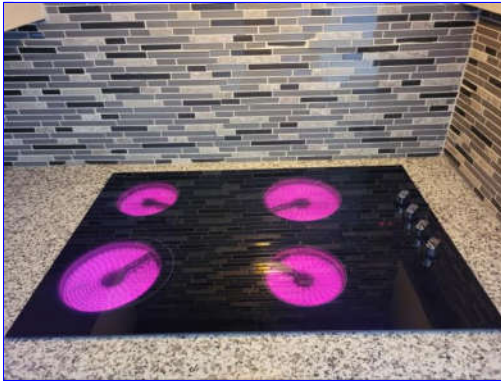
The electrical conduit at the cooktop is not properly secured or installed. Repairs are needed

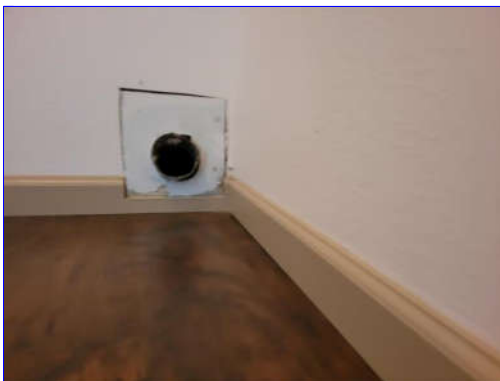
H. Item 1(Picture)

The clothes dryer vent was observed to be in need of cleaning. Clogged dryer vents can be fire hazards.
