# Your Inspection Report

7109 Delesandri Dr  
Hitchcock, TX 77563

Wednesday, May 11, 2022

# PROPERTY INSPECTION REPORT FORM

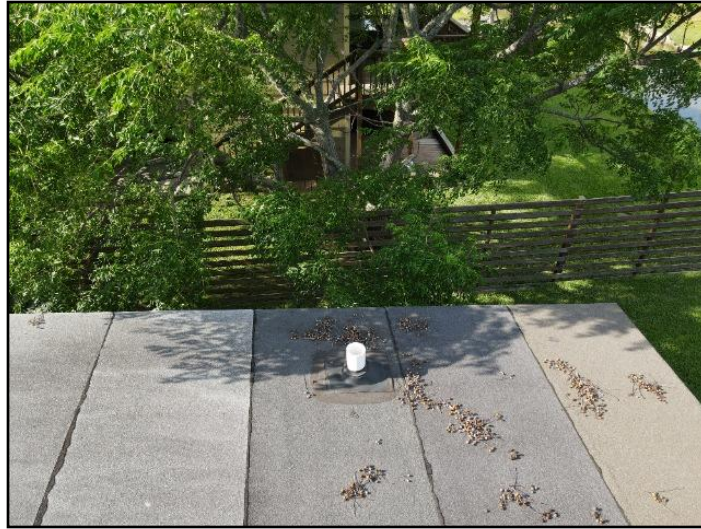
7. Tree branches touching roof

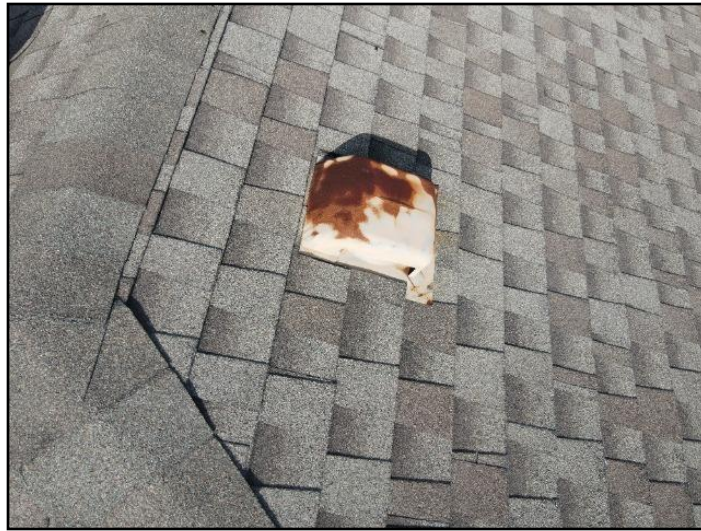
- Sloped roof flashings\Roof vent: **Exposed fasteners not sealed** Notes: **Rusted**

12. *Exposed fasteners not sealed*

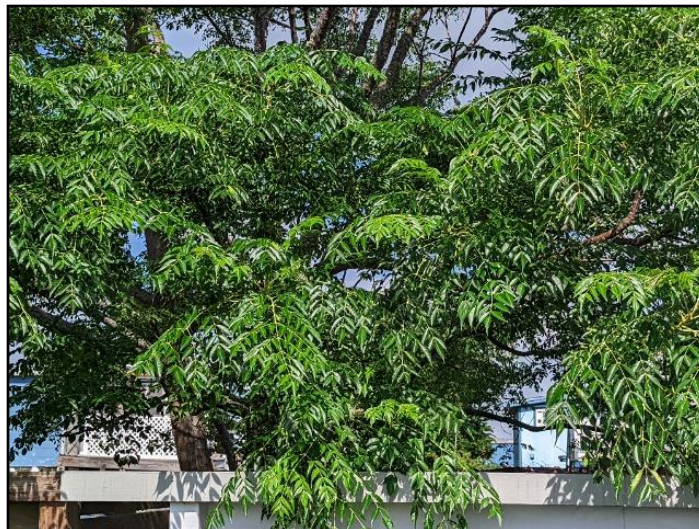
19. *Trees or shrubs too close to building*

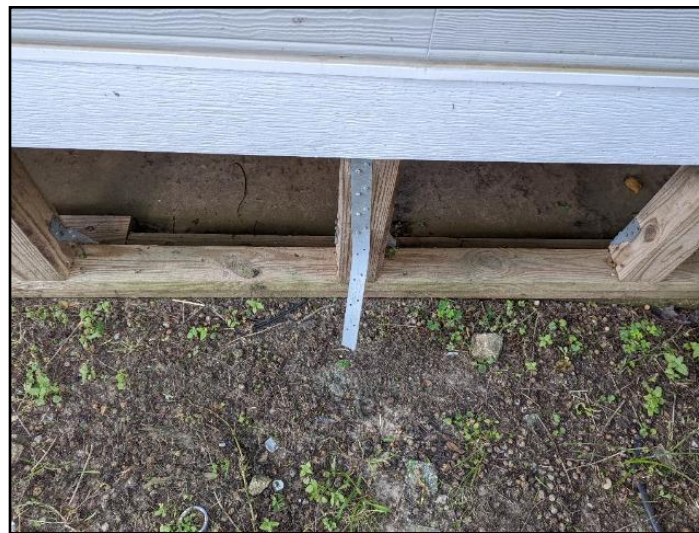
25. Anchors not centered in sill

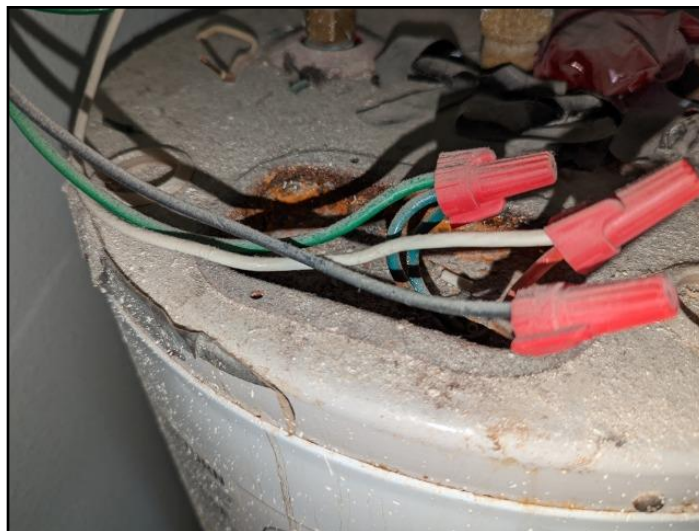
**Implication(s):** Fire or explosion

53. Tank not electrically bonded to ground

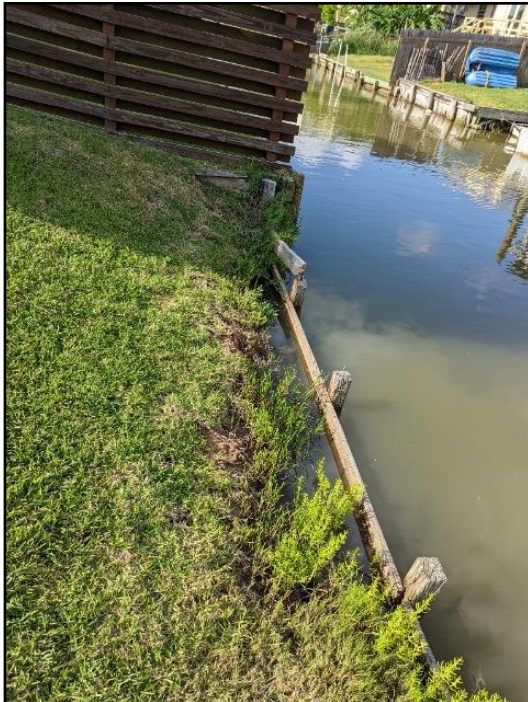
**71. Condition:** • Key Note: The bulkhead appears to be in disrepair and a new bulkhead may need to be installed to prevent further erosion rions from taking place.

**72. Condition:** • Bulk Head In disrepair

**Implication(s):** Major Erosion

**Location:** Bulkhead

86. Bulk Head In disrepair

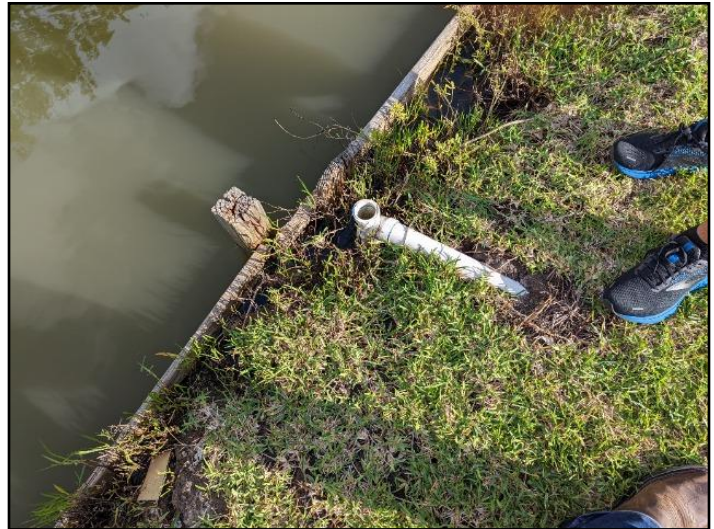
87. Bulk Head In disrepair

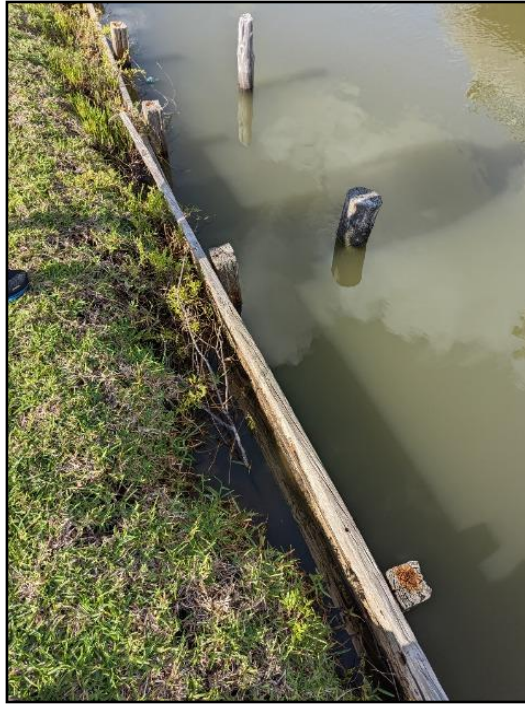
**88.** *Bulk Head In disrepair*
