## MECHANICAL INSPECTION

4131 Durness Way  
Houston TX 77025

Monzer Hourani c/o Mandie Peel  
OCTOBER 14, 2020

# PROPERTY INSPECTION REPORT

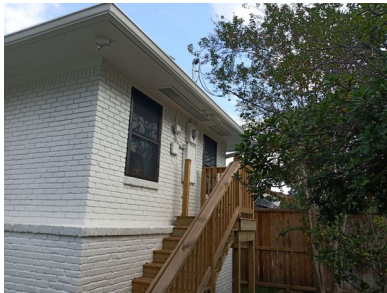
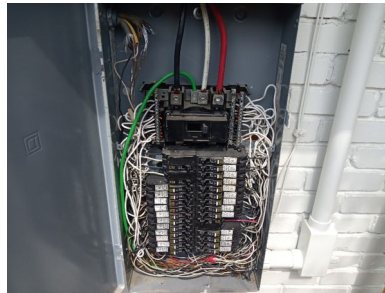
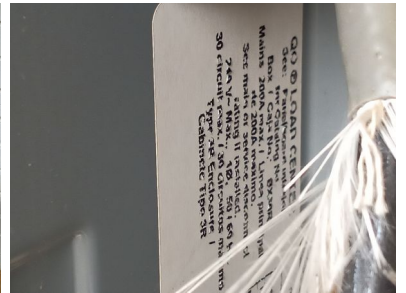
<u>Location</u>	<u>Manufacturer</u>	<u>Rating</u>
Rear	Square D	200 amps

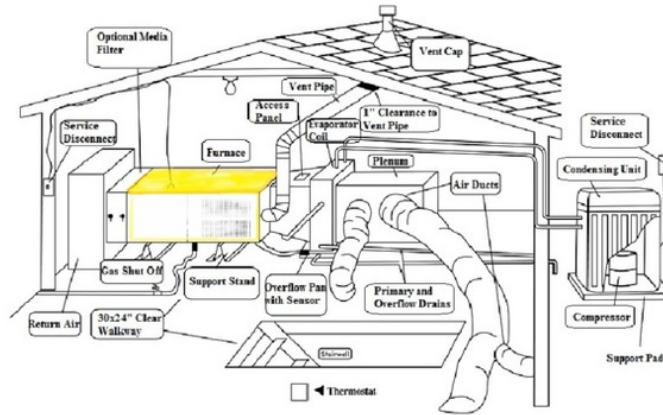
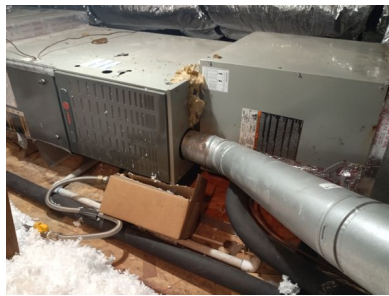
<u>ZONE</u>	<u>BRAND</u>	<u>BTU</u>	<u>DATE</u>	<u>LOCATION</u>
West	Trane	60k	2009	Attic
Easy	Trane	60k	2009	Attic

The heating equipment was observed to be operating and functional at the time of the inspection. The heating equipment responded to the thermostat and the equipment appeared to be heating the air adequately.

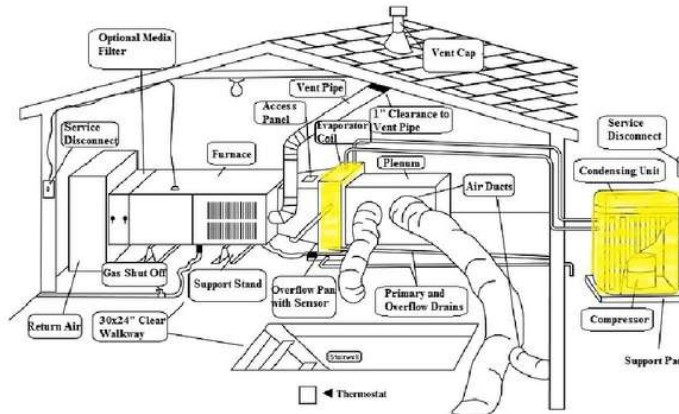
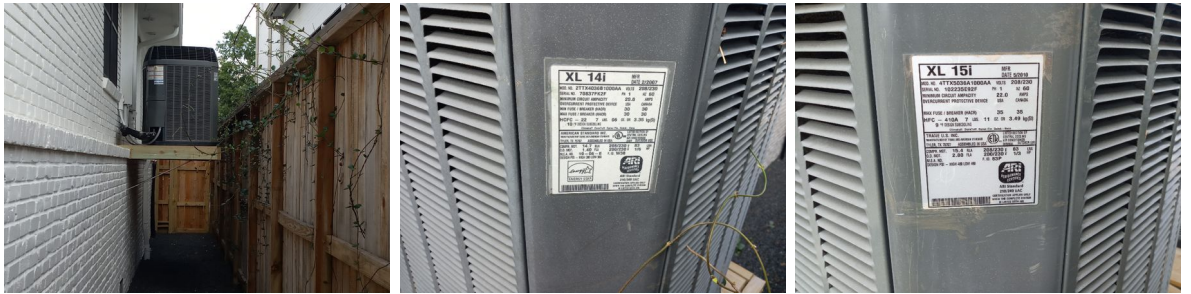
Zone	Brand	Size/Age Condenser	Size/Age Coil	Temp Drop
West	Trane	3-ton 2007	3-ton 2016	20
East	Trane	3-ton 2010	3-ton 2016	20

The condensing unit equipment was functional at the time of the inspection. The equipment responded to the corresponding thermostat, and the compressor components and fan motor components were operating.

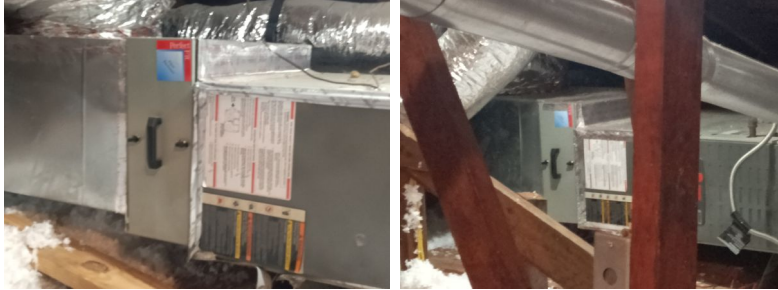
Media filter equipment was installed for the HVAC system(s) in the attic. It is pointed out that when a media filter is installed, a filter should not be installed at the return air grill in the living space. Also, media filters need to be replaced periodically.

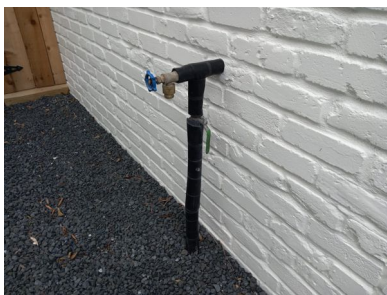
East side of house

The shut-off valve for the main inlet water line was located at the exterior of the house.

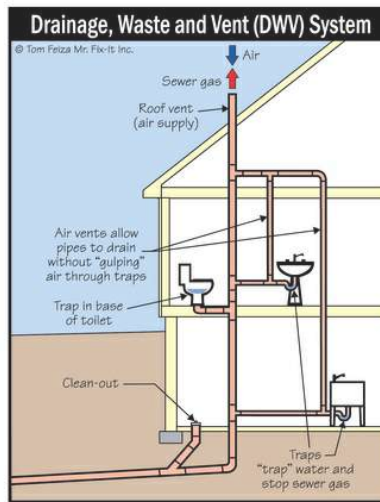
No items requiring repair were visible for the operation of the drain system at the time of the inspection. No evidences of a system wide problem were observed when the system was operationally checked by running water through each of the plumbing fixtures during the duration of the inspection.

It is noted that most of the drain waste system in the walls, under the floors, and in the ceilings is not visible. If further investigation is desired, it is recommended that a plumber be contacted to perform an in depth survey with a camera or hydrostatic test.

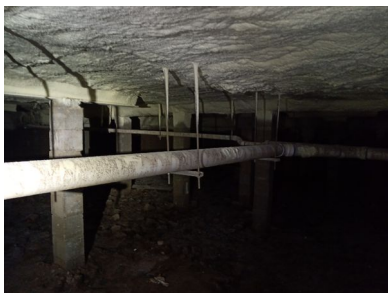
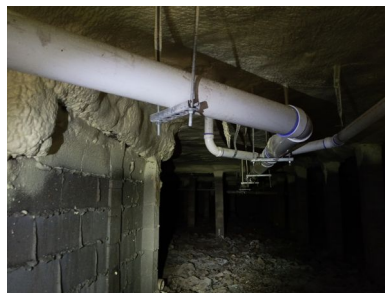
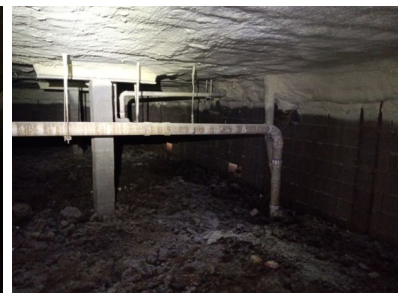
The visible above ground sewer piping at the crawlspace under the house was observed to be PVC.

The sewer piping appeared to be installed properly and no leaks were visible when we ran water down the piping during the crawlspace inspection.

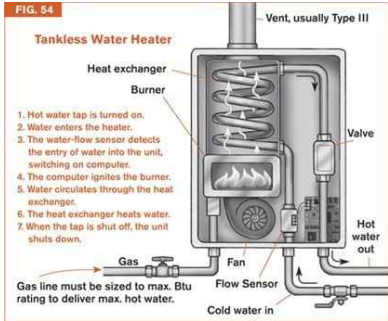
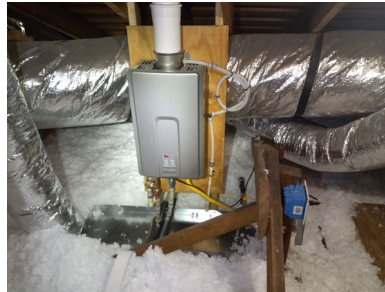
<u>Location</u>	<u>Brand</u>	<u>Capacity</u>	<u>Age</u>	<u>Energy Type</u>
Attic	Rinnai	180 gph	3-5 Years	Gas

The water heater equipment was functional at the time of the inspection and providing hot water to the applicable plumbing fixtures.

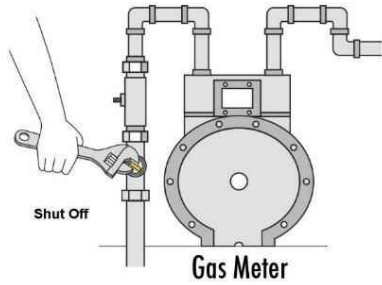
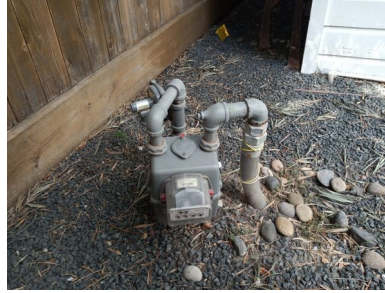
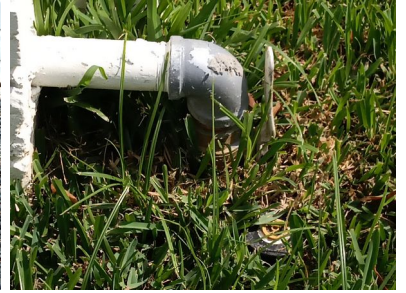
Rear garage

valve was located at the rear of the house.

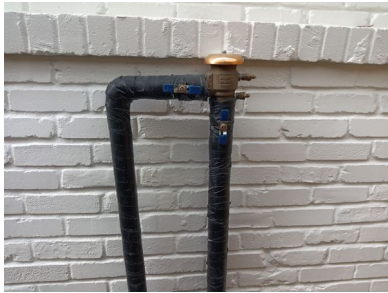
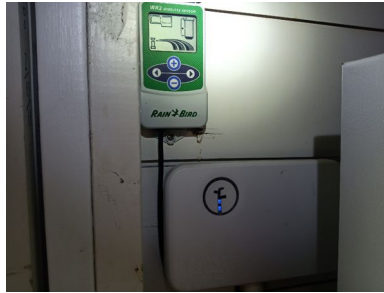
*Sprinkler System:* Rachio, Located inside garage, 10 zones -

An automatic sprinkler system was installed. The system included a control panel, one or more solenoid valves, underground water lines and with sprinkler heads.

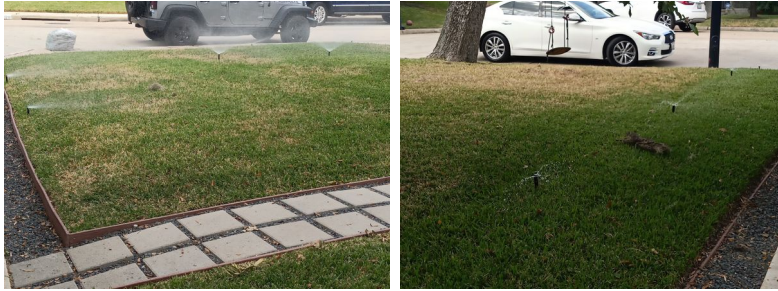
A backflow prevention device was present and was equipped with the two water shut off valves on the water supply line to the sprinkler system.

No items requiring repair were visible at the time of the inspection in the operation of the individual zones. The control panel was functional, all zones were observed to be operating, and all the heads were observed to be spraying adequately.
